Damage of RC Wall Buildings  
due to Past Damaged Earthquake

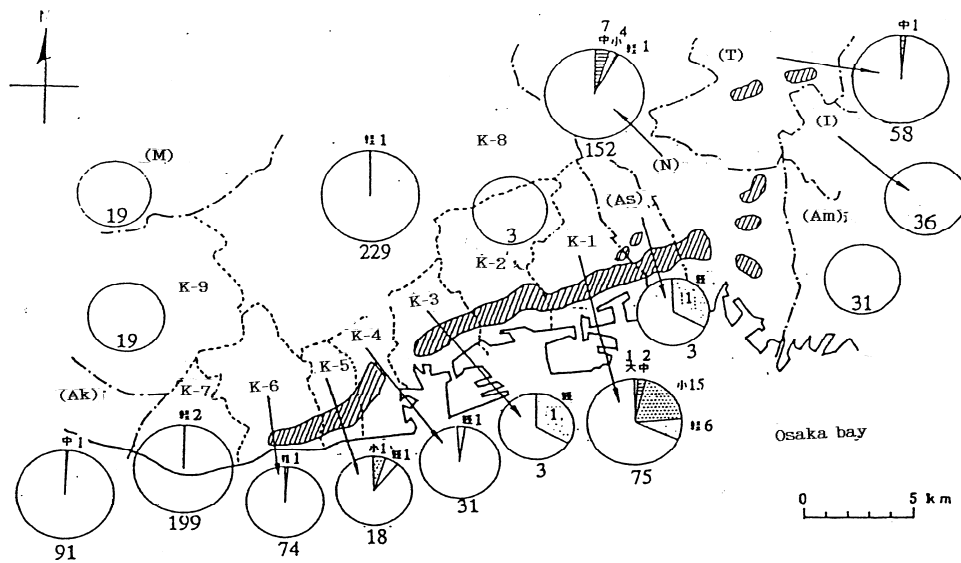
Figure 1.2-1 Regional numbers of investigated and damaged RC wall buildings in Hyogo-Ken Nanbu Earthquake

(Figures mean the number of investigated and damaged buildings)

Area of JMA seismic intensity scale VII
