Seismic and Tsunami Damage on Building Structures Caused by the 2011 Tohoku Japan Earthquake

MIDORIKAWA Mitsumasa
Hokkaido Univ.

Damage to Buildings Caused by Ground Shaking and Tsunami

Summary of damage reconnaissance by the Steel Structures Committee of AIJ

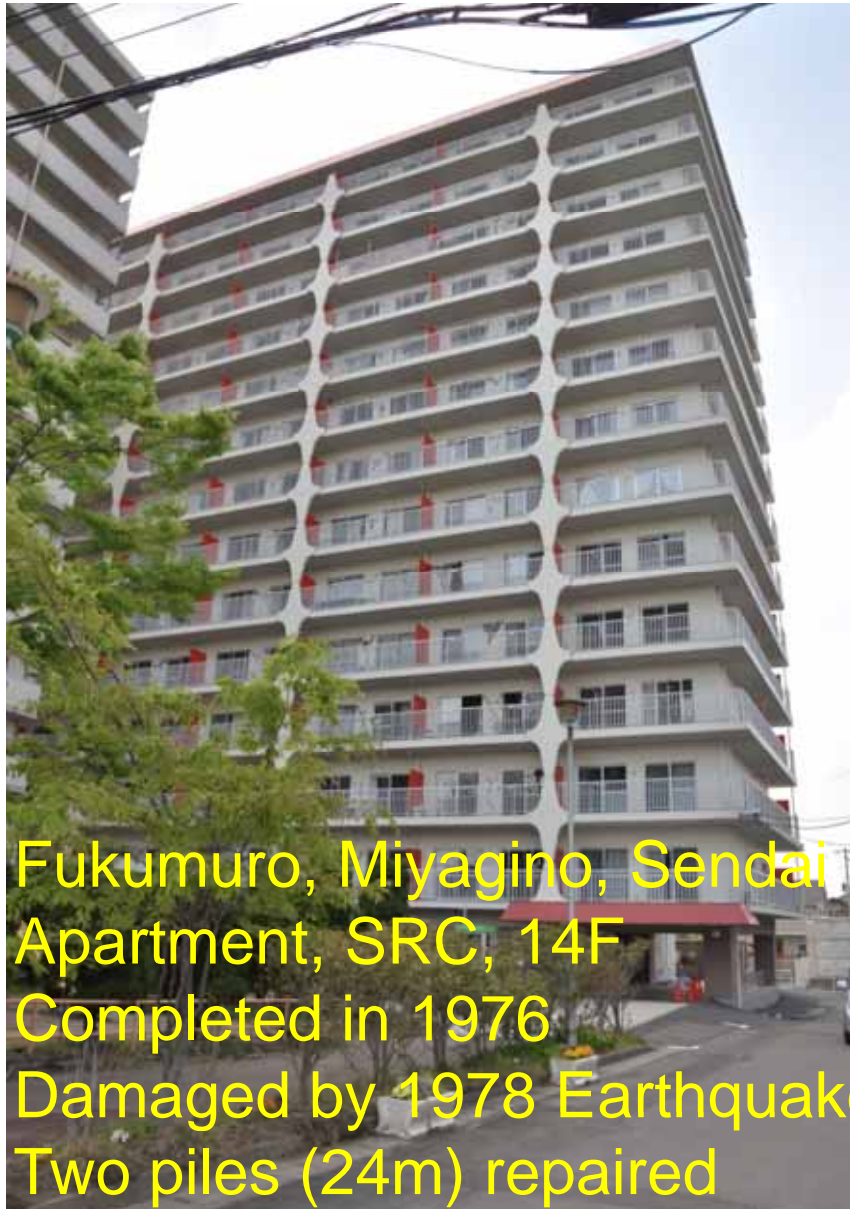
Sunny Heights Takasago (SRC, 14F, 189 units)-1

Fukumuro, Miyagino, Sendai
Apartment, SRC, 14F
Completed in 1976
Damaged by 1978 Earthquake
Two piles (24m) repaired

Severe damage again
Damage to piles
Shear cracks in beams/columns

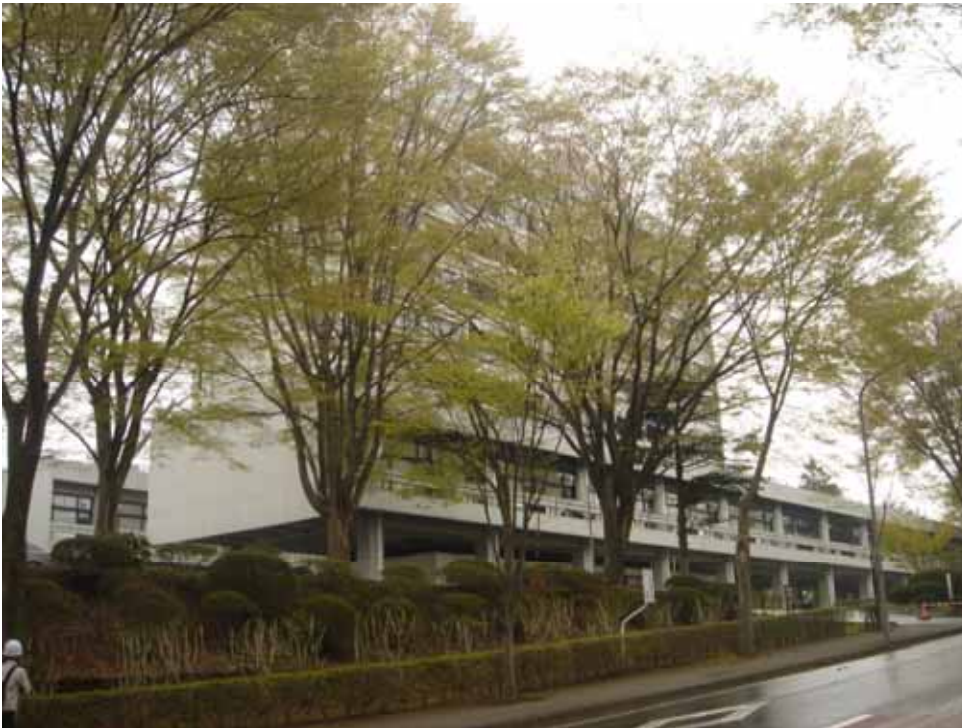
Tohoku Univ. (SRC, 9F)-1 Civil Engrg. & Architecture

Aoba, Sendai
School, SRC, 9F, Completed in 1969
Damaged by 1978 EQ
Strengthened with RC shear walls
after 1978 EQ
Strengthened with steel braces
in 2000

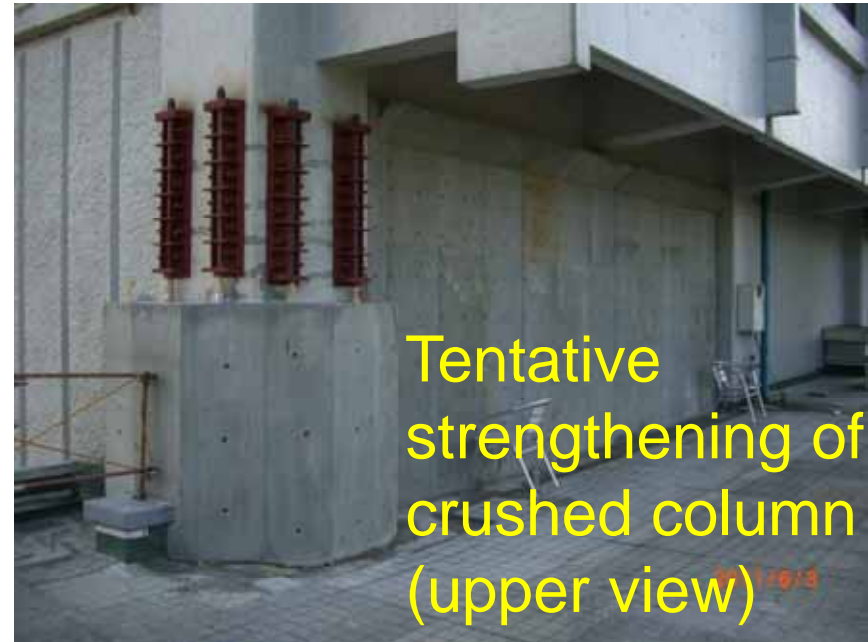
Shear walls failure followed by bending crush of corner columns of side walls

Tentative strengthening of crushed column (upper view)

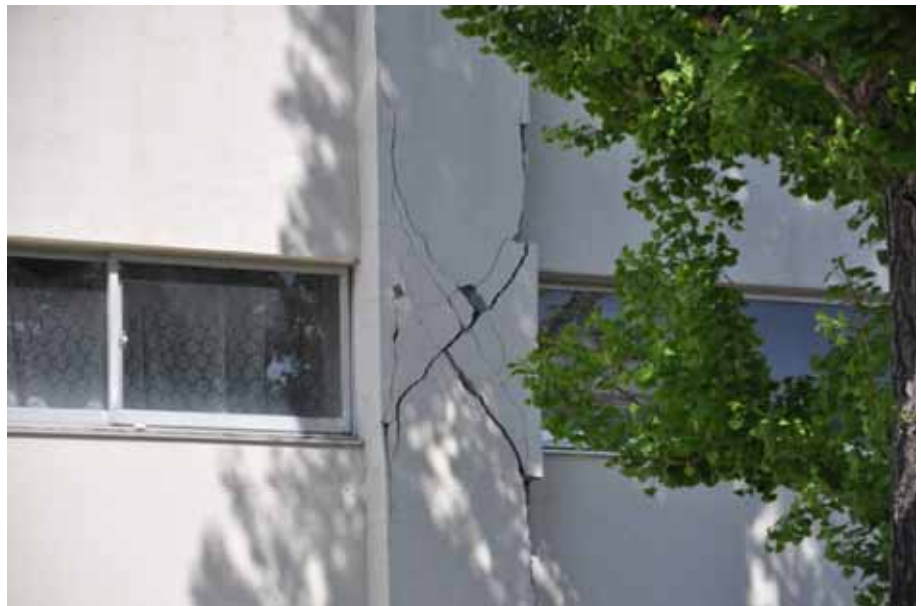
Severe damage to RC Building (3F) 1-1

Office, RC, 3F, Completed in 1969

Shear failure of first story columns

Torsional behavior caused by eccentric core

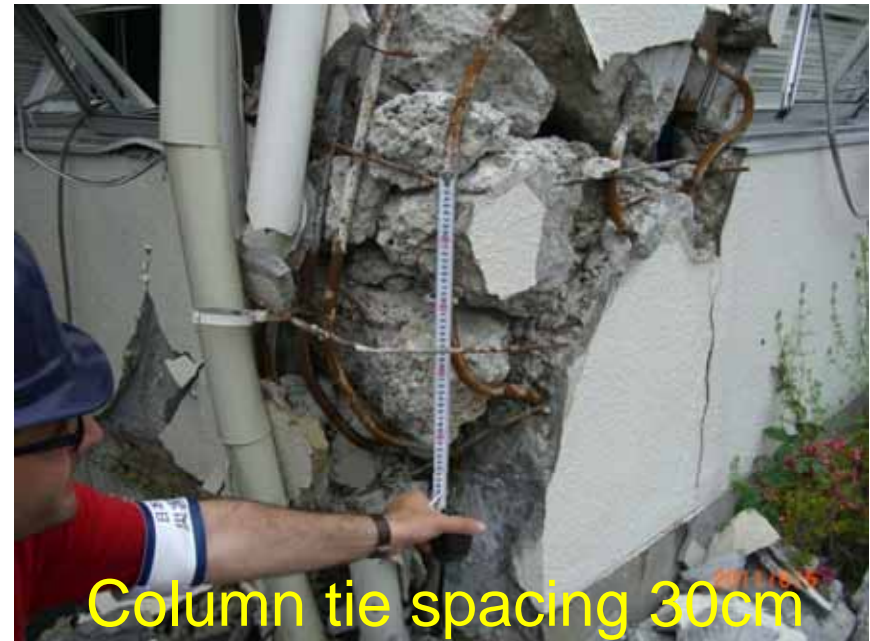
Severe Damage to RC Building (3F) 2-1

Higashimiyagino, Miyagino, Sendai
Office, RC, 3F
Shear failure of first story columns

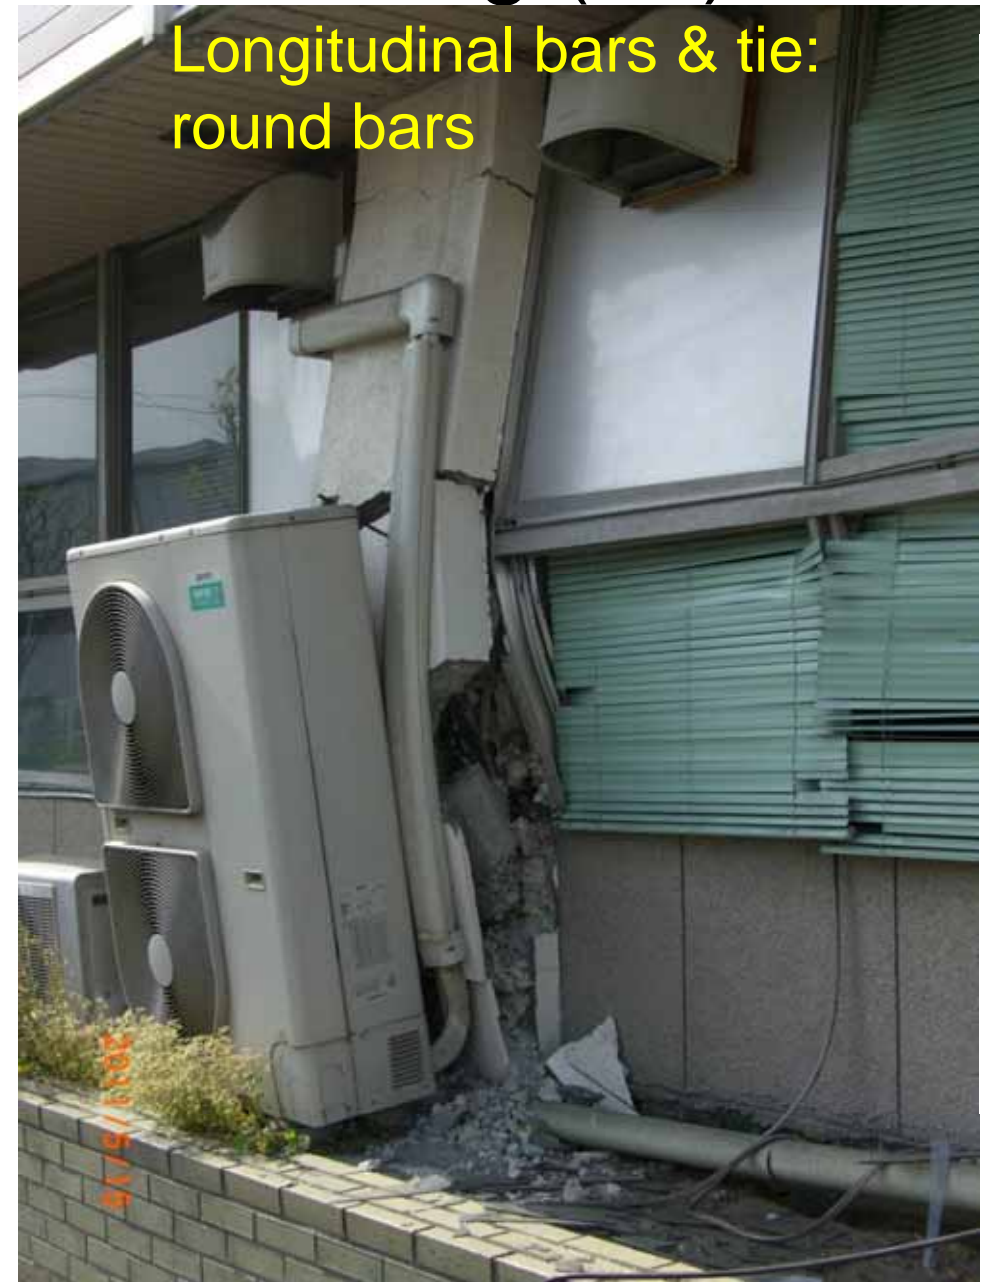
Severe Damage to RC Building (3F) 2-2

Longitudinal bars & tie:
round bars

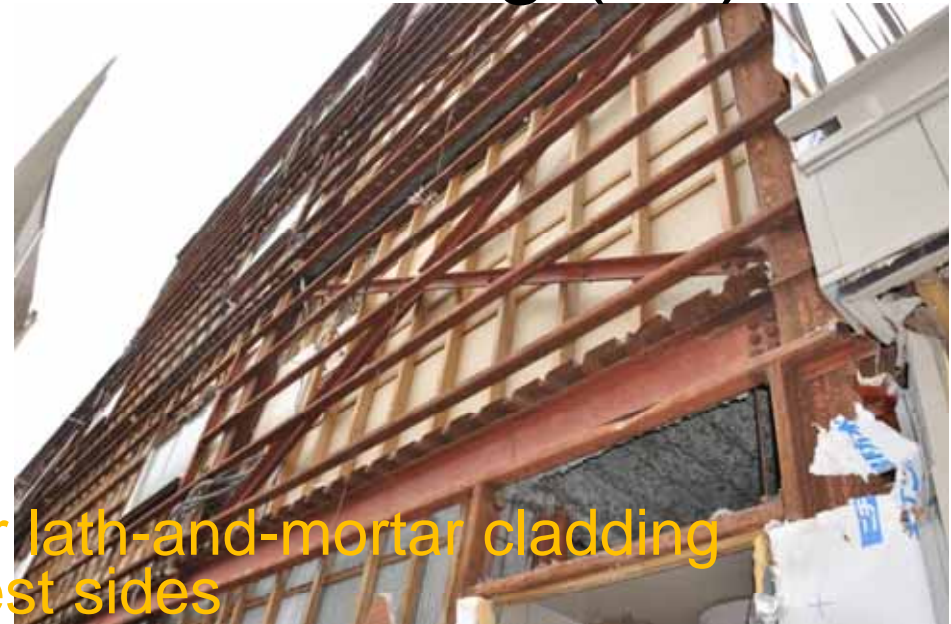
Failure of timber lath-and-mortar cladding
on north and west sides

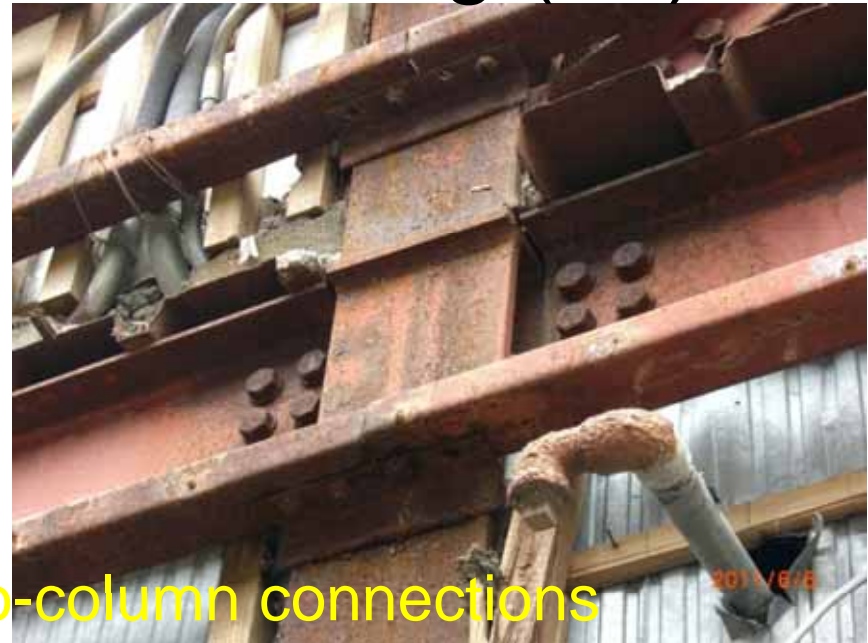
No damage to beam-to-column connections

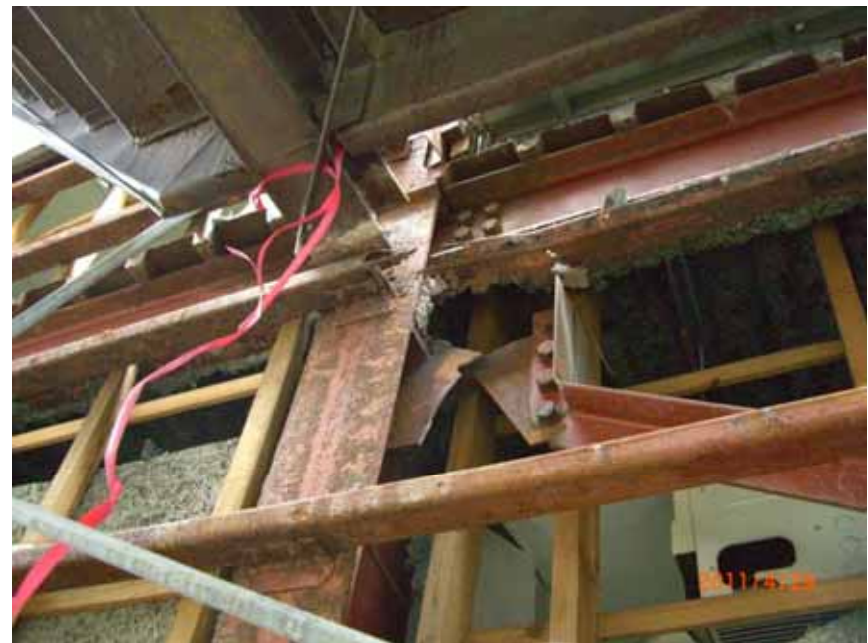
Failure of column
base concrete

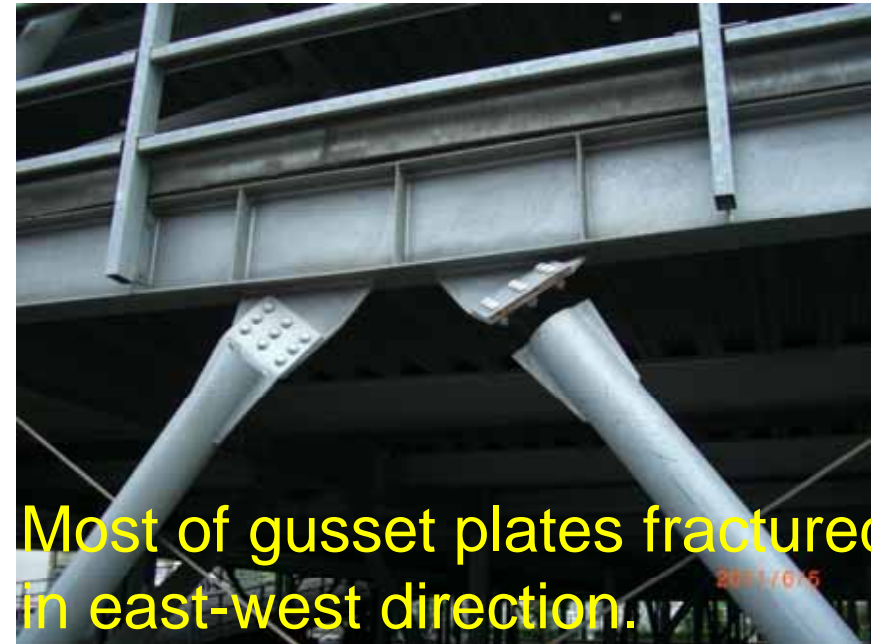
Out-of-plane deformation and fracture of gusset plates

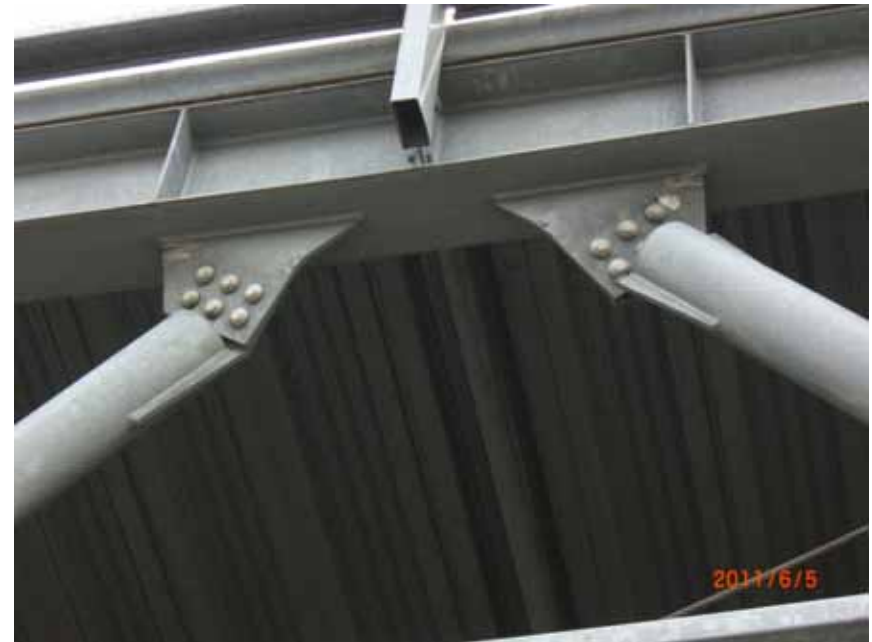
Most of gusset plates fractured in east-west direction.

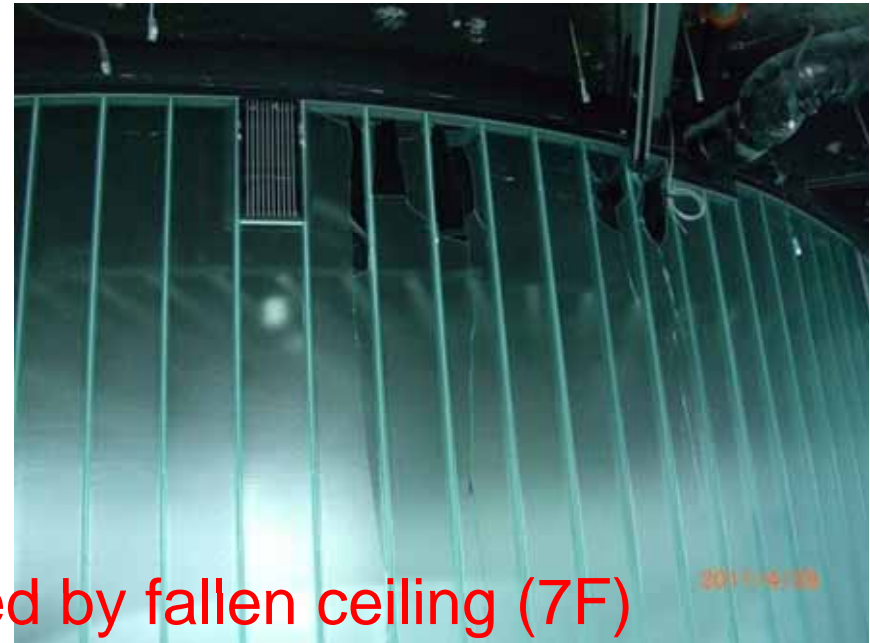
Glass walls damaged by fallen ceiling (7F)

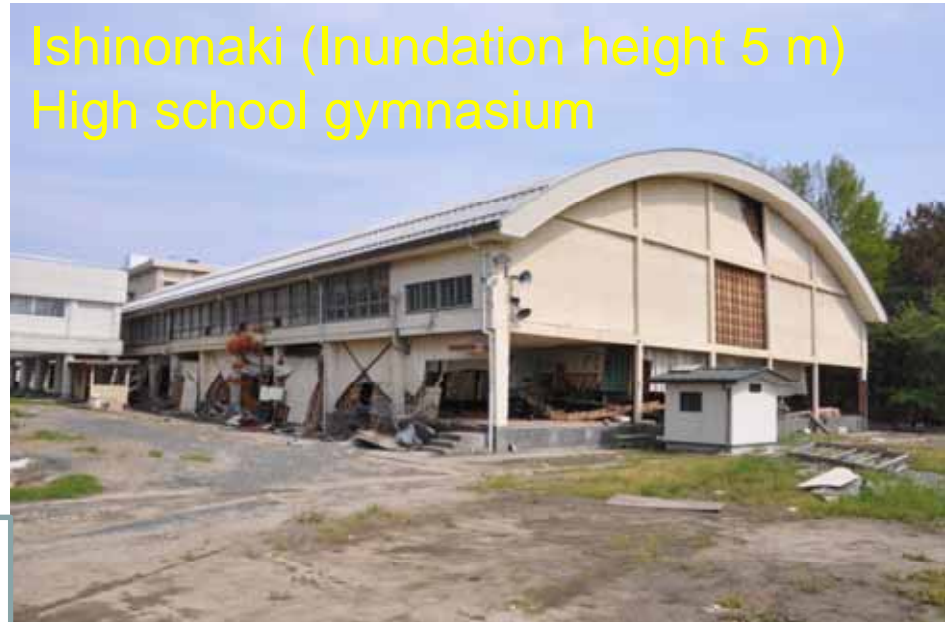
Ishinomaki (Inundation height 5 m)
High school gymnasium

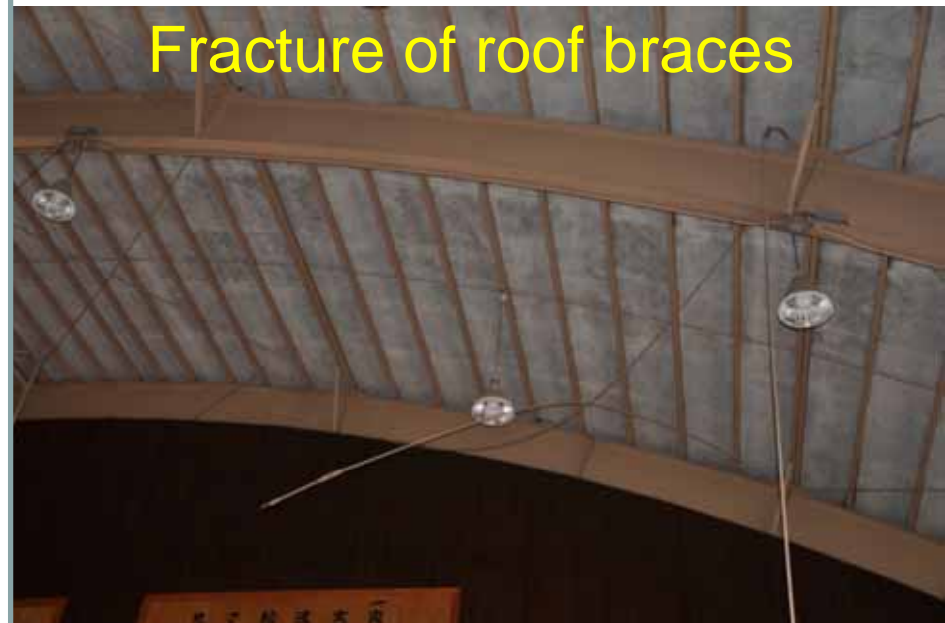
Fracture of roof braces

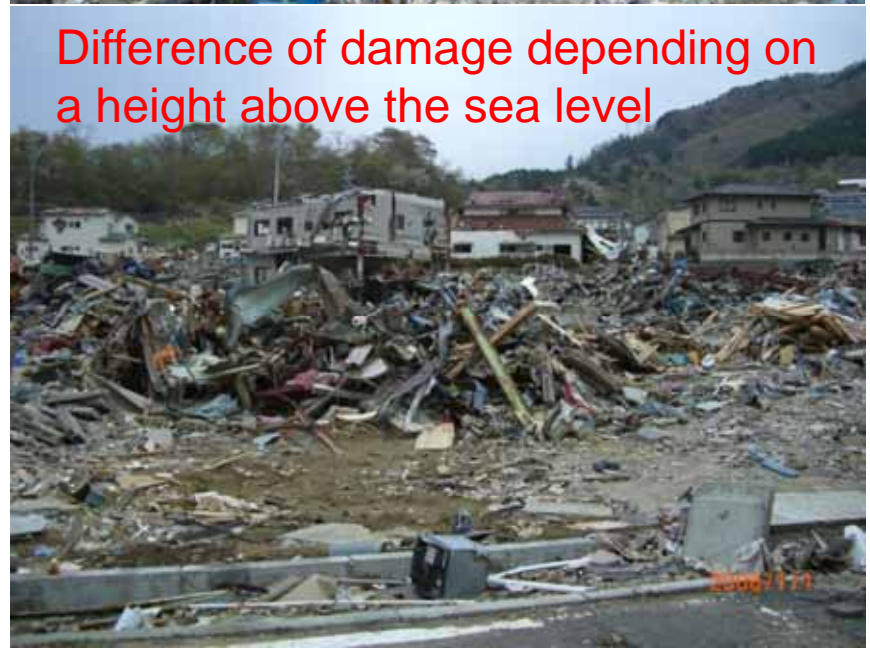
Difference of damage depending on
a height above the sea level

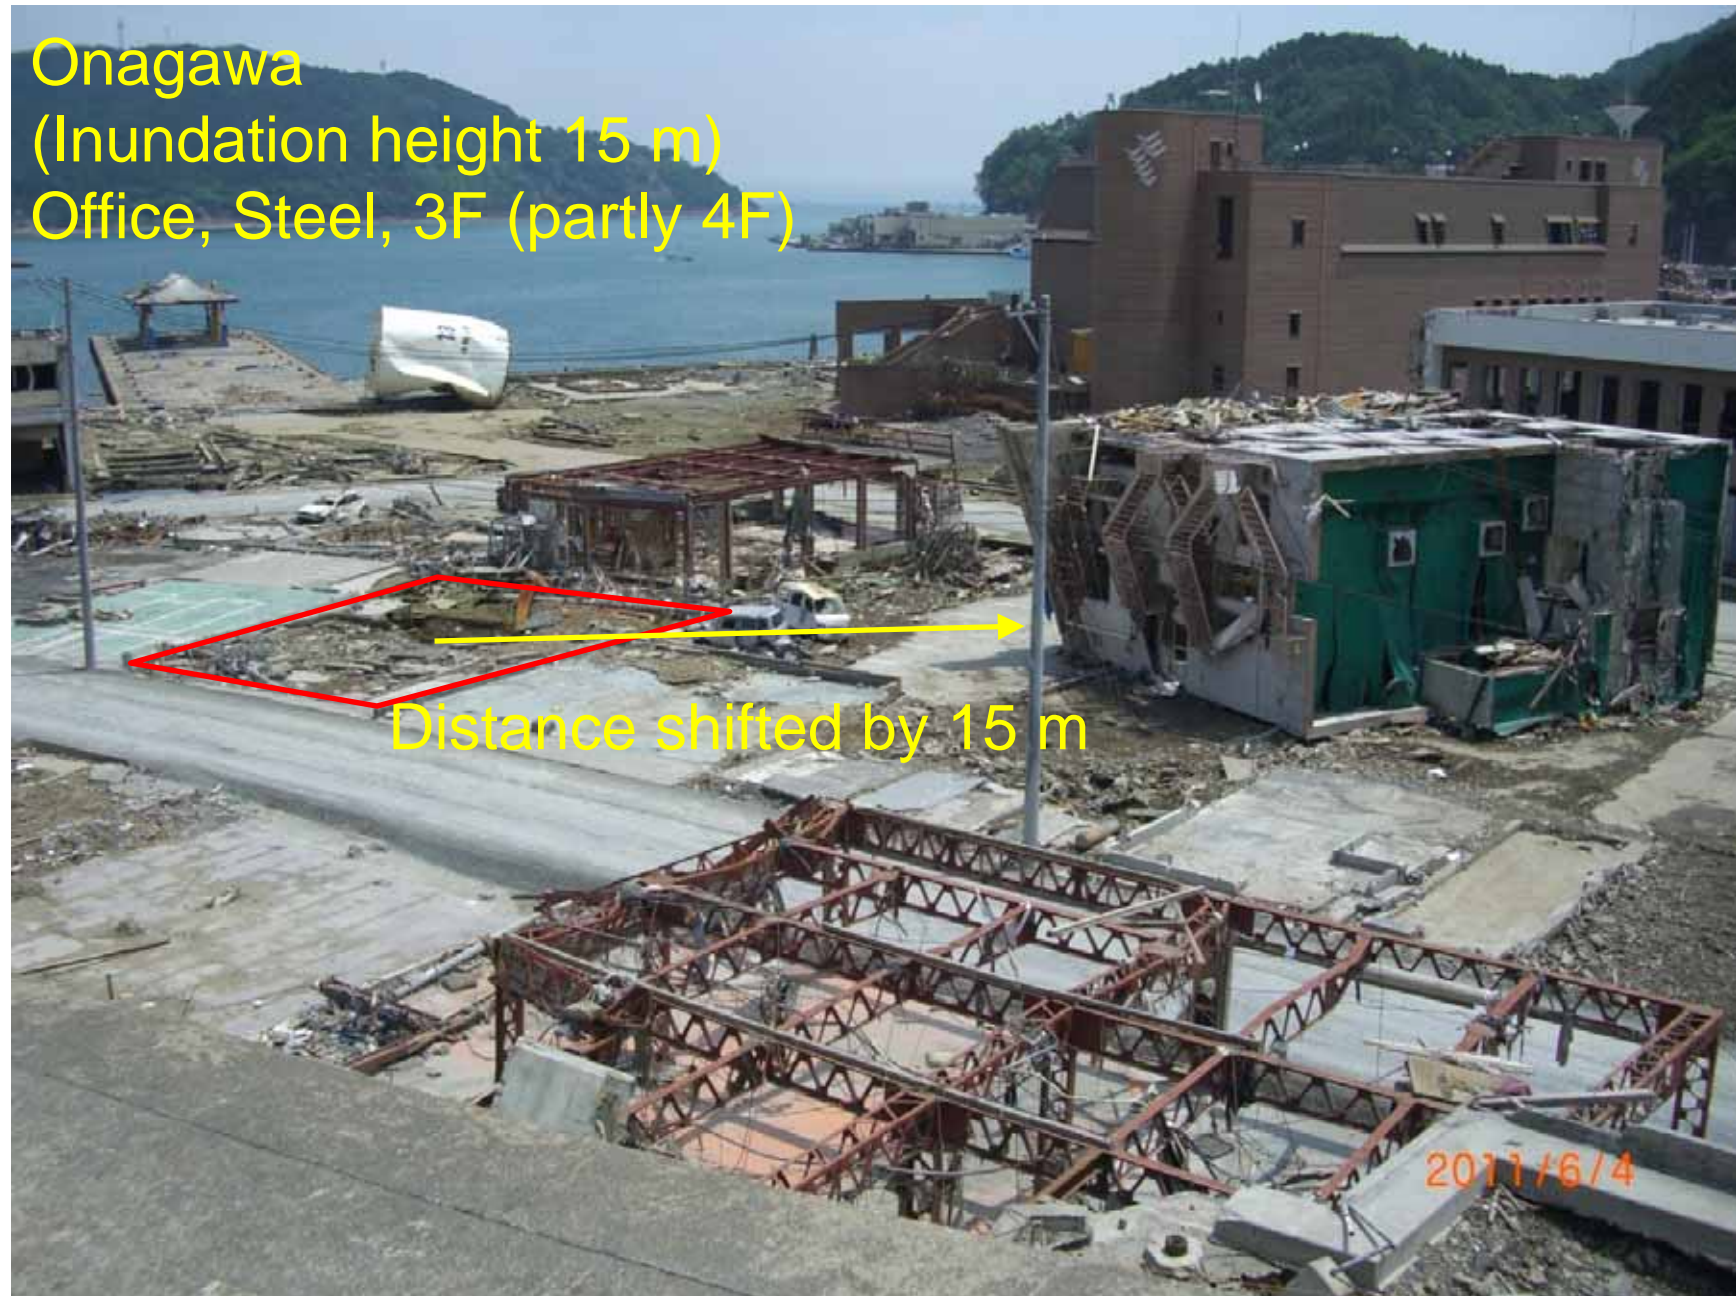
Tsunami Damage to Buildings 2-2: Toppling (Steel)

Onagawa
(Inundation height 15 m)
Office, Steel, 3F (partly 4F)

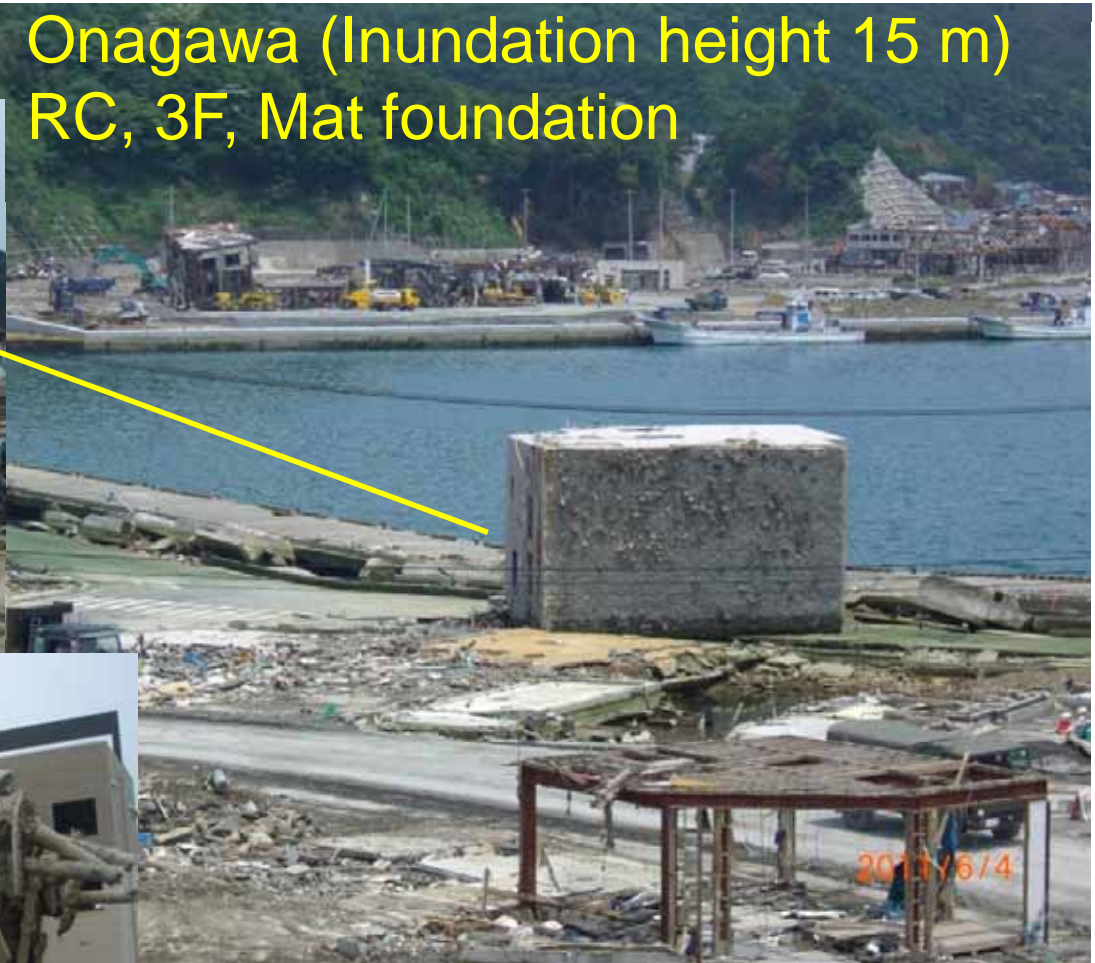
Tsunami Damage to Buildings 2-5: Toppling (RC)

Onagawa (Inundation height 15 m)
RC, 3F, Mat foundation

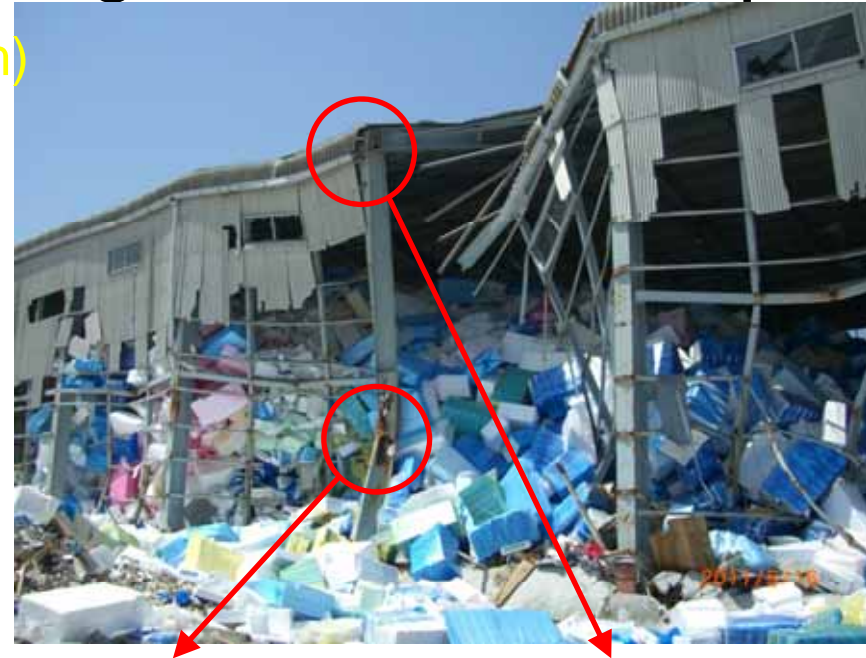
Tsunami Damage to Buildings 4-2: Debris Impact

Ishinomaki (Inundation height 5 m)
Warehouse

Fracture of anchor bolts

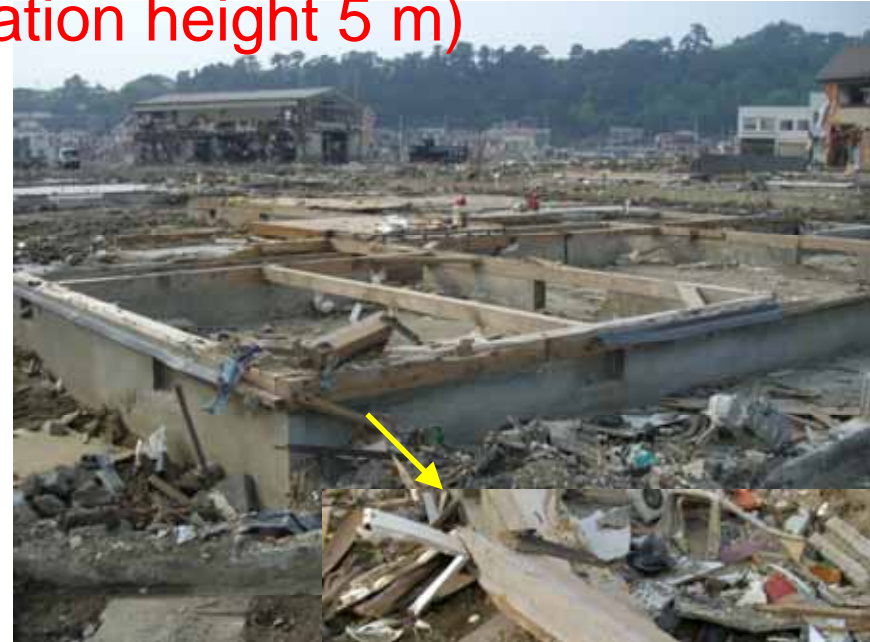
Majority of residential timber buildings were washed away leaving sills and foundation.
