Study Trip Report on  
**ISHINOMAKI HARBOR COMBINATION GOVERNMENT BUILDING**  
By: ZHANG Lifen, Kyi Kyi Swe (S-course)

### 2. Damages of the Ishinomaki Harbor Combination Government Building

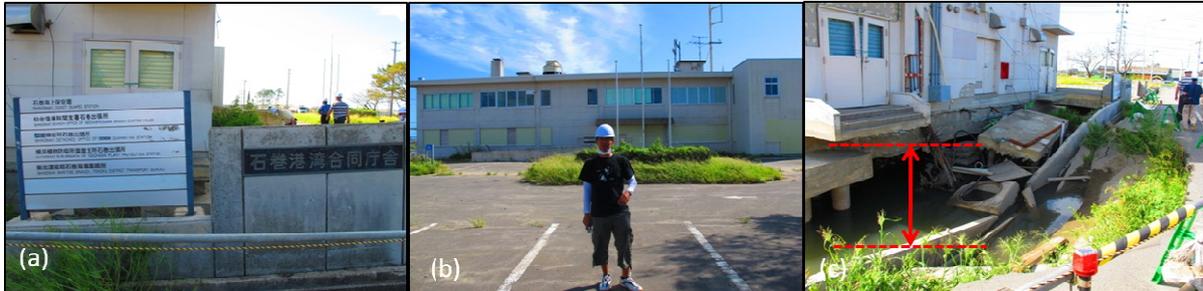
**Figure 1.** Building damages due to Tohoku earthquake and tsunami.

The Ishinomaki Harbor Combination Government Main Building is a 2-story frame building (Figure 1(b)). In this area, tsunami came around 1 hour after the Mw9.0 great Tohoku earthquake occurred. Based on the field observation at the Ishinomaki government main building, where the tsunami

reached to the second floor, the water height was about 3.8 m. The building was damaged mainly by tsunami, but the earthquake also had big influences. From Figure 1 (c), we saw that this earthquake caused serious scouring, which led to the building subside about 1 m. In addition, the fence of the building was collapsed due to the scouring.

(a)The gate of Ishinomaki harbor combination government building; (b) Front view of the building; (c) Side view, collapsed fence, and the building subsided due to scouring.

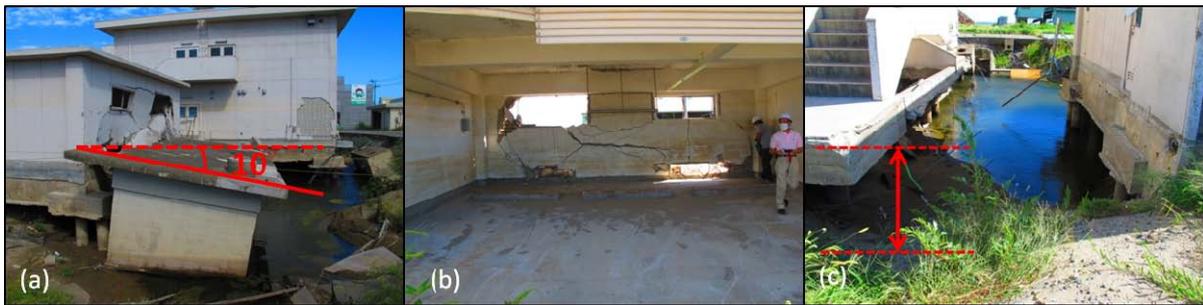
**Figure 2.** The Affiliated Building damages due to Tohoku earthquake and tsunami.

In Figure 2(b), the huge damage caused also by tsunami can be seen. The wall of the affiliated building was totally cracked due to the high water pressure. And from the backside of this building, it is easy to observe the damages both caused by tsunami and scouring (Figure 2 (a) and Figure 2 (c)). The house nearby the affiliated building tilted about 10° due to scouring (Figure 2 (a)).

(a)The affiliated building was seriously damaged by tsunami; (b) Front view of the affiliated building; (c) Scouring caused by earthquake.

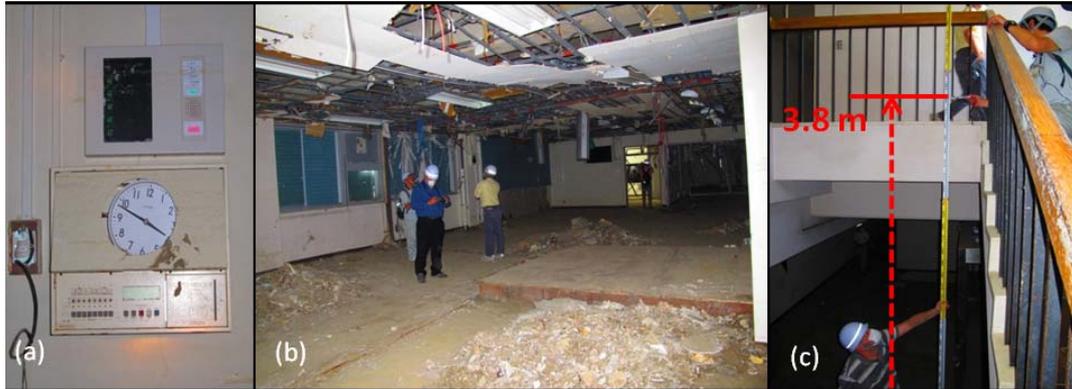
**Figure 3.** Inside view of the main building damages due to Tohoku earthquake and tsunami.

Inside the main building, the clock on the wall was stopped at 3:49 (1 hour after the Mw9.0 Tohoku earthquake) (Figure 3(a)). And on the first floor, the ceilings fell down due to the earthquake and tsunami (Figure 3(b)). According to the observation on the spot, we found the tsunami water reached to the second floor, and the measurement results showed the tsunami height was about 3.8 m (Figure 3(c)).

(a) Clock stopped due to tsunami; (b) all the ceilings collapsed; (c) tsunami water height reached the second floor with height of 3.8 m.

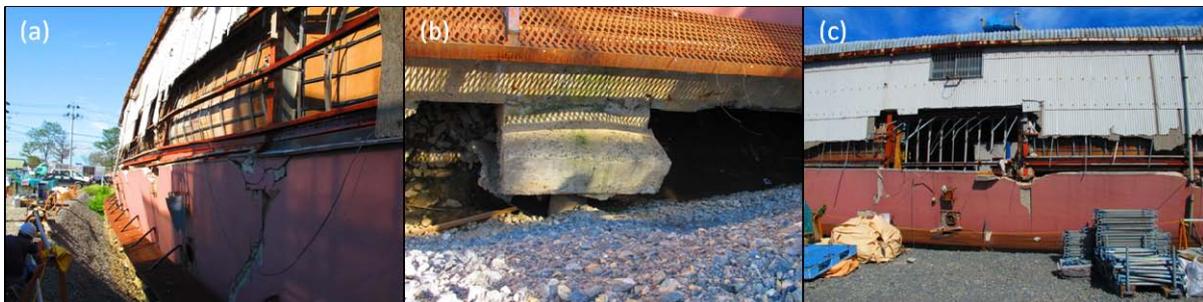
**Figure 4.** Warehouse damages due to Tohoku earthquake and tsunami.

After that, we visited another building, which was opposite to the Ishinomaki harbor government building and the distance between the two buildings was around 100 m. From Figure 4(a), we found that the wall of the building was strongly damaged by tsunami. The wall was broken. It seemed like there were very huge horizontal pressure pushing the building. And the steel pole connecting the upper part and the lower part of the wall was broken. If we saw it carefully, it was not difficult to see that the basement had some cracks and rotation.

(a) Side view of a warehouse; (b) the basement cracked and rotated; (c) Front view of the warehouse.
