INTERNATIONAL INSTITUTE OF SEISMOLOGY AND
EARTHQUAKE ENGINEERING (IISEE)

REPORT OF STUDY TRIP (TOHOKU)

10-14 JULY 2011

TSUNAMI DISASTER MITIGATION

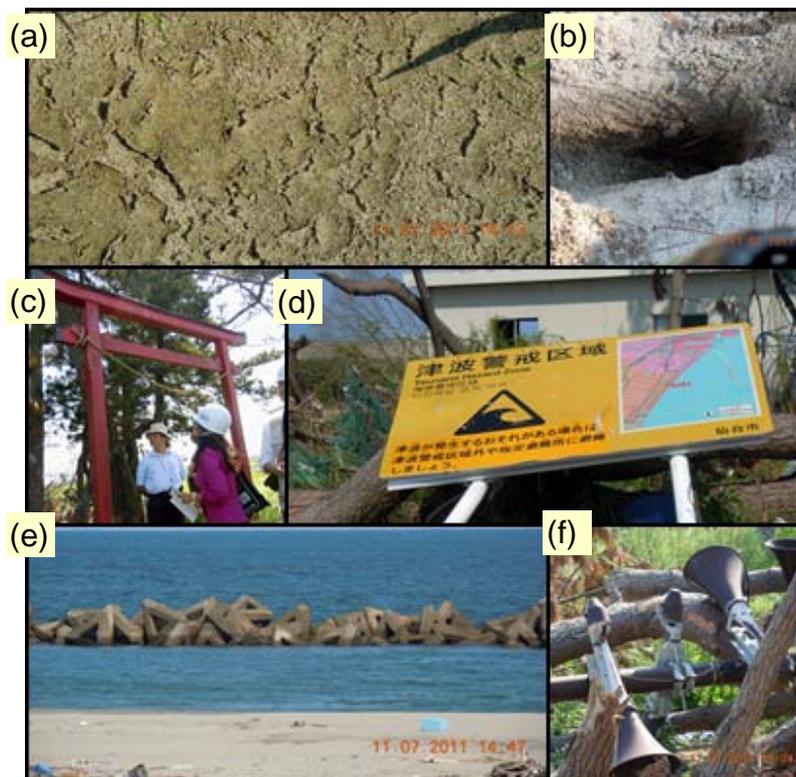
Figure 1 (Photo taken by Mazni Azis)

Figure 1(a): Mud layer top of sand truly came from tsunami.

Figure 1(b): Sand from tsunamis about 30cm thickness.

Figure 1(c): A small temple survived from the tsunami probably because of the Heliport and trees around the temple.

Figure 1(d): Signage “Tsunami Hazard zone” falls down by tsunami.

Figure 1(e): Breakwater at Arahama beach not damaged by tsunami.

Figure 1(f): Tsunami sirens fall down.

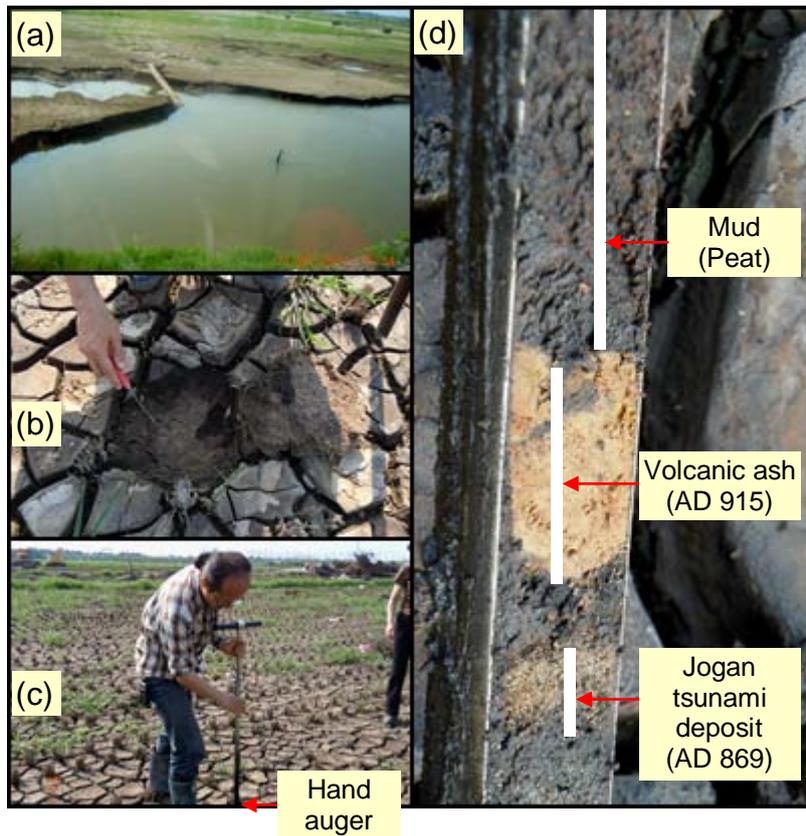
Figure 2 (Photo taken by Mazni Azis)

Figure 2(a): The photo shows the effect of combination of liquefaction phenomenon and scouring due to falling flow (hydraulic jump) behind the elevated roadway.

Figure 2(b): Thick mud from tsunami.

Figure 2(c): Dr. Sugawara shows how to observe Jogan Tsunami deposit using a hand auger.

Figure 2(d): The result from the field observation of the Jogan tsunami.

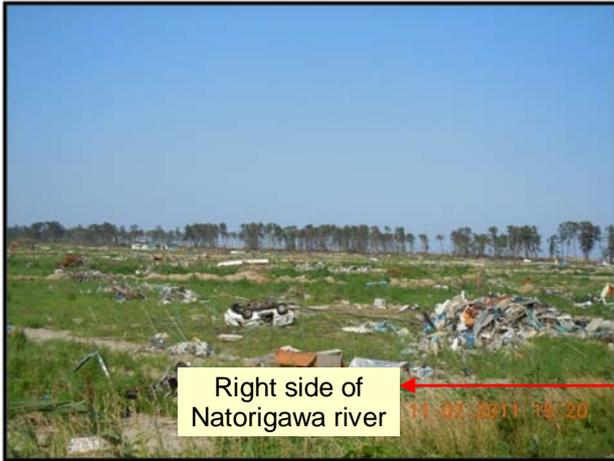
Figure 3 (Photo taken by Mazni Azis)

At the Natorigawa river I asked a question to Dr. Sugawara about the different effect of the tsunami at the left and the right sides of the river, because the right side seemed to be less damaged than the left side. Dr. Sugawara said that it was probably because the river and the dike at the right side of the river is higher compare to the left side (Figure 3 and Figure 4). In addition, he said that the right side was also suffered from the tsunami but it was only the first floor of building.

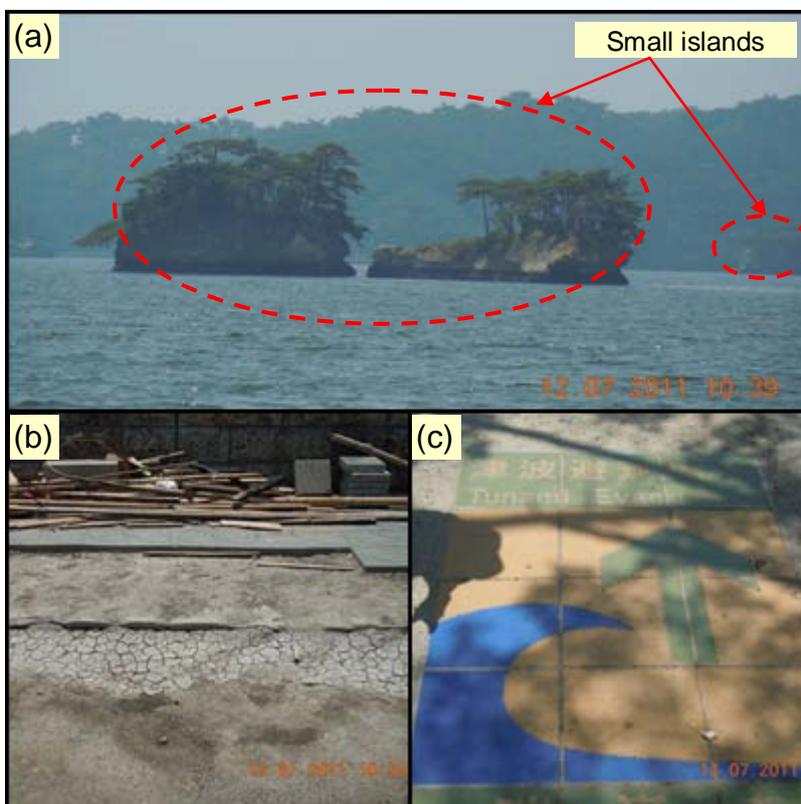
Figure 5 (Photo taken by Mazni Azis)

Figure 5(a): Small islands around Matsushima function as natural “break water” which can reduced tsunami wave.

Figure 5(b): Damage by the tsunami at Matsushima.

Figure 5(c): Signage “Tsunami Evacuation” shows 400m to “Zuiganji Temple” which is tsunami evacuation area. Unfortunately this temple was also inundated by tsunami.

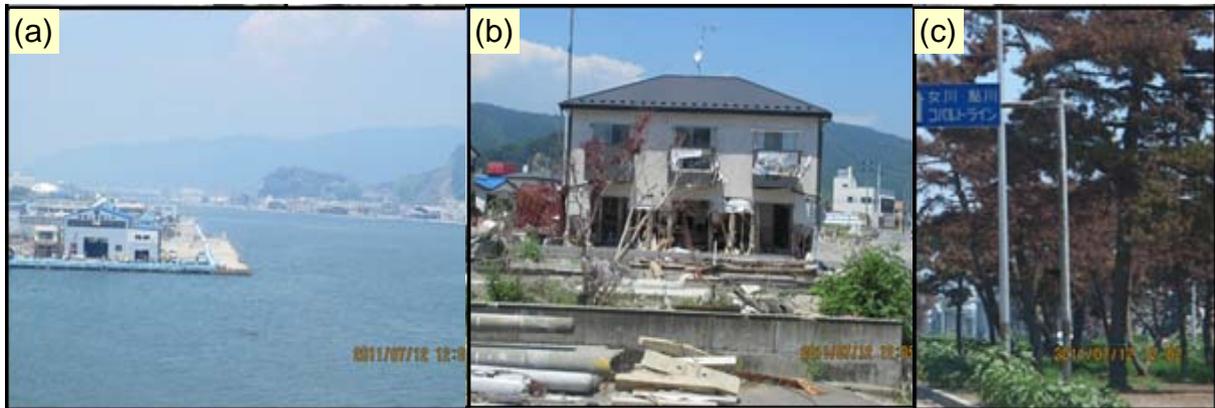
Figure 6 (Photo taken by Fatimah Zaharah Saleh)

After visiting Matsushima, we moved to Onagawa through Ishinomaki. Ishinomaki is one of the areas that were also badly affected by the Tohoku tsunami 2011. On the left and the right, we saw clearly the buildings collapsed, houses damaged (Figure 6(b)), trees in changed colour to brown leaves as a result of sea water arrived up to there (Figure 6(c)). When we went through the area of the beach connected to the sea, we were able to see the water level very close to the road at the time of high tide (Figure 6(a)). It is because of the subsidence.

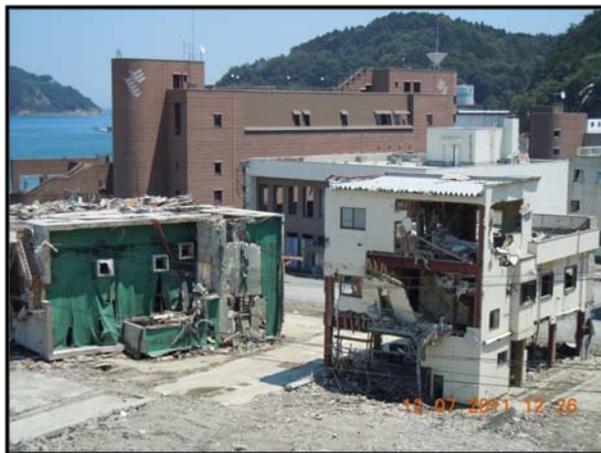
Onagawa was heavily damaged and I saw many buildings collapsed and destroyed by the tsunami. According to the witnesses, residing wave was also strong in this area. Many people did not want to live here again because of the trauma of the tsunami. I asked Prof. Okazaki's opinion about the time needed to recover this area. He said it may take 2-3 years to be reinstated as it was very terrible destruction. Onagawa Tsunami Memorial Park and Onagawa Tsunami Memorial Museum will be built to mark the terrible tsunami disaster and to educate people about the impact of the tsunami in this area. Four damaged buildings will remain as the Onagawa Tsunami Memorial Park. Onagawa Tsunami Memorial Museum proposed by Prof. Shuto as a sign of place near to tsunami run-up. For myself, it was very surprising to see the situation in Onagawa in which buildings were destroyed, turned over and some of them moved up to 70m by tsunami wave although they were constructed using the RC structure.

Figure 7: Heavily damaged buildings at Onagawa city (Photo taken by Mazni Azis)

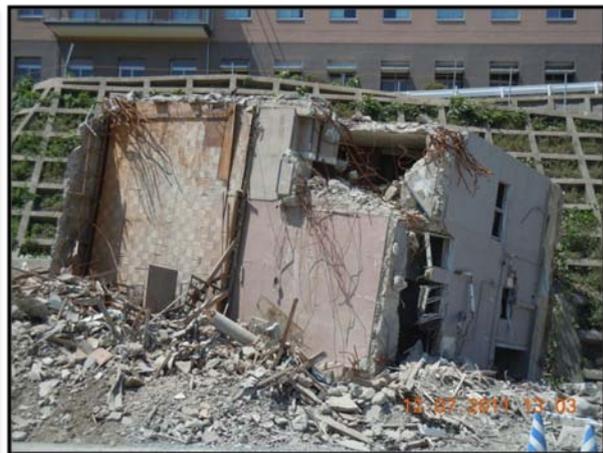
Figure 8: Building moved about 70m (Photo taken by Mazni Azis)

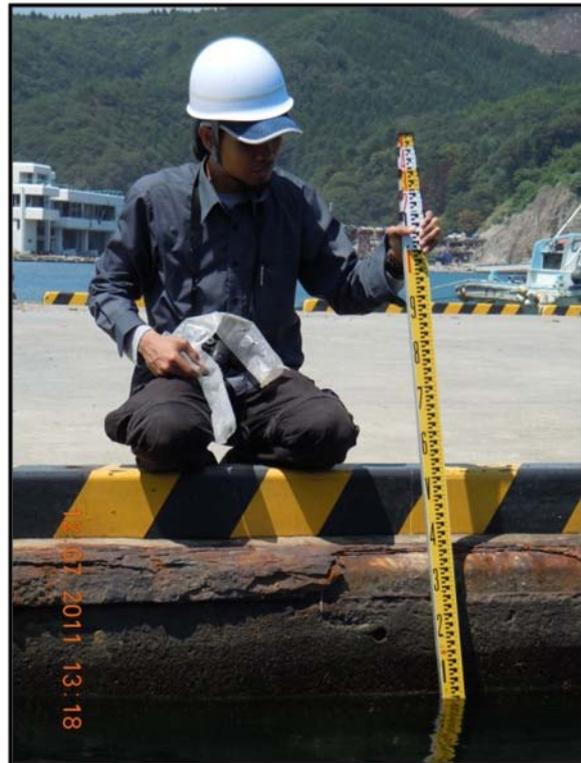
Figure 10: Because of subsidence, sea level is only about 35cm from the road.
(Photo taken by Mazni Azis)

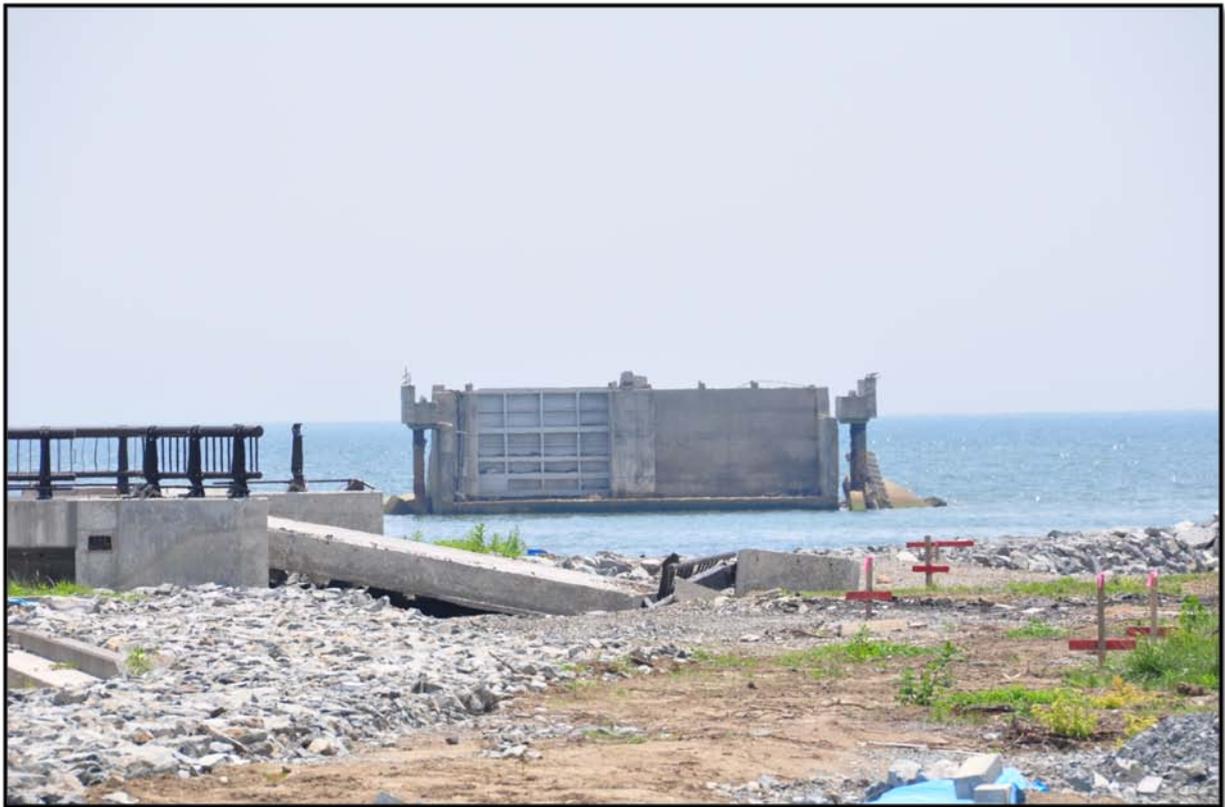
Figure 11: Damaged flood gate caused by tsunami at Rikuzen-Takata. (Photo taken by Fatimah Zaharah)

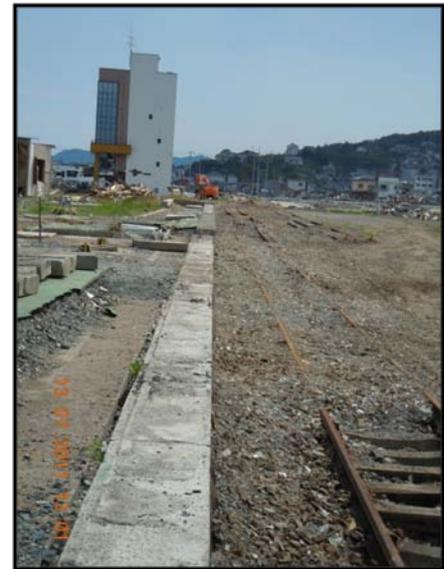
Figure 13: Damaged railway. This is very important transport in Ofunato city. (Photo taken by Mazni Azis)

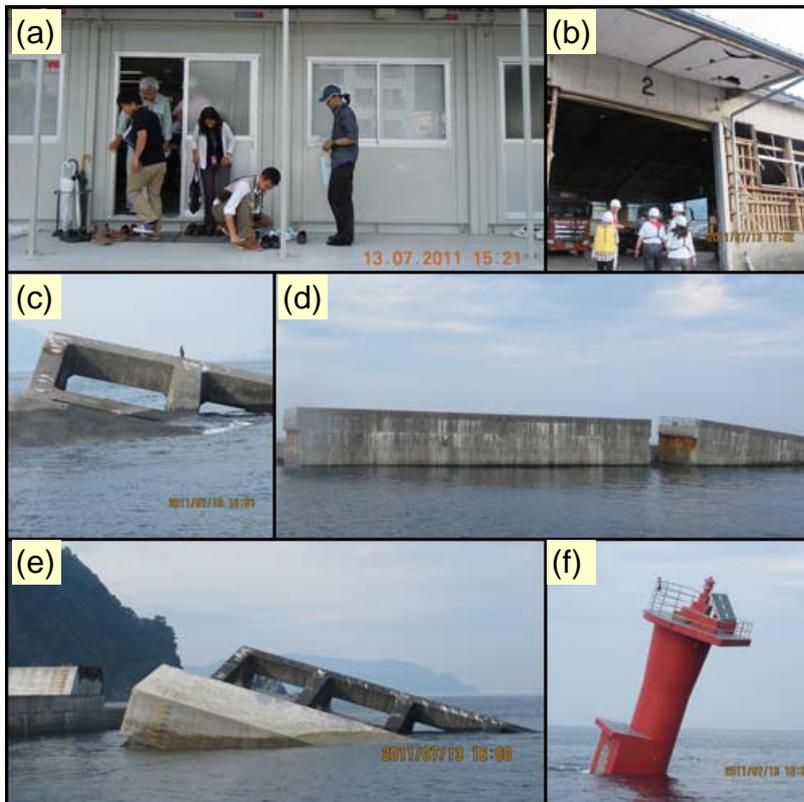
Figure 14 (Photo taken by Fatimah Zaharah Saleh)

We got the opportunity to board a boat to visit Kamaishi break water that was damaged by the tsunami. The Kamaishi break water, 1.950m (6.400ft) long and 63m (207ft) in depth, was completed in March 2009 after construction work started in 1978 with a cost of \$1.5 billion. It was once recognized by the Guinness World Records as the world's deepest Breakwater. [Http://community.guinnessworldrecords.com/_DeepestBreakwater/BLOG/2699333/7691.html](http://community.guinnessworldrecords.com/_DeepestBreakwater/BLOG/2699333/7691.html). Mr. Nagao explained how its constructions worked and it was very interesting for me. We were all interested to know about break water's plan in the future. Mr. Nagao told that at the moment they did not plan to build it back but would probably remove it if the fishermen asked them to do so. Although there are many stories about the failure to break water in the tsunami countermeasure, according to the result from the tsunami simulations conducted by Port and Airport Research Institute (PARI), the break water is able to reduce tsunami run-up to two times. In the result from the simulations, tsunami run-up is about 20.2m if there is no break water while in observation tsunami run-up is 10.0m. Sea wall is also found to delay the tsunami waves for six minutes.

Figure 14(a): Temporary Kamaishi Port Office.

Figure 14(b): Damaged at Kamaishi Port.

Figure 14(c), Figure 14(d) Figure 14(e): Damaged of some part at Kamaishi break water.

Figure 14(f): Lighthouse at Kamaishi Break water tilt and damaged caused by tsunami.
