VAN EARTHQUAKE, TURKEY 2011

Dr. Nazan KILIÇ
Earthquake Department

23 October 2011 Van Earthquake

International Video Conference on Reconstruction of Safer Houses
after Earthquake Disasters
22 February 2012

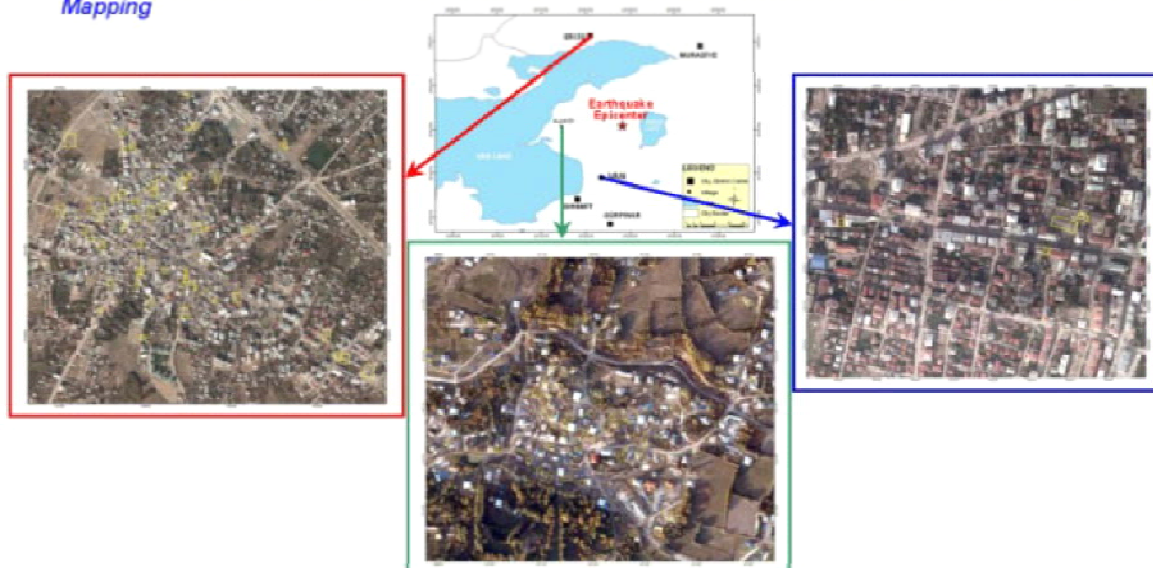
Collapsed Buildings from 23 October 2011 Van Earthquake

- Preliminary Evaluation of Collapsed Buildings from Orthophotos produced by General Command of Mapping

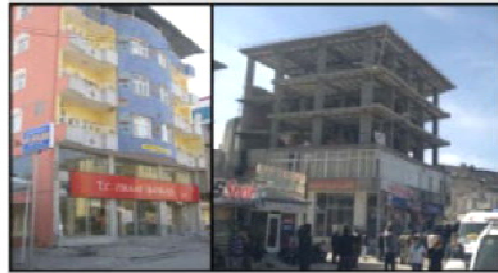
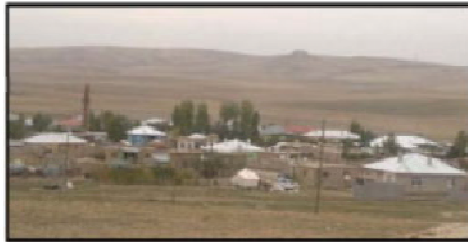
- Building stock in **Van city center and Erciş district center** generally consists of 4-8 story **reinforced concrete structures**.

- In most of the buildings, **asmolen slab** (infilled joist slab) is used.
- Particularly, collapsed buildings are observed to have shops in their ground levels with heights that are almost twice the normal story heights.

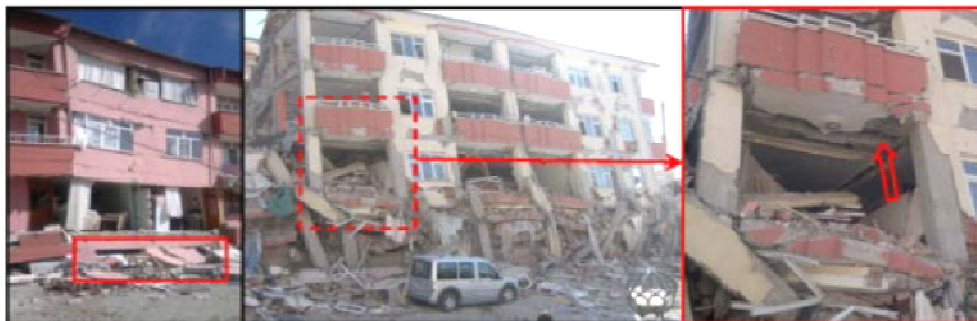
Damage in Reinforced Concrete Buildings

- **Soft / Weak Story and Asmolen Slab**

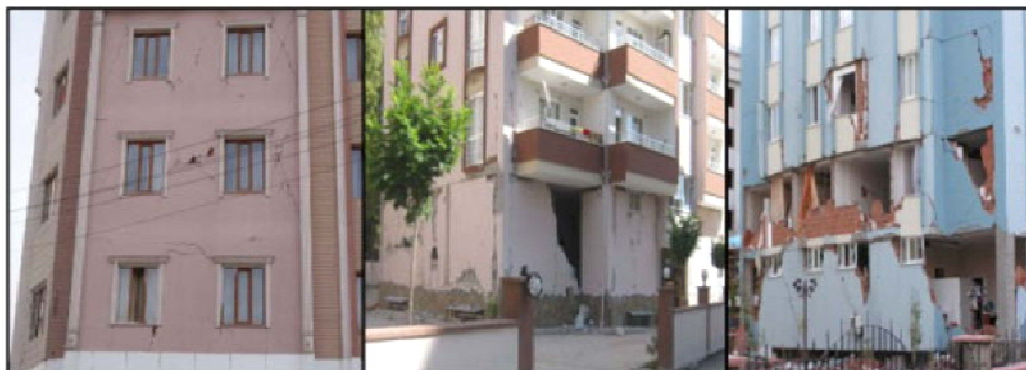
Damage in Reinforced Concrete Buildings

- **Infill Wall Damage**

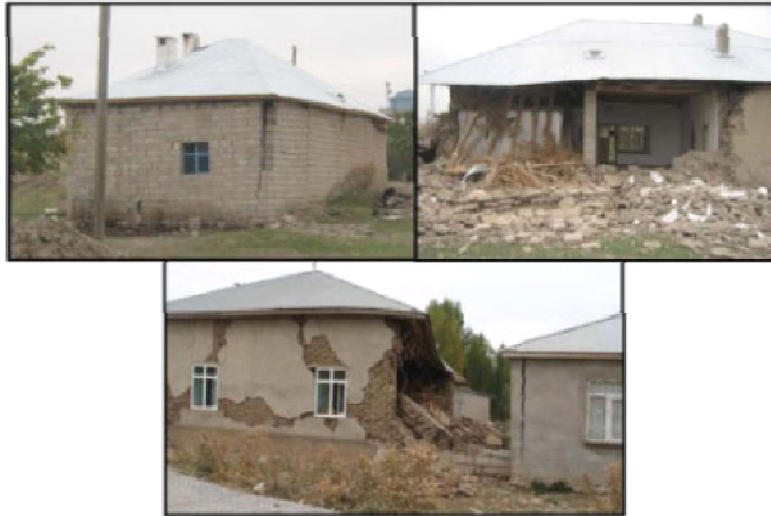
Damage in Masonry Buildings

- **Poor Wall-to-Wall and Wall-to-Floor Connections**

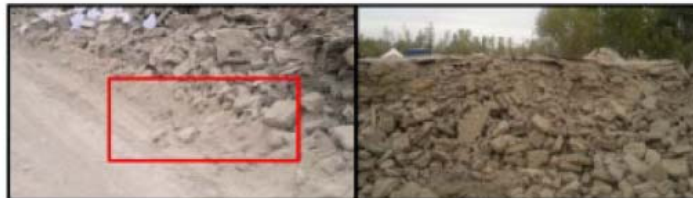
- **Poor Material Quality and Workmanship**

- Use of low quality mud mortar as bonding material between adobe, stone and brick units

- Use of various load-bearing wall materials (i.e. adobe, stone or brick) in the same building

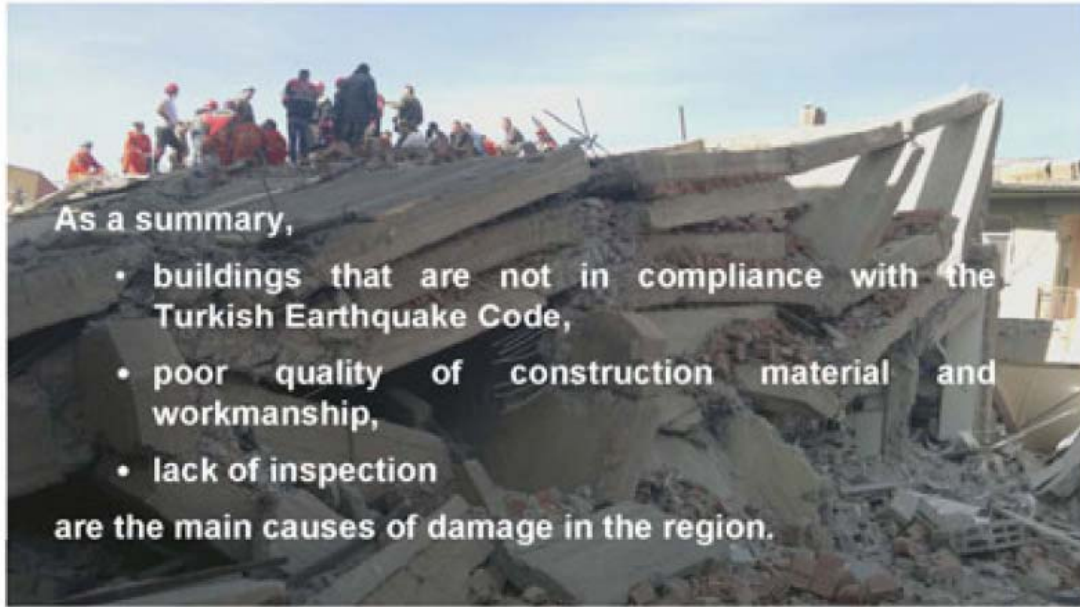
As a summary,

- buildings that are not in compliance with the Turkish Earthquake Code,
- poor quality of construction material and workmanship,
- lack of inspection

are the main causes of damage in the region.
