LESSONS LEARNT FROM DAMAGE TO BUILDINGS BY BOHOL EARTHQUAKE AND TYPHOON YOLANDA 2013 IN THE PHILIPPINES

Tatsuo Narafu¹, Toyokazu Shimizu², Yasushi Sanada³, Yukio Tamura⁴, Noriyuki Mita⁵,
Susumu Takahashi⁶, Hayato Nakamura¹, Atsuko Itsuki¹

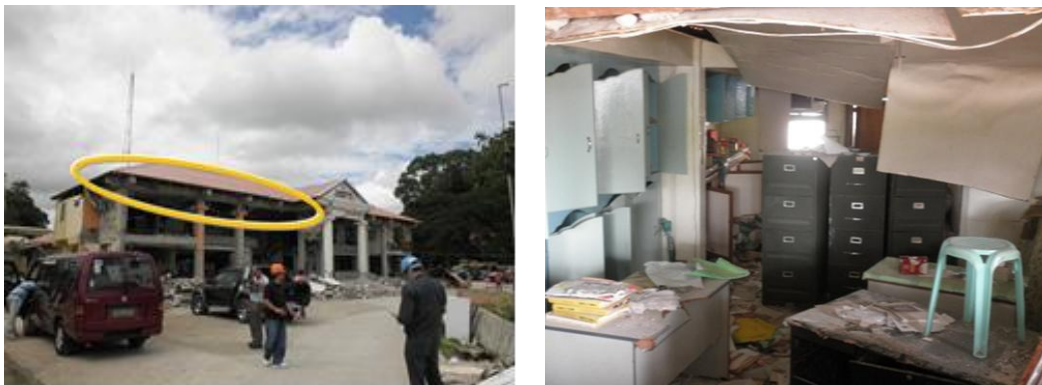
Figure 2. Municipal building of Sagbayan, Bohol: (Left) Heavy damage to shelter walls and so on, and (Right) Inside the buildings

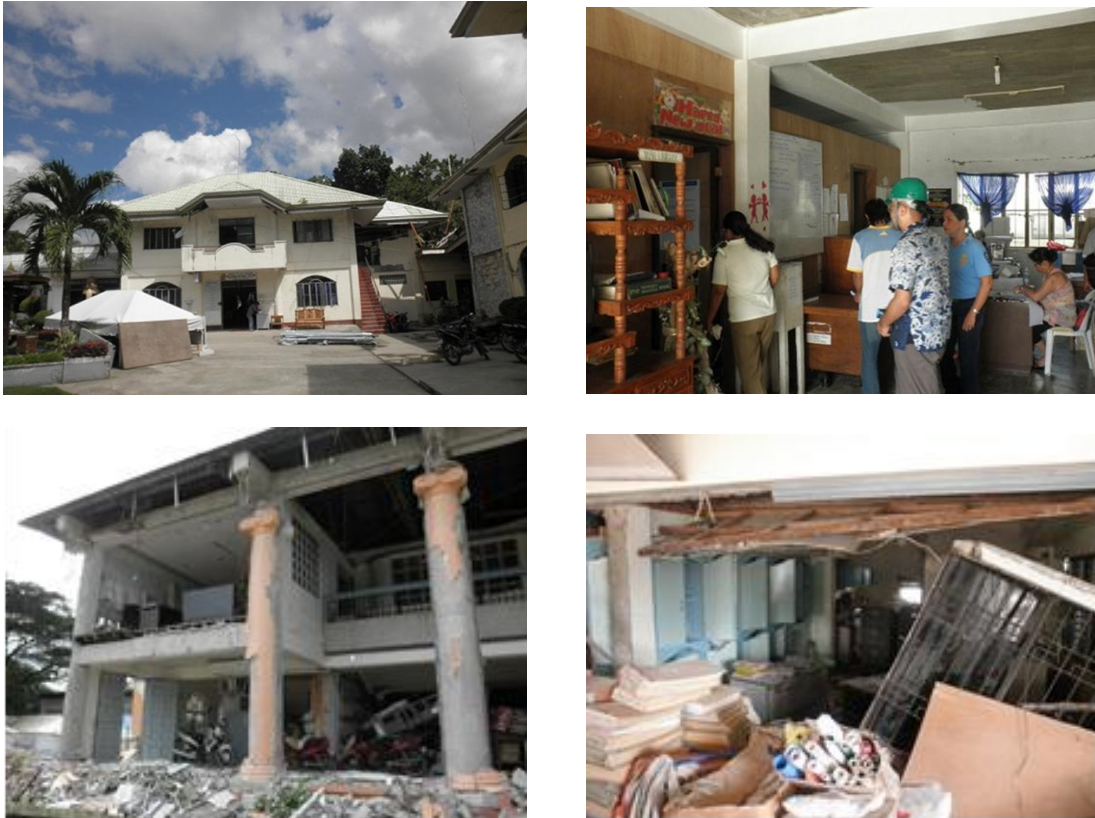
Huge difference in degree of damage is observed. Figure 4 shows huge Difference among municipal buildings of Antequera and Sagbayan, Bohol. Upper left photo shows Municipal office of Antequera (Building 2) suffered little and upper right shows the conditions of the first floor of the upper left that it suffered little and started operation soon after the earthquake. Lower left photo shows exterior view of Municipal office of Sagbayan (refer to Figure 2). Lower right photo shows heavy damage to non-structural members of partition walls and ceiling boards, etc. On the other hand damage to structure is limited. It will be demolished due to the damage.

Figure 4 Huge Difference among municipal buildings of Antequera and Sagbayan, Bohol (Upper left) Municipal office of Antequera (Building 2), (Upper right) First floor of Upper right (Lower left) Municipal office of Sagbayan (Lower right) Interior view of Lower left

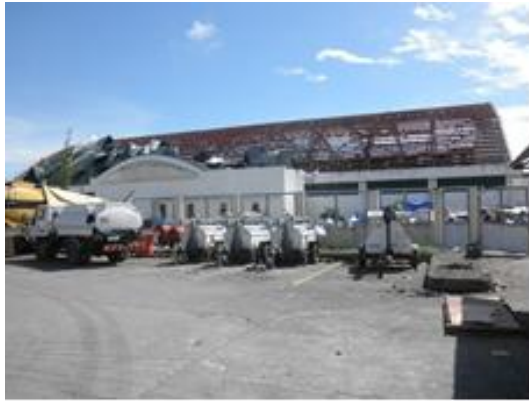
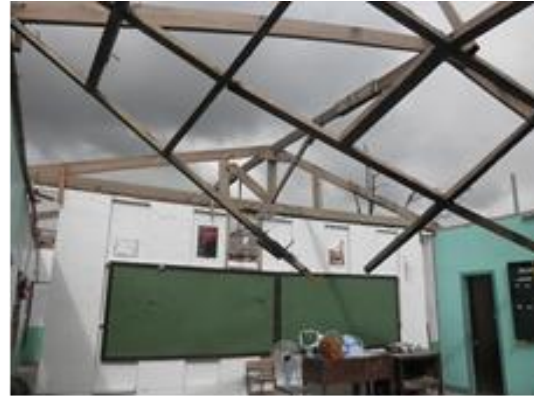
Figure 7 Typical damage by strong winds by the typhoon: (Left) Heavy damage in roofing: Customers' center of private company in Palo, Leyte, (Right) Damage to both roofing and roof trusses. Sagkahan National High school, Tacloban, Leyte

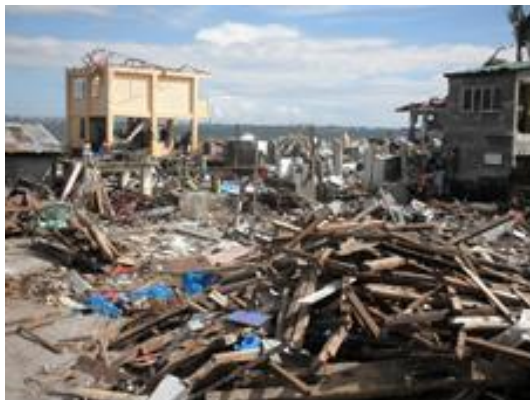
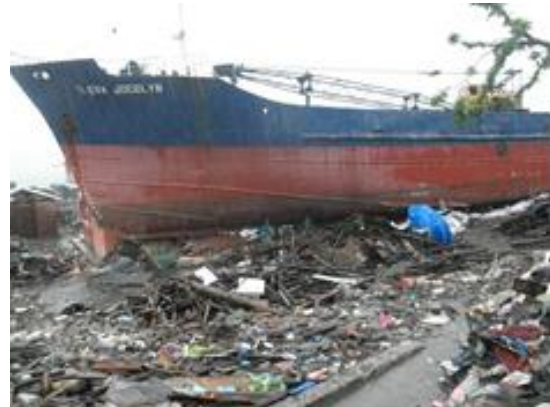
Figure 8. Typical damage by storm surge caused by the typhoon in coastal area of Tacloban city, Leyte

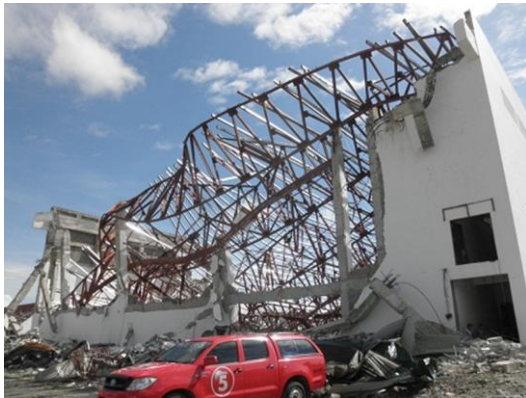
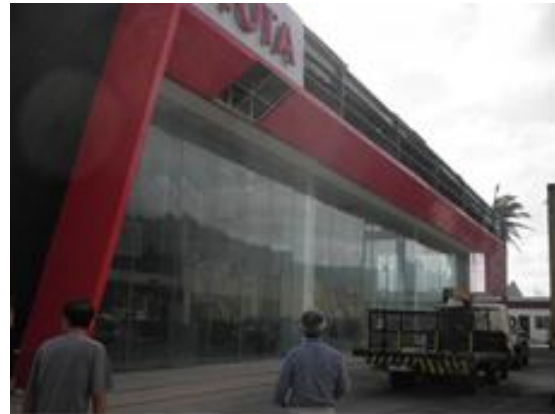
Damage to buildings is caused by two different actions of pressure by strong winds (Figure 7) and inundation by water (Figure 8). Table 3 shows buildings which are analyzed in Section 2.2. Most of buildings suffered from both strong winds and inundation. Huge difference is also observed in degree of damage among buildings even in similar condition. Typical examples are shown in Figure 9 and 10. Figure 7 shows comparison of damage of large buildings by the typhoon. Left is Leyte Convention Center in Palo, which total collapsed. On the other hand, Toyota showroom in Tacloban (Right) got

Figure 9. Comparison of damage of large buildings: (Left) Leyte Convention Center in Palo (Right) Toyota showroom in Tacloban

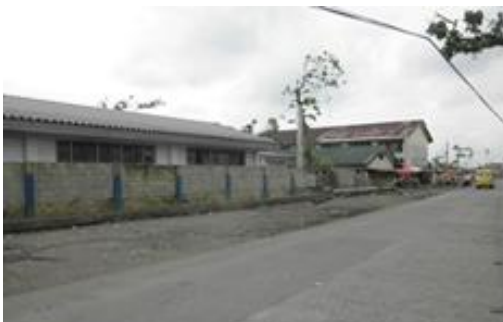
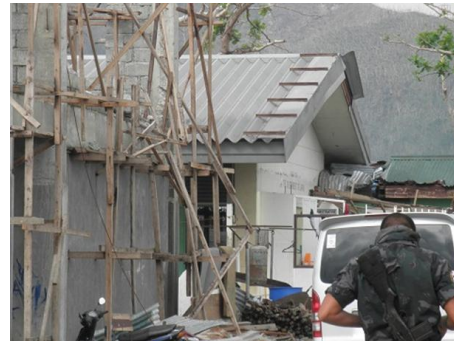
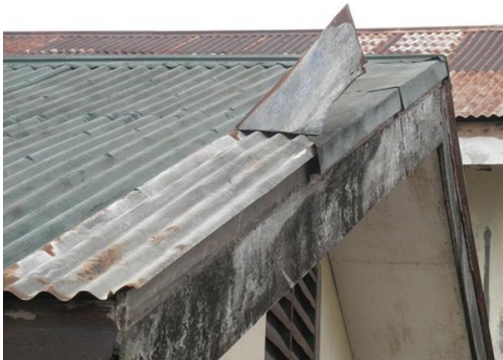
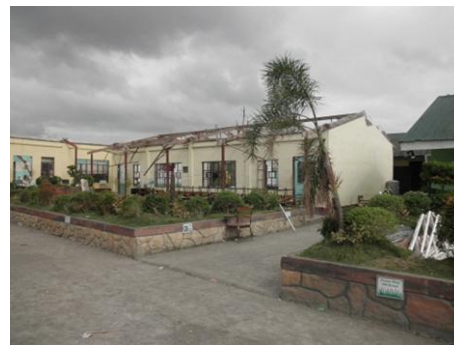
Figure 10. Comparison of damage of school buildings in Sagkahan National High School in Tacloban, Leyte: (Upper left) Overview of the school, (Upper right) a building by Grant Aid project by Japan, (Lower left) a building with limited damage (Lower right) a building with heavy damage

Figure 10 is an example of school buildings in Sagkahan National High School in Tacloban, Leyte. Upper right is a building by Grant Aid project by Japan which suffered little. Lower left is another one with limited damage to roof flash and ceiling boards. Lower right is one with heavy damage of blown away of roofing and failure of roof trusses

It is clearly proved that eaves or ends of roofing are the most critical parts for damage from strong winds and additional reinforcement and appropriate finishing worked well, which is shown in the building by Grant Aid project in Figure 10. This could be a good practice for prevention of damage from strong winds.

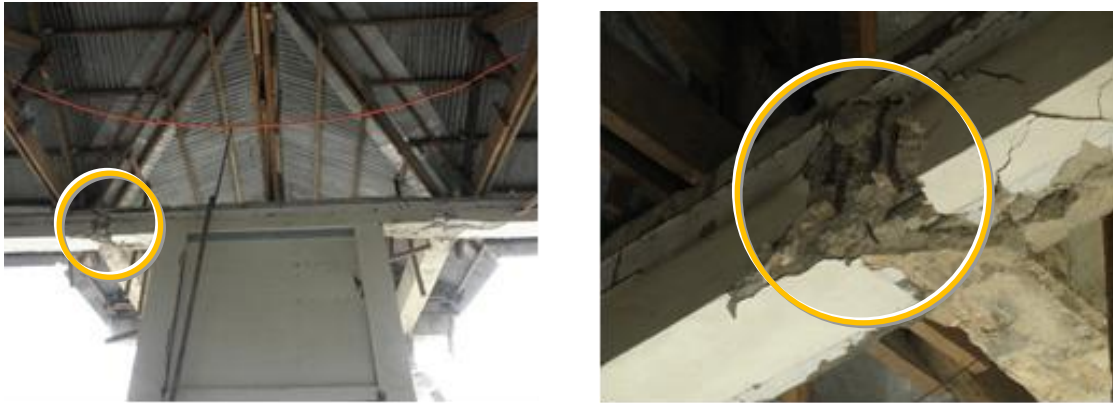
Several cases of damage by improper structural design were found during the field surveys. Typical ones are shown in Figure 11-15. Figure 11,12 and 13 are similar type that structural designs are not regular which invited unexpected force and stress. Irregularities are, Figure 11: beams of canopy were not attached to main structure in consistent manner and were connected to a beam at points without support of columns, Figure 12: levels of beams differ to each other, which caused unexpected stress in columns, Figure 13: irregular configuration of columns and imbalanced layout of non-structural walls might invite torsional force to the total structure.

Figure 11. An example of improper structural design in Municipal building of Sagbayan, Bohol (by the earthquake) (Exterior view: refer to Figure 2) (Left) damaged connection of beams of canopy and main structure (Right) Detail of the damage

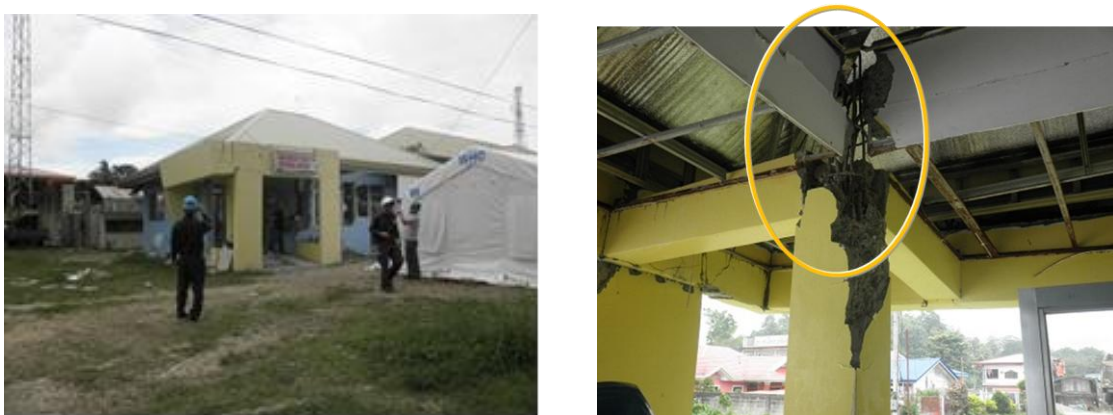
Figure 12. An example of improper structural design (by the earthquake) (Left) Exterior view of District Health Care Center of Sagbayan, (Right) connection of a column and beams

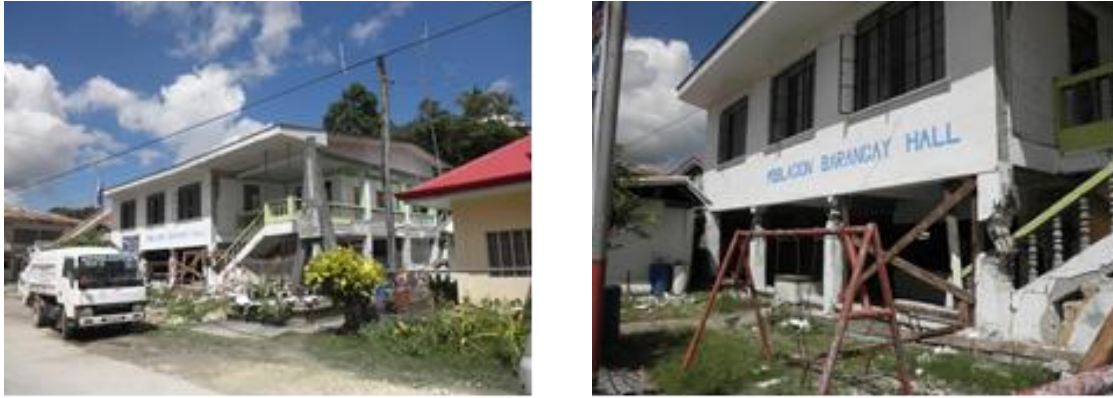
Figure 13 An example of improper structural design in Barangay office in Antequera (by the earthquake): (Left) exterior view, (Right) damaged columns by irregular configuration

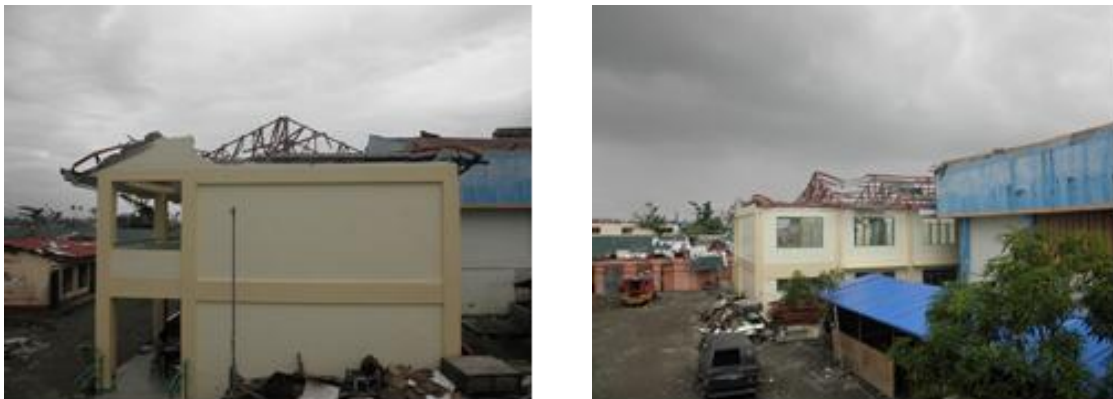
Figure 14 is an example of damage in gable walls and roof trusses. This might be caused by improper designs (load estimation or design strength is not appropriate) or construction might not comply with the designs. Figure 15 is an example of a steel structure. Many failures occurred in connection where welding without gusset plates were applied. Such direct welding may damage parent/base materials and reduce strength of connecting sections. In both cases of Figure 14 and 15, the authors could not clarify the real causes (improper designs or incorrect construction works) as they could not examine drawings and specifications for the buildings.

Figure 14 Tanauan National High School in Leyte (by the typhoon): (Left) Collapsed gable walls of CHB. (Right) Roof truss heavily damaged without sufficient reinforcement in longitudinal direction

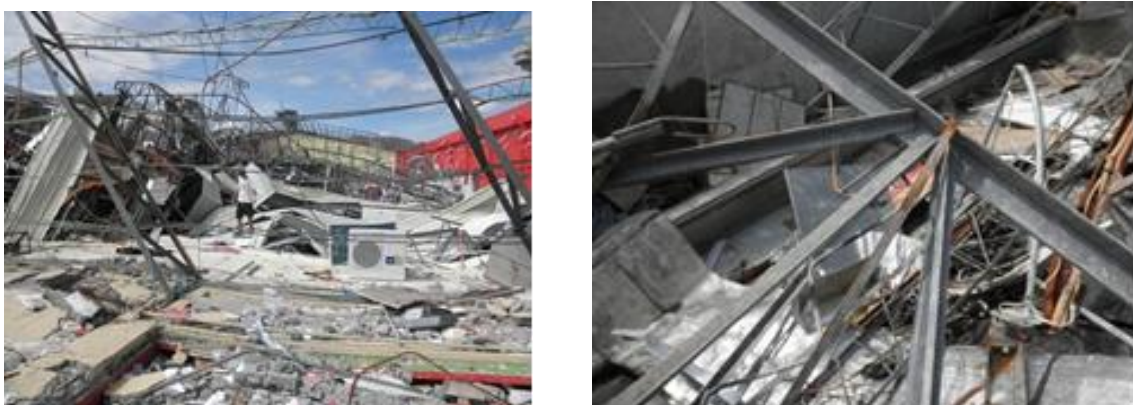
Figure 15 Supermarket Metro in Leyte (by the typhoon): (Left) Roof truss was completely destroyed, (Right) Welding without gusset plates.

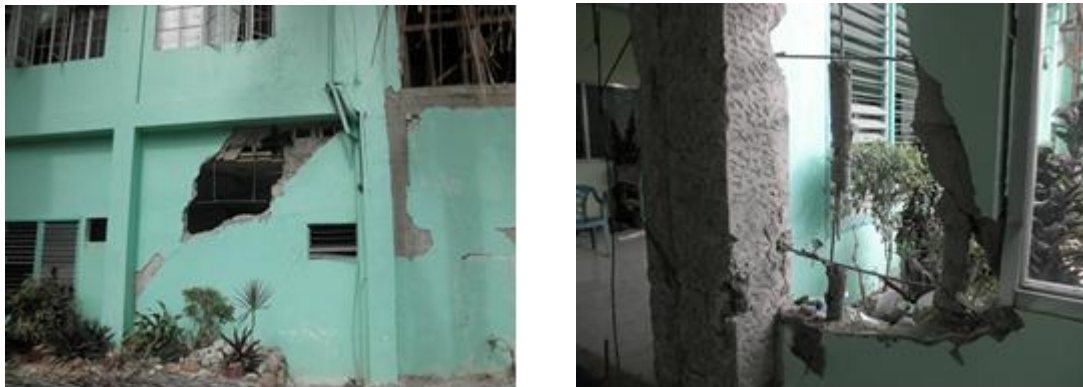
As stated in 2.1.1, damage to non-structural members is dominant by the two disasters. Among them concrete hollow block (CHB) walls are one of the most common damage. One of the major causes of the damage is poor strength of CHB. It is often observed that rebar in wall and mortar filled in hollows remains but most of CHB disappears due to extremely low strength like in Figure 16. Regarding damage to ceilings, use of usual type of nails to fix ceiling boards is one of the causes of heavy damage. Appropriate nails for fixing ceiling boards or nails with washers should be used.

Figure 16 An example of poor quality of concrete hollow blocks (CHB) (by the earthquake): (Left) Damaged non-structural walls in Municipal Office of Catigbian, (Right) Details of a damaged wall.

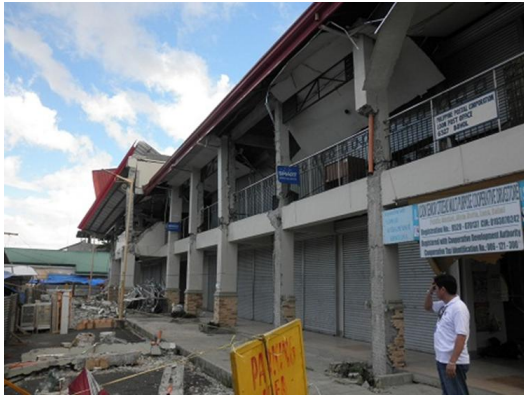
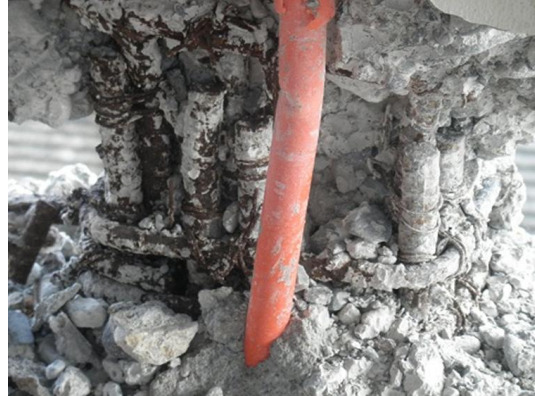
Poor workmanship/improper construction works seems to be another dominant causes both in Bohol and Leyte. The authors find various types of defects shown in Figure 17-21. In a case of Figure 17, several improper construction works are identified. Longitudinal rebar is positioned inaccurately (placed inside than the designed position). All the overlap splices of longitudinal rebar locates at the same level of a critical position, the bottom of the columns. (A red pipe in right photo is a pipe for electric wire installation) In a case of Figure 18 failures of concrete occurred at the one of the most critical part of structures, panels (crossing parts of columns and beams), where hoops are absent (right photo). Honeycomb caused by insufficient compaction of concrete are often found (Left photo of Figure 19). There found some cases that pieces of board penetrate into columns which might be used to prevent fresh concrete coming out through gap between form panels (Right photo of Figure 19). Figure 20 shows improper rebar works. The left photo is a case that spacing of hoops is too large, which might allow inside concrete coming out (Barangay Office in Antequera) and the right photo has several improper rebar works: bending of hooks of hoops is 90 degree, all the overlap splices of longitudinal rebar locate at the bottom of a column.

Figure 17 Examples of improper rebar works in Market Building in Loon (by the earthquake): (Left) Heavy damage at the bottom of most of columns, (Right) Detail of the damage.

the defects and damage like in Figure 17. (The positioning of longitudinal rebar and bending work of hoops are consistent, which supports the supposition) Another possible way to avoid this kind of problems could be training to make standard coverage of concrete to be common knowledge to all the workers.

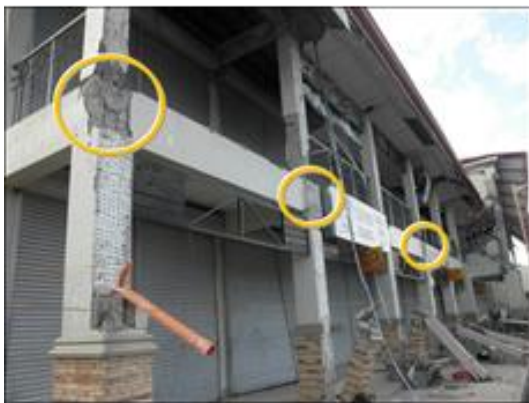
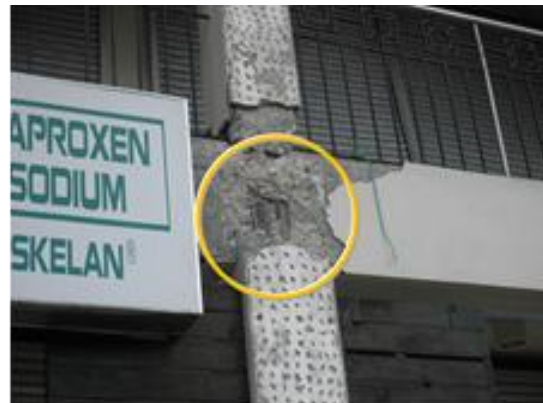
Figure 18 An example of improper rebar works in Market Building in Loon (by the earthquake): (Left) Failures at panels, (Right) Detail of damaged part

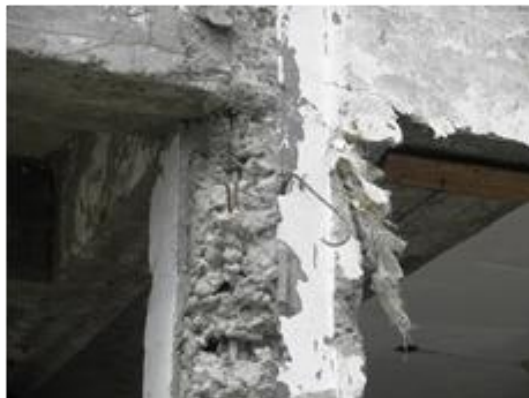
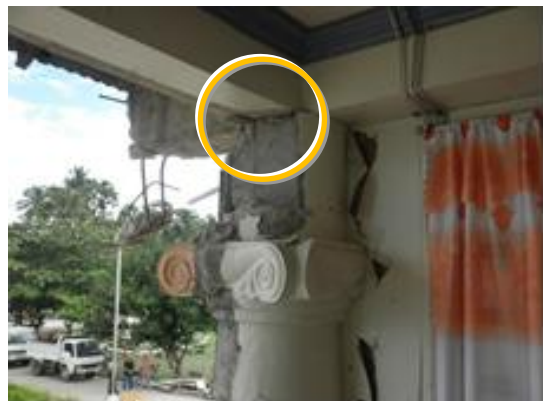
Figure 19 Examples of improper concrete placing (by the earthquake): (left) Market Building in Loon, (Right) Sagbayan Municipal Office

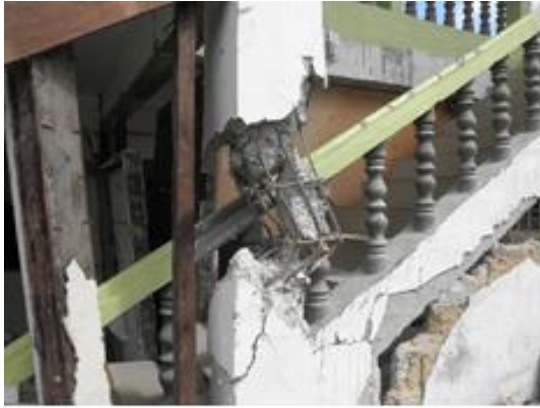
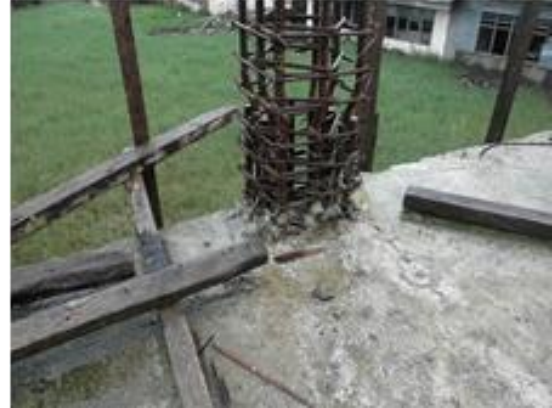
Figure 20 Examples of improper rebar works (by the earthquake): (left) Barangay Office in Antequera, (Right) A building under construction, Basey National High School

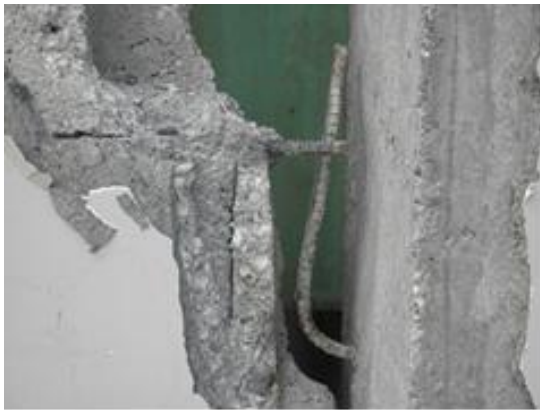
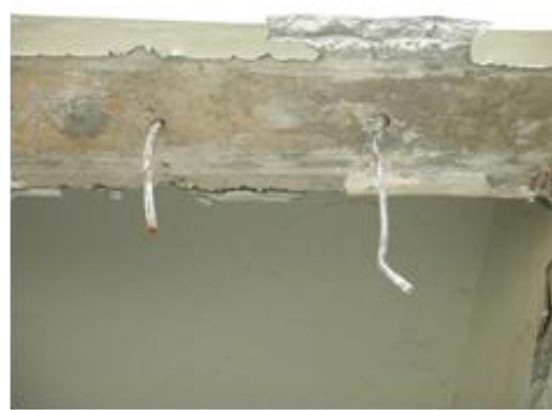
Figure 21 shows examples of improper anchorage of CHB walls to RC members in Market Building of Loon. The left photo is a case that horizontal rebar in a wall is not correctly anchored to a column and the right is a case that anchorage to a beam seems not work well. Figure 22 shows improper installation of concrete gutters in Sagbayan Municipal Office that a precast concrete gutter fell down to ground by shaking motion (exterior view and original position of the the gutter: refer to Figure 2).

Figure 21 Examples of improper anchorage of CHB walls to RC members in Market Building of Loon (by earthquake): (Left) a case of horizontal rebar, (Right) a case of vertical rebar

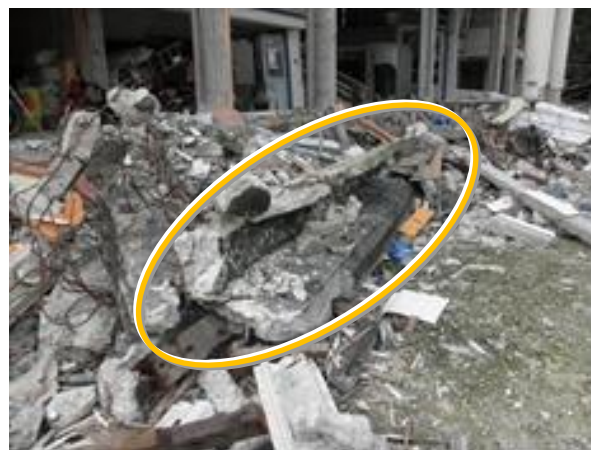
Figure 22 An example of improper installation of concrete gutters in Sagbayan Municipal Office (by the earthquake)

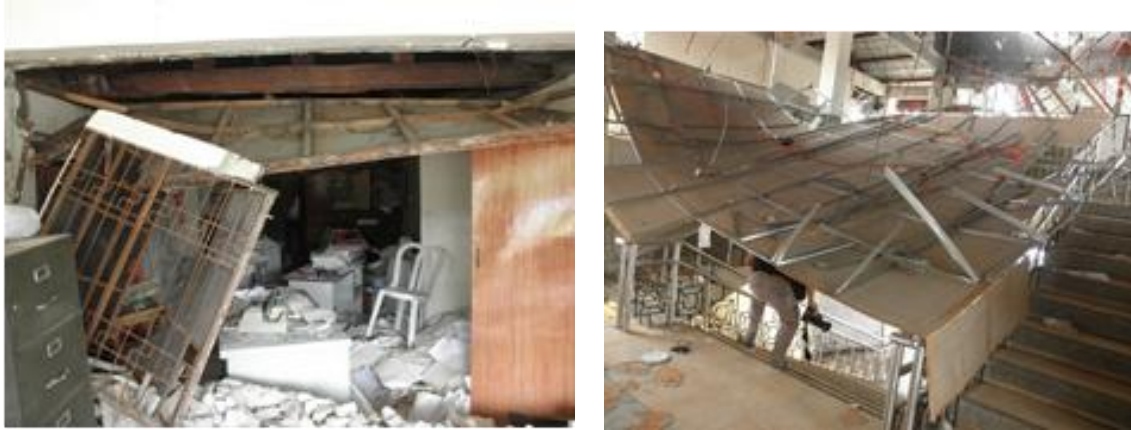
Figure 23 shows cases of ceiling boards. The left photo shows extreme damage that most of ceiling boards were damaged in Sagbayan Municipal Building and the right is a case ceiling of second floor fell down onto a stairway in Market Building in Loon.

Figure 23 Examples of improper fixing of ceiling boards (by the earthquake): (Left) Sagbayan Municipal Building, (Right) Market Building in Loon.

As to design of ceiling boards, description on drawings is usually only on type and quality of materials, not on design of ceiling frames and hungers, and fixing methods like type of nails and spacing. Therefore workers could not understand proper way of fixing and might fix them in a way they like, which might invite the defects and damage like in Figure 23.

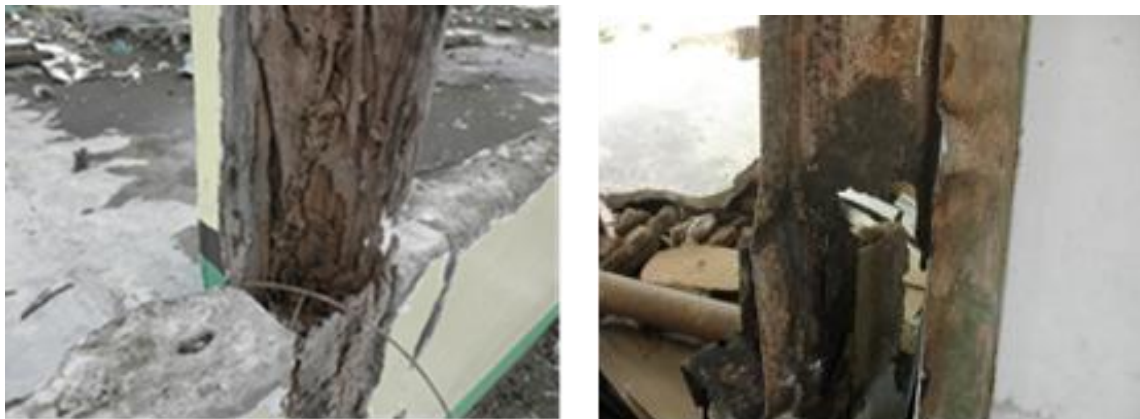
Lack of maintenance works invited heavy damage in several situations. Corrosion of steel members by rusting, damage to woods by termites, fatigue of roofing sheets by cycles of expanding and shrinking by sunlight are the typical examples. Figure 24 left photo shows a case of a wood column heavily damaged by termites at St. Joaquin Central Elementary School, Palo, Leyte (by the typhoon), and the right, a heavily corroded steel column at Cogon Norte Elementary School, Loon, Bohol (by the earthquake).

Figure 24 Examples of failures by lack of maintenance: (Left) St. Joaquin Central Elementary School, Palo, Leyte (by the typhoon), (Right) Cogon Norte Elementary School, Loon, Bohol (by the earthquake)

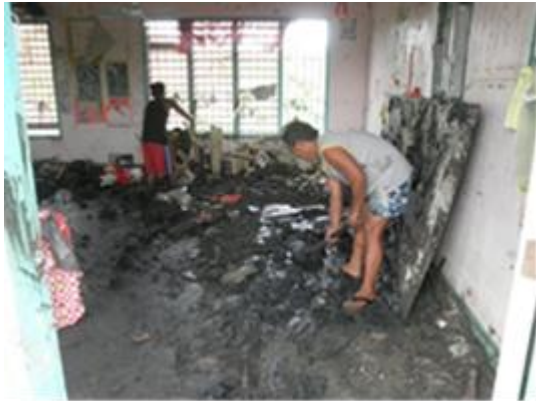
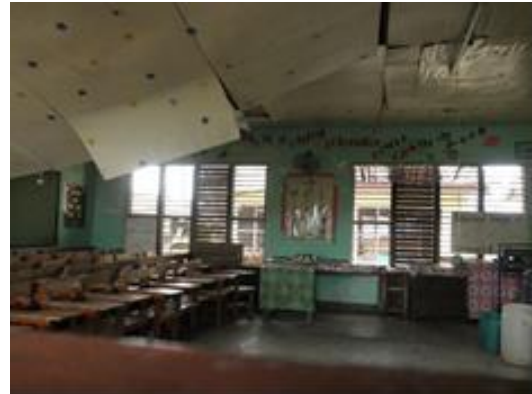
Most of buildings are designed without consideration of inundation and do not use water-proof materials except roofing. Therefore various inundated materials got damage shown in Figure 25. The left photo of Figure 25 shows situation that the storm surge brought much mud into buildings, Basey National High School, Samar, and the right photo is an example of damage to ceiling boards by inundation (Sagkahan National High School in Tacloban, Leyte. Figure 26 is a case of Municipal Health Office of Basey, Samar, which employ simple finishing of concrete walls with durable painting and ceiling without boards. It allows easy recovery and quick restart of operation within several weeks

Figure 25 Examples of damage by inundation (by the typhoon): (Left) Basey National High School, Samar, (Right) Sagkahan National High School in Tacloban, Leyte

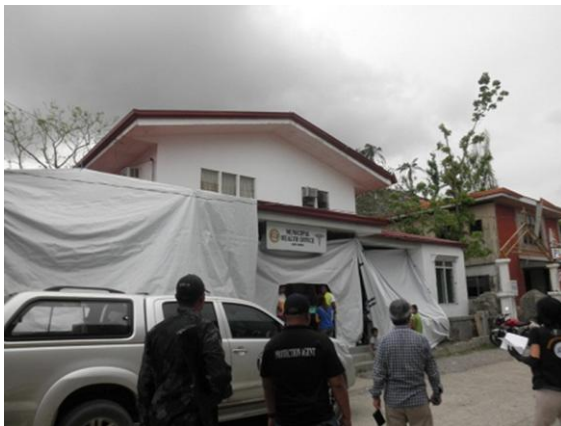
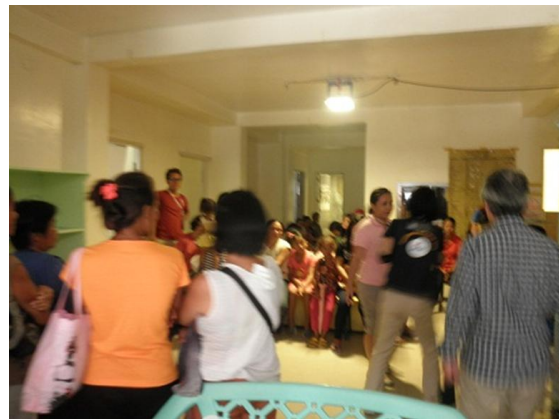
Figure 26 Municipal Health Office of Basey, Samar (Left) exterior view, (Right) interior view of the first floor
