# **Report on the Damage Investigation of the 2001 Atico Earthquake in Peru**

**Koichi KUSUNOKI**

**Senior Researcher  
Building Research Institute of Japan**

April 2002

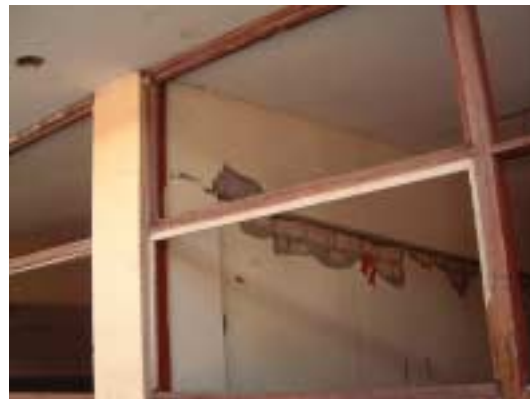
This school, located in the southern part of Arequipa City, suffered damage to its building, which was constructed in 1975 and consists of a one-storied reinforced concrete building 3 m in height. It is 7 spans in the longitudinal direction; the brick spandrel walls are about 2 m high and columns (25 cm x 35 cm, 30 cm x 45 cm) have limited effective height. In the span direction there are 1-span brick walls acting as separators, located at every other vertical plane in the structure. Major damage was observed in between the beam-column joints and the column capitals in the longitudinal direction as well as in the span direction. This building escaped total collapse due to its being light and only one-storied. Insufficient shear reinforcement and structural management of brick walls are considered problematic. There appears to be no problem with the materials or construction.

**Picture 2.1.2-2.** Separation wall in span direction. Damaged capital and beam-column joints. Shear in upper part of brick separation wall.

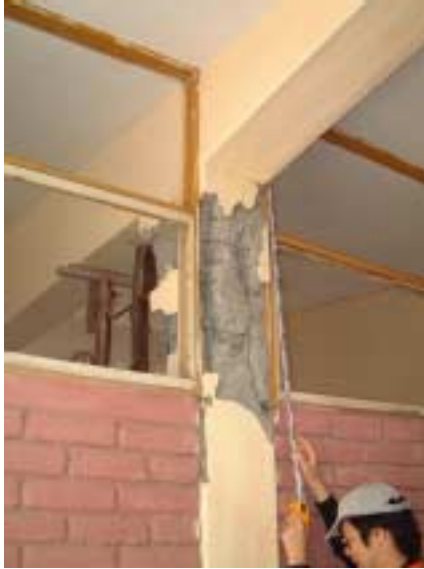
**Picture 2.1.2-3.** Shear failure of column. Shortened column due to high spandrel wall. Shear reinforcement intervals of 30 cm.

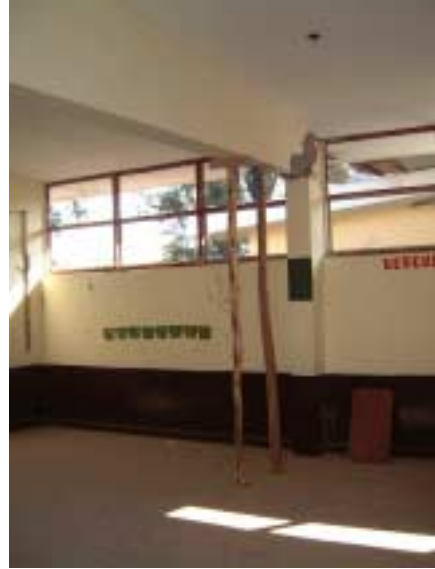
**Picture 2.1.2-4.** Damaged beam-column joint. Supported with wood.

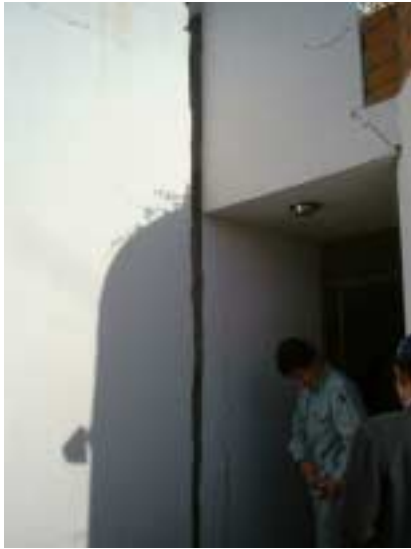
Digging to a depth of 1 m creates a stream, since the water table is only 80-100 cm below the soil surface. This district has the lowest elevation in Arequipa, and is close to a river. Several active volcanoes, including Mt. Misti, are near this area, where granite is quarried. Dwellings leaned towards the river due to outflow of soil following liquefaction.

**Picture 2-1-3-3.** Separated boundary due to the inclination of the building caused by liquefaction.

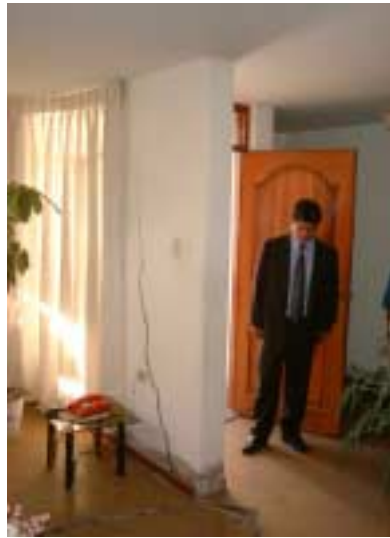
**Figure 2-1-3-4.** Large cracks in the walls and floors caused by inclination of the building.

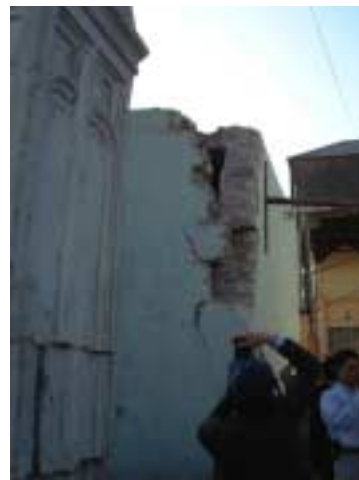
This hospital is located in the central area of Arequipa City. This is a one-storied sillar building. Story height is 5-6 m. Wall thickness is about 80 cm. Major damage includes collapse of walls at the corners of the building, damage to joints of upper openings in the longitudinal direction, and damage to parts where buildings are adjacent to each other. A beam in the span direction was added to the roof after the hospital was damaged by an earthquake in 1960.

**Picture 2-1-4-2.** Walls with damaged corners.

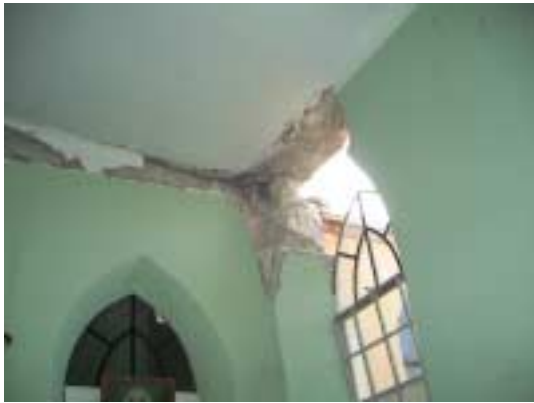
**Picture 2-1-4-3.** Damaged upper opening. Damaged part where buildings are adjacent and at right angles to each other.

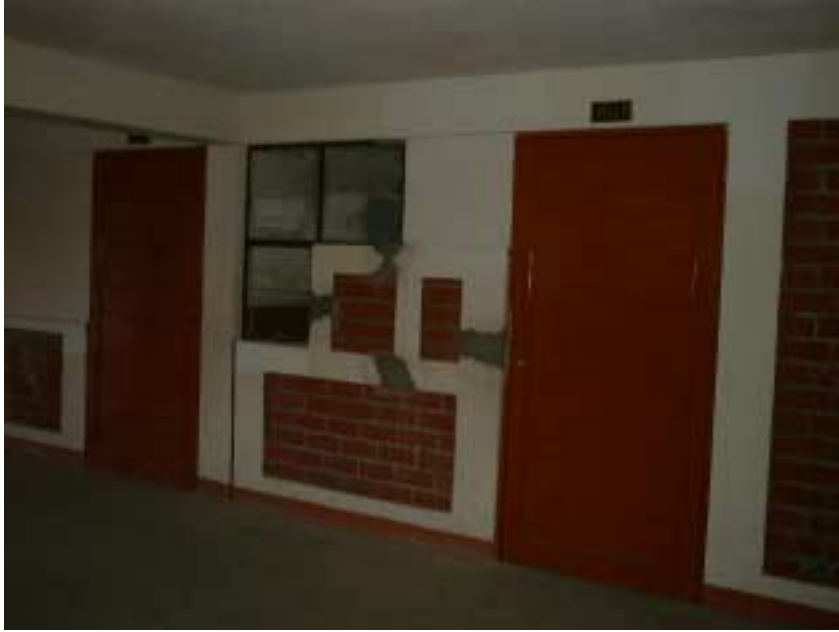
Two schoolhouses were constructed in 1993 and 1995, respectively. The one constructed in 1993 is three-storied and RC-framed. The other is one-storied and RC-framed. The latter was intact but the former suffered slight damage. Although hollow bricks were used for nonstructural walls and spandrel walls in the former schoolhouse, they had collapsed out-of-plane because no reinforcement was provided within the walls. In both buildings, there were 3 cm wide slits around nonstructural walls revealing the insulating foam inside. The columns were intact.

**Picture 2-1-5-5.** Partial damage to nonstructural walls.

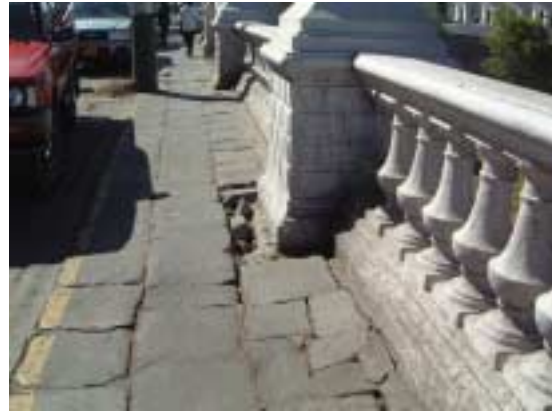
This masonry bridge crosses the river, which runs past the Centro (the central part of the old town) in Arequipa City. Displaced stone blocks used for the balustrade, ripples in the road surface, and cracks on the surface indicating extension in the crosswise direction can be seen. A loosened joint in the upper arch can also be observed. The lowermost foundation part of the bridge was intact.

**Picture2-1-6-2.** Damaged balustrade. Outwardly-displaced balustrade. Road surface showing ripples.

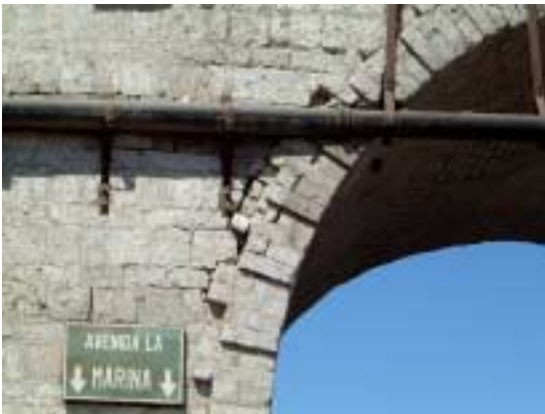
**Picture 2-1-6-1.** Loosened arch. Loosening between the surface of the arch and other stone masonry was observed.

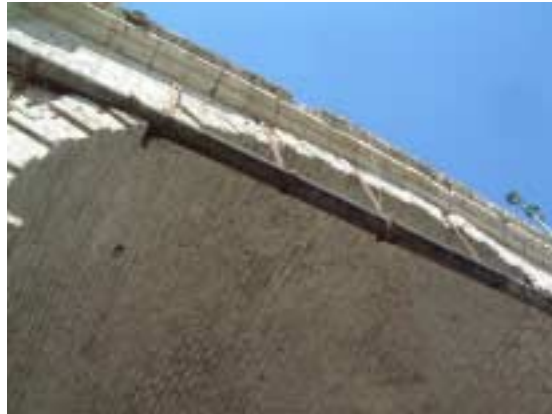
**Picture 2-1-6-2.** Crack in arch. Crack on the surface of the arch. Some masonry blocks were cracked and displaced.

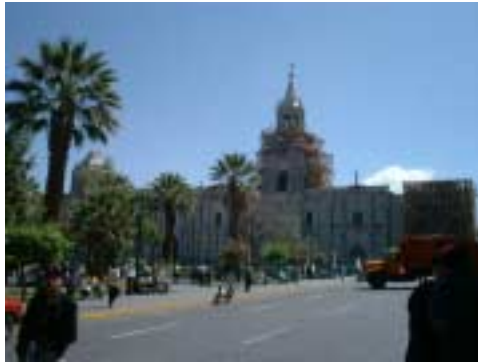
This cathedral, built of sillar blocks, is located at the front of Plaza de Armas. After the earthquake, one of the two towers collapsed and another closely escaped collapse. Loosening of the decorative arch due to the earthquake was also observed. This cathedral had been repeatedly hit by previous earthquakes and was repaired every time. The tower which escaped collapse was internally reinforced with steel beams after collapsing in past earthquakes. Repairs have been initiated with the aid of the Spanish Government. There was a "Danger" sign placed by INDECI (National Institute for Civil Defense).

**Picture 2-1-7-1.** Full view of the Cathedral. The left tower has collapsed. The right-hand tower, which just escaped collapse, under repair at the time, was reinforced with scaffolding.

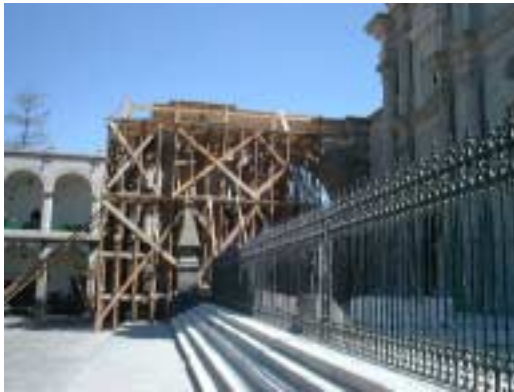
**Picture 2-1-7-4.** Decorative arches on both sides at the front and loosened due to the earthquake, under repair.

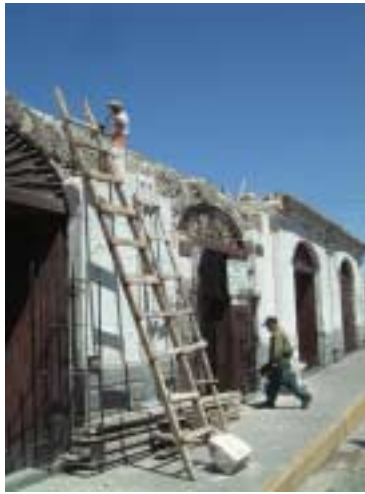
The roof of the top floor and the roof arch between buildings fell to the ground. There were many cracks, probably due to the earthquake, and loosening of joints.

**Picture 2-1-8-1.** Damage to the top floor. The third floor, facing the road Falling roof eaves.

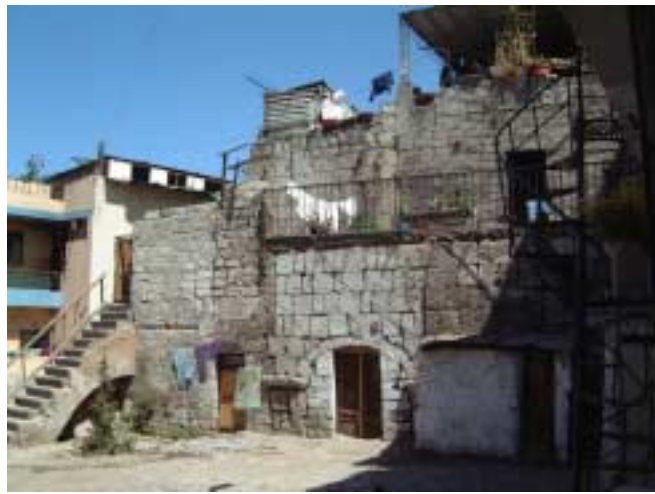
**Picture 2-1-8-2.** Appearance of the first and second floors. Masonry and brick. Limited damage due to the earthquake but the building is structurally impaired.

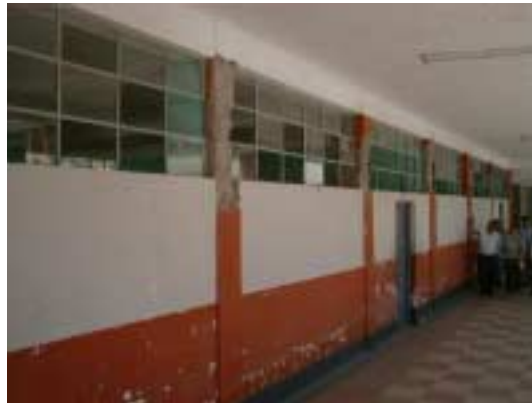
A two-storied building with a 6 x 1 span, with a structure in which brick walls are inserted into RC frames. The span in the longitudinal direction is 6 m, the span direction has a length of 3 m, and the story height is about 3.5 m. Columns on the first floor were shortened because they were limited in height by the nonstructural wall (brick; 2 m in height). Shear failure and bond splitting were observed in these short columns. The space between hoops was a very wide 25 cm.

**Picture 2-2-3-2.** Damaged short column.

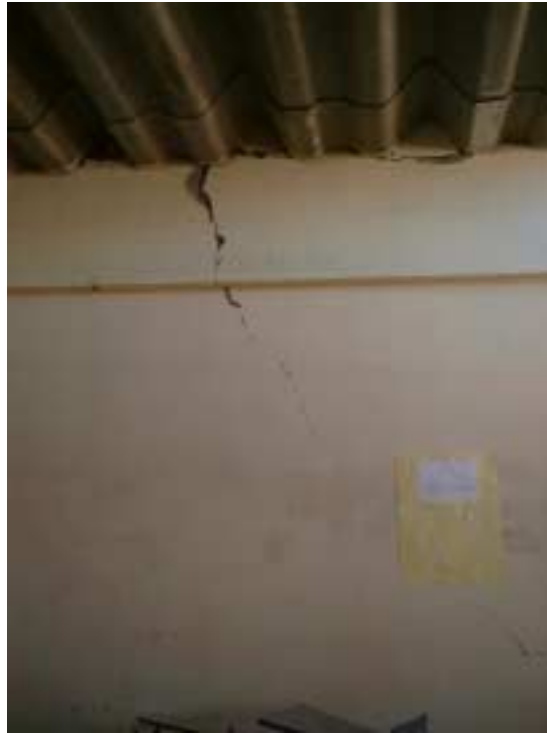
This two-storied building with 4 x 3 span has a structure of brick walls inserted into RC frames on the first floor and concrete blocks on the second floor. The story height is about 3.5 m. An engineer designed the first floor, and the second floor was homemade. Only the second floor suffered damage from the earthquake: there were shear cracks on the wall in the span direction, and the roof supports collapsed.

**Picture 2-2-3-6.** Damaged wall in the span direction.

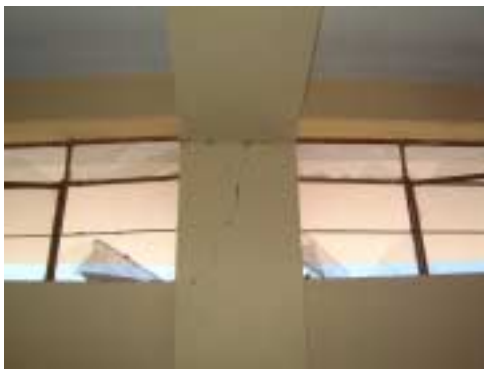
**Picture 2-2-4-6.** Damaged short column.

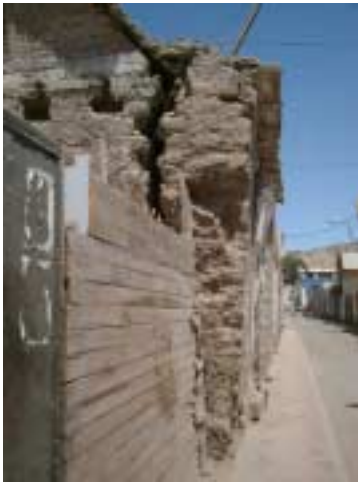
In the Centro District, the damage rate of adobe buildings was no higher than that in the San Francisco District. The damaged adobe houses were studded. There is no standard for adobe blocks; most were about 40-80 cm in size. Adobe walls are occasionally built two layers thick. INC (Peru's National Institute of Culture) has been conducting measurements of crack width in affected buildings for potential widening. The walls of affected adobe walls collapsed mostly out-of-plane. Safety measures, such as the hooping of entire buildings, are required.

**Picture 2-2-5-3.** A wall likely to fall out-of-plane. The space widened to this extent in the week after the earthquake.

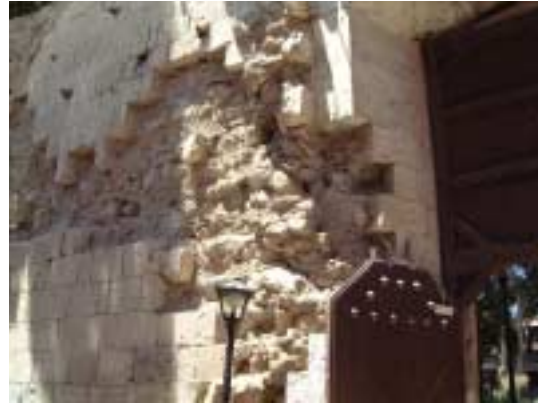
This is the façade of a building constructed in 1792. It also suffered damage from the earthquake of 1868, in which the back surface of the wall was removed. Damage from this earthquake was not too serious: some of the sillar blocks in upper wall toppled. However, a bench is still in place beneath the part where some

**Picture 2-2-6-2.** Damage from the earthquake in 1868. The back surface of the wall detached.

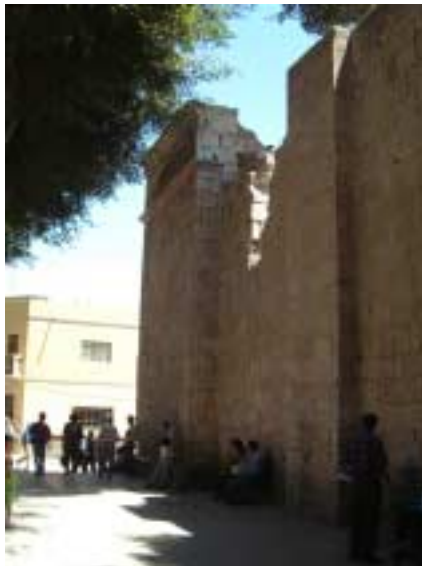
sillar blocks fell, and people still sit on the bench. This is extremely dangerous because of the risk of more falling objects. We informed INC of this.

**Picture 2-2-6-3.** Falling upper wall.

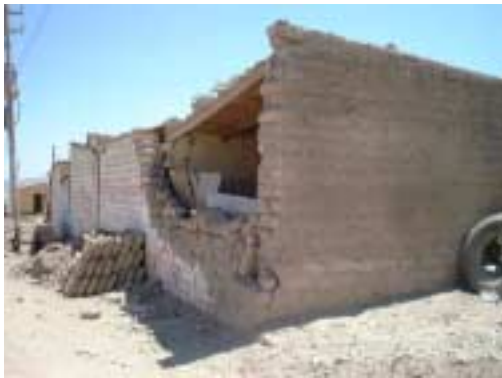
Approximately 80% of the buildings in this area are made of adobe, and most suffered some degree of damage. This district contains a ravine. Houses on the sloping areas suffered more damage than on the bottom, probably due to soil amplification. The construction of dwellings had started from the upper slopes and was extending to the bottom. No major damage was observed in non-adobe buildings. The inhabitants of buildings on this sloping area will be relocated to the Pampa de Chanchan District, which, although known to be comprised of soft bentonite, is the only available district to which people can be moved since the other potential site for relocation, the San Antonio District, is already overcrowded. The Peru-Japan Center for Seismic Research and Disaster Mitigation (CISMID) conducted a geological survey of the Pampa de Chanchan and advised that adobe buildings should be limited to one story.

**Picture 2-2-7-3.** Damaged adobe building. Walls collapsed.

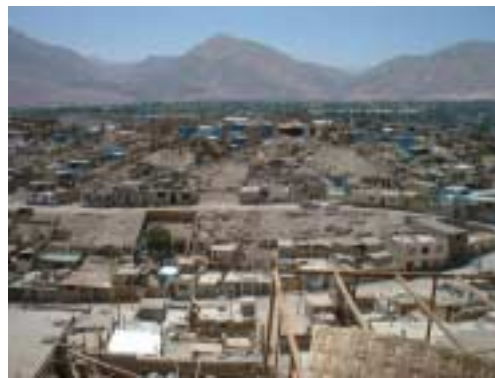
**Picture 2-2-7-4.** Greater damage seen in sloping areas. Less damaged non-adobe buildings (two or more storied). The blue buildings are temporary dwellings.

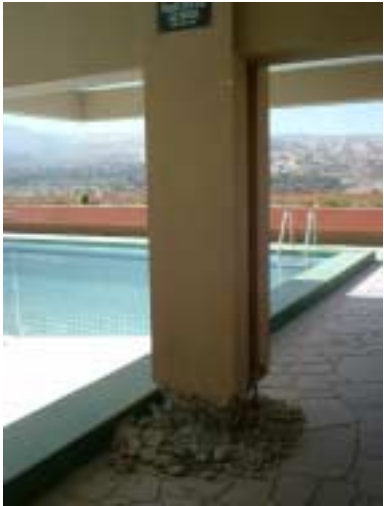
Flexural failure of a column holding a sunshade at the poolside of the hotel occurred at its base. Two columns had supported a roof slab. One column carried only a roof frame and the other carried a roof slab; the latter column base suffered flexural shear failure. The reinforcement bars, which were jointed at the terminal hinge region, had buckled.

**Picture 2-2-9-2.** A column supporting a roof slab. Flexural shear failure at column base.

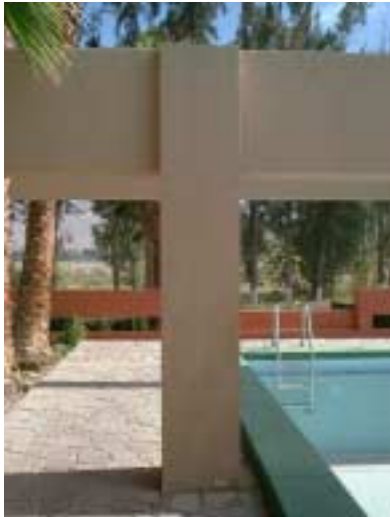
**Picture 2-2-9-3.** The other column is intact. Flexural cracks are observed in the beam.

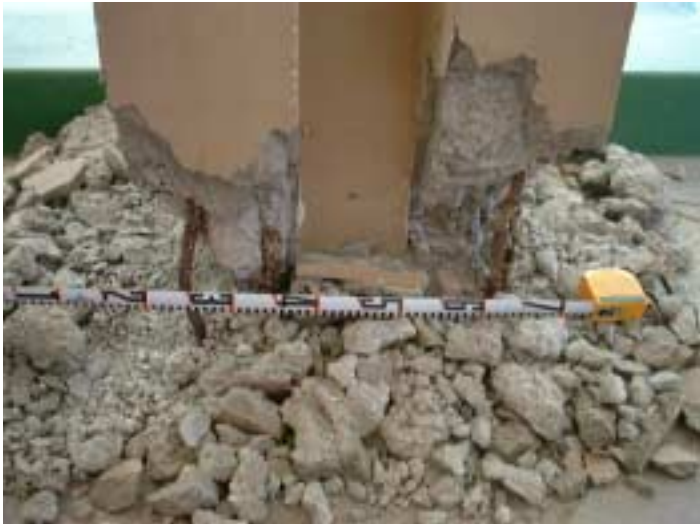
**Picture 2-2-9-4.** Column base. Reinforcements are jointed at the terminal (right terminal).

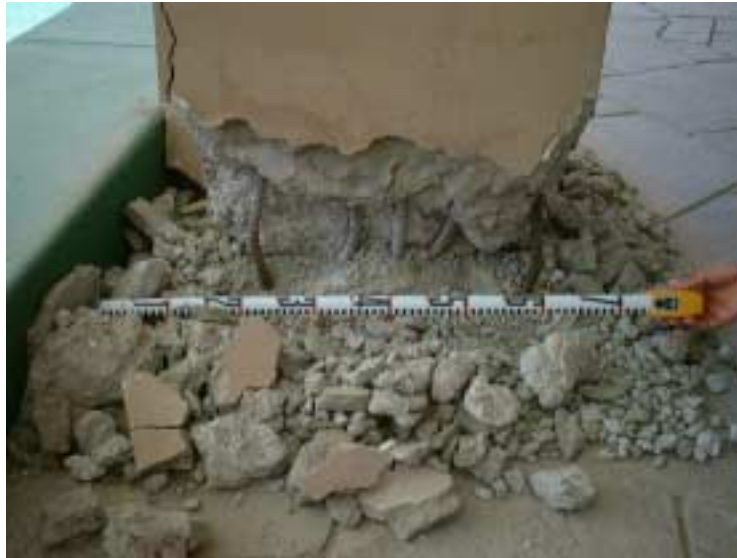
**Picture 2-2-9-5.** Column base. Buckled main reinforcement.

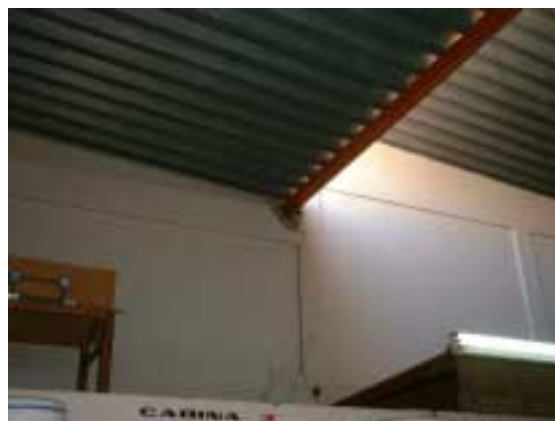
The steel and R/C frames supporting the roof of the SENCICO workshop suffered damage. These frames became deformed out-of-plane together with the frame in the span direction, which exerts a tensile force on the steel frame, resulting probably in removal of the steel frame at the joint with the concrete member.

**Picture 2-3-2-1.** Damaged connection of steel frame with concrete member.

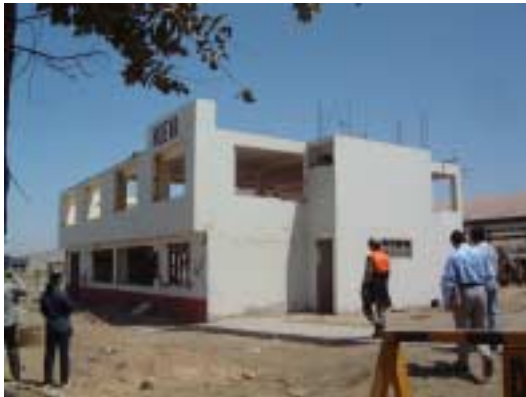
**Picture 2-2-3-1.** Appearance of the building. The parapet on the rooftop toppled.

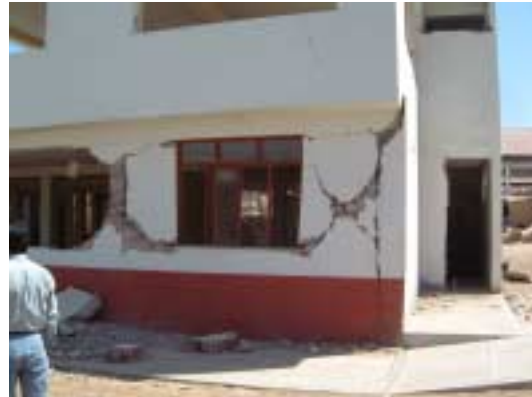
This building, which used to be a ward office and was scheduled to be used as a disaster refuge, suffered damage from the earthquake. It consists of a first floor with concrete block walls infilled into RC frames and a second floor with hollow brick walls infilled into RC frames. Construction engineers were not involved in planning or design. The longitudinal direction comprises 4 spans, and the span direction has 3 spans. The column size is 55 cm x 35cm, 6-D18, and Ø8@200 at the core. Some columns had no lateral reinforcing bars. There are no beams in the span direction. Damage was limited to the first floor. In particular, the posterior columns of the building, which were short due to the high spandrel wall that occupied and limited the space available for columns, showed occurrence of shear failure.

**Picture 2-2-3-2.** Damaged CB wall and column.

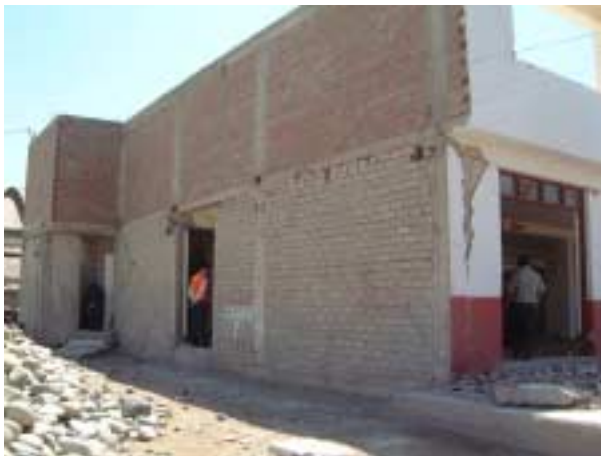
**Picture 2-2-3-3.** Shear crack in the wall. First floor: concrete block wall. Second floor: brick wall.

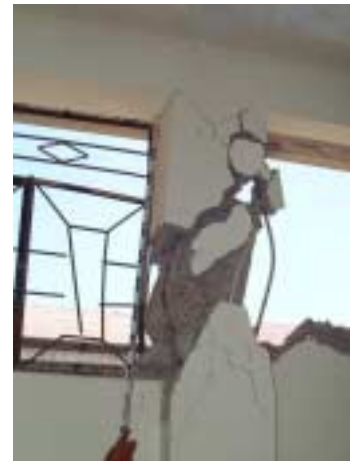
**Picture 2-2-3-4.** Shear failure of the short column. No lateral reinforcing bar.

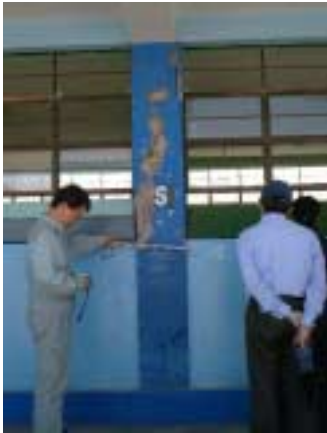
This is a two-storied schoolhouse with an 8 x 1 span, constructed in 1994. In the longitudinal direction, which extends to the northeast, it has a span of 4 m, a length of 5 m in the span direction, and a story height of about 3 m. Deformed bars were also used as lateral reinforcing bars; the size of columns was 45 cm x 36 cm, width at the core measured about 20 cm, and the thickness of covering concrete was about 7.5 cm. There is a wall in the span direction every other span. Structural calculations may have been performed for the walls; however, different diameters of reinforcement bars of columns and different types of reinforcing

**Picture 2-3-4-2.** Shear failure of the column on the corridor side resulting from shortened columns due to limited vertical space, occupied by the spandrel wall.

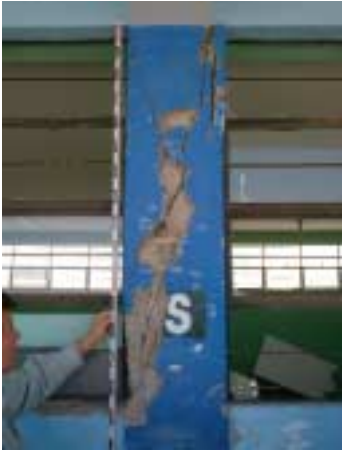
**Picture 2-3-4-3.** The length of the compressed column was about 145 cm.

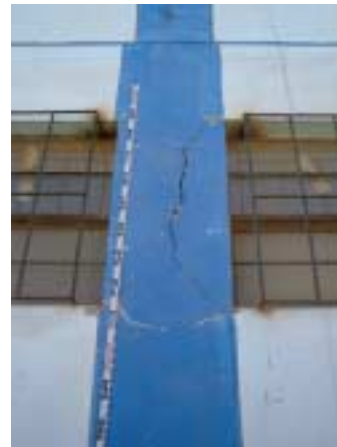
hoops were used (round steel for parts where nonstructural walls were attached, and deformed bars for parts without nonstructural walls). Concrete blocks were used for the walls. A two-storied schoolhouse at the same site and facing in the same direction, which was constructed with assistance from Japan in 1990, suffered slight damage, including a shear crack in one column.

**Picture 2-3-4-9.** Damaged column. A shear crack was observed in one column.

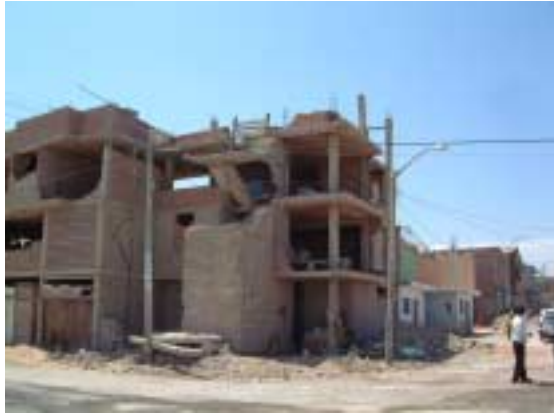
This residential area is located in the bottom of a landfilled valley. A three-storied building suffered serious damage. Building workmanship was questionable because not all columns were vertical and there are some honeycombs. Reinforcements were not attached to the walls of the staircase, and these walls collapsed.

**Picture 2-3-5-1.** Damaged three-storied building.

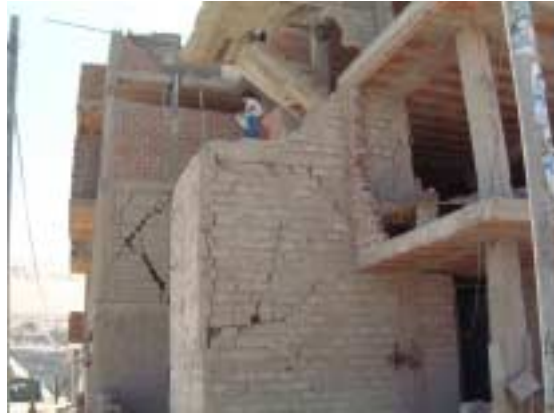
**Picture 2-3-5-2.** Damaged wall of stairhall  
The wall of the stairhall on the third floor collapsed.

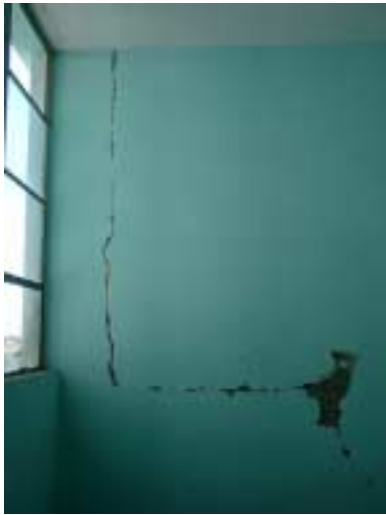
This is a national hospital with 5 floors and 1 basement level, constructed around 1950. Its structure features an R/C frame with CB wall and several brick walls. It sustained minor damage, including slight cracks in nonstructural walls. After the earthquake, both public water supply and sewerage broke down, and the gas supply facility was seriously damaged. The steam machine (used by the hospital for disinfection) was also damaged and needed to be replaced, but the entire set of equipment, including buried piping, should in fact be replaced. Normally, groundwater is pumped into an elevated water tank, but the pump did not work after the earthquake. Even now, only outpatients and emergency patients are accepted, and the number of hospital beds is very limited. The structure of the building itself is intact, but hard putty was used in the window frames, which increases the risk of shattering glass during the next earthquake.

**Picture 2-3-6-2.** Cracks between nonstructural walls and structural member Crack (stairhall).

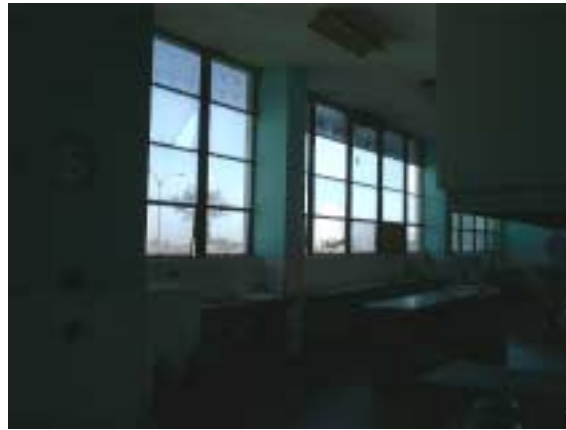
**Picture 2-3-6-3.** Broken window. Hard putty was used.

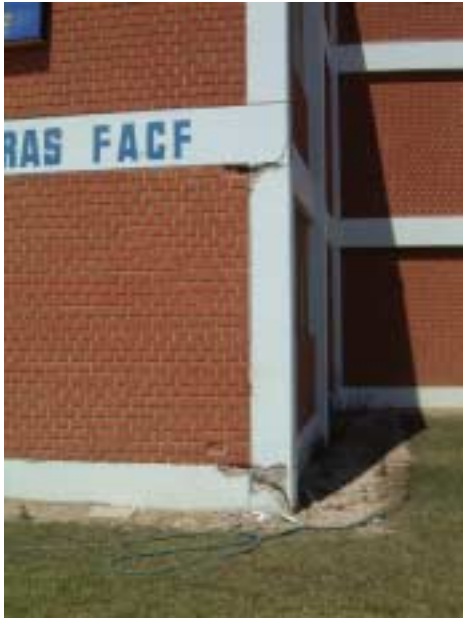
Jorge Basadre Grohmann National University is home to 8,000 students in 14 faculties including 30 departments. The damaged FACH building was constructed in 1996. There are flexural shear cracks at the column bases in the southwest corner and shear cracks at the joints between the upper and lower terminals on the first floor. The inner pillars on the first floor have flexural cracks at the upper and lower ends. A seismometer was supplied by JICA and installed by CISMID.

**Picture 2-3-7-1.** Damaged wall and beam-column joints.

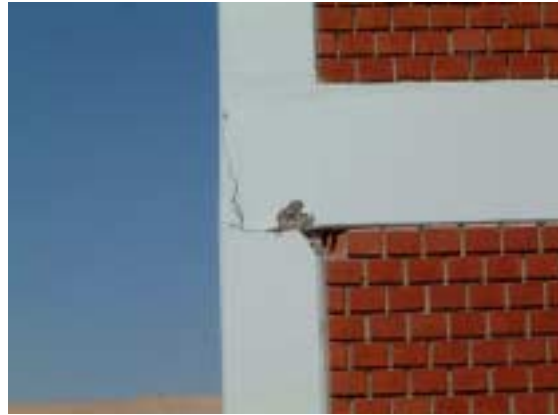
**Picture 2-3-7-2.** Damaged capital.

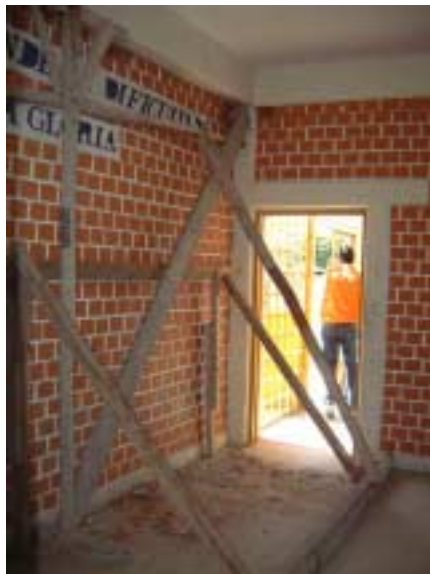
**Picture 2-3-7-3.** Damaged wall. Emergency support.
