**STUDY TRIP TO ITAKO CITY**

A Technical Report

**By MARTINEZ BRAVO Delvin Abdiel (MEE10515)**

**Disaster Management Policy Program (2010-2011)**  
**(Earthquake Engineering)**

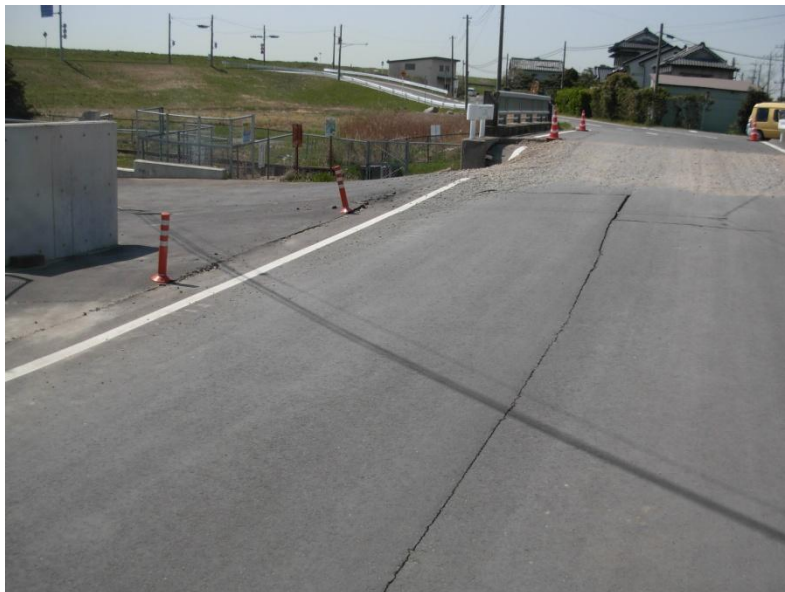
**Photo 1. Crack at the middle of the road.** Many time this kind of damage is presented when earthquake occur due to change of level of the ground (down or uplift of the ground). The localization of the crack, at the middle of the road, can be due to separate construction of each way, different level of compaction

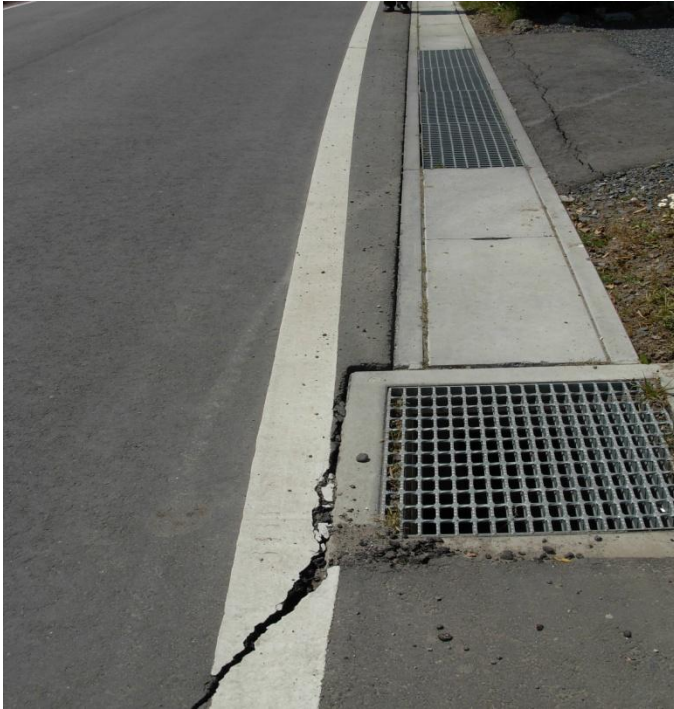
**Photo 2. Crack at the border of the road.** This kind of damage can be occasioned due lateral displacement not uniform of the ground, because the shaking from the earthquake.

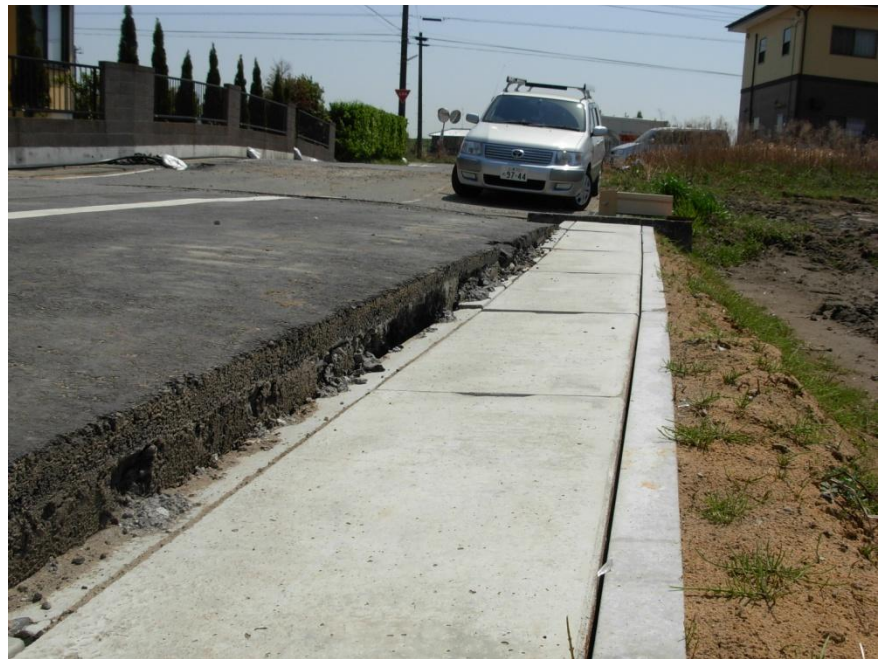
**Photo 3. Settlement of the sidewalk.** Difference of level, due to liquefaction phenomenon. In this case the settlement of the sidewalk was around 16 cm. This kind of damage is common in area with soil condition susceptible to liquefaction. At this site was possible to observe the liquefaction phenomenon, so, is sure about the cause of this kind of damage.

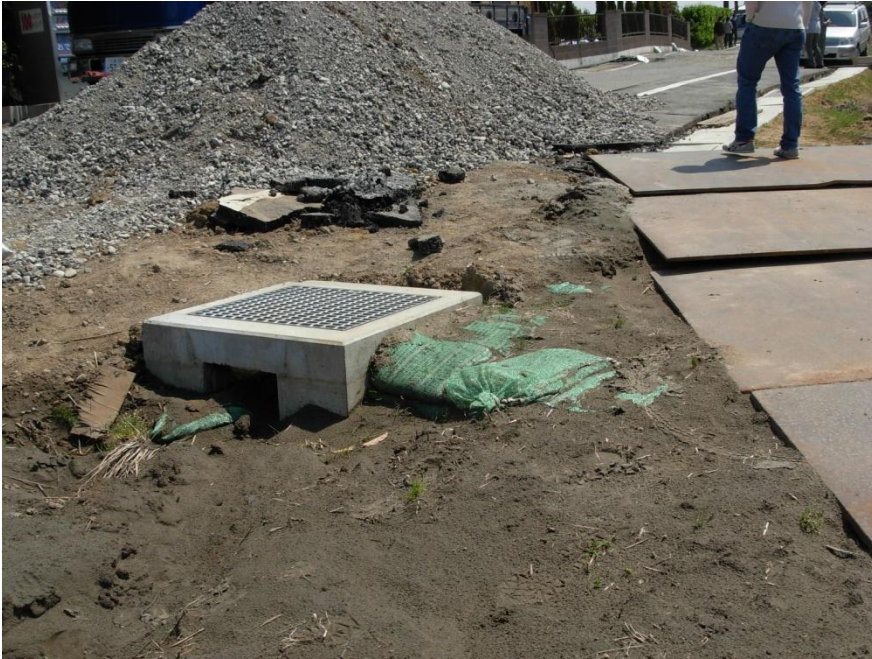
**Photo 4. Uplift of the drainage structure.** Due to liquefaction phenomenon the structure of the concrete utilized for drainage system was uplifted around 15cm from the original level.

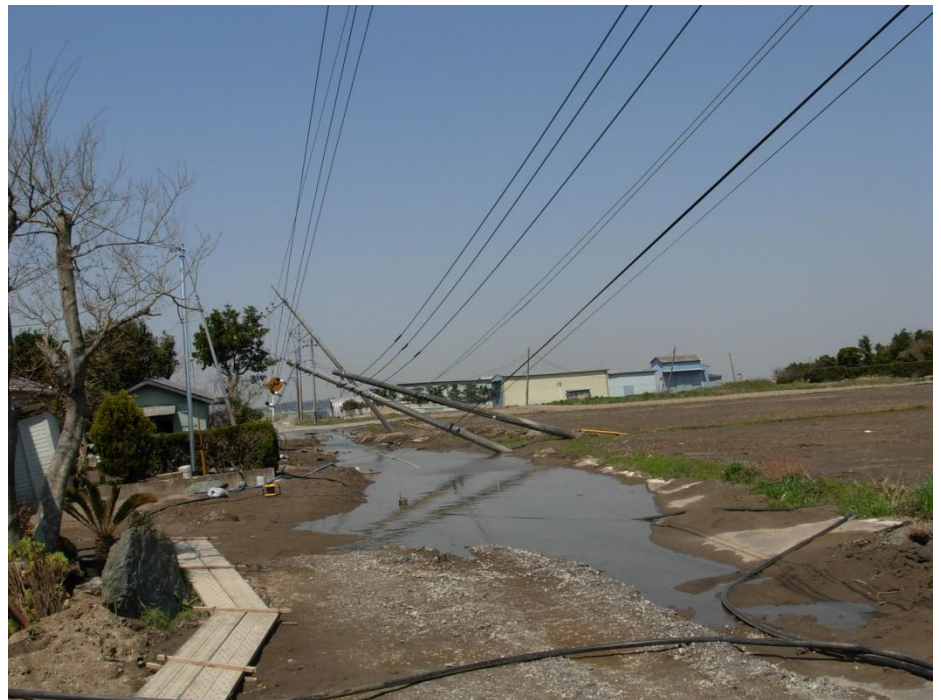
**Photo 5. Inclination and collapse of electric post.**

Due to liquefaction phenomenon the loss of the shear strength of the soil, the electric post is impossible to keep straight. In this photo we can see also, the water from the ground that indicates that liquefaction was occurred.

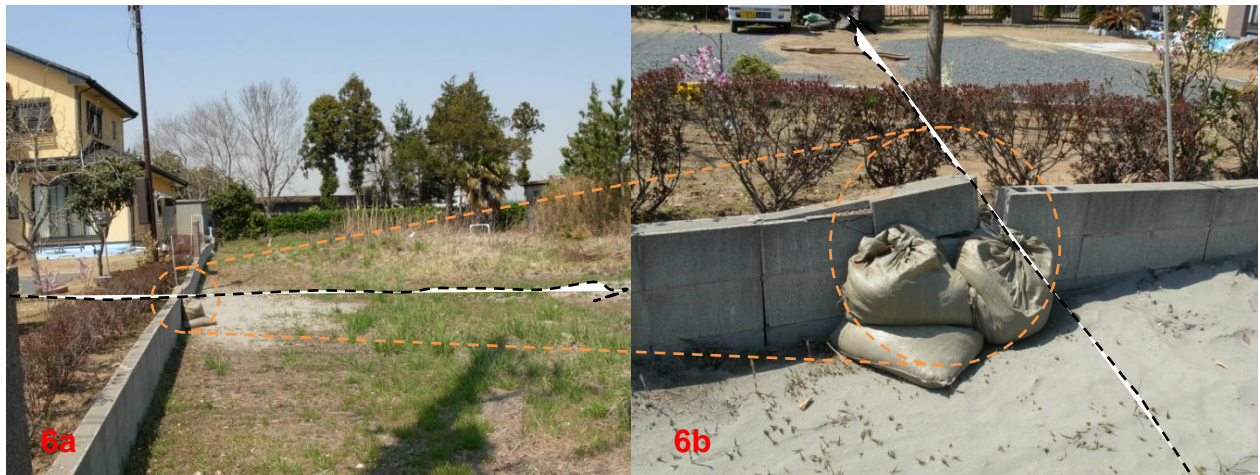
**Photo 6a) and 6b). Crack and displacement (vertical and horizontal) in the fence retaining wall (concrete block).** Damage due to liquefaction phenomenon, the dash line show the direction of the crack on the ground, the fine sand is evidence of liquefaction, the lateral and vertical displacement on the retaining wall is showed (orange dash circle).

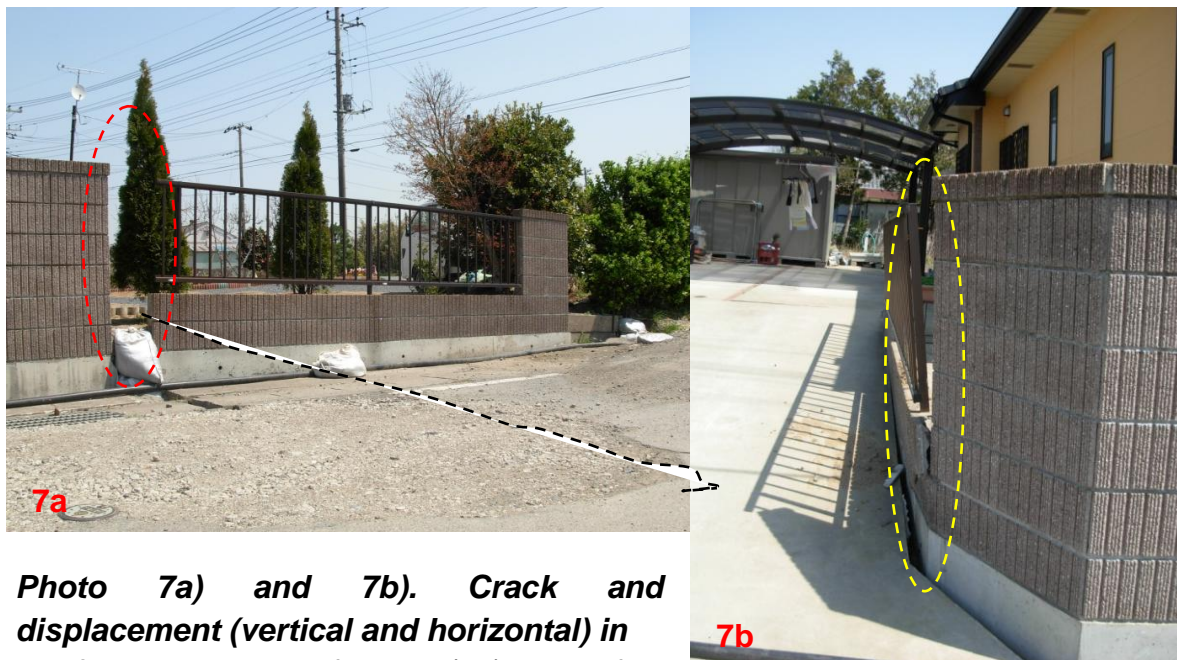
**Photo 7a) and 7b). Crack and displacement (vertical and horizontal) in the fence wall.** The left photo (7a) show of the continuation of the crack (black dash line) and the damage in the fence wall (red dash ellipse). Horizontal and vertical displacement, due to liquefaction phenomenon. Also, the right photo (7b) show the effect of liquefaction, lateral and vertical displacement, tilted wall, crack on the bottom of the wall and separation between the road and the fence wall (yellow dash ellipse).

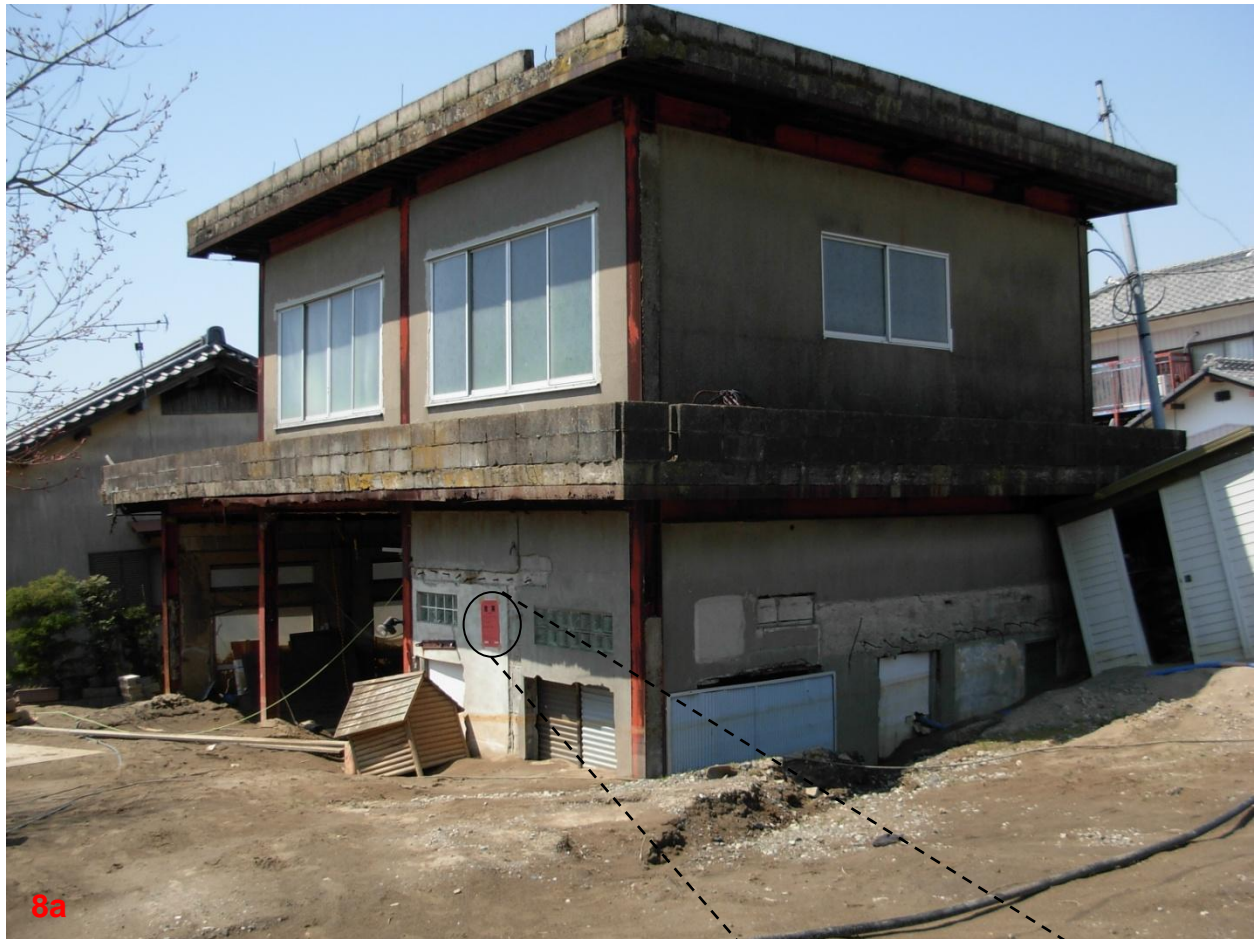
**Photo 8a) and 8b). Settlement of the building.** Due to liquefaction phenomenon, several building suffered severe settlement like this building of two stories at Inashiki city. The settlement was around 1.8m, this is enough for become useless the building, the message in front side (8b) indicate that the building is “UNSAFE”. This message was collocated after the earthquake by the inspector from the local government.

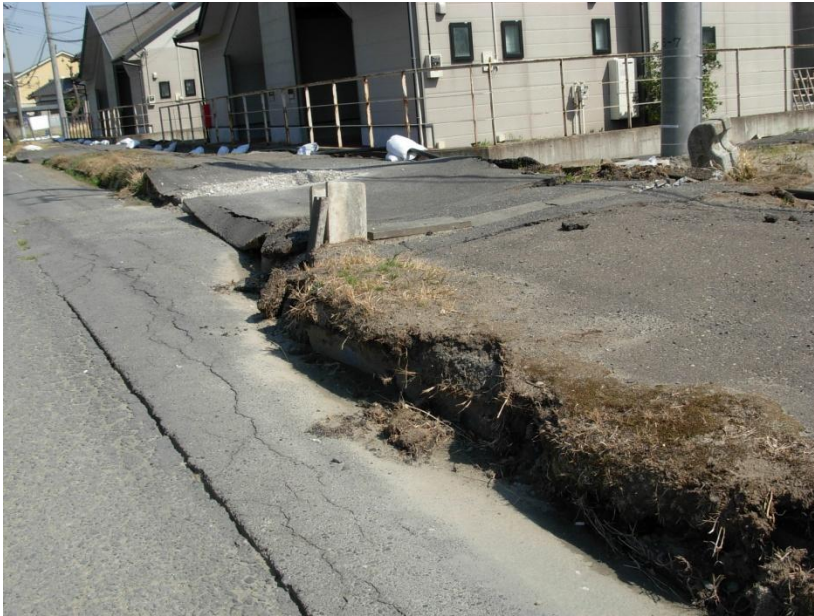
**Photo 9. Distortion of the ground surface.** The sidewalk went up and the road went down, crack at the road, this is clear evidence of the occurrence of liquefaction phenomenon.

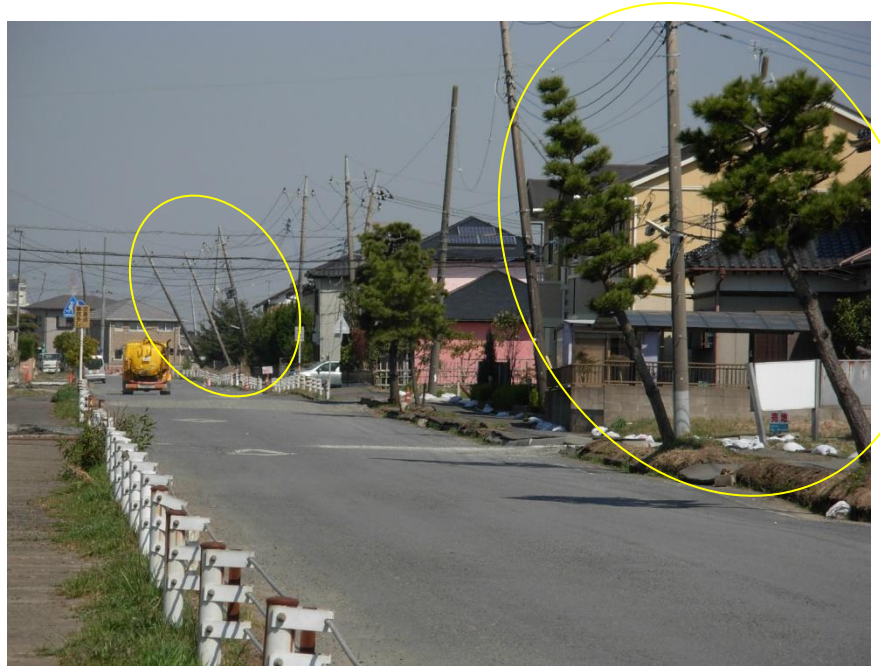
### **Photo 10. Inclination of the electric post and tree.**

When liquefaction occurs, the main effect on the ground is the loss of the capacity shear strength, so the slender structure, like electric post, can not keep straight, and sometimes fail down (including tree)

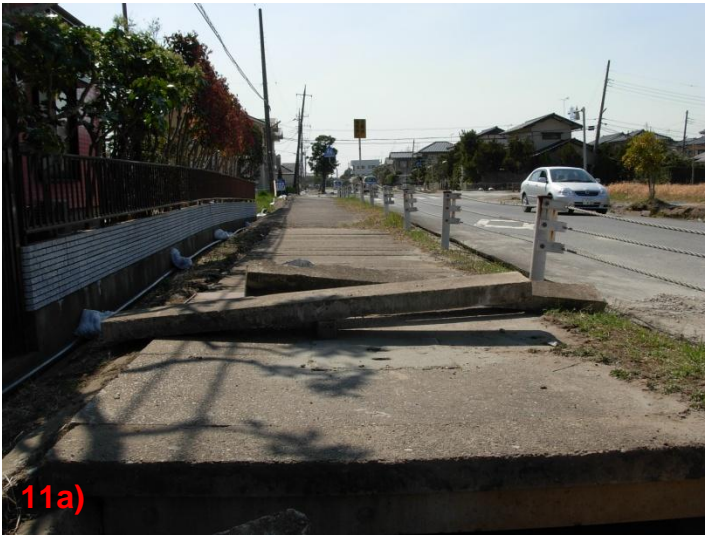
**Photo 11a) and 11b). Distortion of the ground surface under the sidewalk.** The Photo 11b) shows the sidewalk after the earthquake, before the seismic event this sidewalk was like Photo 11a). This photo was taken in the middle of two segments of sidewalk, so this indicates different effects of the ground motion over the structure; this can be due to different soil conditions on each side or different construction methods or different quality of the construction or the combination of these and other factors.

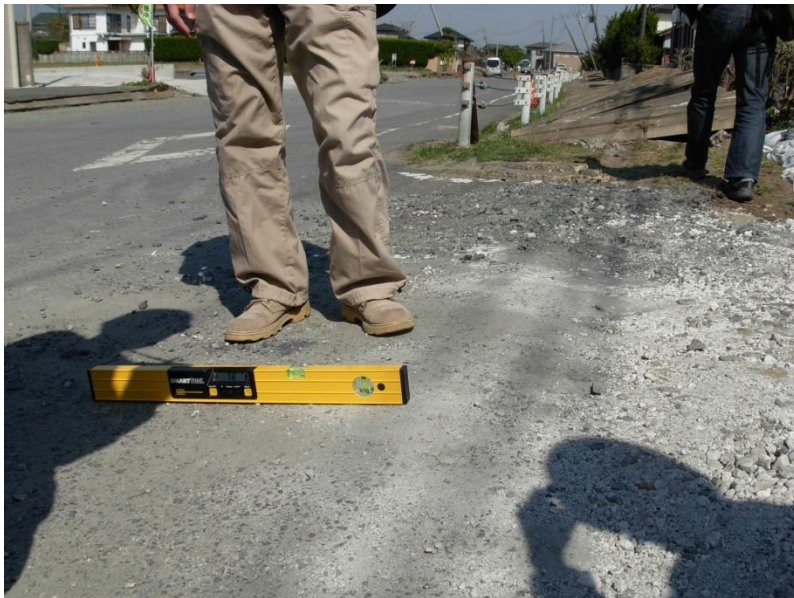
**Photo 12. Distortion of the ground surface on the road.** This point is between two segments of sidewalk shown in Photos 11a) and 11b). The underground went up, around 10cm, and the lateral inclination is 7.6 degrees. (In the photo, Rusli-san, took the inclination measurement)

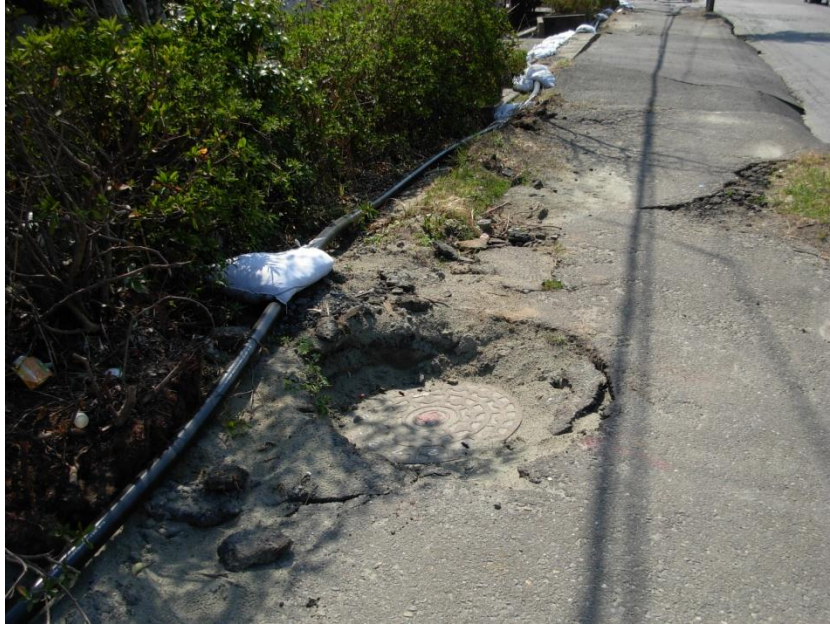
**Photo 13. Down of ground level.** In this case the manhole went down due to liquefaction phenomenon.

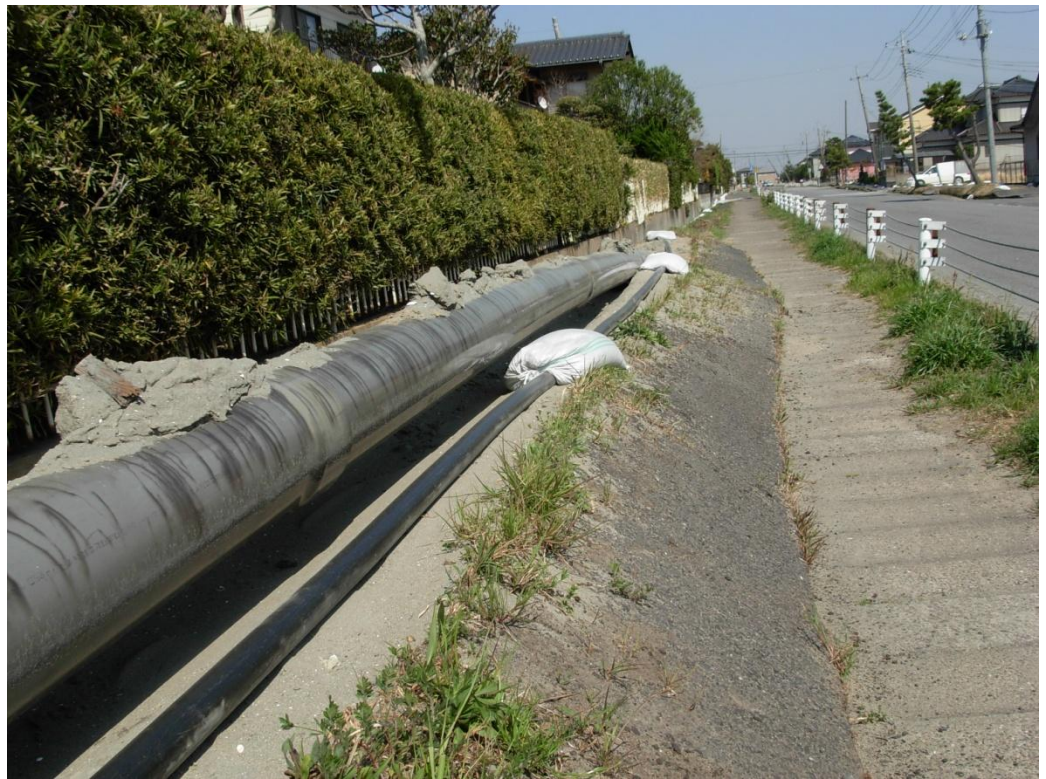
**Photo 14. The pipe water went up.** After the earthquake the water service remained out of service, this kind of damage is due to liquefaction also.

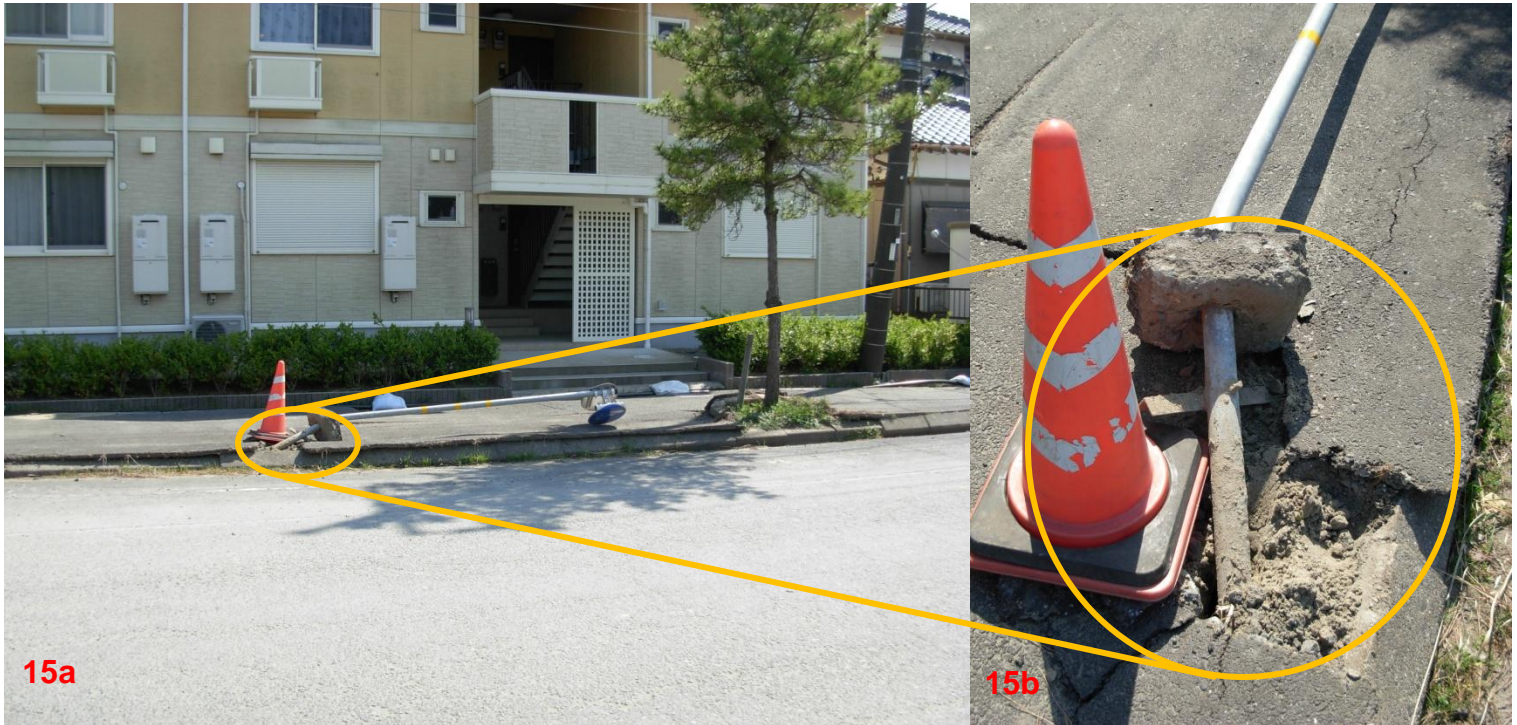
**Photo 15a) and 15b). Fall down of the small structure for “road signs”.** In the case of the slender structure is very easy fall down when occur the liquefaction phenomenon, like the electric post, tower structure, but in case of small structure, like as the shown on the photo 15b, is not common, and also is very difficult fall down due to the large (height) is relative small, so the momentum force necessary for become fall down is big, however is necessary to take account, also, the foundation condition of the structure. In this case, we can see a weak foundation, combined with the liquefaction phenomenon, the soil behavior, like water, without shear strength, all these factors combined can be the cause of several damages.

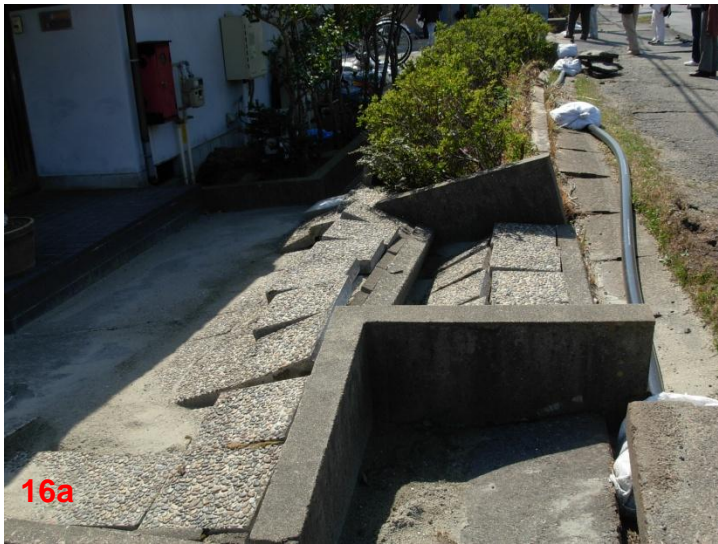
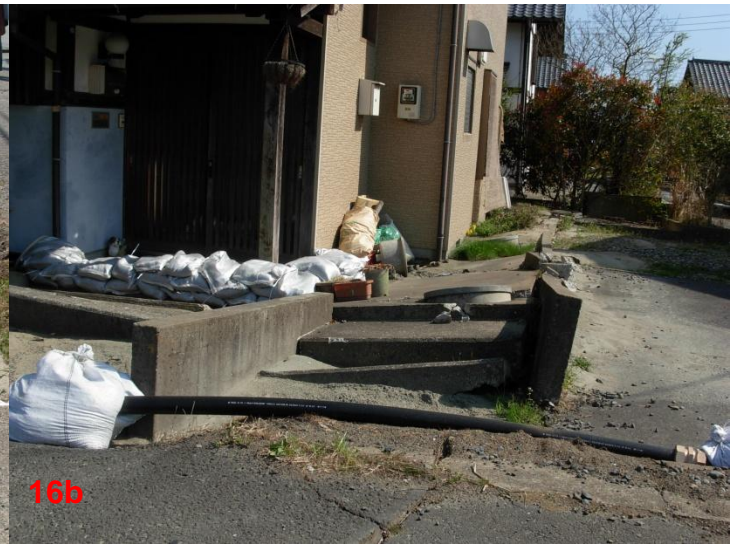
**Photo 16a) and 15b). Distortion of the ground in the surrounding area of building.**  
Down of ground level causing severe damage (crack on the sidewalk) and differential settlement on the structure around of the building.

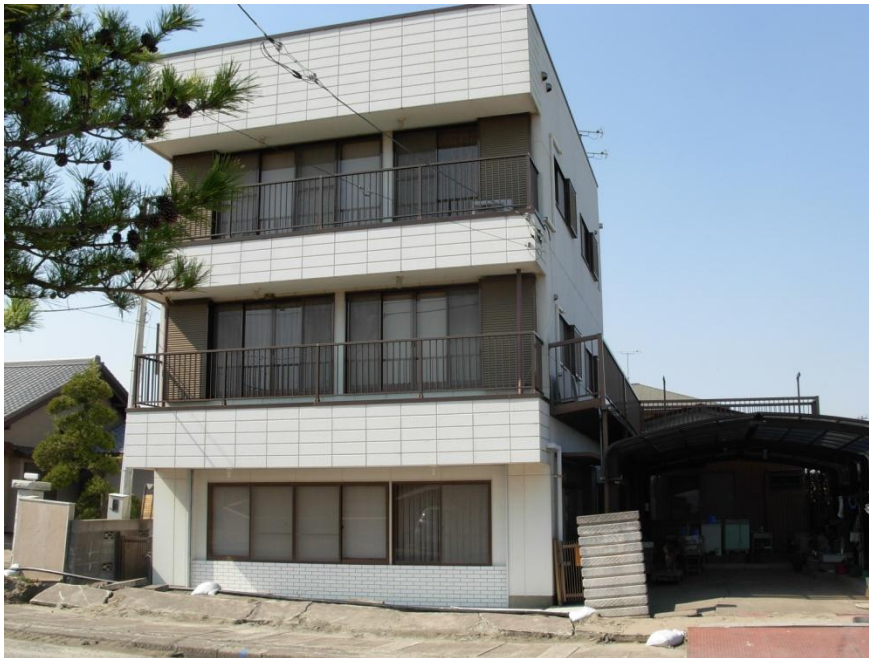
**Photo 17. Settlement around of the building.**  
Some case differential settlement can cause the total collapse of the building, however when the settlement is uniform, the building can keep straight, in this case the photo shown good behavior of the building against differential settlement, due that the structure around the building suffered settlement with different magnitude, maybe due to kind of foundation .

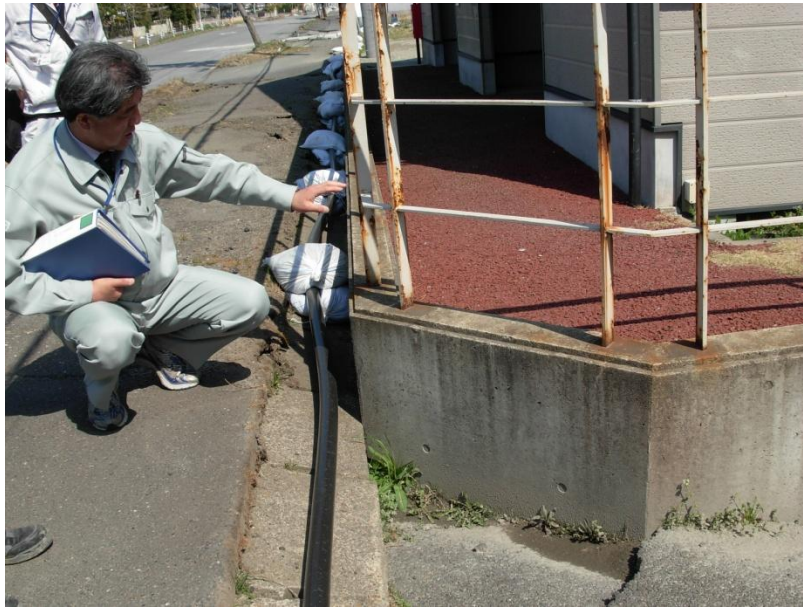
**Photo 18. Settlement of retaining wall.** The engineer indicates the original level of the retaining wall before of the earthquake; in this case the settlement was around 50 cm.

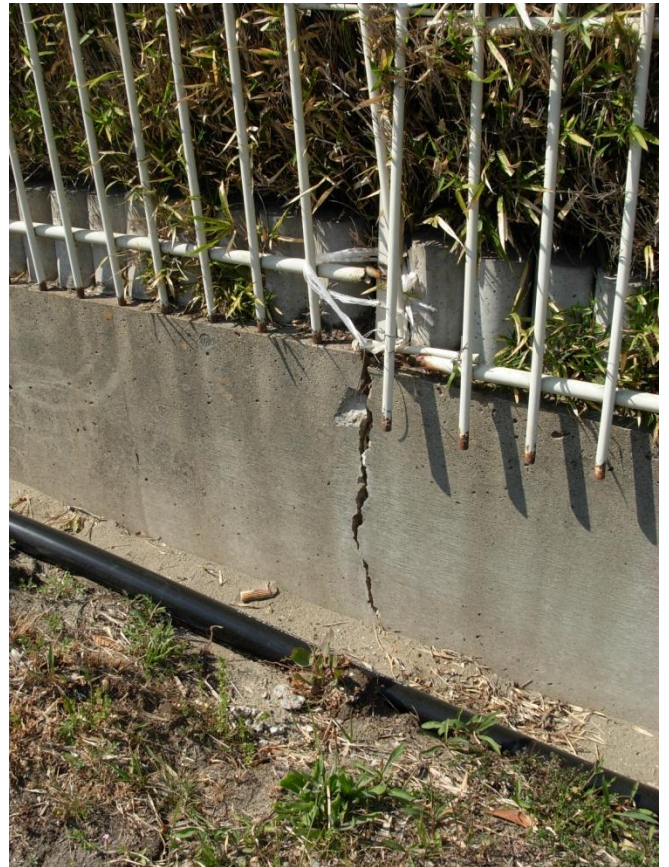
**Photo 19. Crack and difference level at the retaining wall.** In this case was difficult see, if this wall has steel reinforce, because the crack is not perpendicular to the longitudinal section. On the top of the wall the wide of the crack is around 1.5 cm.

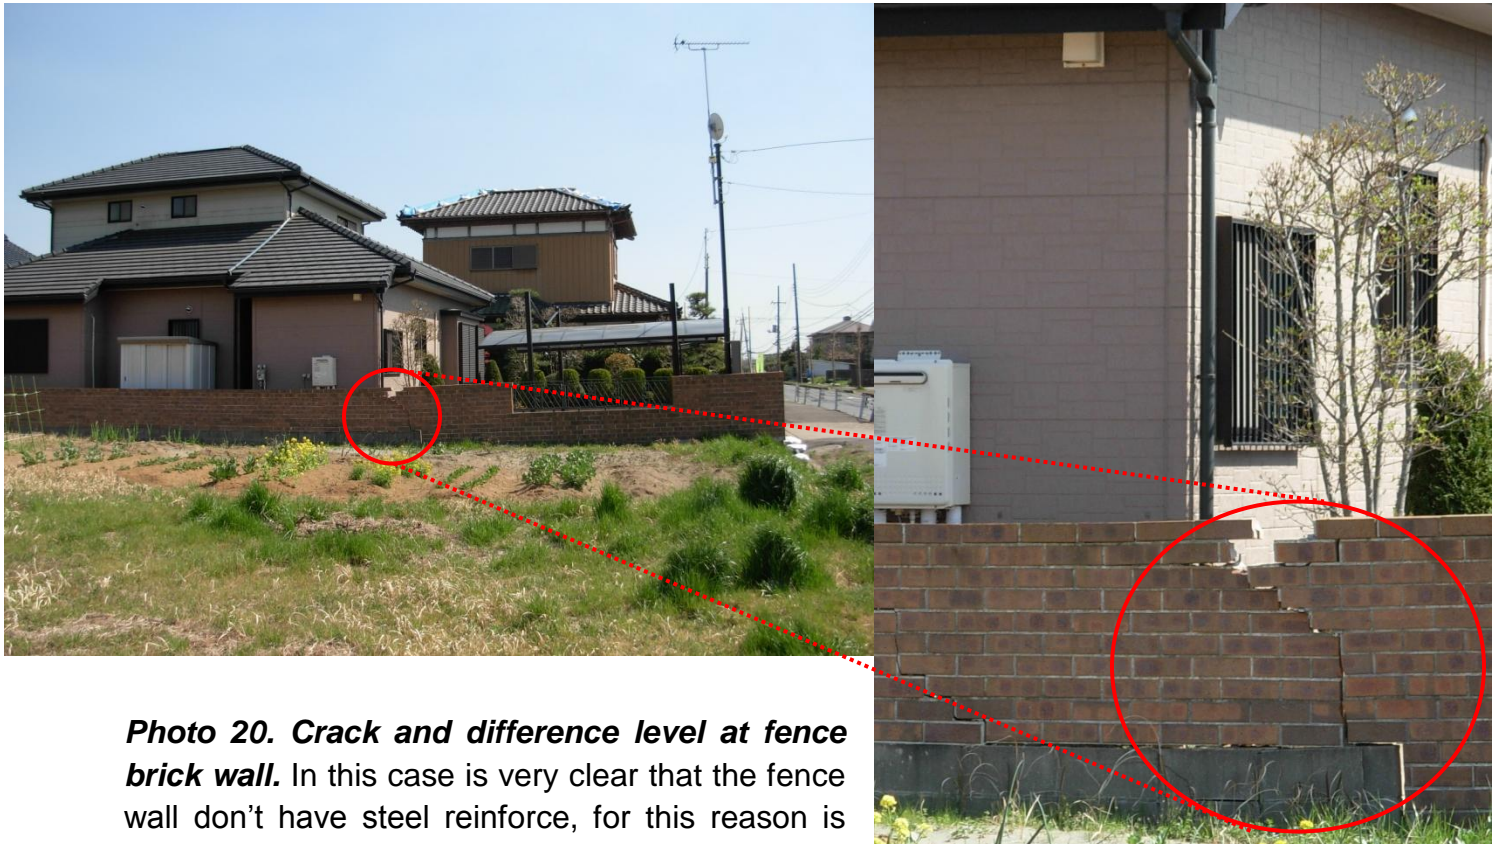
**Photo 20. Crack and difference level at fence brick wall.** In this case is very clear that the fence wall don't have steel reinforce, for this reason is very weak against lateral and vertical force.

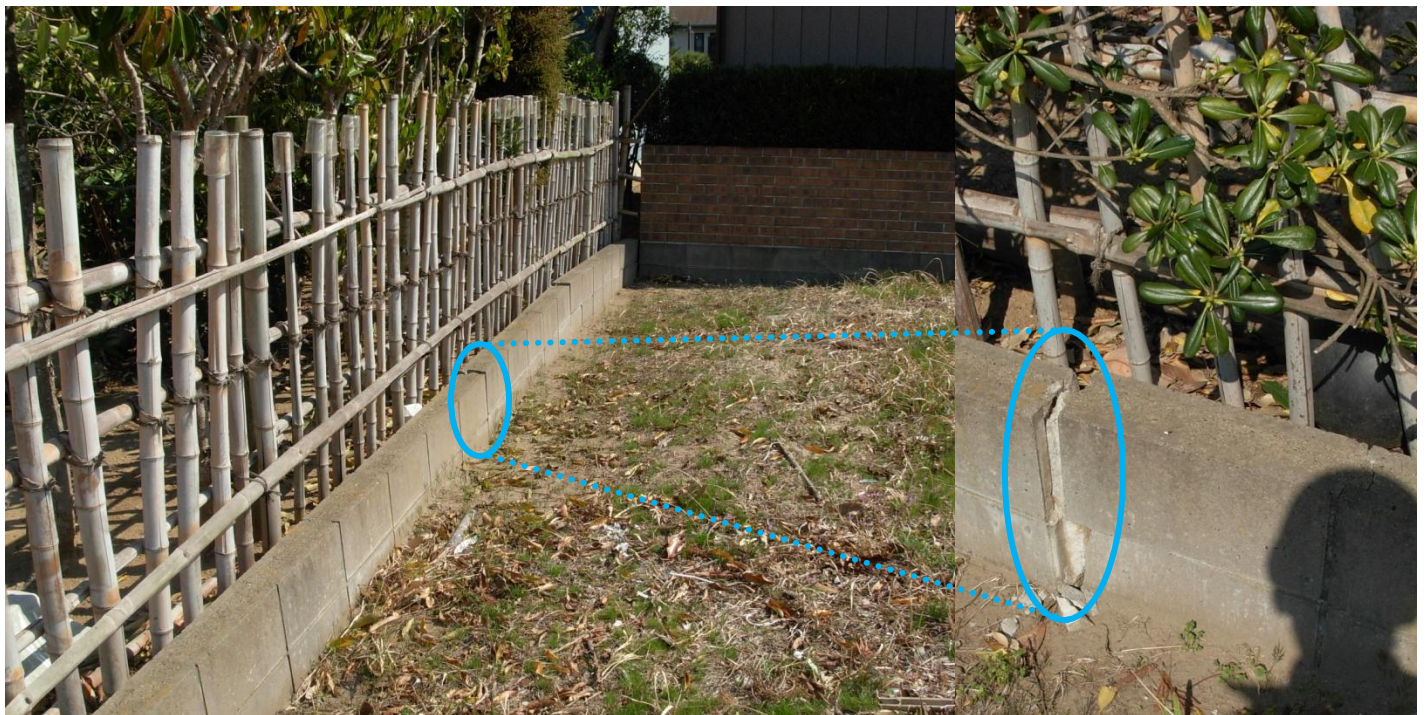
**Photo 21. Crack and horizontal displacement on the fence concrete block wall.** Without steel reinforce.

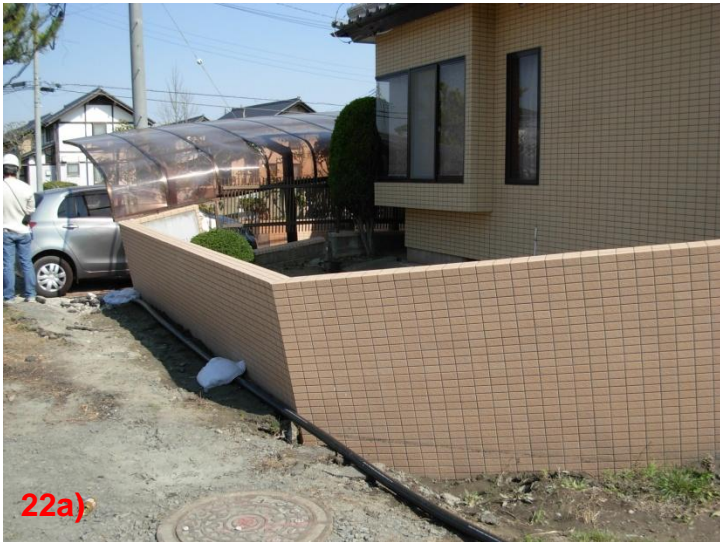
22a)

**Photo 22a), 22b), 22c) and 22d). Differential settlement: crack and different level on fence brick wall and retaining wall.** Due to liquefaction phenomenon, this wall suffered higher differential settlement, causing lateral-vertical displacement and crack. The photo 22d) show that the wall don't have steel reinforce, so is very weak in horizontal direction. The horizontal displacement of the wall (crack) in the superior side was around 15cm, and in the inferior side was around 5 cm (photo 22d)

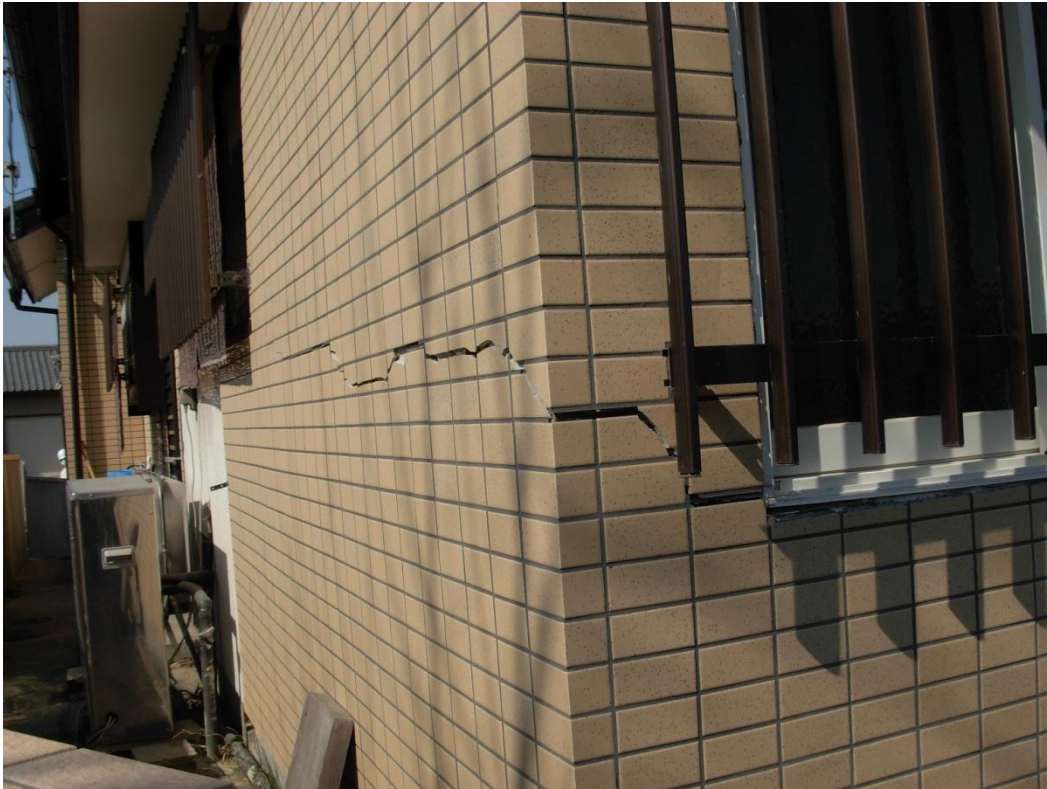
**Photo 23. Crack at the house's corner.** Due to lateral displacement and settlement in the front side, this house suffered damage in the back side, specifically crack at the both mainly corner.

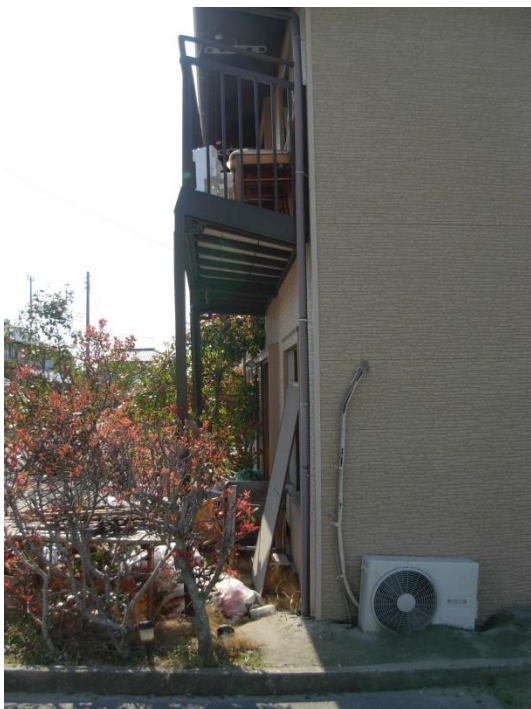
**Photo 24. Differential settlement of the two stories building.** This kind of damage was observed in several houses around the area visited, this is due to liquefaction phenomenon and foundation condition.

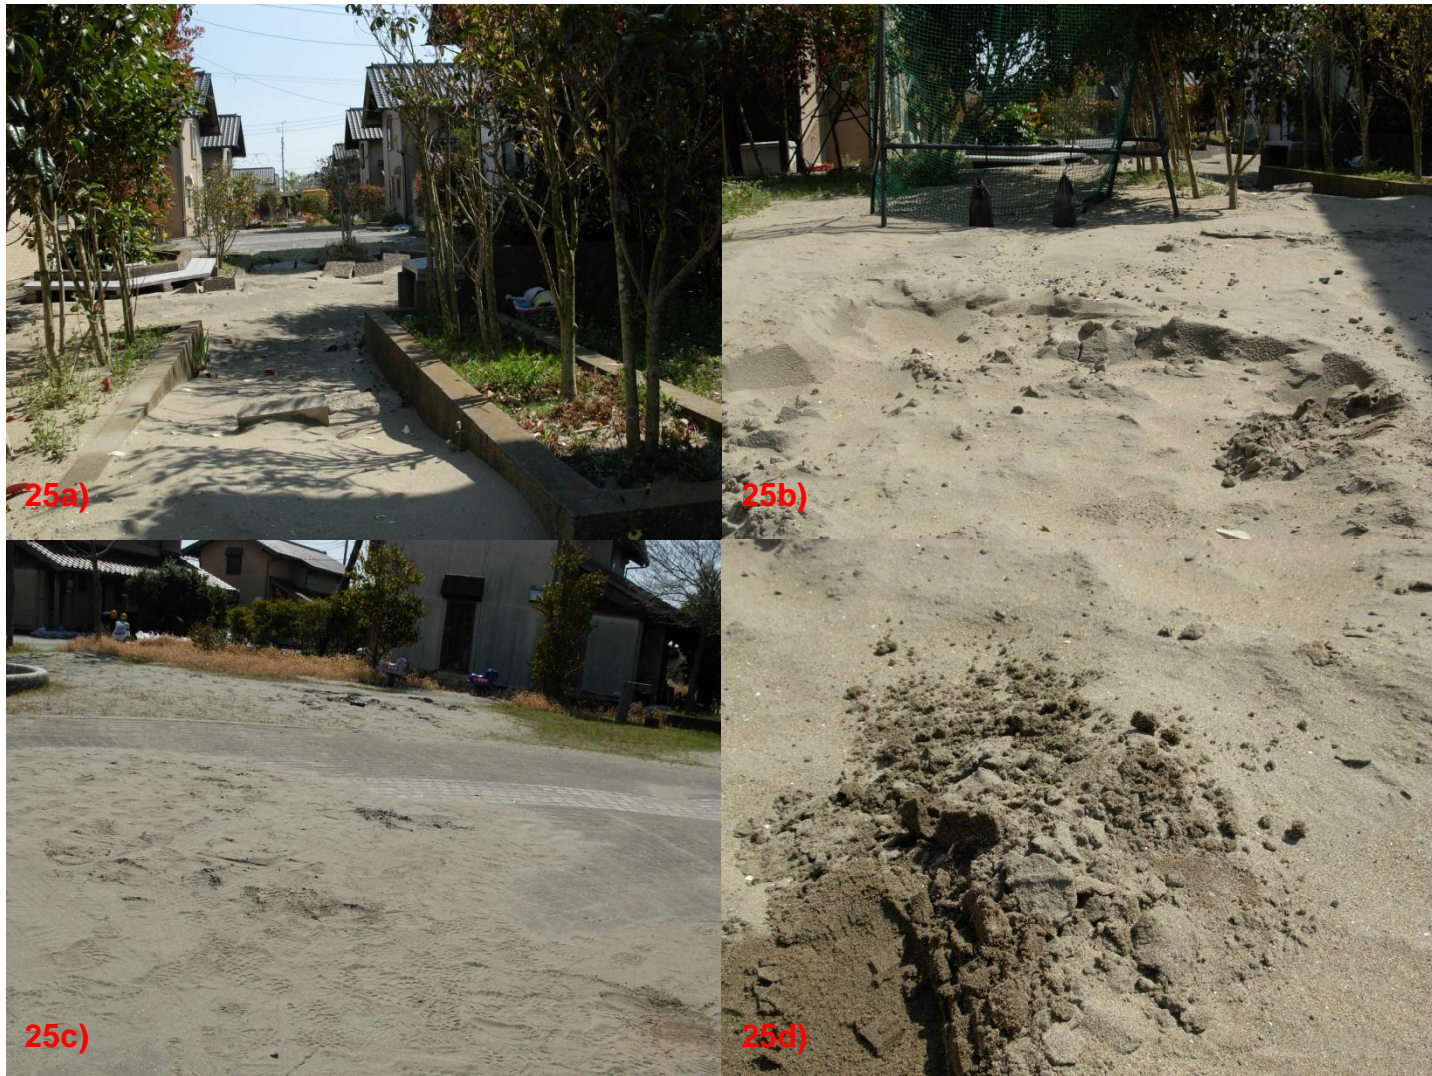
**Photo 25a), 25b), 25c) and 25d). Alteration of surface soil characteristics.** Before the earthquake this kind of soil (fine sand) there was not on the surface, due to liquefaction phenomenon, the uplift of the underground occurred. The kind of sand is fine sand silty (photo 25d), even on the paving stone the sand came up (photo 25c)

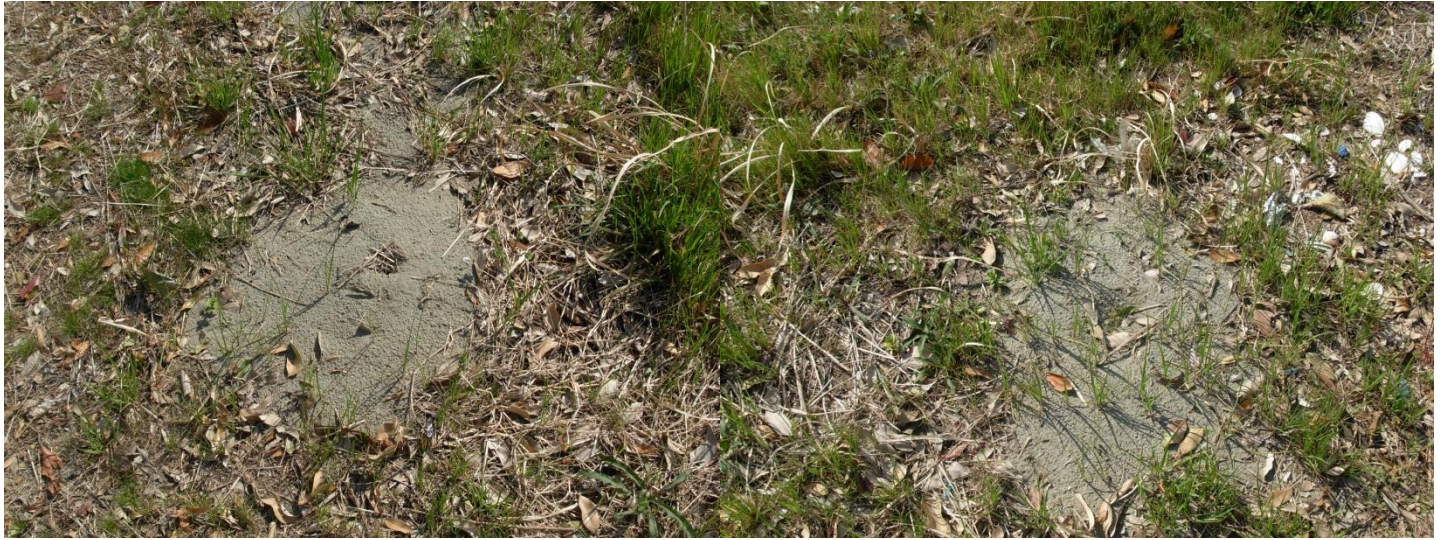
**Photo 26. Sand boils was observed.** Sand boils are diagnostic evidence of elevated poor water pressure at depth and an indication that liquefaction has occurred.

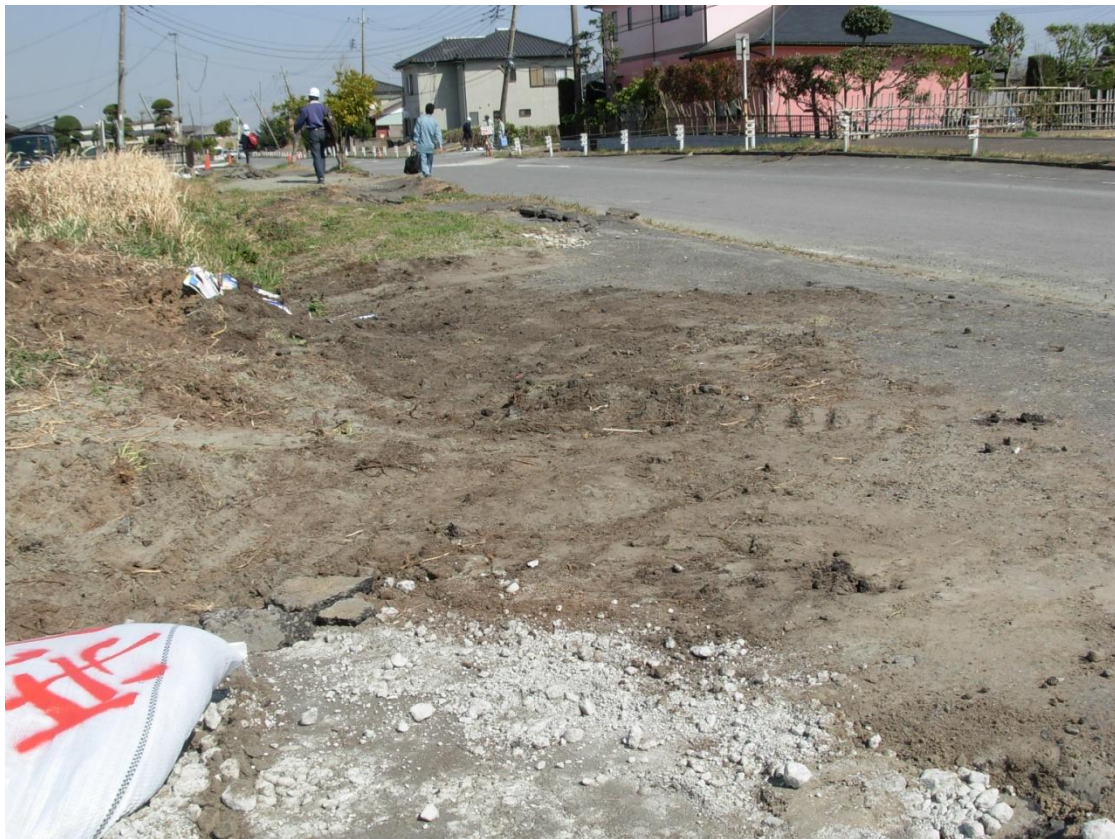
**Photo 27. Deformation of the surface ground.** Difference of level of the ground, due to settlement occurred.
