INTERNATIONAL INSTITUTE OF SEISMOLOGY AND
EARTHQUAKE ENGINEERING (IISEE)

REPORT OF STUDY TRIP (TOHOKU)

14 – 18 November 2011

Prepared by: Nur Intan Irzwanee Nurashid
T course
(Malaysia)
5/12/2011

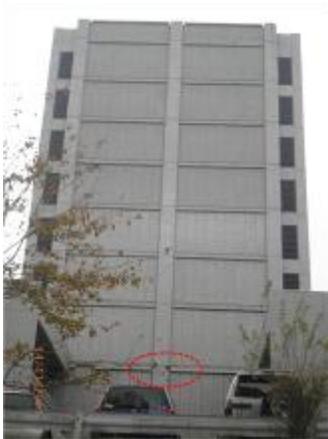
We went to Disaster Control Research (DCC) of Tohoku University to meet Dr. Suguwara. Before leaving, we had a chance to see a damage of a building caused by the Tohoku earthquake. There was a crack at the second floor of the Civil Engineering building with approximate height of 10 meters from the ground. From here, we visited the damaged places hit by tsunami of the Tohoku earthquake on March 11, 2011.

Figure 1.1. Traces of crack at Civil Engineering building in Tohoku University.

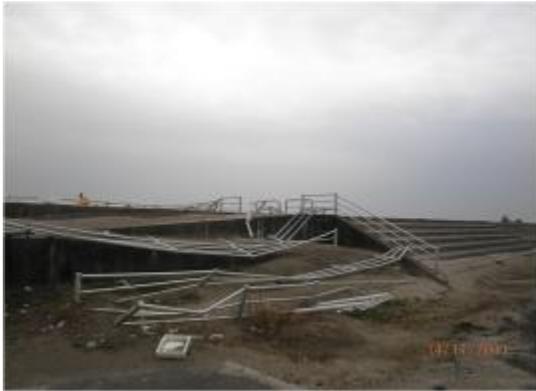
Figure 1.2. The broken sea wall in Arahama Beach.

The seawall of 5 meters height and the breakwater was broken. As this beach was a tourist attraction, a tsunami siren had been installed. However, it was collapsed and broken.

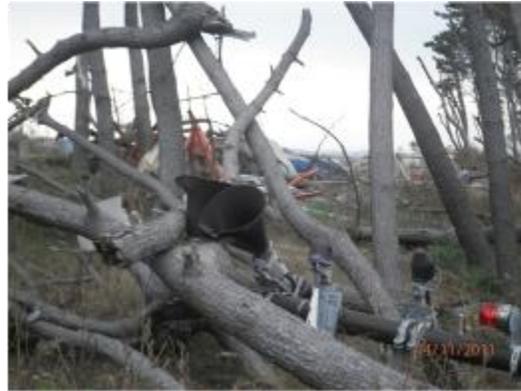
Figure 1.3. Tsunami Siren collapsed in Arahama Beach.

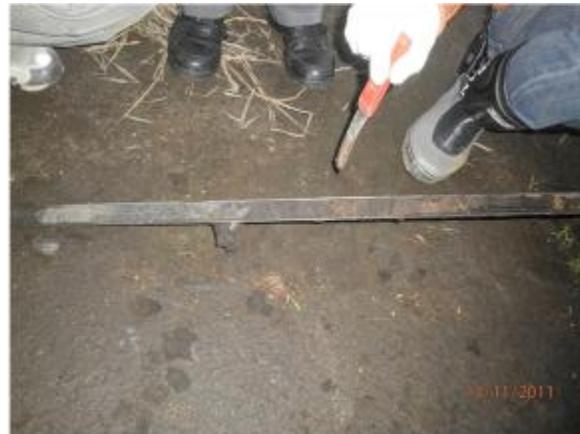
Figure 1.5. Deposit of the 869 Jogan tsunami.

We moved forward to another paddy field located about 2.7 km from the coastline for another sediment observation. Hand auger was used to dig up some soil. We found the 869 Jogan deposit and a layer of older tsunami deposit beneath. It is believed to be a tsunami soil of the tsunami that occurred 2000 year before the Jogan tsunami. The layer below was unidentified except for the grey layer at the bottom part identified as paleo soil which contained rice paddy field.

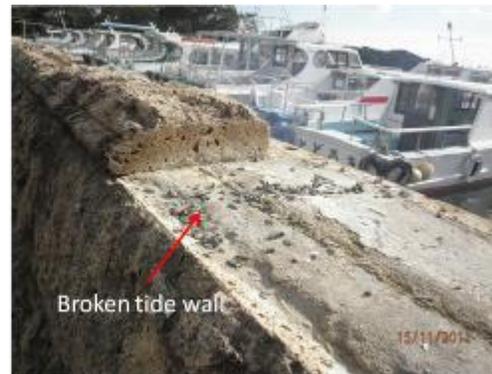
Figure 2.2. Broken tide wall in Matsushima.

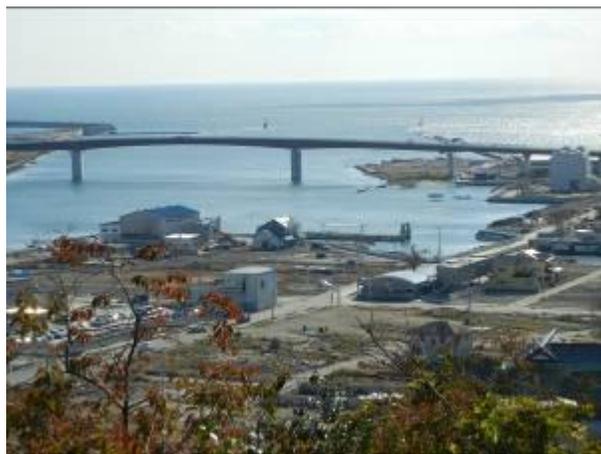
Figure 2.4. View of Ishinomaki City from Hiyoriyama Park.

We then continued to Ishinomaki City. From the bus window, we could see the damages along the way. We could see an overall damaged view of Ishinomaki City from Hiyoriyama Park. The city was among the most seriously affected by the March 11, 2011 tsunami. The waves inundated 600 m inland, 60 minutes after the earthquake.

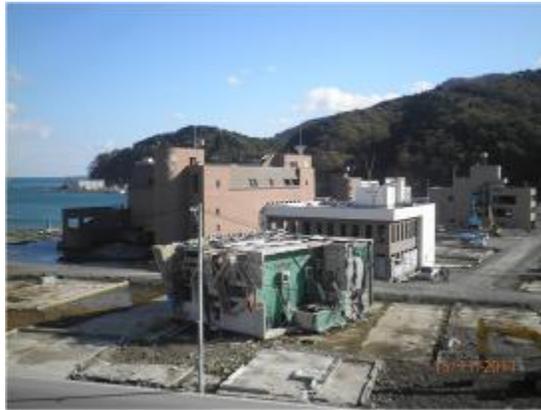
We observed a building which collapsed in the opposite way of the tsunami propagation direction. It is believed that the building was collapsed due to the receding tsunami wave current. Some other buildings were partially damaged.

Figure 2.5. The collapsed RC building in Onagawa town. View from the evacuation point (15 m from the ground level).

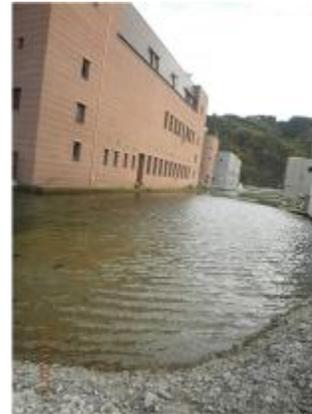
Figure 2.6. Sea water covering the road around the building describes the land subsidence.

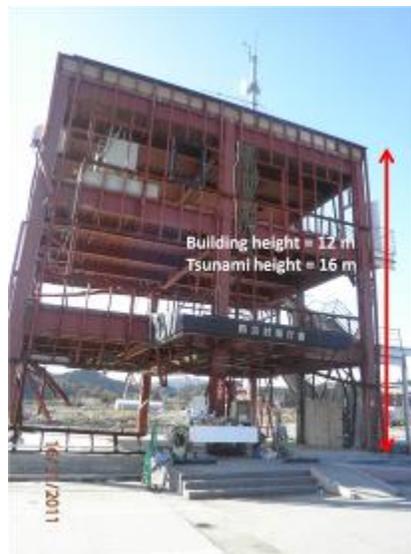
Among the totally destroyed buildings was the disaster mitigation centre of 12 m height. The building was totally damaged when a 16 m of tsunami height came. 2 people died in this building while giving evacuation instruction. A 6 m high breakwater was also broken. Land subsided about 1 m and wave inundated 3 km inland.

Figure 3.1. Disaster Mitigation Centre in Minami Sanriku.

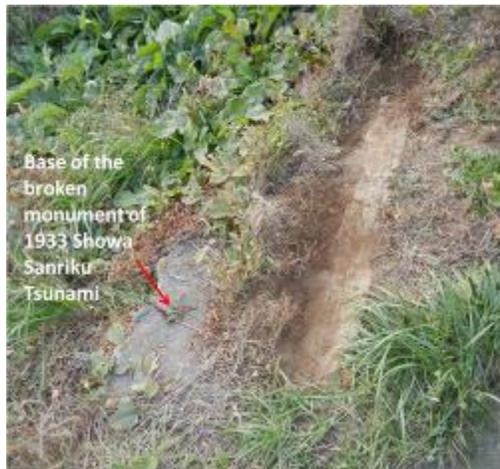
In Ofunato Bay, we found a broken monument of 1933 Showa Sanriku tsunami. About 200 m away we found a monument of 1896 Meiji Sanriku tsunami still intact on the ground. The area was inundated during the tsunami in March 2011.

Figure 3.2. The broken monument of 1933 Showa Sanriku tsunami in Ofunato Bay.

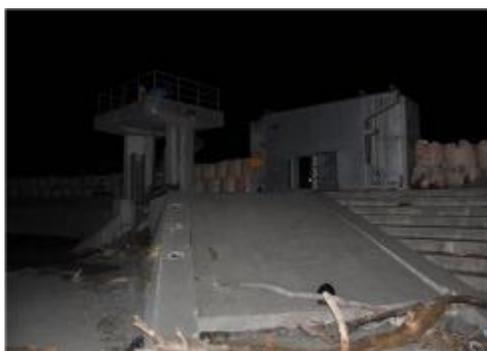
Later we went to Shirahama beach. The tsunami height recorded in this area was about 10 m. The 7.6 m height of sea wall was totally damaged left only the broken tsunami gate. Temporary barrier were set up to prevent the overflow of seawater during high tide.

Figure 3.4. The broken sea wall at Shirahama Beach.

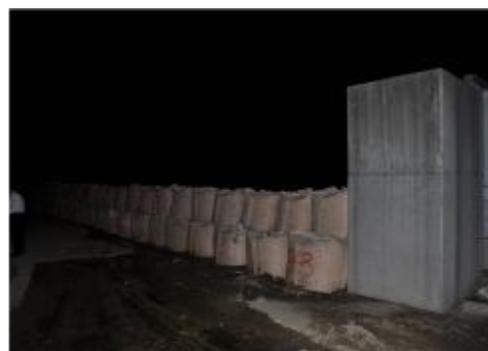
Figure 3.5. Temporary barrier to prevent overflow of sea water.

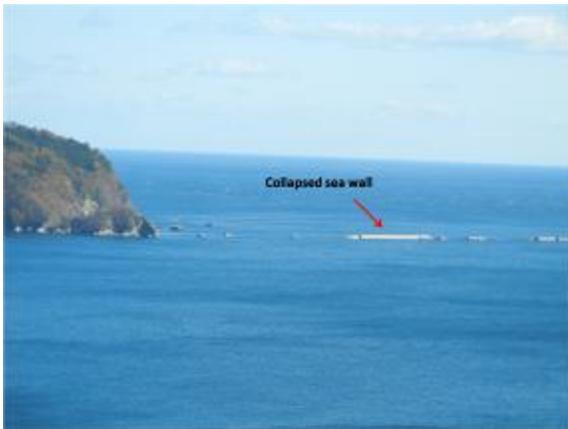
This breakwater was the deepest breakwater and one of the counter measures that have been established in Kamaishi because it was hit by many tsunamis in the past; 1896 Meiji Sanriku tsunami, the 1933 Showa Sanriku tsunami and the 1960 Great Chilean tsunami. The breakwater was located at the bay mouth. It consisted of north and south part with length of 990 m and 670 m respectively. The entire 990 m length of the northside of the breakwater was broken whereas 300 m from the entrance to the south side of the breakwater remained intact but the following 370 m had sunk.

We then visited the Kamaishi port to see the breakwater closely. The port area was subsiding 0.6 m and it caused the increasing of water level. Temporary barriers were set up to prevent the overflow of seawater during high tide.

Figure 4.1. The collapsed sea wall in Kamaishi Bay.

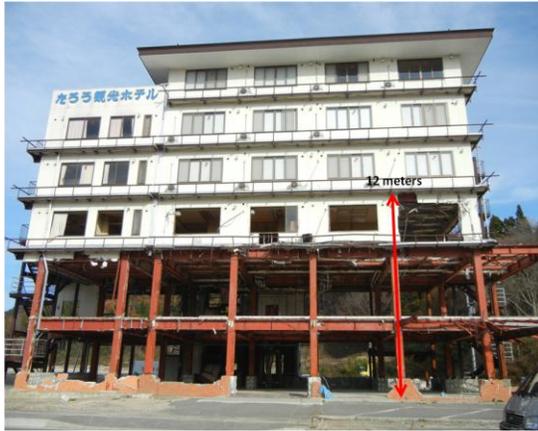
We went up to the higher ground which had been designed as the evacuation place in this area. According to the local resident that we met there, about 40 – 50 peoples came here for evacuation. The road in this town had been designed in such a way to make it easier for evacuation. It didn't have this normal 90 degrees corner instead it was built as in diamond shape to make the road bigger for easy evacuation escaped (Figure 5.2). We went to the Taro Kanko Hotel to have a better look of the damaged. Damaged can be observed up until level 3 of the building, which was about 12 m from ground level.

Figure 5.3. The damaged building in Taro.

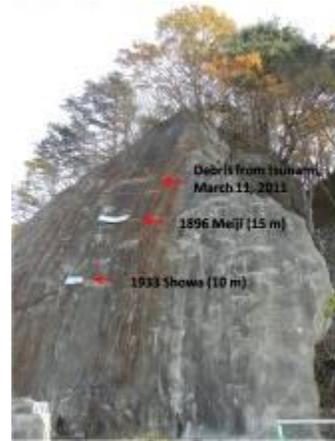
Both Meiji Sanriku and Showa Sanriku tsunami has inundated this area in 1896 and 1933 respectively and devastated the town. The water level from both events were marked on the rock as shown in Figure 5.4. Clearly, the tsunami from the Tohoku earthquake was larger than both Meiji and Showa Sanriku tsunami. The evidence can be observed from the debris found higher than the Meiji Sanriku water level mark.

Figure 5.4. The previous tsunami water levels were mark on the rock.

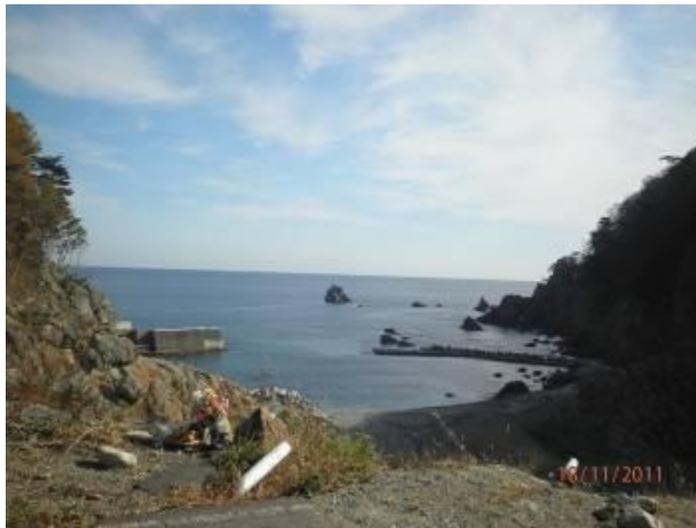
Our final destination was Koborinai Port in Miyako City. The highest run up of March 11, 2011 tsunami was recorded in this small fishing port at 37.9 m. The tsunami went up the valley and it was explained by the debris we found up side the valley. The port was located in low land, sandwiched between two mountains which may have contributed to the big wave size.

Figure 5.5. Koborinai Port.
