SEISMIC RESPONSE EVALUATION AND RETROFIT OF A FIVE-STORIED RC BUILDING DAMAGED DUE TO THE 2017 TRIPURA EARTHQUAKE

Sk Toufiqur RAHMAN*
MEE17715

The target building of this individual study which was subjected to the Tripura Earthquake, January 3, 2017 experienced some damage in the ground floor. This building is a five-storied reinforced concrete residential building named as “Sarkari Shishu Paribar”. It is located in Sreemangal Upazila of Bangladesh. According to BNBC 2015 Draft, this area is in Zone IV ($Z = 0.36$) and the site class is SD ($\bar{V}_s \leq 180$ m/s). This building is located 40 km away from the epicenter of the 2017 Tripura earthquake. The isometric view and location of the target building are shown in Figure 1 and Figure 2 respectively.

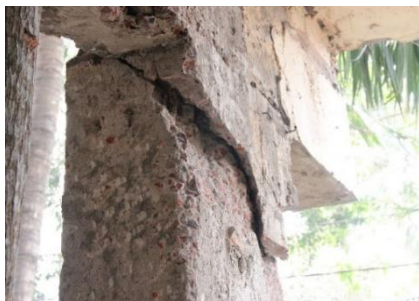
One column in the ground floor damaged severely. Big shear cracks and concrete spalling were found at the top of the column (Figure 3). Flexural Cracks were found just below beam-column Joints for most of the ground floor columns. One masonry wall in the ground floor suffered heavy damage (Figure 4). At first, diagonal cracks initiated and then sliding failure occurred. Lots of horizontal cracks were found in the masonry walls of the staircase in the ground floor.

Figure 3. Big shear crack in column.

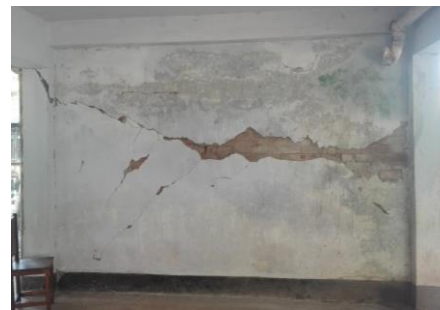
Figure 4. Damaged masonry infill.

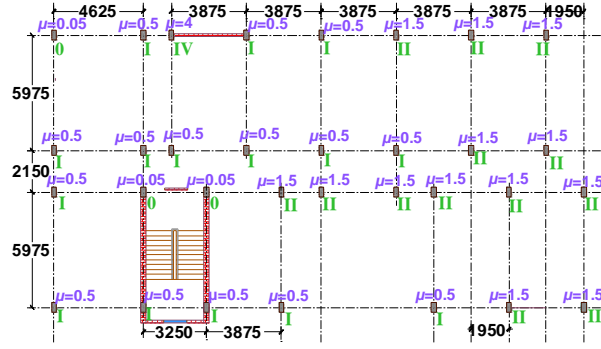
Damage classes based on “the Japanese Damage Evaluation Guideline” (JBDPA 2001a) were assigned to structural members of the target building according to the post-earthquake field survey after the Tripura Earthquake, 2017. Figure 5 shows the damage ranking of each structural vertical member and associated average ductility factor (μ) proposed by Maeda *et al* (2012).

Figure 5. Damage distribution in the ground floor and associated average ductility factors.

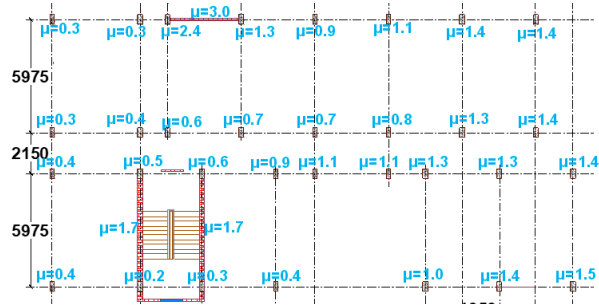
The comparison between average ductility factors based on damage class (Figure 5) and the ductility factors (Figure 8) acquired from non-linear time history analysis using synthetic ground motion shows reasonable correlation. The values of ductility factors for vertical structural elements obtained from time history analysis are close to the average value of ductility factors depending on damage rankings of structural members.

Figure 8. Ductility factors in the ground floor through nonlinear time history analysis.

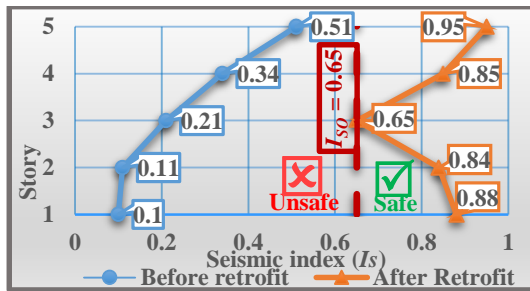
Seismic evaluation after the retrofit is conducted taking into account the strength of masonry infill. Seismic indices (I_s) of the stories of the target building along longitudinal direction and transverse direction before and after the retrofit are depicted in Figure 9 and Figure 10 respectively.

Figure 9. Seismic Index (I_s) along longitudinal direction before and after the strength oriented retrofit.

Required seismic performance can be achieved through improvement of strength or ductility or both. For retrofit design strength dominant seismic rehabilitation is given a priority. Three retrofitting methods have been applied. Chosen retrofitting methods are steel framed brace insertion, RC column jacketing and aramid fiber sheet wrapping.

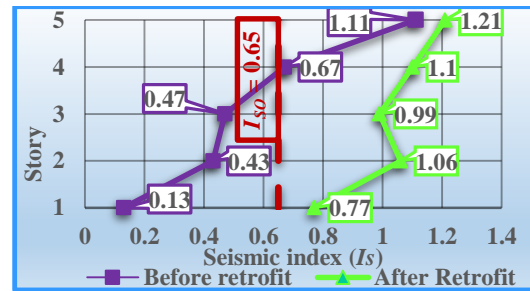
Figure 10. Seismic Index (I_s) along transverse direction before and after the strength oriented retrofit.

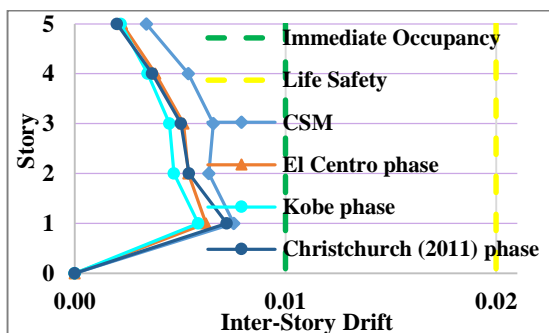
When strength oriented retrofit was opted, inter-story drift ratio of all the stories were (shown in Figure 11) below the immediate occupancy level. In the case of ductility dominant retrofit inter-story drift ratio (depicted in Figure 12) exceeded the immediate occupancy level. From Capacity Spectrum Method (CSM), inter-story drift ratios for all the stories for both directions are higher than those from the accurate method time history analysis.

Figure 11. Inter-story drift ratio after the strength oriented retrofit along the longitudinal direction for THA and CSM.

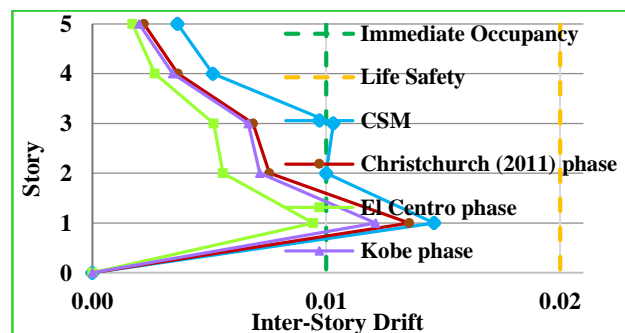
Figure 12. Inter-story drift ratio after the ductility oriented retrofit along the longitudinal direction for THA and CSM.
