# **FRAGILITY EVALUATION OF BUILDING STRUCTURES BASED ON DAMAGE SURVEY RESULTS OF TSUNAMI DISASTER FROM HUNGA TONGA – HUNGA HA'APAI VOLCANO ERUPTION ON 15 JANUARY 2022.**

**Mele Siale Manu<sup>1</sup>**  
**MEE21715**

**Supervisors: Toshiaki YOKOI<sup>2</sup>, Tatsuya AZUHATA<sup>3</sup>**

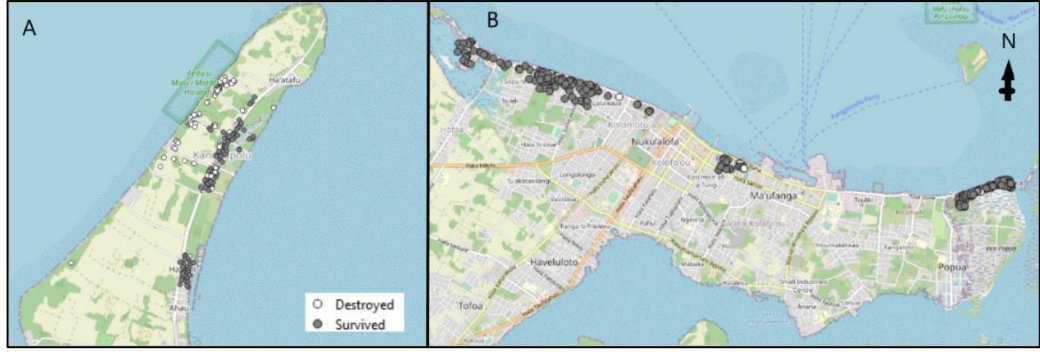
On the other hand, the Ministry of Infrastructure (MOI) and disaster-related ministries conducted an initial damage assessment, which collected damaged data used in this study. The data did not have the location and the damaged building type, except for a few that MLNR collected. Therefore, I went out to the field and completed data collection independently. I used the QField application to collect data on the field and then analyzed it with the QGIS. The spatial distribution of damaged buildings in the Hihifo area showed that the survived buildings were away from the shoreline of its northern side (Figure 2A). In contrast, the damaged buildings were distributed along the shoreline in the Nuku'alofa area (Figure 2B).

in this study as damaged houses that were repairable and houses that were not affected at all. There were 85 destroyed buildings with 112 in the Hihifo area and 27 destroyed buildings with 237 survived buildings in the Nuku'alofa area.

Figure 2. Spatial distribution of damaged buildings in (A) Hihifo and (B) Nuku'alofa areas. It shows the destroyed buildings (white dots) and survived buildings (grey dots).

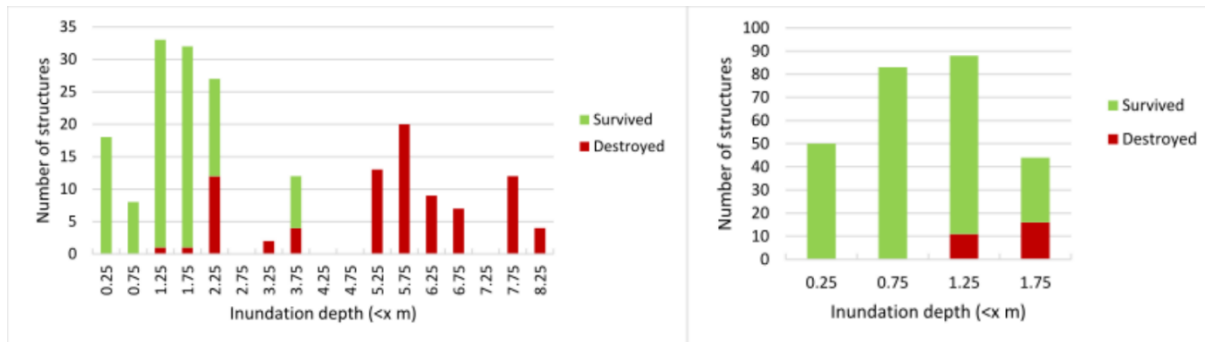
The data was categorized into ranges of inundation depth with an interval of 0.5 meters (Figure 3). The midpoints of the inundation depth ranges are used in drawing the histograms. After around 3.75 meters of inundation depth, all building types in the Hihifo area were destroyed. However, in the Nuku'alofa area, the inundation depth did not reach any point where such destruction would occur.

Figure 3. Histograms of the number of survived (green) and destroyed (red) buildings in each inundation depth range in the tsunami inundated area of Hihifo (left) and Nuku'alofa (right).

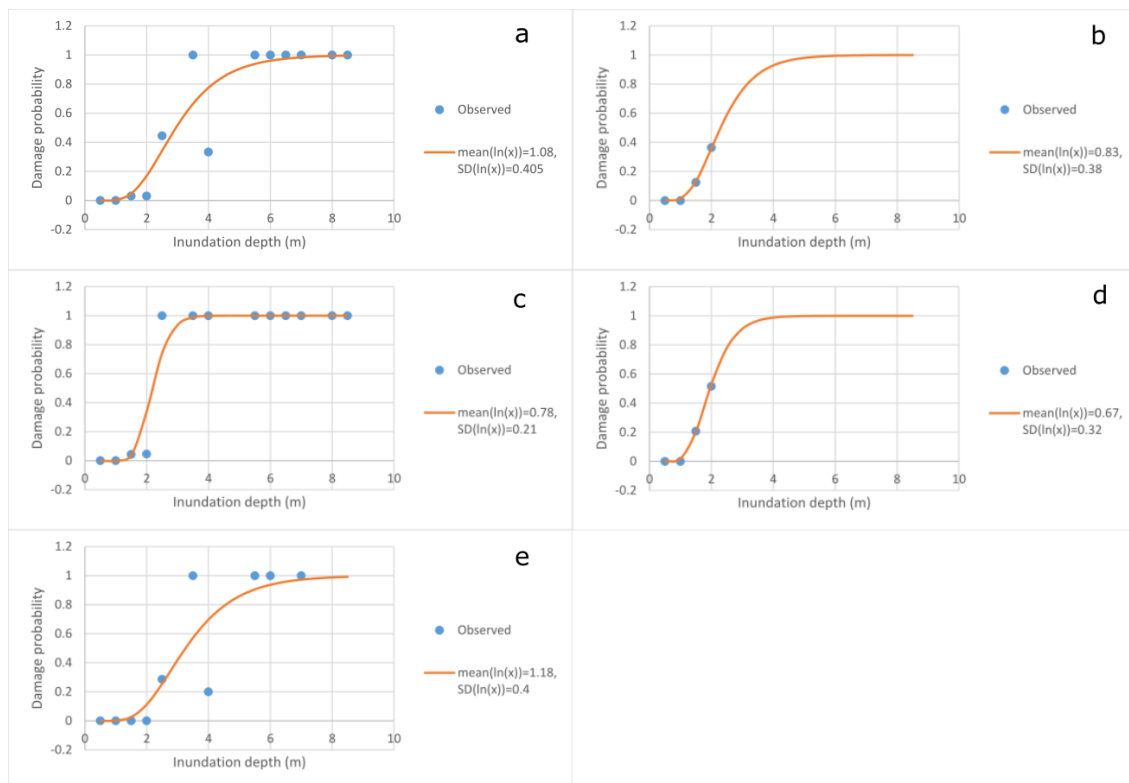
Figure 4. Fragility curves (orange curves) and the observed damage probability (blue dots) for (a) all types of buildings for Hihifo, (b) all types of buildings for Nuku'alofa, (c) timber buildings for Hihifo, (d) timber buildings for Nuku'alofa, (e) RC structures with masonry infill in Hihifo.

In comparing the fragility curves obtained, the buildings of the Hihifo area (Figure 4a) are stronger than those of the Nuku'alofa area (Figure 4b). Though both the fragility curves start rising after one meter, indicating damages start to occur when inundation depth is above one meter, the fragility curve for Hihifo's all types of buildings rises gently after one meter. In contrast, the fragility curve for Nuku'alofa's all types of buildings rises steeply after one meter. It means that the same degree of

Moreover, comparing the fragility curves for timber buildings, the fragility of timber buildings in Hihifo (Figure 4c) began after 1.5 meters of inundation depth, while Nuku'alofa (Figure 4d) began after one meter. Nuku'alofa's fragility curve is a bit steeper than Hihifo's (Figure 6), indicating that the Nuku'alofa area has more destroyed timber buildings than those in Hihifo at the same inundation depth. For example, the timber buildings of Hihifo will be 60% destroyed at 2.3 meters, while 60% of Nuku'alofa's timber buildings will be destroyed at 2.1 meters. Hence a slight difference was observed in the curves.

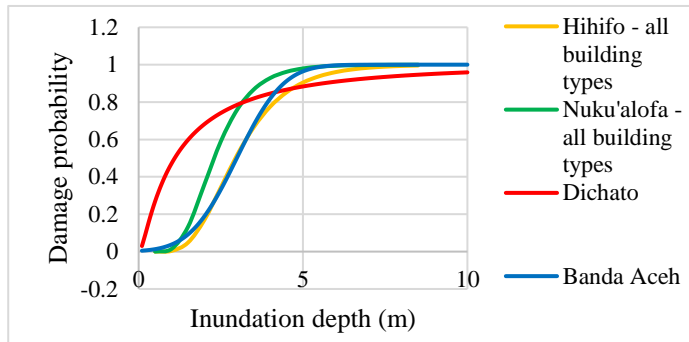
destruction occurred in Nuku'alofa at a higher inundation depth also occurred in Hihifo at a lower inundation depth, indicating the vulnerability of structures in Nuku'alofa. Comparing these fragility curves with the existing fragility curves of Banda Aceh, Indonesia and Dichato, Chile (Figure 5), the structures of my study areas are more resilient than Dichato's. At the same time, Hihifo's buildings are similar to Banda Aceh's, while Nuku'alofa's buildings are more vulnerable than Banda Aceh's.

Figure 5. Comparison of tsunami fragility curves for different types of buildings. It shows Hihifo's (orange) and Nuku'alofa's (green) all types of buildings; wood, timber, and RC buildings in Banda Aceh, Indonesia (blue); wood, masonry, and mixed buildings in Dichato, Chile (red) (Mas et al., 2012).

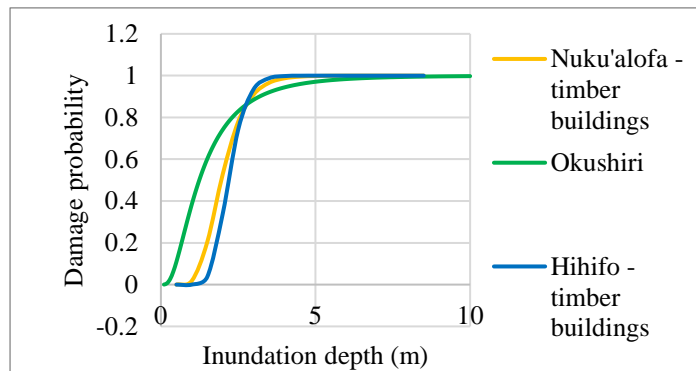
Figure 6. Comparison of tsunami fragility curves for timber buildings of Hihifo (blue) and Nuku'alofa (orange) with wood buildings in Okushiri, Japan (green) (Mas et al., 2012).

The starting inundation depth of destruction shows that the timber buildings of Hihifo are somehow strong enough to withstand tsunami to some extent because, in other countries such as Japan, the timber structures are completely destroyed when the inundation depth is higher than two meters (Koshimura et al., 2009a). Timber buildings in Tonga, both Hihifo and Nuku'alofa, are designed to withstand the impacts of tropical cyclones, and

therefore, they are resilient to tsunamis to some extent. Therefore, the timber buildings in my study areas are stronger than those on Okushiri Island, Japan (Figure 6).

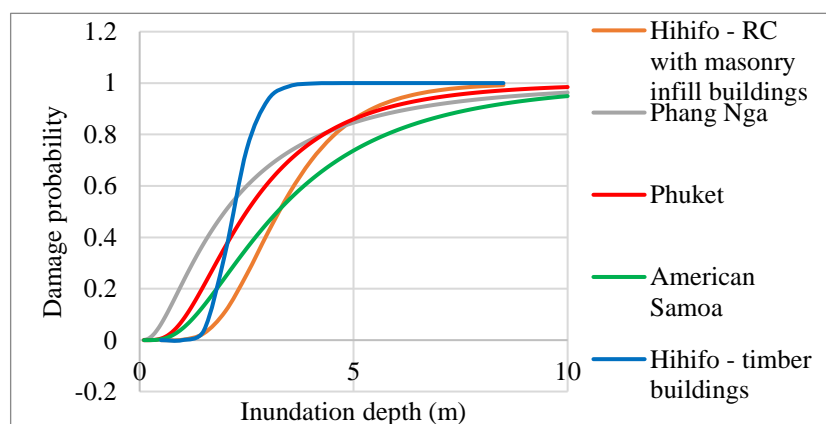
Furthermore, a close look at the building types of Hihifo shows that the RC structures with masonry infill are stronger than the timber structures. The pattern of the fragility curves shows this (Figure 7). The fragility curve of the RC with masonry infill structures rises gently after 1.5 meters, while the timber structures' fragility curve rises steeply. However, comparing the fragility curves of RC with masonry infill structures of

Figure 7. Comparison of tsunami fragility curves developed for RC with masonry infill structures (orange) and timber buildings (blue) of Hihifo with those of RC buildings in Phang Nga (grey) and Phuket (red), Indonesia and American Samoa (green) (Mas et

Hihifo with that of RC structures of Phang Ga and Phuket, Thailand, the RC structures of Hihifo are stronger (Figure 7). On the other hand, the fragility function of RC buildings in American Samoa is stronger than that of the Hihifo area when looking at higher inundation depth (Figure 7). Nevertheless, at inundation depths lower than three meters, the Hihifo RC structures are stronger than American Samoa's. It can also be observed in the fragility curve for RC structures with masonry infill of Hihifo (Figure 4e) that the damage probability varies, unlike Hihifo's timber structures (Figure 4c) where the damage probability is uniform.

Since RC structures with masonry infill of Hihifo are stronger than timber buildings, we recommended that areas exposed to tsunamis build RC with masonry infill structures instead of timber structures. RC buildings are more resilient to tsunamis than timber buildings. However, we can liaise with American Samoa on what makes the differences in fragility function of RC structures at higher inundation depth to modify the RC structures of Hihifo and Tonga to be more resilient to tsunamis.
