Citation: Leger, V., T. Azuhata (2022), Structural performance evaluation of cyclone resilient houses damaged due to tsunami after the January 2022 Hunga Tonga – Hunga Ha'apai volcanic eruption, Synopsis of IISEE-GRIPS Master's Thesis.

# STRUCTURAL PERFORMANCE EVALUATION OF CYCLONE RESILIENT HOUSES DAMAGED DUE TO TSUNAMI AFTER THE JANUARY 2022 HUNGA-TONGA-HUNGA-HA'APAI VOLCANIC ERUPTION

Victorina Stephanie Nodis LEGER<sup>1</sup> MEE21714 Supervisor: Tatsuya AZUHATA<sup>2</sup>

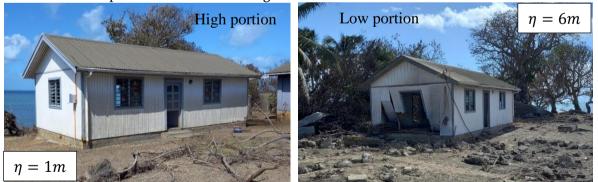
In the 'Atata Island, the damages observed to the CRH were different in comparison to the damages seen at the 'Eua Island. Figure 18 shows the location of the damaged CRH according to different inundation depths. The damages observed were different at high points and low points of the island. At high points, no structural damage was observed as shown in Figure 2. However, at low points of the Island where inundation depth reached 6 m, the damaged CRH showed some structural damage to the shear wall panels as shown in the Figure 2.

Figure 2: Damaged CRH with different inundation depths at low and high points of 'Atata Island
