## Study Trip Report on TOHOKU UNIVERSITY: INSPECTION OF DAMAGED BUILDING By: Sergio Sunley (E-Course)

Tohoku University is located at Sendai city, at the north region of Honshu island. After the March 11<sup>th</sup> 2011 Earthquake, some facilities of the university were damaged. This report summarizes the most important damages presented in the buildings of Aobayama campus of the university.

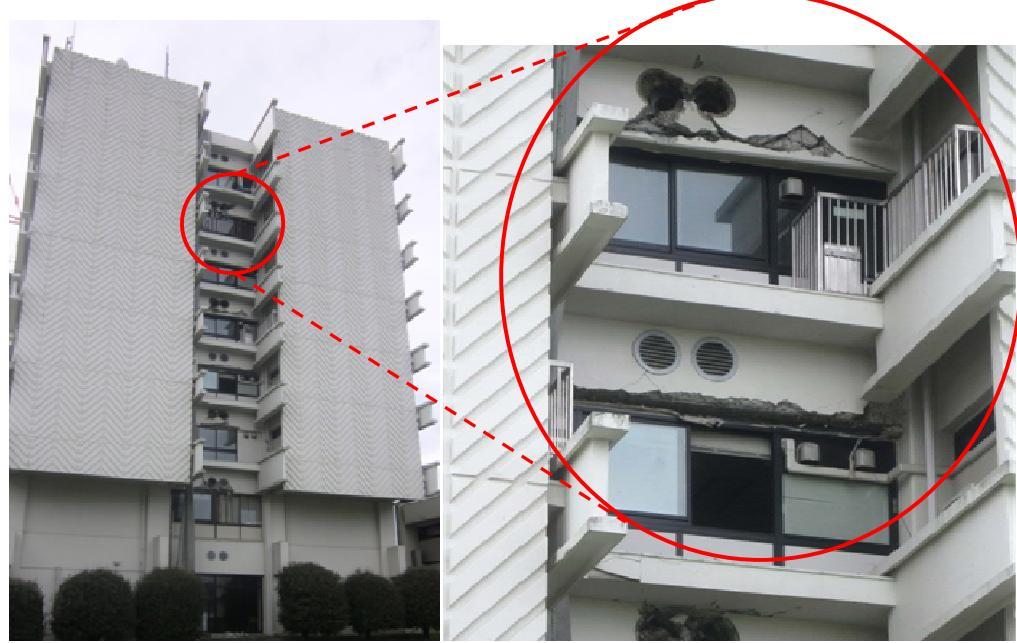
Figure 1 shows some damages presented on the building, such as the separation of the window panel from the main RC walls. Sliding was presented in 7<sup>th</sup> and 8<sup>th</sup> floors.

Figure 1. Elevation view of department of information and Intelligent systems.

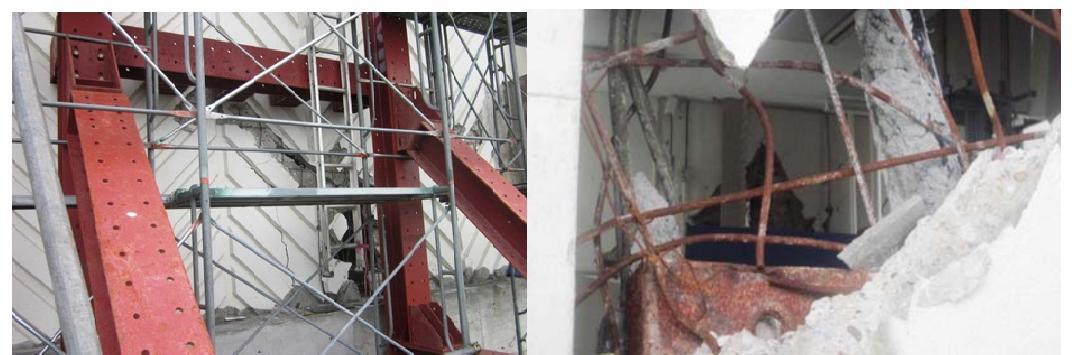
Figure 2 shows the most critical damage on the same building. The building had a discontinuity in elevation for levels higher than the  $8^{th}$  where the worst damages were presented.

As can be seen, shear failure was presented in RC wall's main sections and also the concrete was collapsed and completely shattered in the small sections close to openings. In the figures it can be seen that only the main vertical reinforcement uses deformed bars, but the horizontal reinforcement bars are smooth, due to the fact that reduces the anchorage significantly.

Figure 2. Damage at the top floor of the Department of Information and intelligent systems building

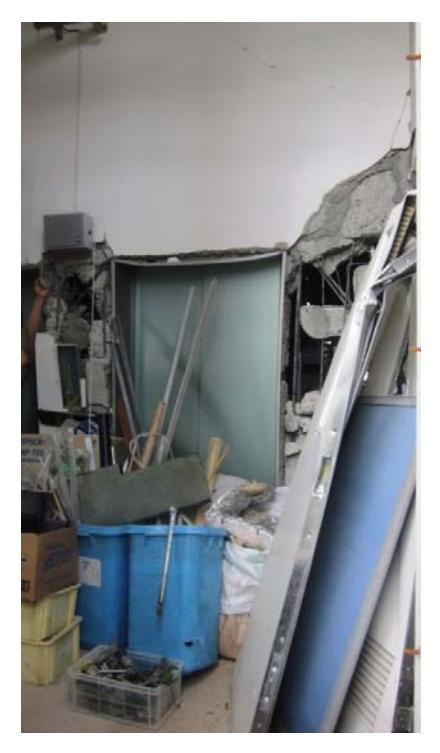
Figure 3. Collapse of walls around openings

Figure 3 shows the collapse of the walls around openings. The concrete in those walls was also shattered but some steel reinforcing bars were not buckled. This failure seems like the walls behaved as short columns, this is evidenced because the walls without opening didn't show concrete collapse.

The amount of horizontal reinforcement bars in the collapsed sections was poor to carry the shear force by the walls in the concrete sections.

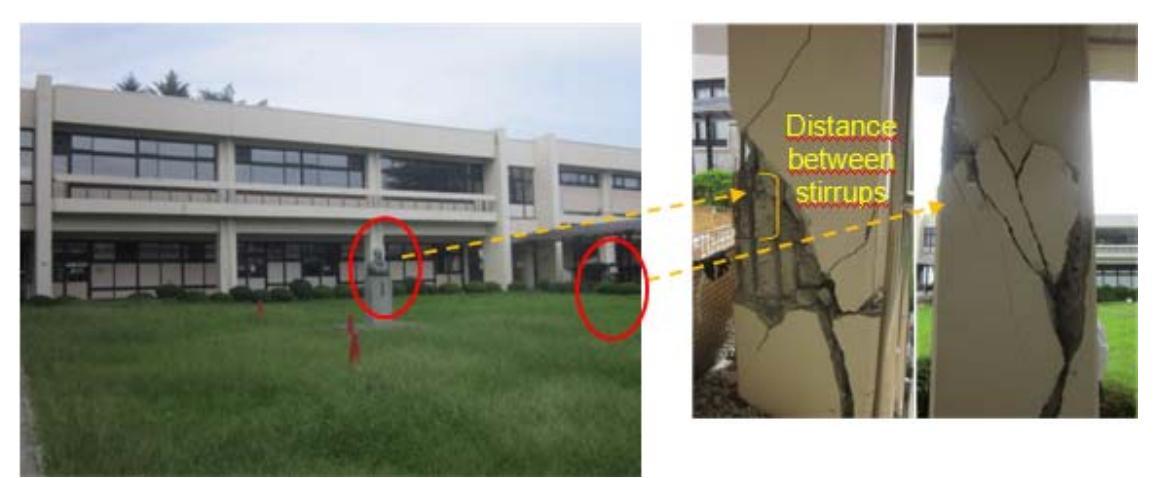
Damages were also presented in the columns of the first floor. Figure 4 shows the collapse of the columns of the first floor. Main observed damage was due to the shear cracks. The distribution of the steel reinforcement can be seen in the figure showing a long separation of the stirrups that allow the formation of shear cracks along columns and the consequent failure.

Figure 4. Damage in columns at the first floor

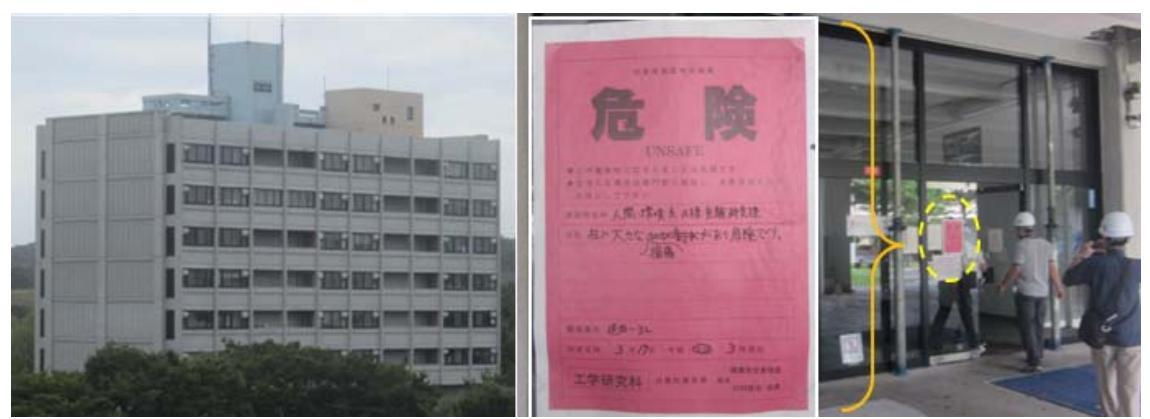
Figure 5. Research Building of Department of Civil Engineering and Architecture

The research building of Department of civil engineering and architecture was classified as unsafe. This is a 9-story building (non-full web Steel Encased Reinforced Concrete Building according to Professor Motosaka). It was damaged in the past by the 1978 Miyagi-ken Oki earthquake. This building was discontinuous in the third floor with a smaller cross section in plane from the  $3^{rd}$  to the  $9^{th}$  level. The main damage occurred in the base columns of the  $3^{rd}$  level because of the collapse generated by the axial force due to the overturning moment as is shown in Figure 6. Horizontal cracks were also developed at the base of the wall showing sliding, however this sliding damage was slight according to the commentary of Professor Motosaka.

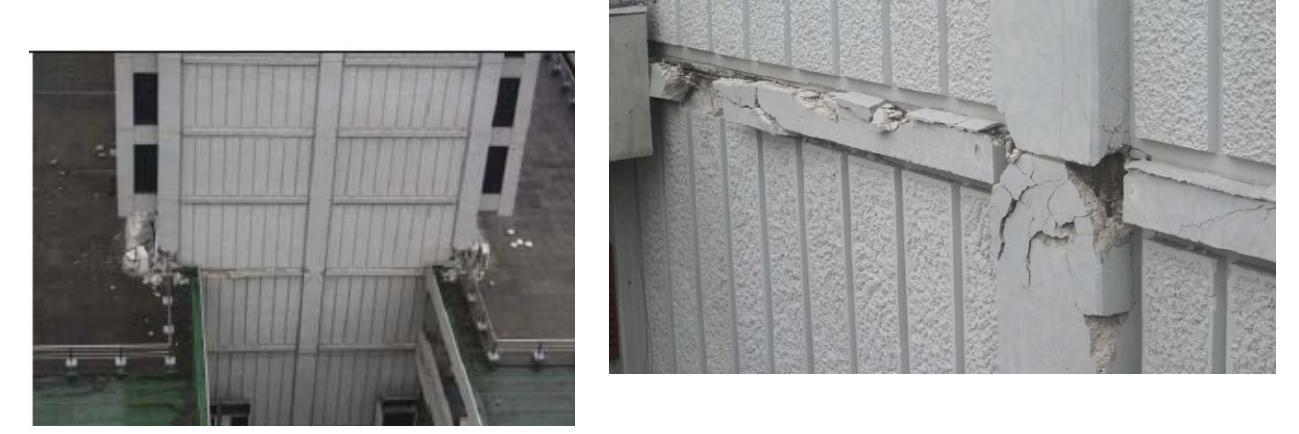
Figure 6. Damage on the walls of 3rd floor

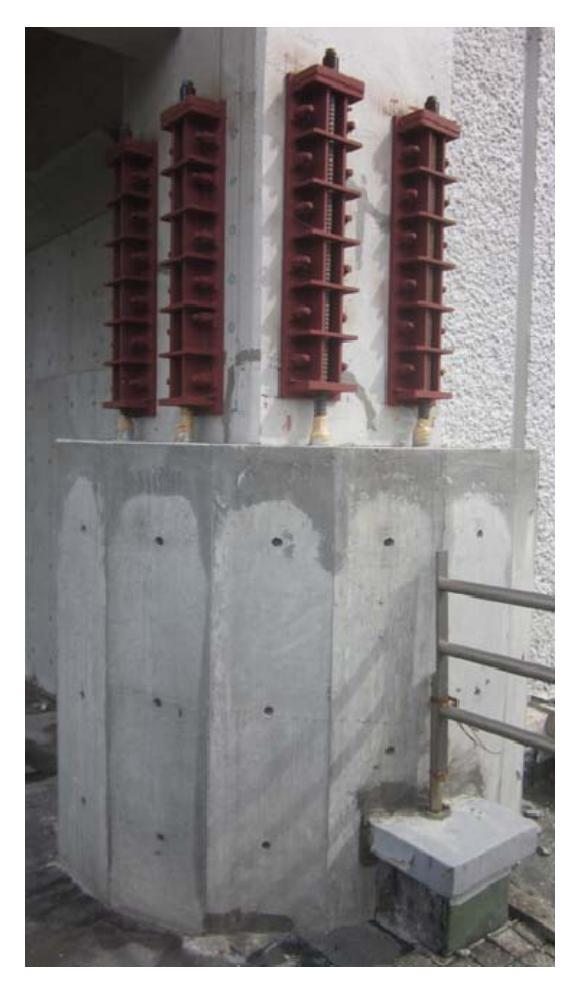
**Figure 7.** provisional retrofit of the base of walls of 3<sup>rd</sup> floor.

After the 2011 earthquake, a provisional retrofitting has been performed as shown in Figure 7. This retrofitting consists of the installation of new pretensed columns, with steel bolts able to resist the

axial load at the bottom corners of the wall, and prestressed concrete to support large compression forces.

The permanent retrofit of the building or reconstruction has not been performed because the information about the damages and structural health is still being analyzed.
