PERFORMANCE BASED EARTHQUAKE EVALUATION OF SCHOOL BUILDING IN SRILANKA

Chandima Kularatne*
MEE07153

ABSTRACT

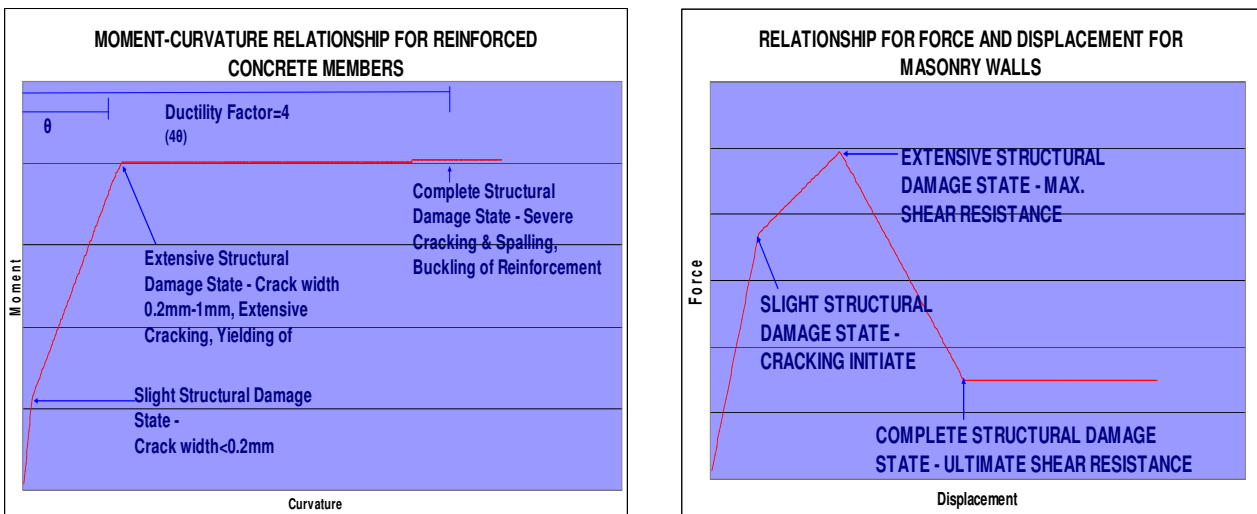
Figure 2. Damage states of structural members and infill masonry wall

Accordingly the structural damage states such as slight, extensive and complete of structural members and masonry walls were classified based on the pushover analysis results. The damage states are shown in Figure.2. Besides, the repair methods for each damage state were studied.

It was observed that all most all of the beams spanning in X-X direction reached the complete damage state in case of pushover analysis was performed in X-X direction. Thus, it was determined that the base shear coefficient of this structure at X-X direction is 0.08 and this is not sufficient even for regions where seismicity is very low. Besides, story drift at respective damage state was almost same for second and third story. However, it was somewhat different in roof level and out of thirty six(36) beams spanning X-X direction, only twenty beams reached complete damage state.

Similarly, pushover analysis results on Y-Y direction were also studied. It was found that only some of the columns reached these damage states. The beams spanning Y-Y directions did not reach even the slight structural damage state. Even at second story only sixteen columns had reached the complete structural damage stage. However, it was found that the base shear coefficient of Y-Y direction is 0.245, as such that is sufficient enough for low seismicity countries like SriLanka.

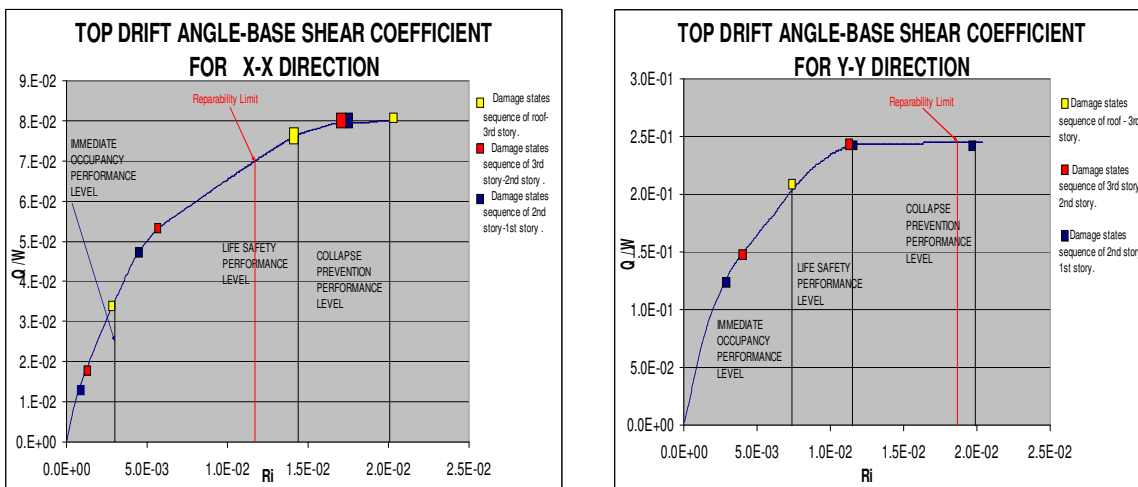
Figure 3. Damage sequence of members X-X and Y-Y direction

In addition, it was decided to define structural performance level of this building based on Prestandard and Commentary for the Seismic Rehabilitation of Building published by FEMA(FEMA 356). Therefore, an attempt was made to represent the probable Structural Performance Levels of this building in terms of top drift. According to the results of pushover analysis, the relationship of top drift versus base shear coefficient for both directions were drawn and shown in Figure 3.

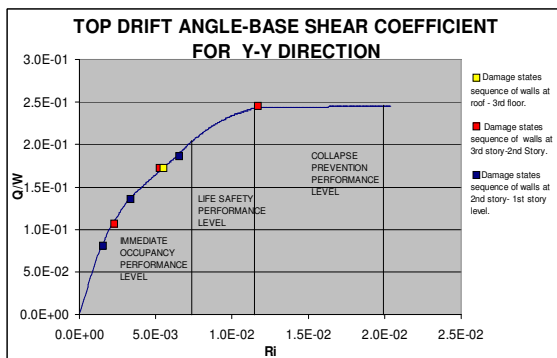
Figure 4. Damage sequence of masonry walls

In addition to concrete frame structure, behavior of the masonry infill walls were studied according to the above defined performance level. Results of pushover analysis were used to identify the top drift when masonry walls reached respective performance level and which is depicted in Figure 31.

According to the defined performance level of building, all the masonry walls at first story level will be collapsed before the Immediate Occupancy Performance Level. All the masonry walls at second story level will reach extensive damage stage before the Immediate Occupancy Performance Level while it will reach complete damage state at the Life Safety Performance Level. However, masonry walls at third story level will be reached only slight structural damage state.

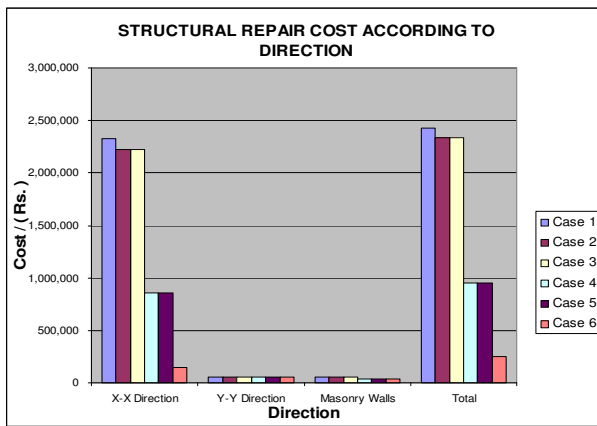
Figure 5. Structure Repair Cost According to Direction

pushover analysis to story drift. It was observed that total structure repair cost would be between Rs.240,000.00 and Rs.2,500,000.00. The average total structure repair cost is Rs.2,337,550.00. However it was learnt that the total construction cost of this building is Rs. 16,000,000.00. Thus the average repair cost is 14.6% of total construction cost.

The variation of total structure repair cost of each case with direction of the structure was studied to identify which direction contributes most to the repair cost. The graphs of total repair cost versus direction and story are depicted in Figures 5.
