Study Trip Report on  
**HIYORIYAMA PARK and ISHINOMAKI TAX OFFICE**

By: Herrera Puma Dina Bilha, Martinez Bravo Delvin Abdiel, Qi Wen-Hao (E-Course)

### **Introduction**

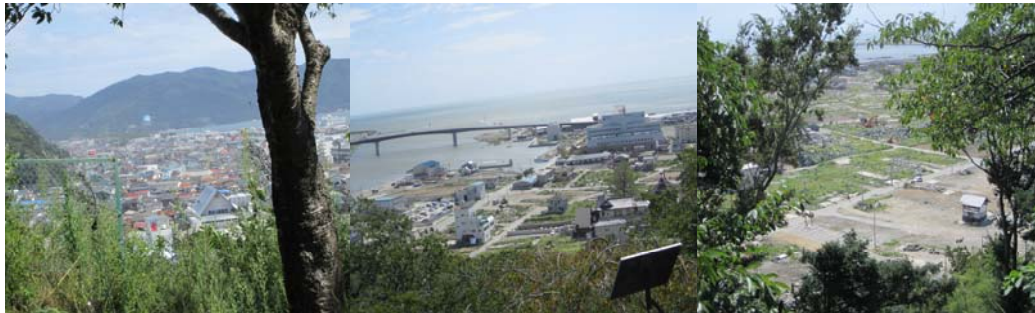
From that point, we could see a huge area that had been devastated by the tsunami such as Minato area and surrounding areas of Ishinomaki. The difference in tsunami damage was quite clear. The view from Hiyoriyama Park to the left side of Ishinomaki Port was protected by a seawall, so it did not suffer heavy damage. The right side of Ishinomaki Port, including the district of Kadowaki-cho, suffered devastating damage. We were able to see toppled homes and bare foundations.

**Photo 1.** (left) The area on the left side of Ishinomaki port was protected by the seawall and suffered minor damage. (center) The view of Ishinomaki port. (right) The area devastated by the tsunami.

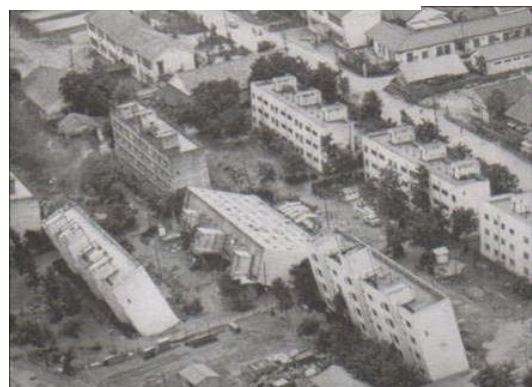
Liquefaction is one common disaster due to earthquakes. The typical phenomena of liquefaction are water spraying and sand emitting. If liquefaction occurs in some sites, the foundation soil will lose one part or even total bearing force, and uneven settlement of the soil will take place. Then the foundation will get damaged. Thus the buildings and structures will incline or overturn as some buildings were damaged in the 1964 Niigata earthquake of Japan (Photo 2).

**Photo 2.** Liquefaction in 1964 Niigata Eq. (USGS)

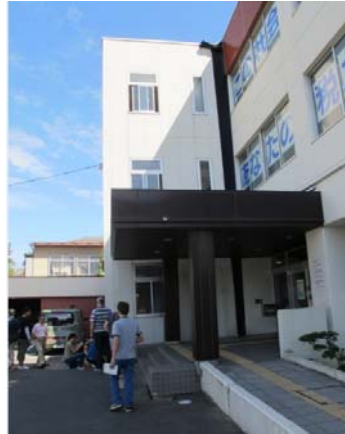
site of the Ishinomaki tax office where the typical phenomena of liquefaction occurred. The office building inclined about an angle with 1/80 (Photo 3), and the ground in front of the building became out-of-flatness due to the uneven settlement of foundation soil (Photo 4). The foundation soil became more close-grained due to liquefaction and larger settlement occurred, so some RC water tanks (Photo 5) and other facilities cropped out the ground (Photo 6).

**Photo 3.** Inclined building

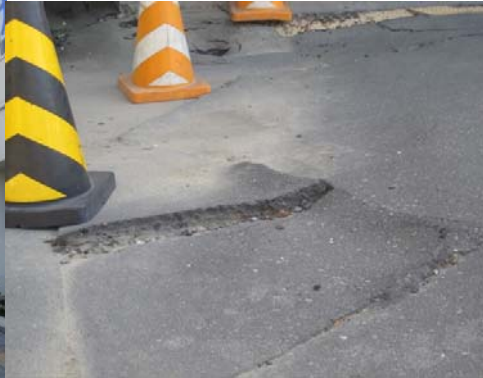
**Photo 4.** Out-of-flatness ground

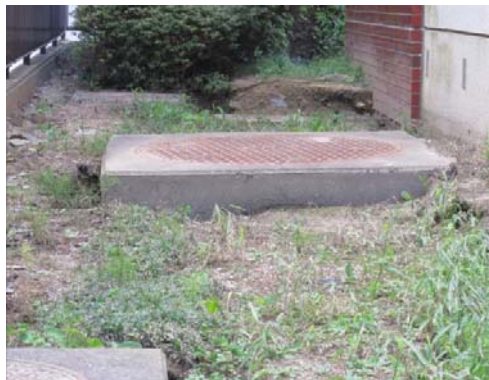
**Photo 5.** Outcropping RC water tank

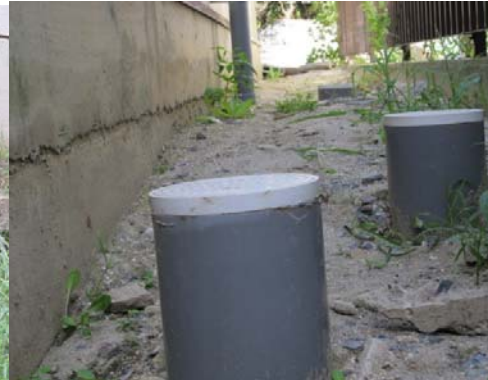
**Photo 6.** Outcropping steel facilities

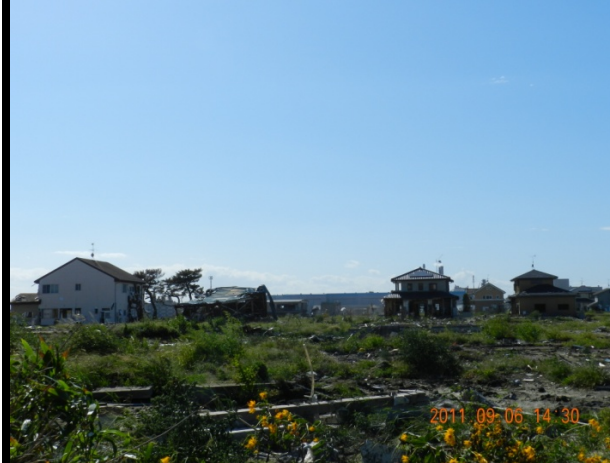
The more important income of this city is from the fishing activity, due to its location in the coast line, in front of the Pacific Ocean. All the facilities dedicated to the fishing activity were severely damaged by the tsunami. According to the report from the Port and Airport Research Institute, the tsunami height was 5 m at Ishinomaki Harbor, and 16 m at Ogatsu-machi, Ishinomaki City (Architectural Institute of Japan, April 15<sup>th</sup> 2011). The Tsunami traveled around 600 meters inland and destroyed around 80% of the houses (Japan times, March 18<sup>th</sup> 2011). Most of them were wooden houses which were totally destroyed by the earthquake and the following tsunami (Photo 7 and 8).

**Photo 7.** View of the Ishinomaki City, 6 month after the great earthquake.

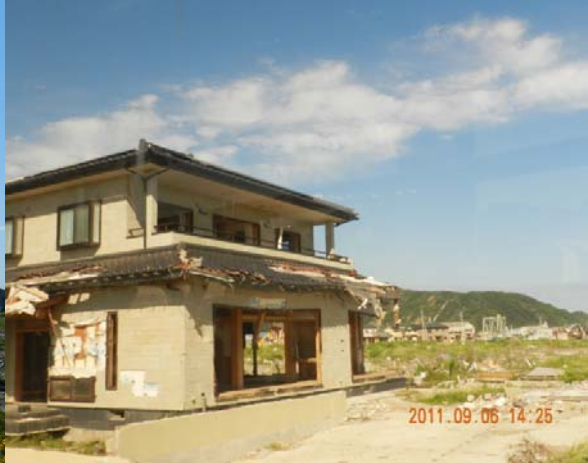
**Photo 8.** Severe damage caused by Tsunami to a wooden house in Ishinomaki city

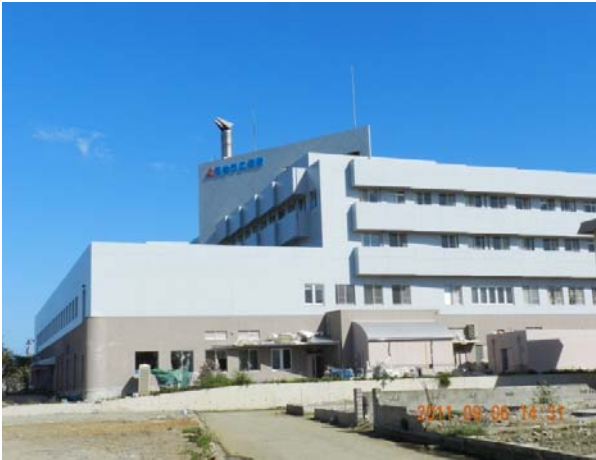
The important structures, like hospital (Photo 9) and School (Photo 10), in this city were severely affected by the earthquake and then struck by the following great tsunami. These structures are indispensable in the case of emergency; the hospital to attend the injured people and the school can be used as a shelter.

**Photo 9.** Hospital in Ishinomaki city severely damaged by earthquake and tsunami

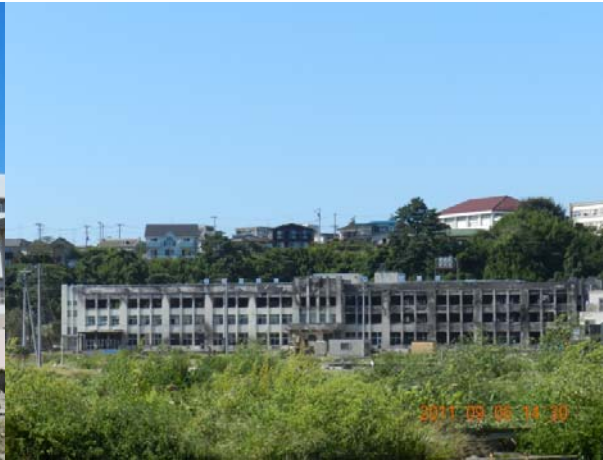
**Photo 10.** Kadowaki elementary school, completely destroyed, also due to fire.
