Study Trip Report on
ONAGAWA TOWN OBSERVATION
 By: Cigdem Tetik, Nolan Evangelista and Mehmet Baykal (S-course)

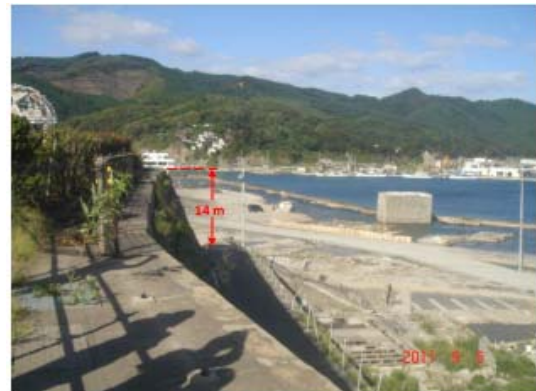
Figure 5. The high wall just near the hospital about 12 m high. Tsunami exceeded from the wall and washed away first floor of the hospital.

There were at least four pile-supported buildings toppled and /or carried over some distances in Onagawa. Buildings were uprooted, floated several meters away from their original positions. A three storey-hotel fronting the pacific was totally inundated. Cars were like papers crumpled and thrown into small pieces with the strong impact of the tsunami. Roads were subsided as well as the port facilities. Besides the massive destruction it brought to the town, 900 people were killed or missing in Onagawa Town. As shown in Figure 5, the hospital was located approximately 14 meters high from the sea level. Based on our observation, the trees were dried up which reveals that the tsunami reached and inundated the hospital

which surpassed the height of the wall surrounding the area of the infrastructure.

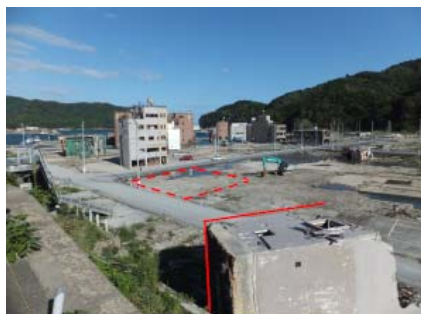
Figure 6. Drifted building with tsunami. It was drifted about 70 meters by the waves.

Most of the buildings located near the seashore were completely destroyed and drifted by the strong tsunami waves. Figure 6 shows one of the examples of building which was drifted by the tsunami about 70 meters. Most of the roads in Onagawa town especially those near the seashore were no longer visible. The roads were subsided by approximately 80 cm as shown in Figure 7 which can no longer be used for transportation. Some of the roads were still covered with tsunami debris and covered with sea water. However, many roads were already built by the government to pave for continuous repair and reconstruction of the devastated town. Display of column steel bars was overturned by the backflow of the tsunami wave (Figure 8).

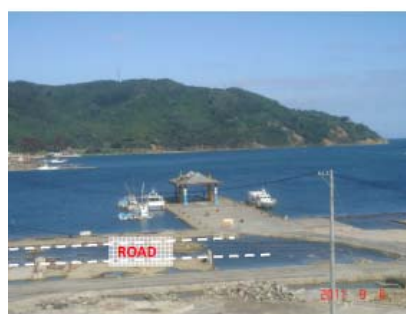
Figure 7. The old road near the port subsided about 80 cm.

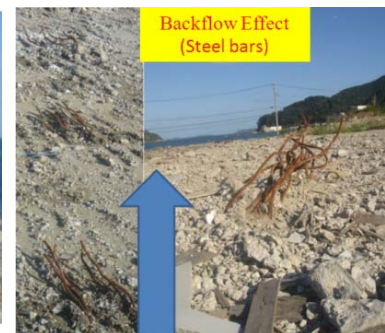
Figure 8. Backflow Effect
