Report of study trip II

Fatimah Zaharah Binti Saleh

8/1/2011

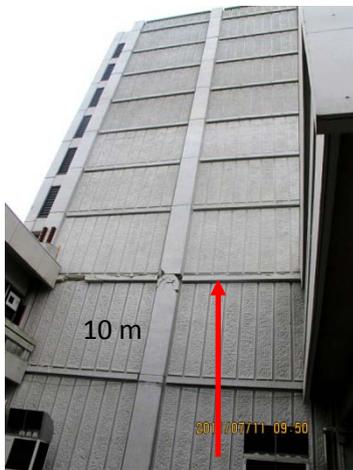
We began our trip by visiting the Tohoku University. Before meeting the Professor Imamura, we visited an effected building caused by the Tohoku earthquake. We were able to see a crack at the second floor of the building. We tried measuring the heights of the crack from the ground. The traces were approximately 10 meters high from the ground.

- Photo 1.0 and photo 2.0: The traces of crack at Civil Engineering building in Tohoku University

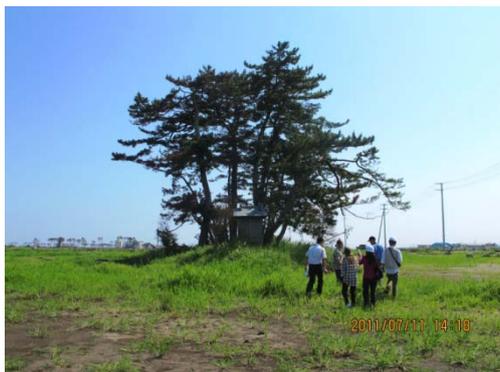
This little shrine is the only place which was safe from the tsunami. It is believed that it was protected by its location situated in front of a heliport. The protected shrine is located approximately

- Photo 2.0: The only survived shrine located in the inundated paddy field.
- Photo 3.0: The heliport which protected the little shrine from the tsunami.

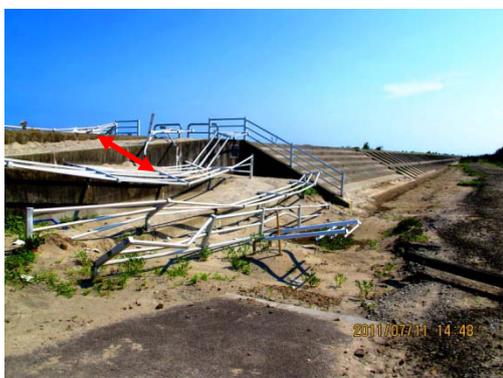
Photo 4.0: The sea wall at Arahama Beach.

We visited the Arahama beach, the tourist location, which had seawall and break waters. The seawall was 5m height from the sea level and these facilities were constructed for the storm surges protections. The break waters helped to reduce the energy of tsunami waves. We were able to see several buildings which had been washed away by the tsunami. As a tourism place, a tsunami siren had been installed. However, it was also collapsed together with other buildings because of the tsunami.

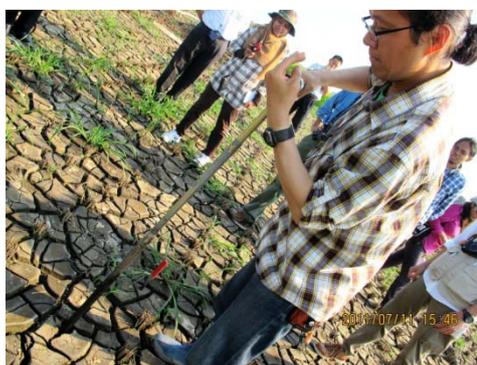
Photo 5.0: Hand auger

We went to a paddy field area to make sediment observation. The technique of hand auger was applied in order to see the tsunami deposits. As a result, we found the 869 Jogan deposit. The Jogan deposit consists of the marsh deposit below the volcanic tephra (AD915), while the 2011 earthquake deposit consists of the thick massive layer of medium-grained sand. In order to identify the origin of the sand layer, we need to do laboratory experiment.

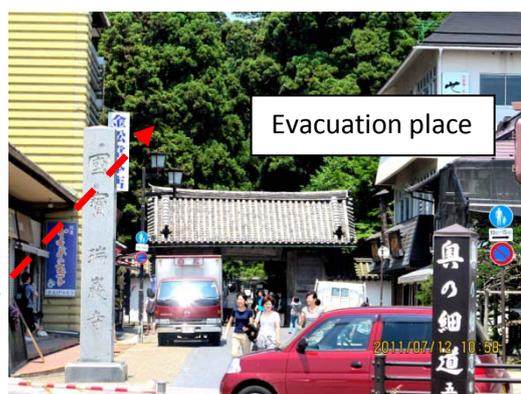
Photo 8.0 (b)

- Photo 7.0: The group of small islands at Matsushima
- Photo 8.0: (a) The evacuation sign which leads to the place of evacuation (b)

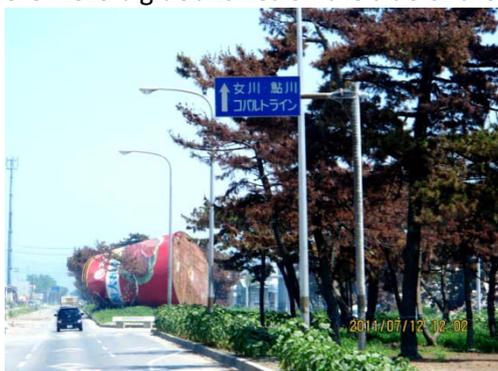
Photo 9.0

- Photo 9.0: The dead trees caused by the salt water.
- Photo 10.0: The debris.

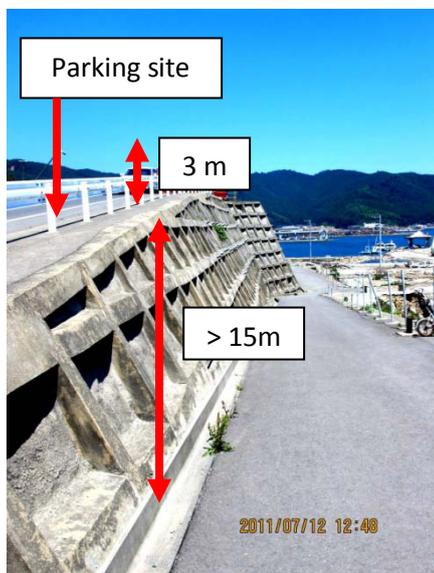
Photo 11.0

been dragged by strong wave current. There were RC buildings which fell down and were apart from the building site. The highest tsunami height that approached at this place was more than 15m. We measured tsunami height that arrived to the damaged buildings. The traces at buildings might have come from the second or the third waves. It is believed that the tsunami height was reached more than the 3rd floor. The tsunami swept away along the valley, approximately 2km of inundation distances. The Onagawa reconstruction community plans to establish a tsunami memorial park for remembering the event. Therefore, some selected damaged buildings are planned to be kept as memorial sites.

- Photo 11.0: The photo shows the height of tsunami which could reach the parking site and it is more than 15m height.
- Photo 12.0: The appearing of sea water in the land shows the evidence of subsidence.

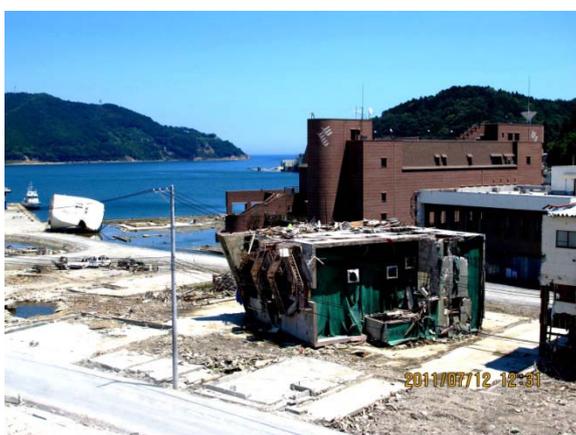
Photo 13.0

- Photo 13.0: A fell down building which are separated from the building site caused by the strong waves.
- Photo 14.0: The building has moved about 70 m from the origin site with the tsunami's buoyancy.

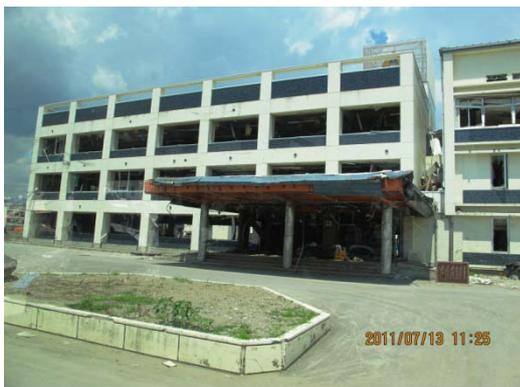
Photo 1.0

- Photo 1.0: A damaged City Hall at Rikuzentakata city. About 120 workers at this hall were dead.
- Photo 2.0: A high school was completely washed away by tsunami and being transferred to another city.

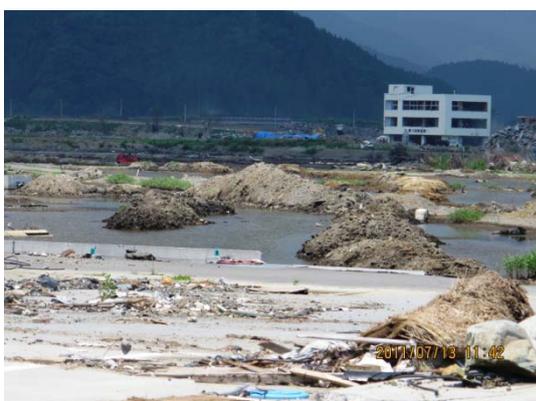
Photo 3.0

- Photo 3.0: Subsidence, the sea water appeared in the land when high tide.
- Photo 4.0: This broken sea wall was inland and now are surrounded by sea water due to the subsidence.

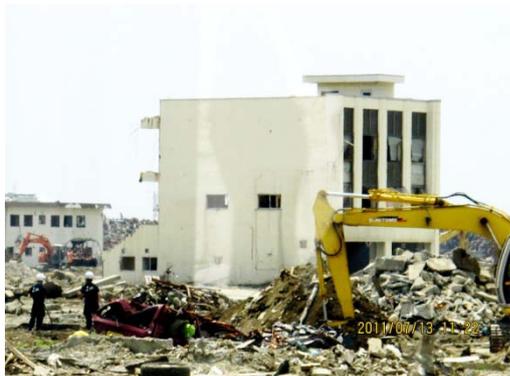
Photo 5.0

- Photo 5.0: The constructors collect the concrete pieces and make it as sea wall.
- Photo 6.0: Debris almost covers the places and the solution to manage it is still indecisive.

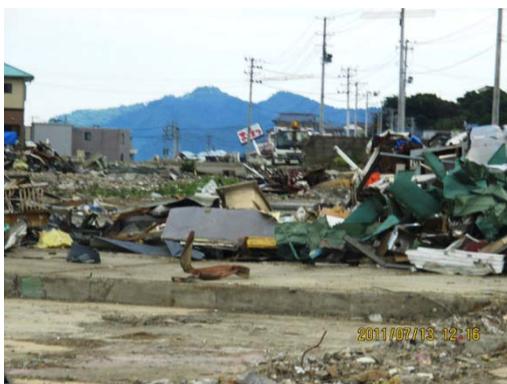
Photo 7.0

- Photo 7.0: The Ofunato town was affected by the tsunami
- Photo 8.0: The railways station had totally destroyed. The station was run for JR Line and Sanriku Railway.

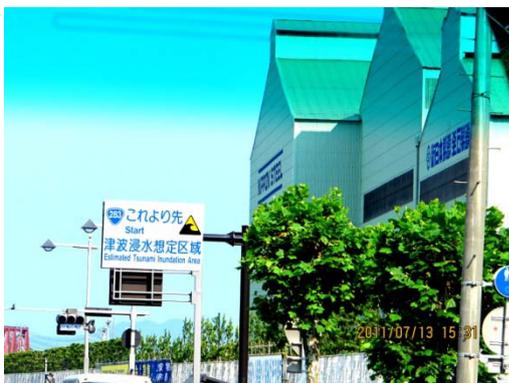
Photo 9.0

- Photo 9.0: The estimated tsunami inundation signboard is available at Kamaishi area.
- Photo 10.0: The destroyed building's structure at the Kamaishi port

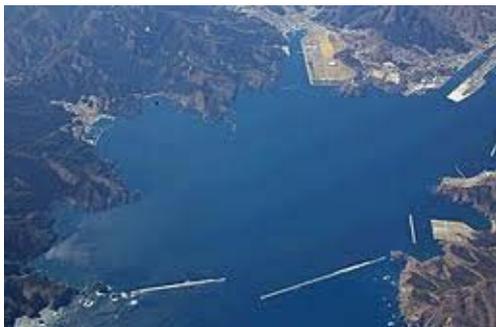
Photo 11.0

The breakwater was one of the main elements of the countermeasures which were established at the Kamaishi city. The Kamaishi Tsunami Protection breakwater has 63m deep from the sea level, with 1960 meters long. It is located at the bay mouth. As the results of the protection of the breakwater, the inundation height inside the bay was reduced to 11.7meter. The breakwater was broken into several parts due to the high impacts of the tsunami energy. Although the breakwater was hardly be tsunami barrier but the effect of its existence cannot be denied. It helped to reduce the energy of the tsunami and lessen the oncoming waves at the shore lines. According to the Mr. Nagao, the wave simulation had been done and the result showed that the percentage of wave run up reduced by 50% compared to the scene without the barrier.

- Photo 11.0: Kamaishi Tsunami Protection ; the breakwater

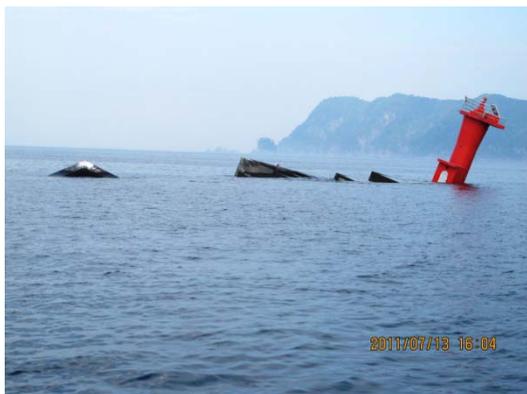
- Photo 13.0: The damage of break water from the north side. The red one is a light house.
- Photo 14.0: The damage of break water from the south side.
-
