Sloshing Damage to Oil Storage Tanks due to Long-Period Strong Ground Motions during the 2011 Tohoku, Japan Earthquake

National Research Institute of Fire and Disaster (NRIFD)
Fire and Disaster Management Agency (FDMA)

Sloshing Damage in 2011 Mw9.0 Tohoku Eq.

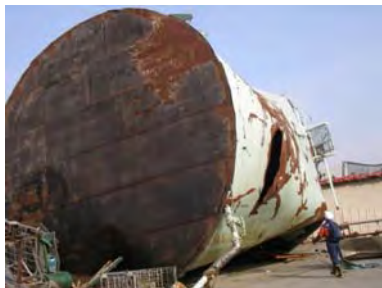
Kesen'numa, Miyagi

Overview of Tsunami Damage to Oil Tanks during 3.11

- Largest-scale oil tank disaster due to a tsunami worldwide ever.
- Totally 417 oil tanks damaged.
- 157 oil tanks washed away, drifted away, slid, floated, or tipped.
- Several tanks burned in a spreading fire caused by the tsunami.

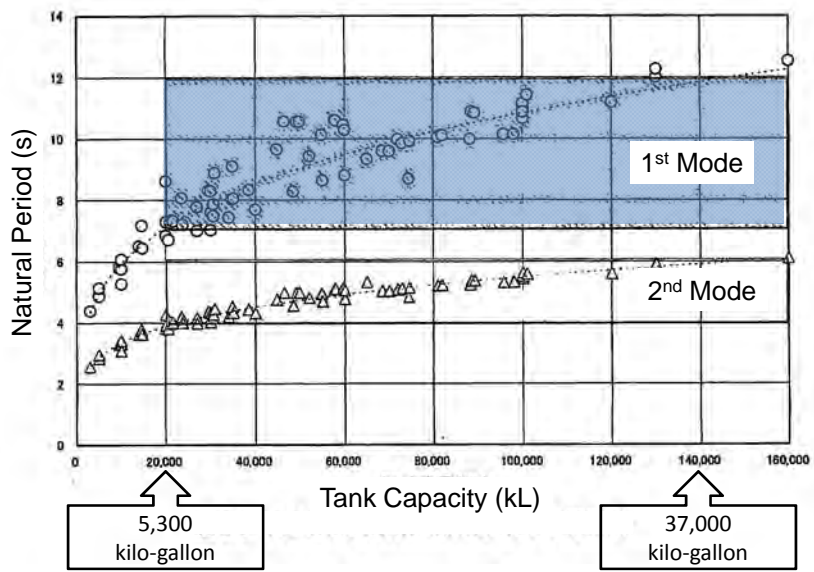
Natural Period of Liquid Sloshing of Large Tanks

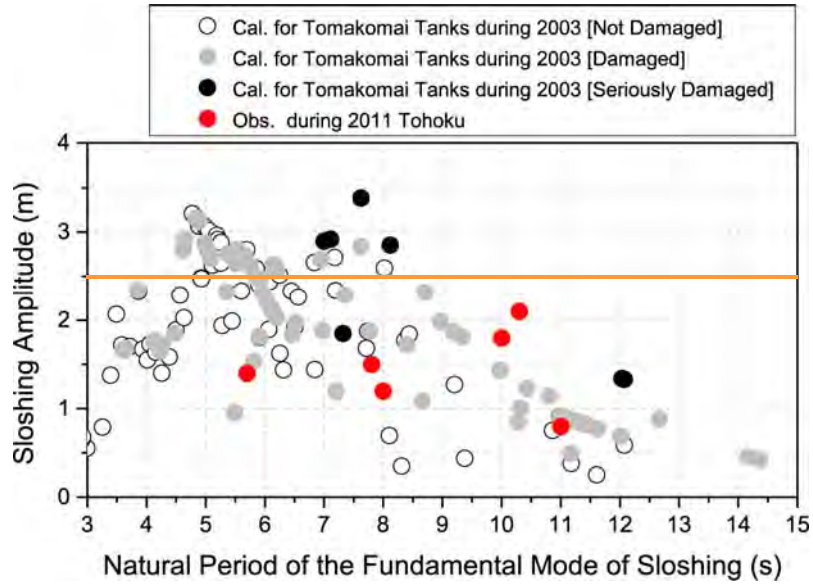
Sloshing Amplitude: 2011 Tohoku (Mw9.0) & 2003 Tokachioki (Mw8.0)

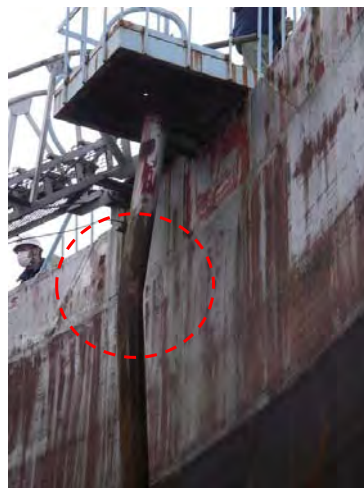
Sloshing Damage in Niigata during 3.11

Infiltration of oil into pontoons (Wh-1.9 m)

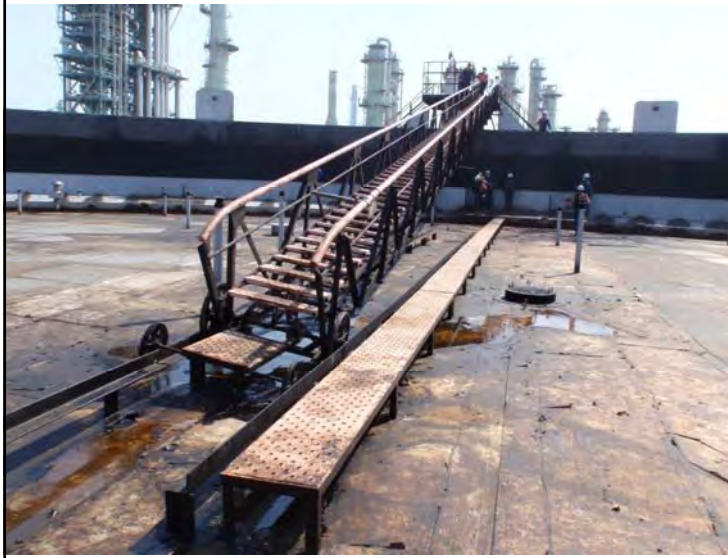
Sloshing Damage during 3.11:
Running-off of the rolling ladder in Sendai

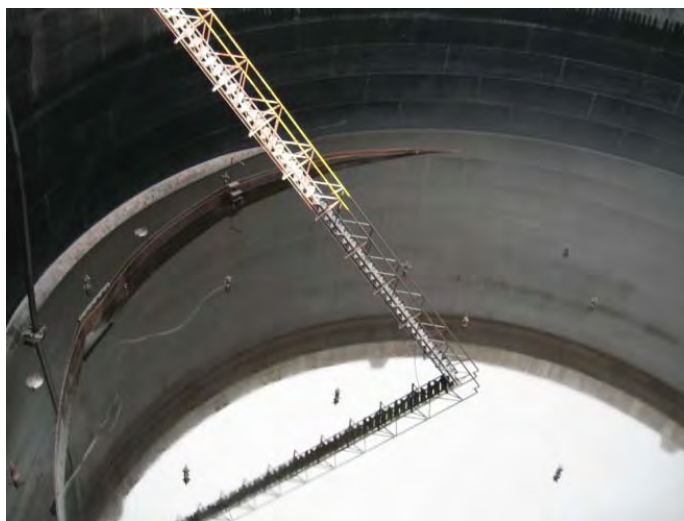
Severe Sloshing Damage during 3.11:
Sinking of the floating roof in Kawasaki

Heavy Oil
 $C_L = 20,000$ kL
 $D = 38.7$ m
 $H_{Lmax} = 16.4$ m
 $H_L = 8.9$ m
 $T_s = 7.8$ s
 $\eta_{max(obs)} = 1 \sim 1.5$ m
 $\eta_{max(cal)} = 1.3$ m

Preventing sinking of the floating roof is important for fire prevention.

Legally-require pontoons ensure resistance against oscillation of the floating roof in the areas where large LPGM is predicted (by 2017).

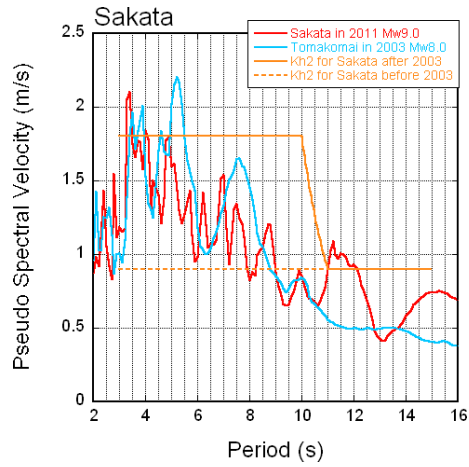
Sakata

- The largest LPGM observed at Sakata.
- Comparable level to the 2003 Tomakomai.
- No floating roof tank located in Sakata.
- Only one internal floating roof tank placed in Sakata.
- This tank's roof collapsed completely.

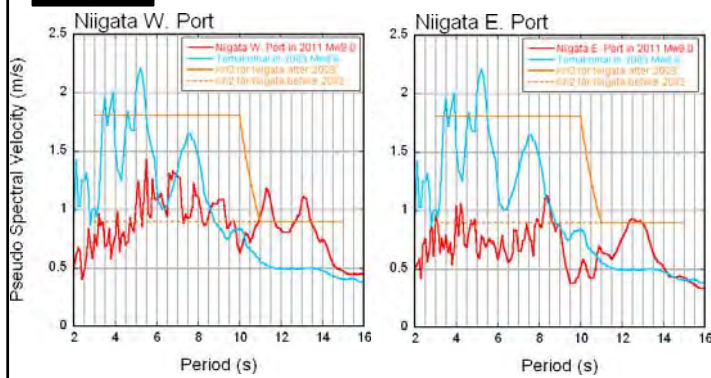
- Niigata W. Port exceeding the design spectrum before the post-2003 revision.
- If the design spectrum had not been raised, oil might have spilt out of the tanks.

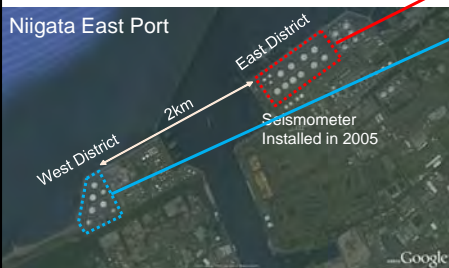
Comparison of Observed Sloshing Heights with Sloshing Heights Calculated from the 2011 Niigata-E Seismogram

If W. District LPGM is 50% larger than E. District, the observed sloshing amplitudes in W. District will be reproduced.

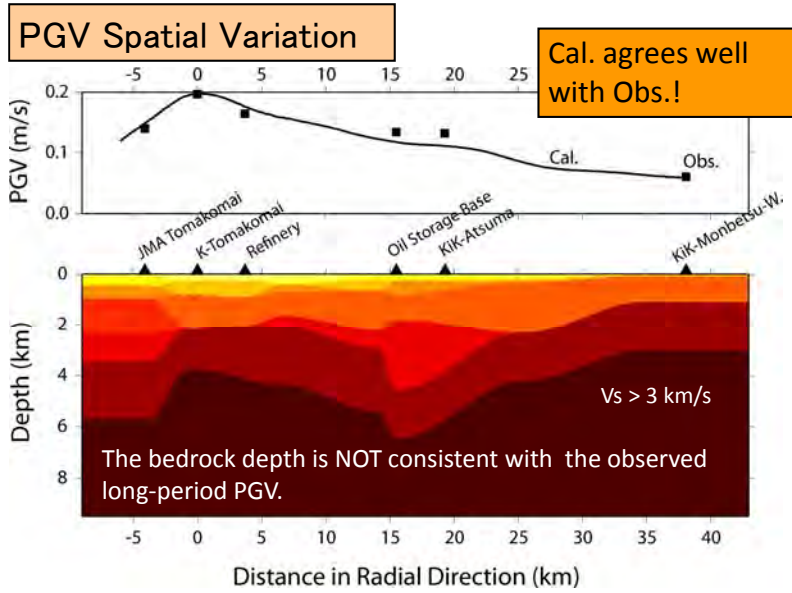
Obs. vs. Cal.: PGV (Period: 6.5 – 15 s)

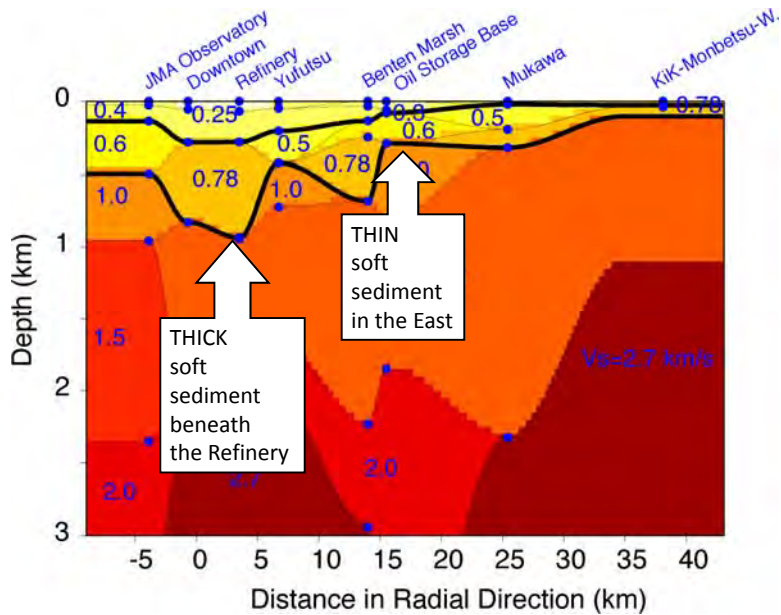
Characteristics in the Shallow Part

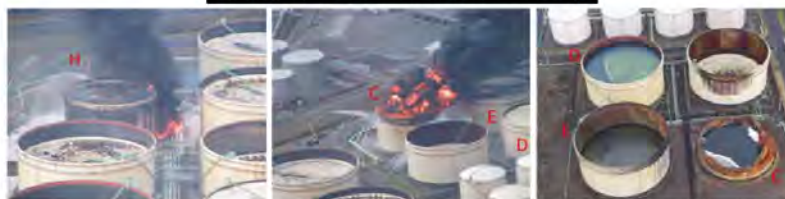
Damage due to the 2003 Tokachi-oki Eq.
