Heights Distribution and Damage of the Tsunami of the 2011 off the Pacific Coast of Tohoku Earthquake on the north part of the Sanriku Coast

**Lessons given by the Tsunami of the Great
East
Japan Earthquake of March 11th,
2011**

**—Disaster Prevention for Millennium Earthquakes-
Tsunamis**

**Yoshinobu Tsuji
Building Research Institute,
Tsukuba Science City, Japan**

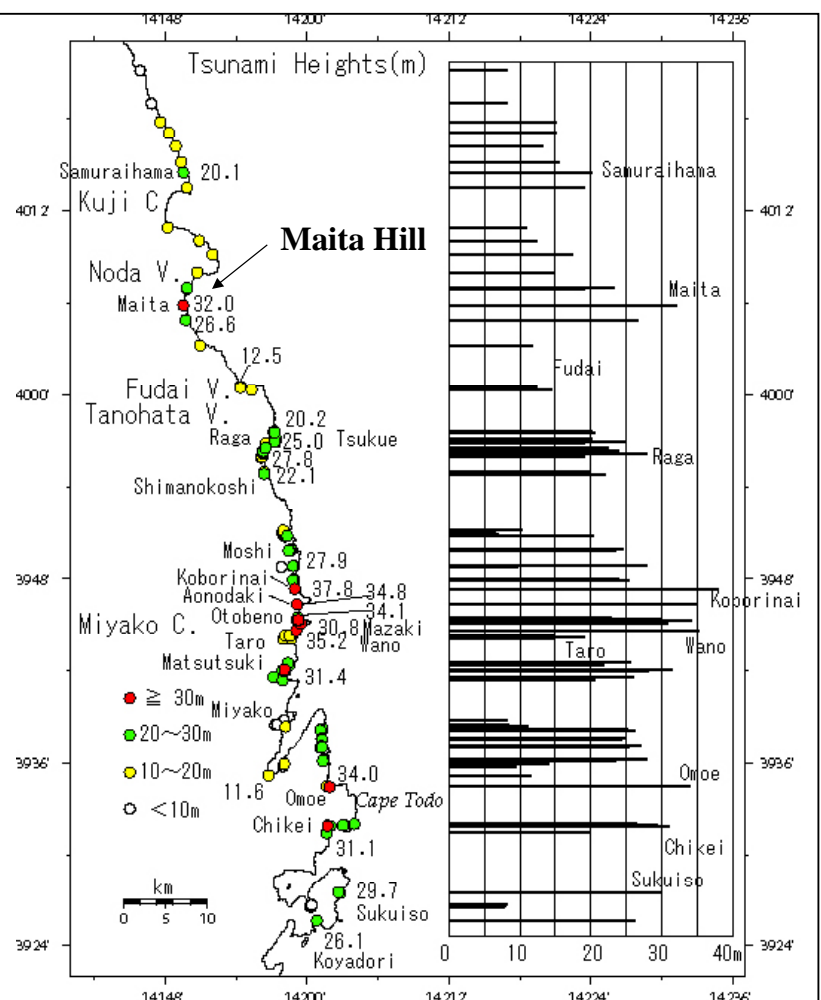
Tsunami height distribution on the north part of Sanriku Coast

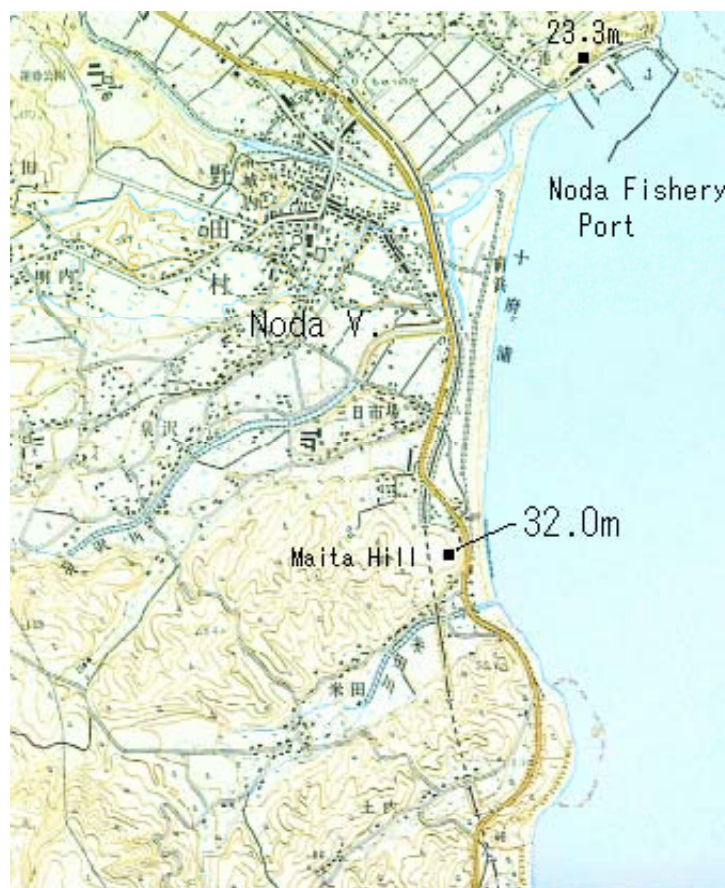
Map of Maita Hill

The coastline is not an innermost point of a V-shaped bay.

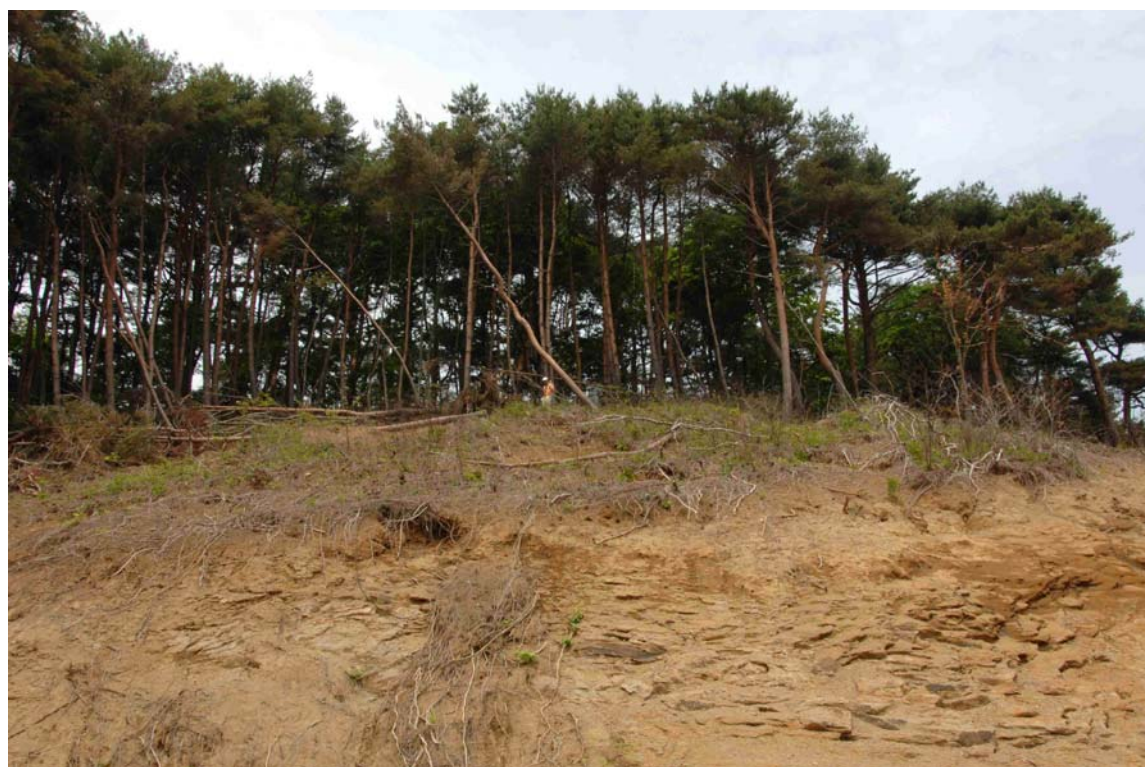
**Maita Hill, sea water rose up to near the top of
the hill. run-up height: 32.0m**

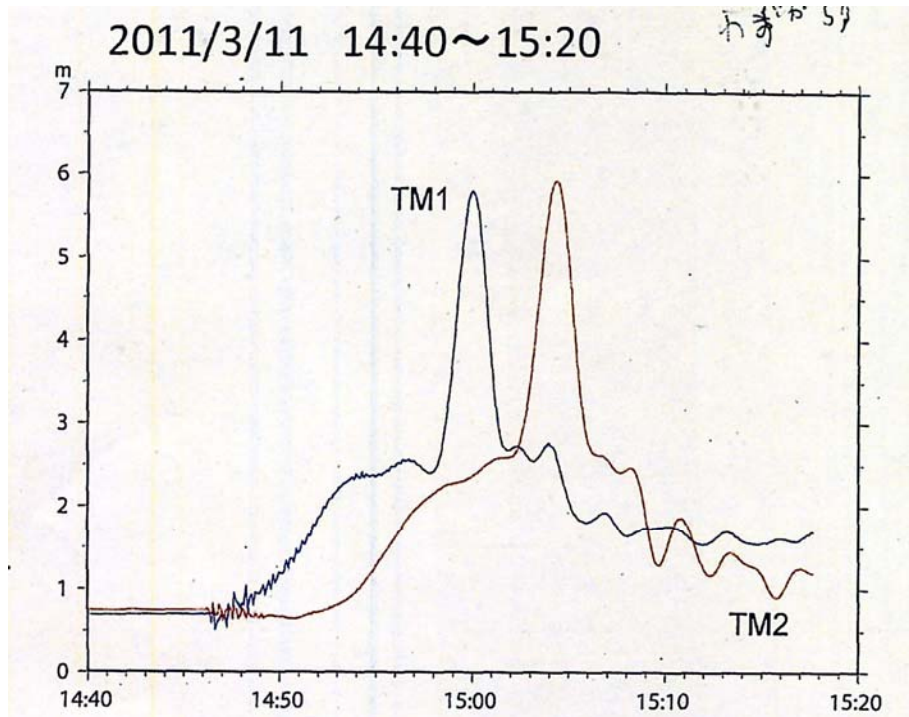
Sea level records obtained at the ocean bottom sensors

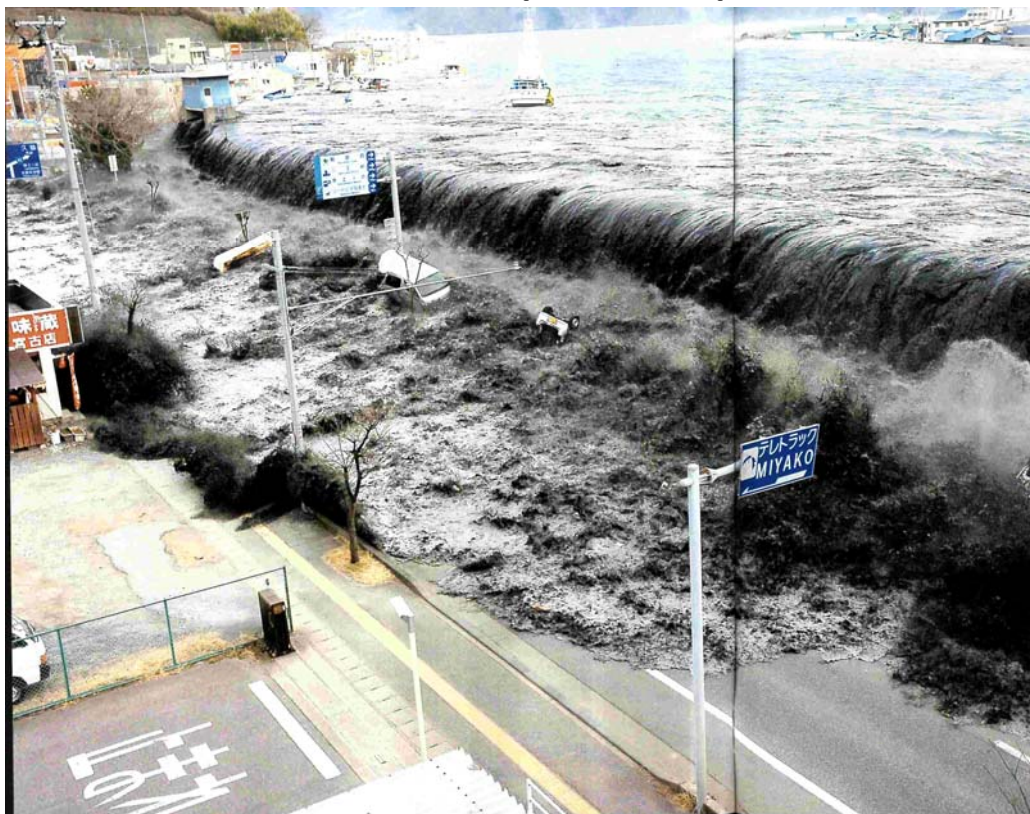
Tsunami suddenly came at 30 minutes after the main shock (Hiyako City Hall)

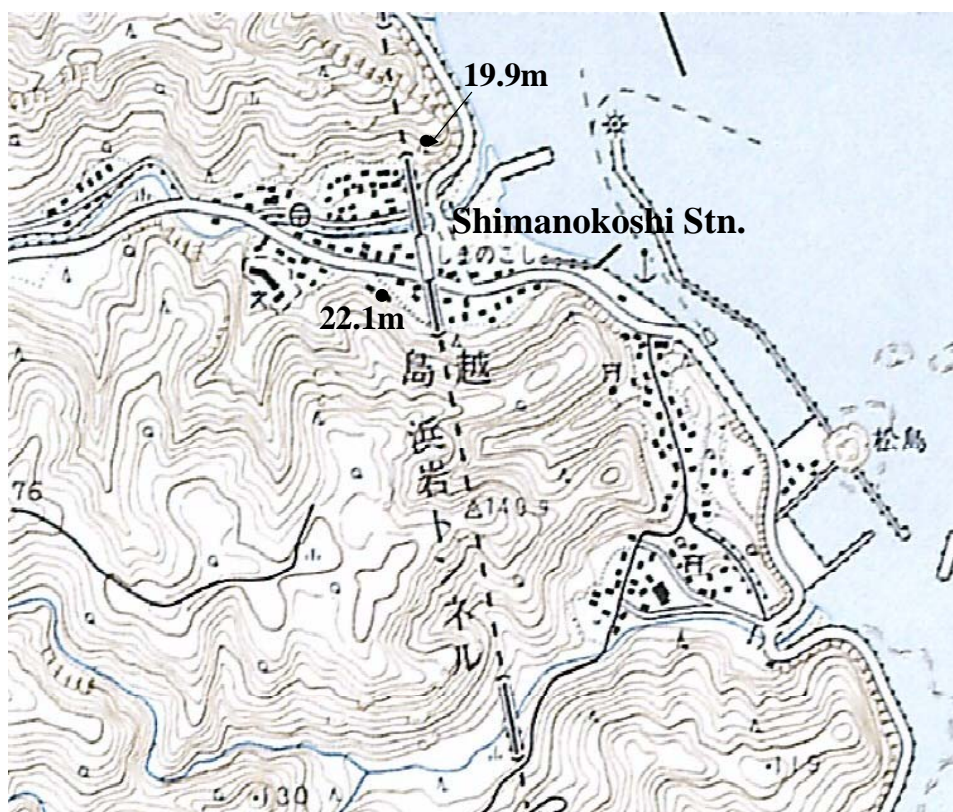
Railway station was lost at Shimanokoshi

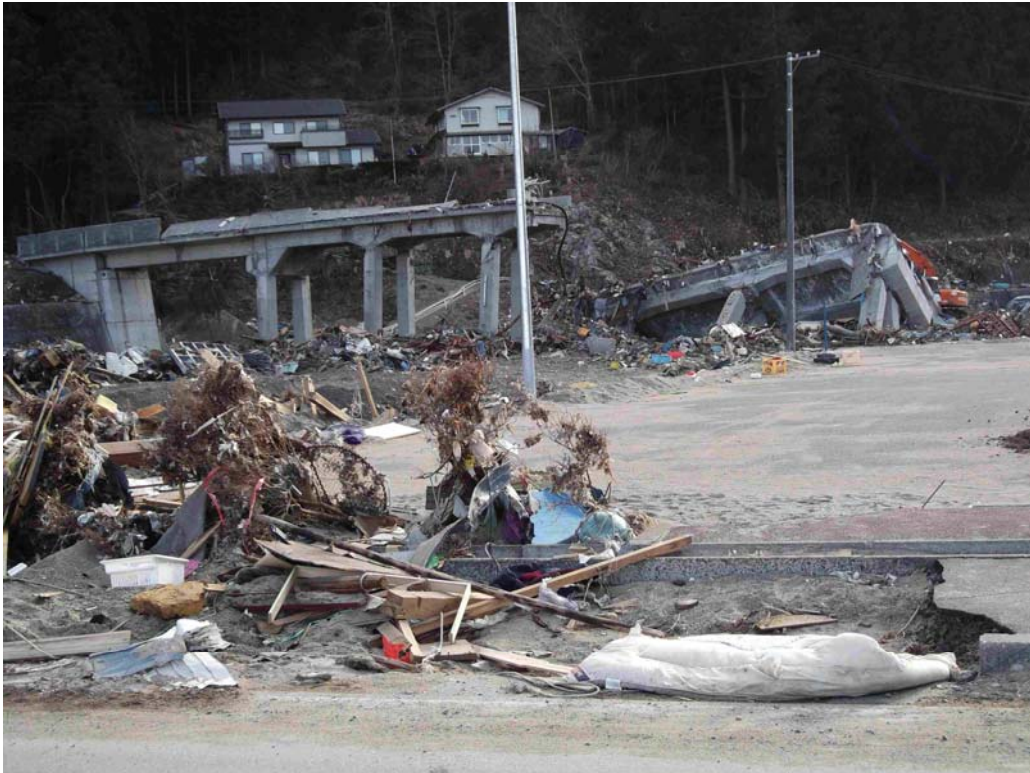
Railway station “Shimanokoshi” was washed away

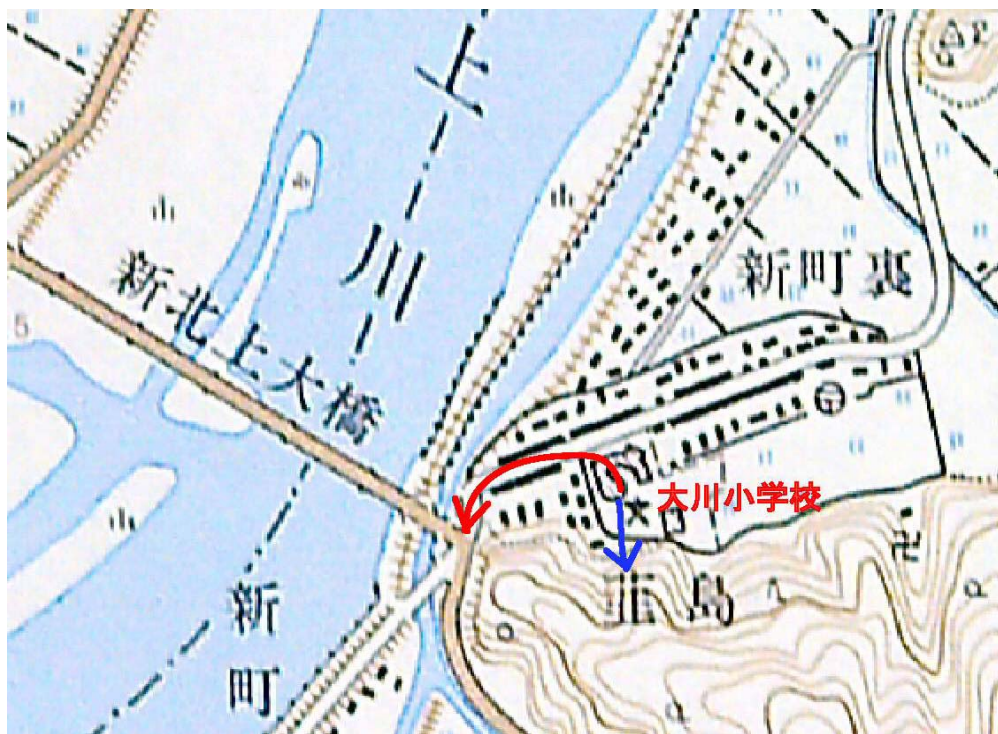
Teachers guided students in red arrow

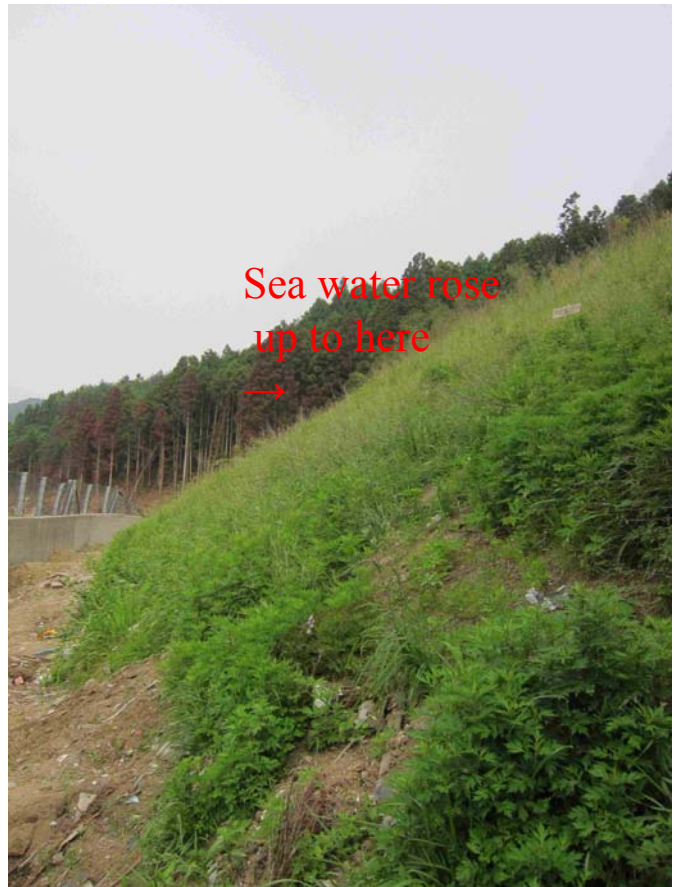
**The hind slope
Children could not
climb up on this slope
No hiking route!**

→ A zigzag climbing route
should existed

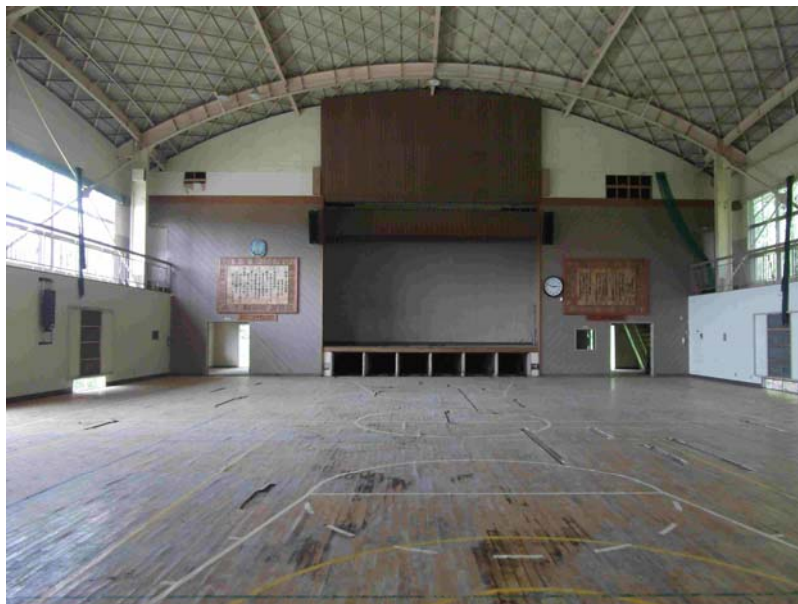
Sea water rose up to the level 3 meters above the floor. 20 people were killed here.

About 100 people sheltered here after the issuance of tsunami warning.

We once entered here, we can not see outside.

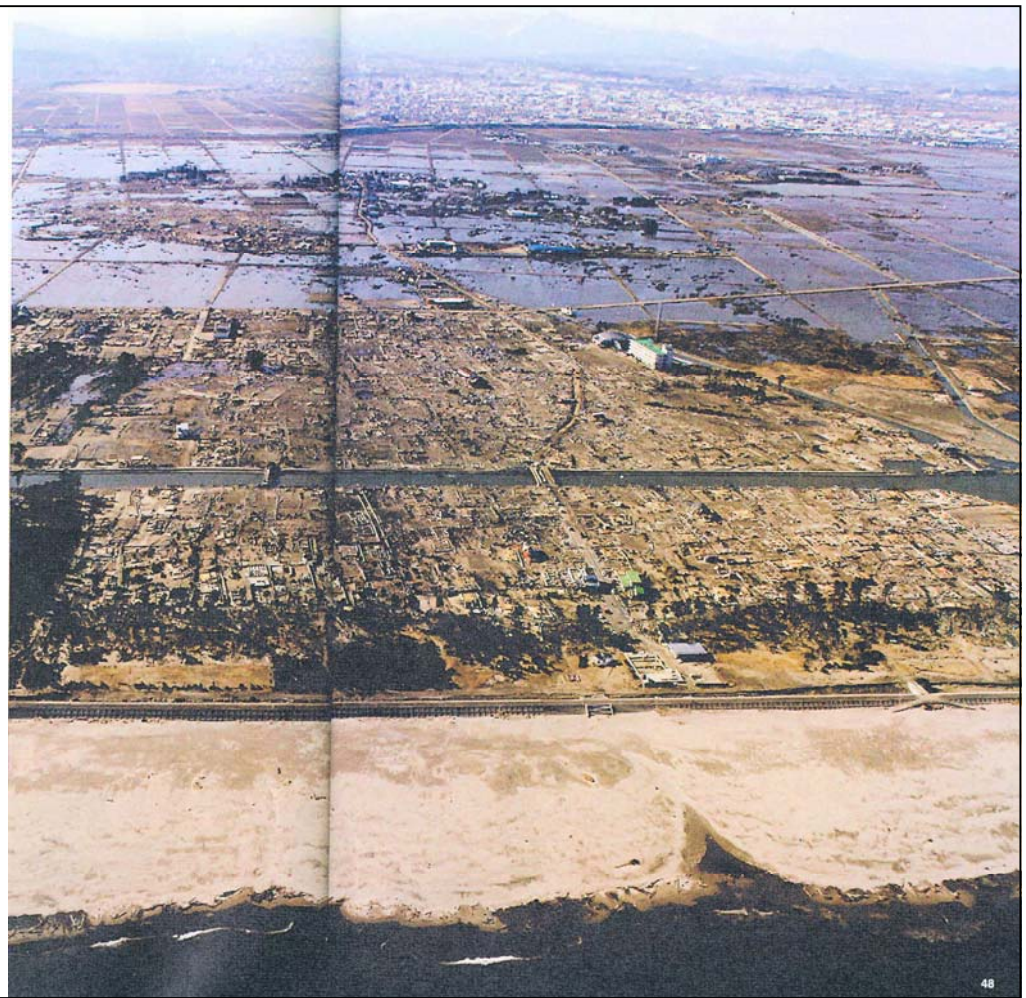
Failure
Example 3.
Arahama
area in
Sendai City.

Only the 4th
floor of the
elementary
school
building was
not
submerged.

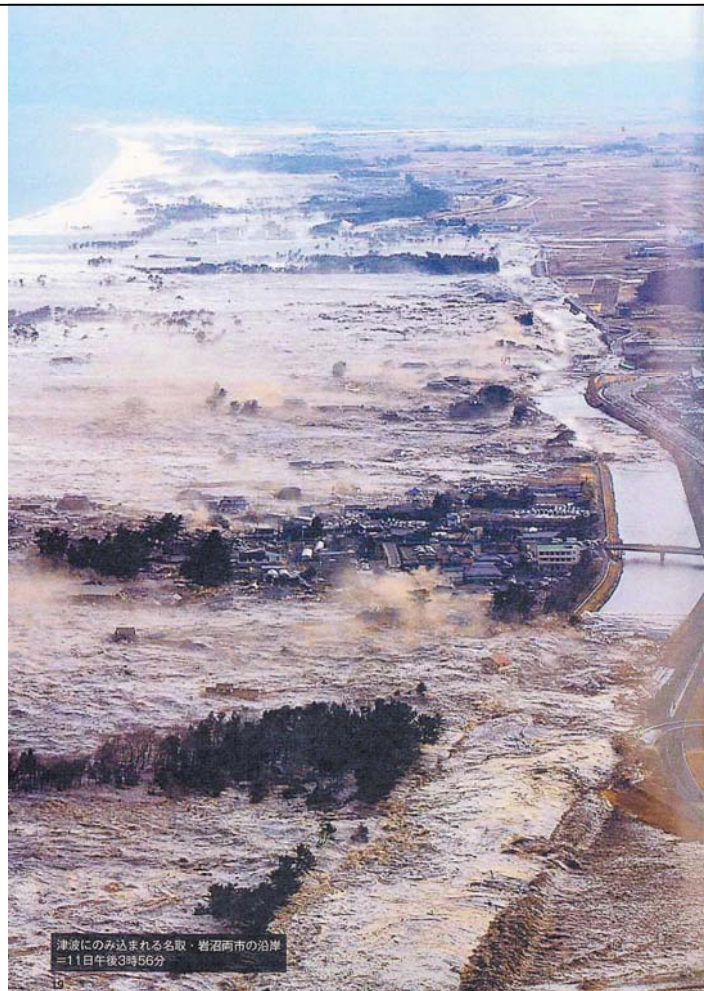
Tsunami hit
the coast!

Notice the channel
called “Teizan-Bori”
which prevent
evacuation of people.
これが避難を妨げた。

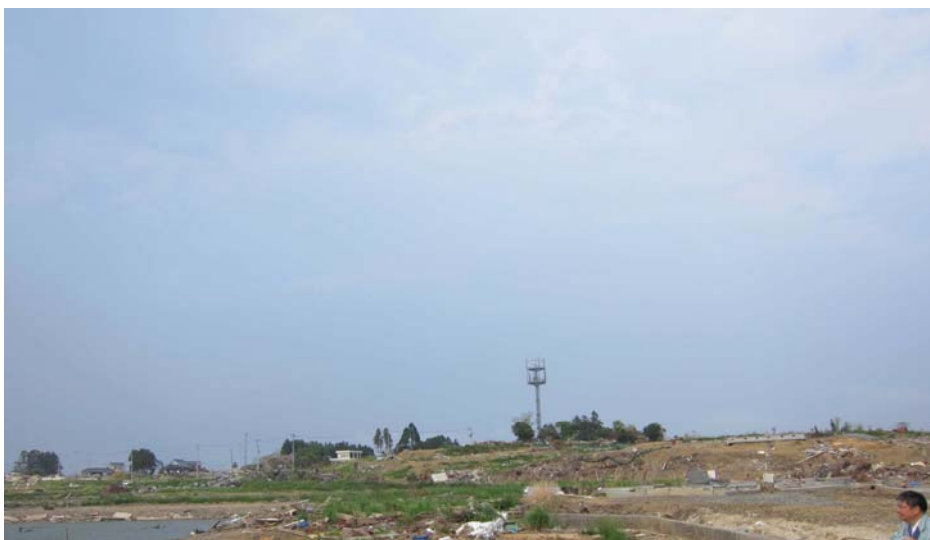
Failure Example 4: Tragedy on Suginoshita Hill in Kasen-numa City, Miyagi Prefecture

Suginoshita Hill (height: 12m) had been appointed as a shelter place from tsunamis, and about 100 people were evacuated. Sea water passed over the top of this hill with making water layer thickness of two meters, and 93 people were killed.

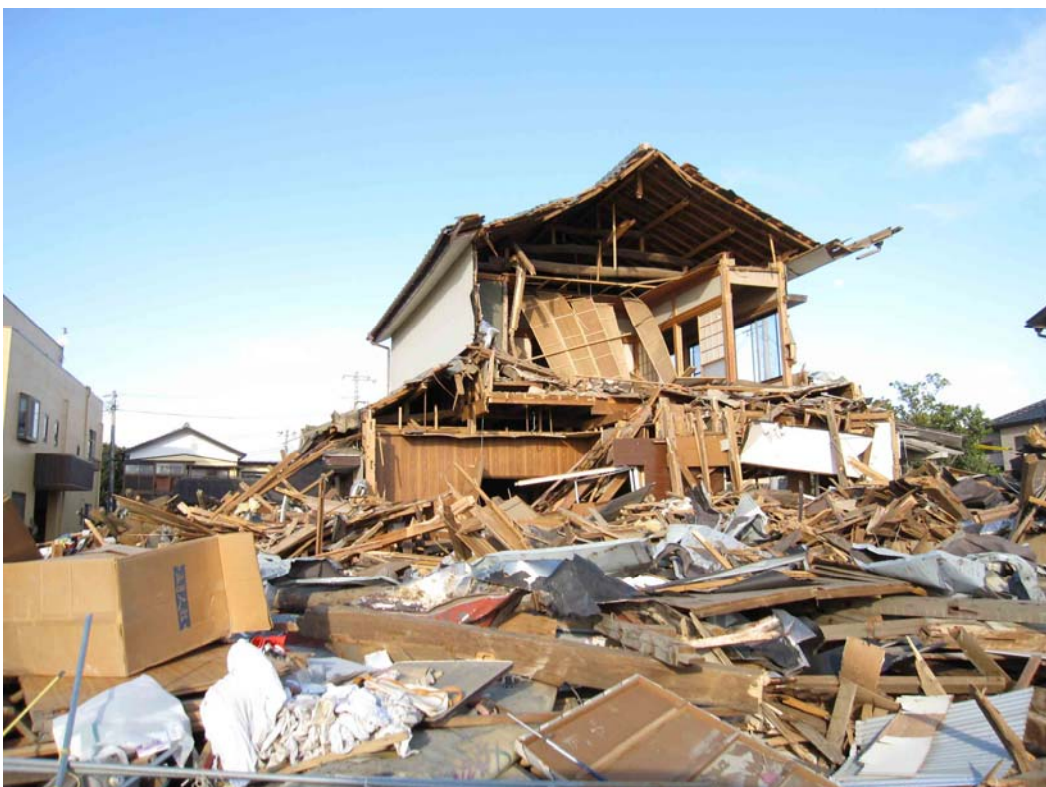
- 13 people were killed, 2 missings
- at Iioka Town

- → Tsunami Heights 7.6meters
-

Damaged houses at Iioka

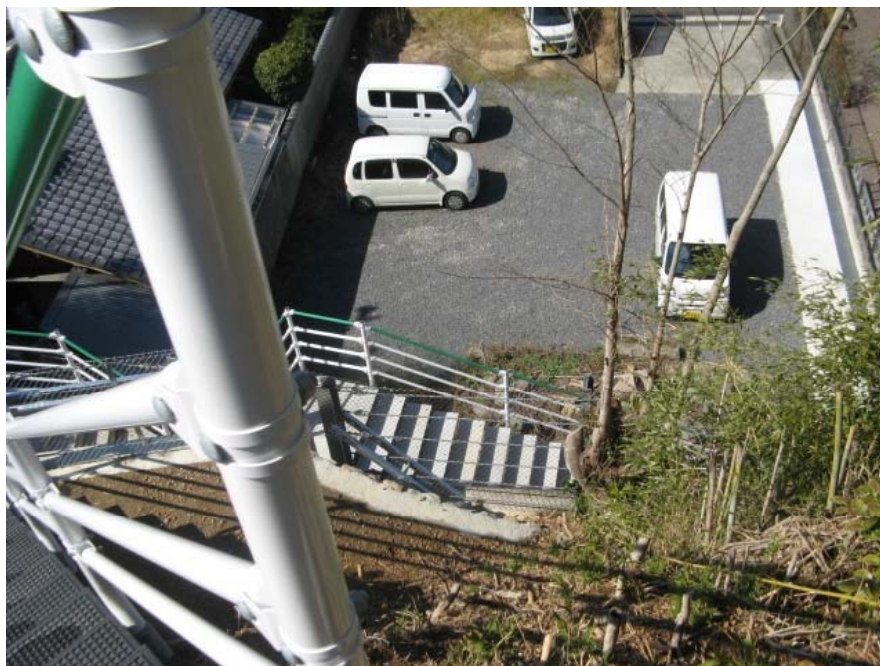
Tsunami Escape Stairs (20m)

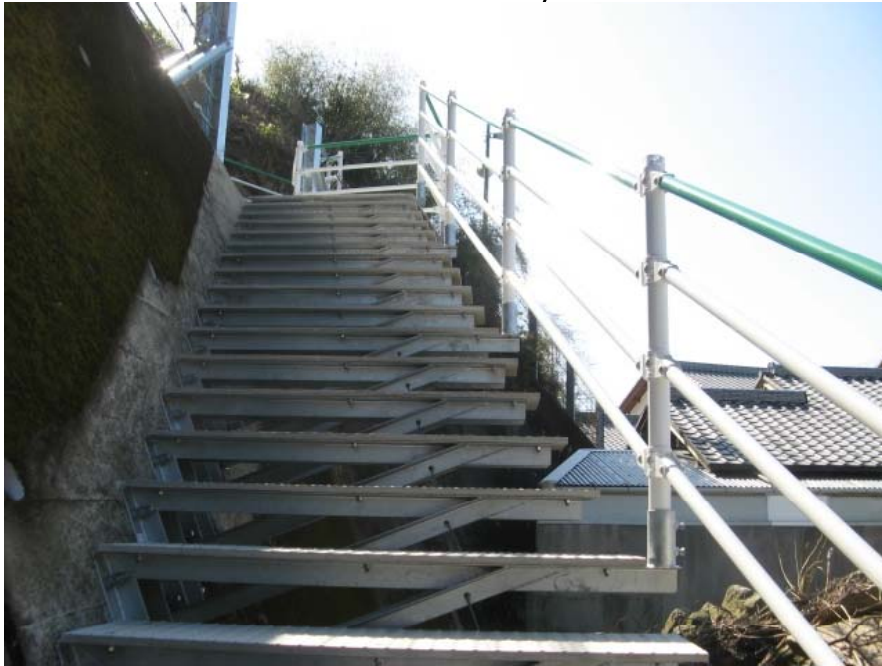
They set each step on the surface of a concrete wall by anchor bolts

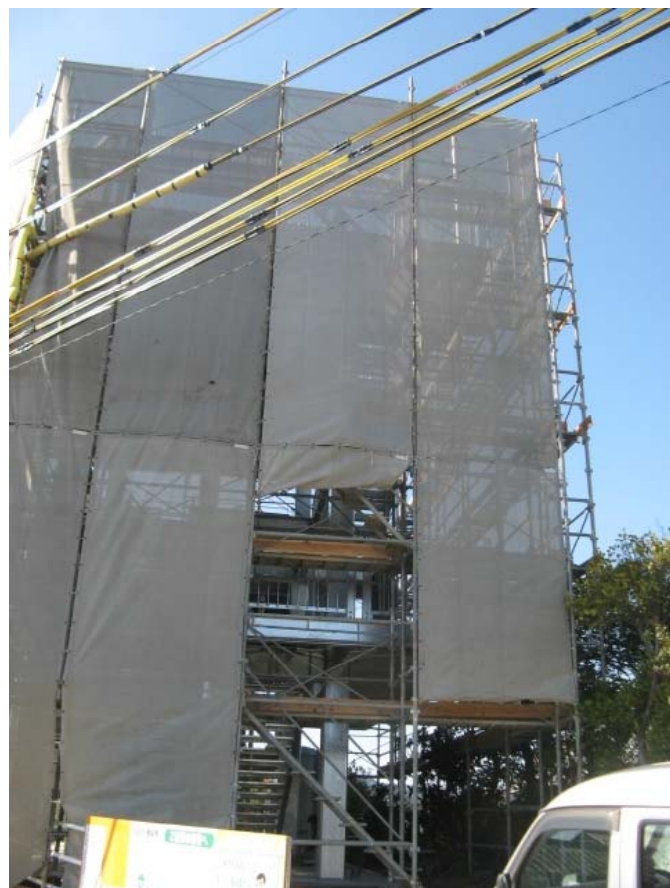
Tsunami Escape Tower in Shimanto City

Height 18 meters. The top floor area has 500 square meters in order to accept 1,000 people.

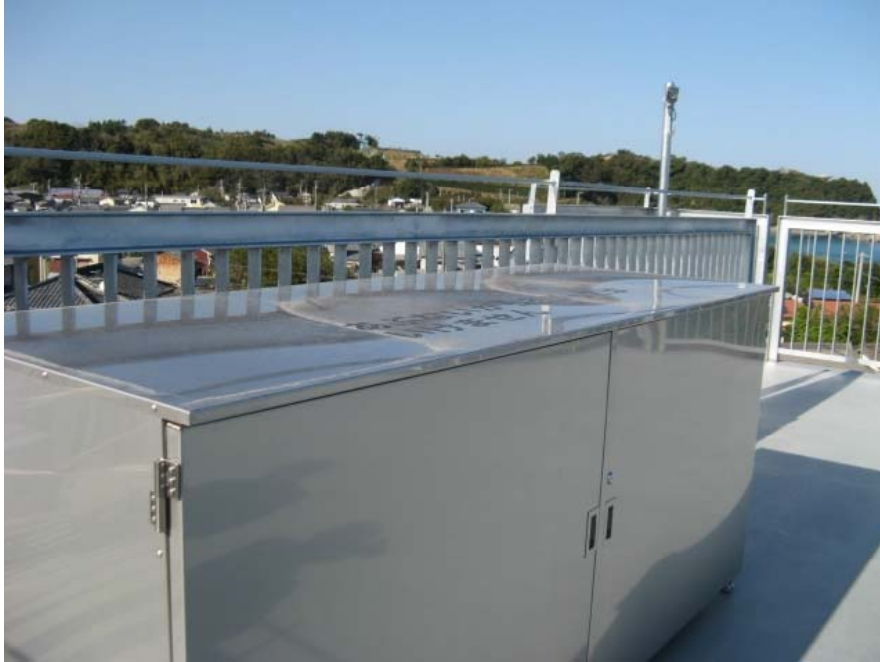
Life Jackets are kept in the Box
The door of the box will be broken by
a young refugee

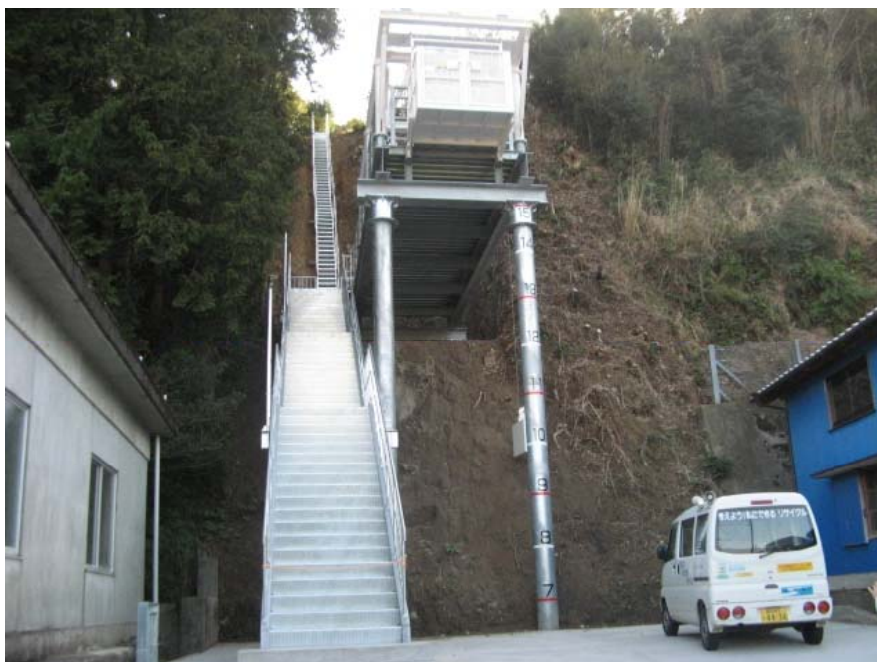
Pull up box equipped at a shelter place.
Leg weak people will be pull up by human
power. (Shimanto City)

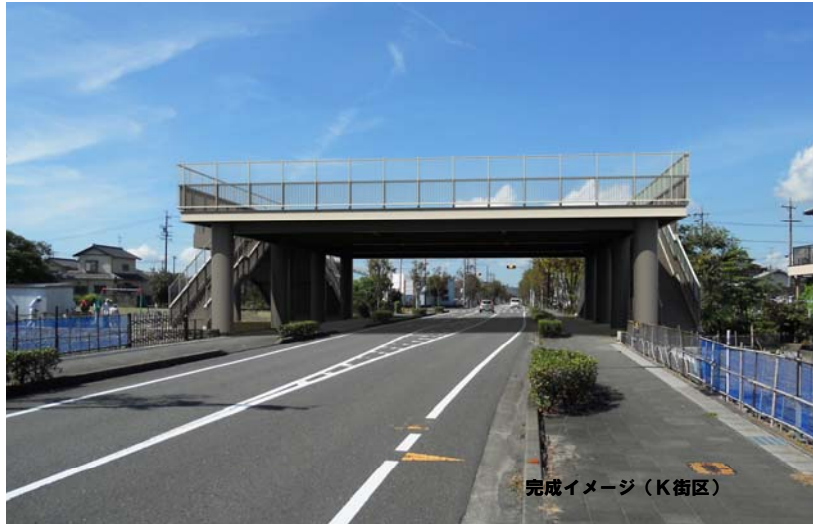
Tsunami Escape Station for a Millennium Tsunami at Yoshida Town, Shizuoka Prefecture.

The construction was completed on 23rd September, 2013.
Deck Height is 10.5 meters above mean sea level. This
place of refuge can accommodate 1,000 people.
