**LESSONS OF RECENT GIGANTIC EARTHQUAKE DISASTERS IN JAPAN**

Taiki SAITO<sup>1</sup>

<sup>1</sup> Chief Research Engineer, International Institute of Seismology and Earthquake Engineering, Building Research Institute, Tsukuba Japan, tsaito@kenken.go.jp

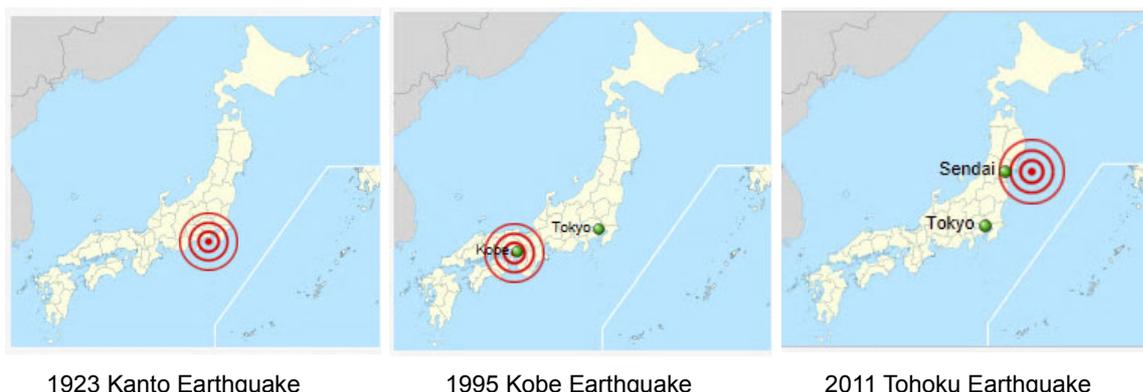
Figure 1 Epicenters of earthquakes (figures are cited from Wikipedia)

In the last 100 years, there are three gigantic earthquake disasters in Japan which caused tremendous loss of human life: the 1923 Great Kanto Earthquake Disaster (hereinafter referred to as **1923 Kanto Earthquake**), the 1995 Great Hanshin-Awaji Earthquake Disaster (hereinafter referred to as **1995 Kobe Earthquake**) and the 2011 Great East Japan Earthquake Disaster (hereinafter referred to as **2011 Tohoku Earthquake**). Figures 1 shows the epicenters and Table 1 summarizes the disasters.

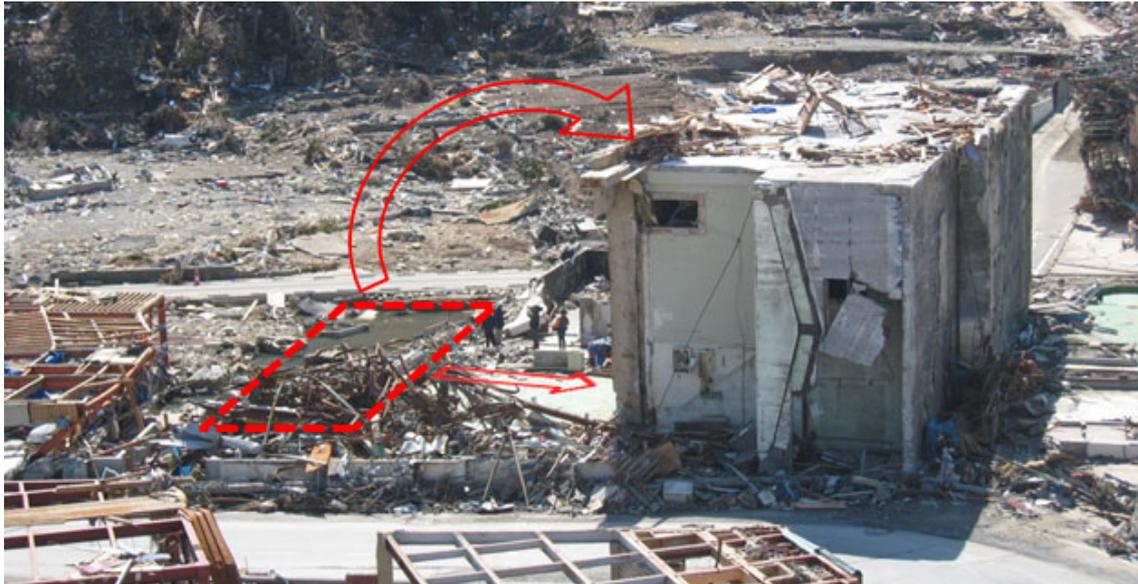
In tsunami disaster site, overturning was observed in 4-story or lower reinforced concrete buildings with relatively small size of openings as shown in Figure 8. In all overturned buildings, the maximum inundation depth exceeded their height. Most of the overturned buildings are of mat foundation. In some overturned buildings on pile foundation, piles were pulled out from the ground.

Figure 8 Overturning of a reinforced concrete warehouse in Onagawa city
