The 2011 Tohoku-oki tsunami in Sendai and its neighborhood

Hazard and Risk Evaluation Research Division

International Research Institute of Disaster Science (IRIDeS)

Field guide in Sendai on 12th Nov. 2012 (Mon)

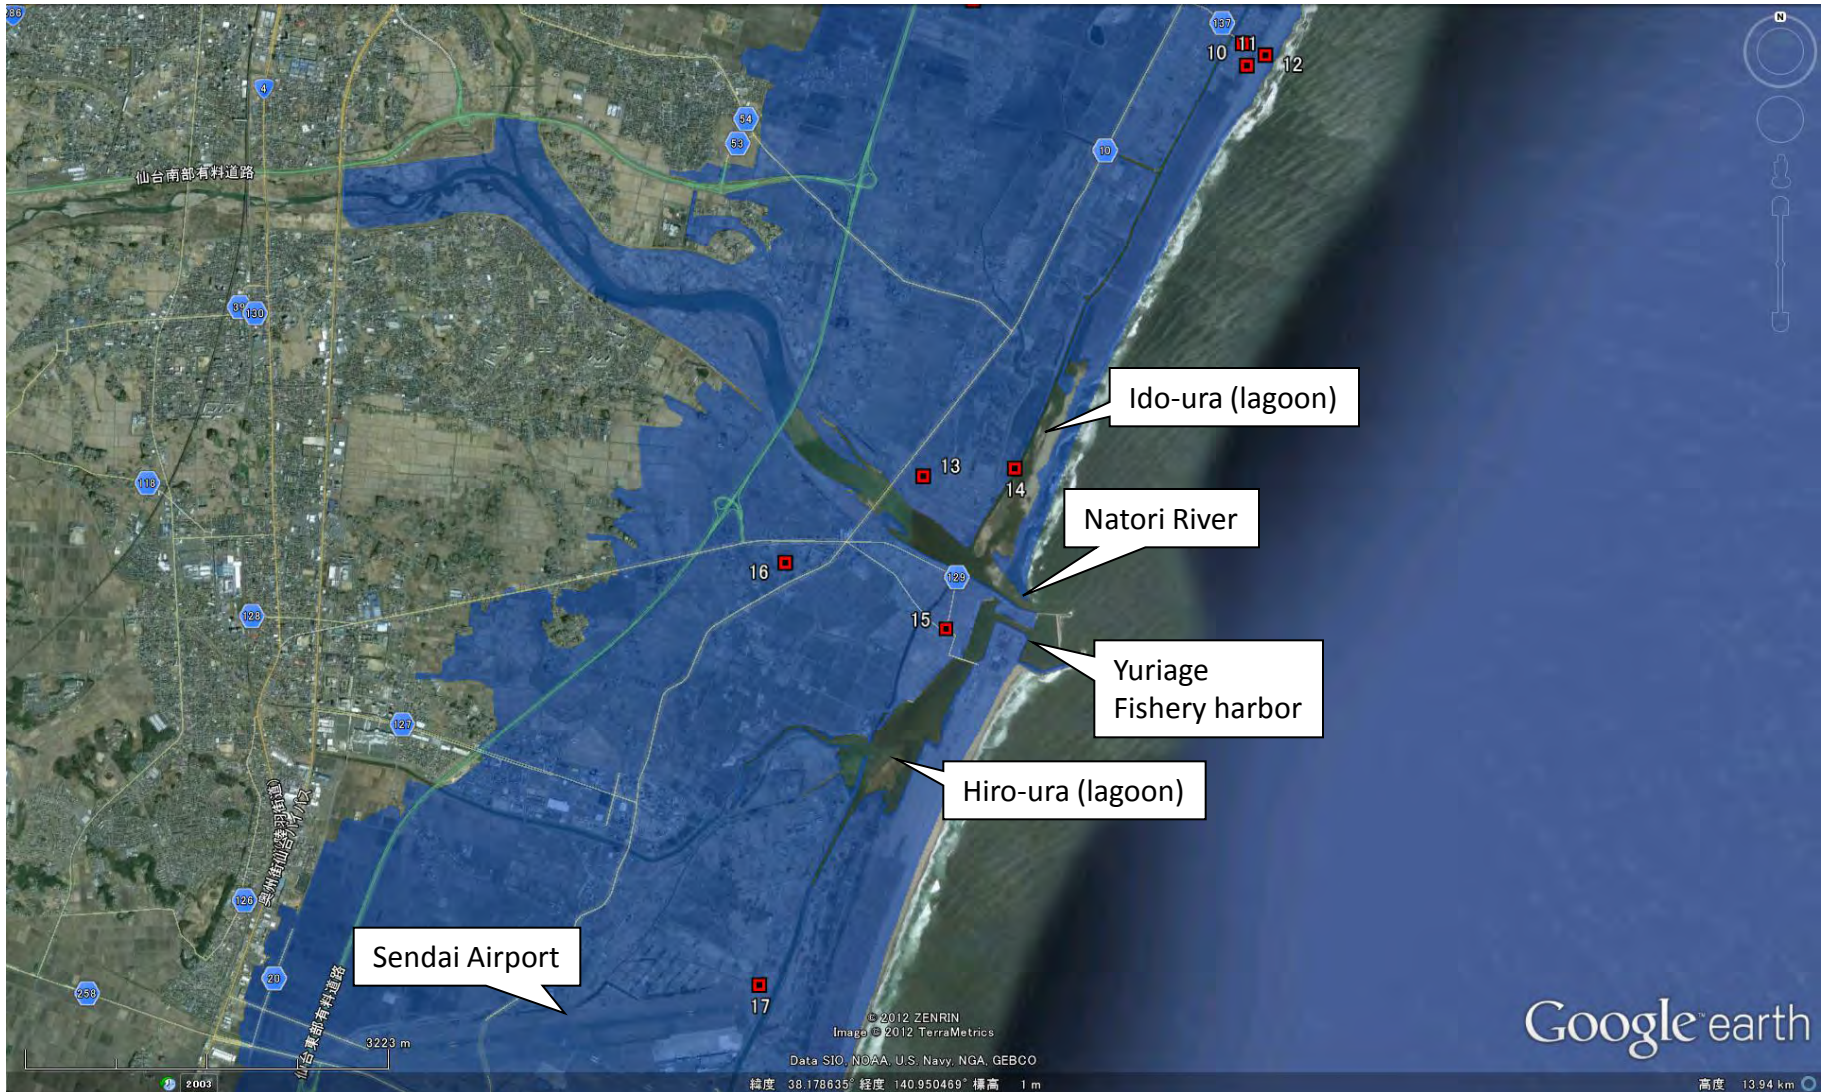
South area (Sendai & Natori)

Inundation area is based on Japan Society of Geoinformatics (<http://www.jsgi-map.org/tsunami/>)

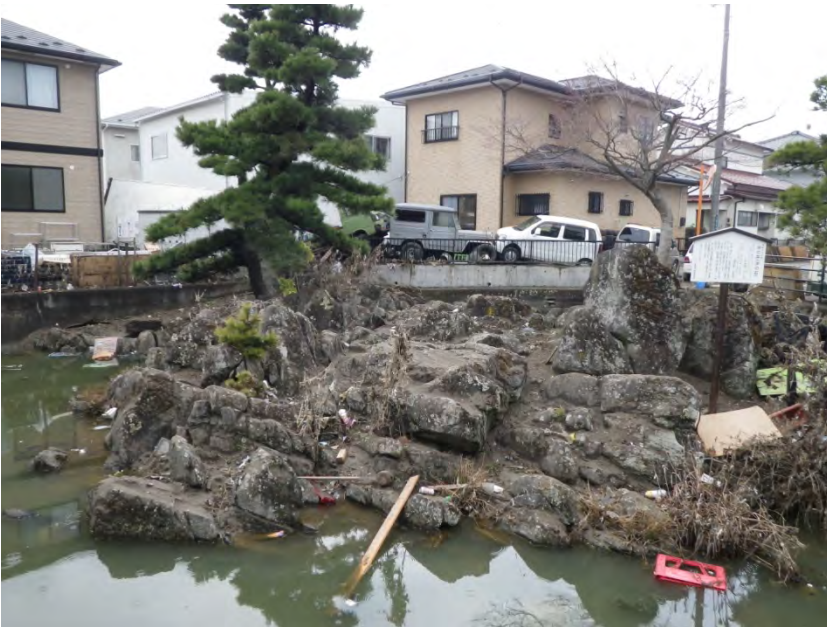
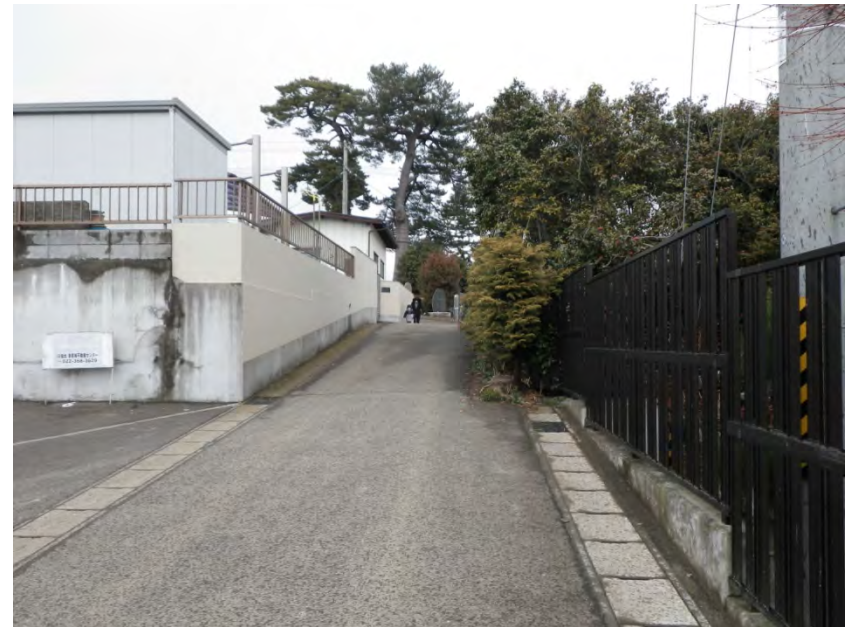
[1] Tsunami evacuation hill

- The small hill, called *Sueno-matsuyama*, has been well known from legends of the Jogan tsunami
- The hill was not flooded by both the AD869 Jogan and the 2011 Tohoku-oki tsunamis

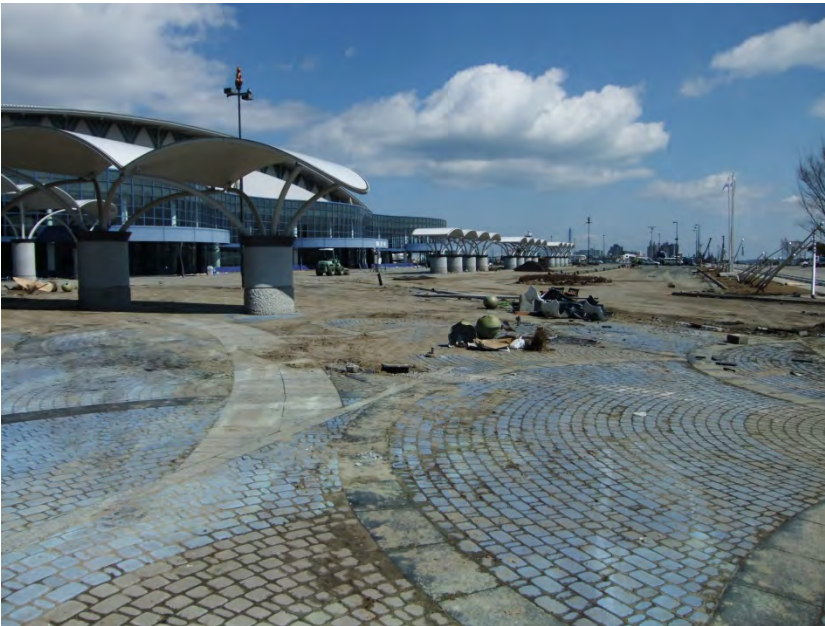
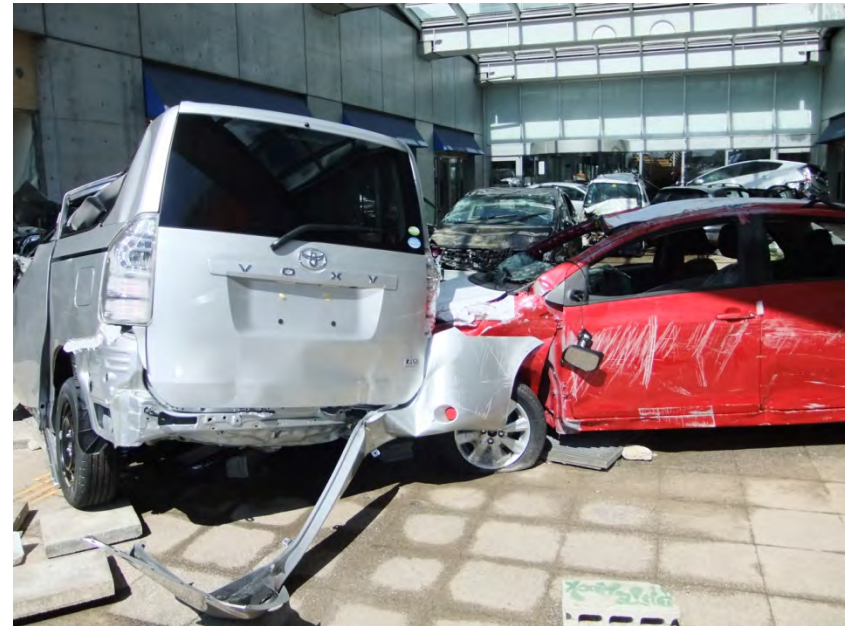
[2] Sendai Port

- Numbers of cars were washed and piled up everywhere around this area
- These cars were drifted even inside the exhibition hall
- Container traffic in Sendai Port was restarted 3 months after the tsunami (8th June)

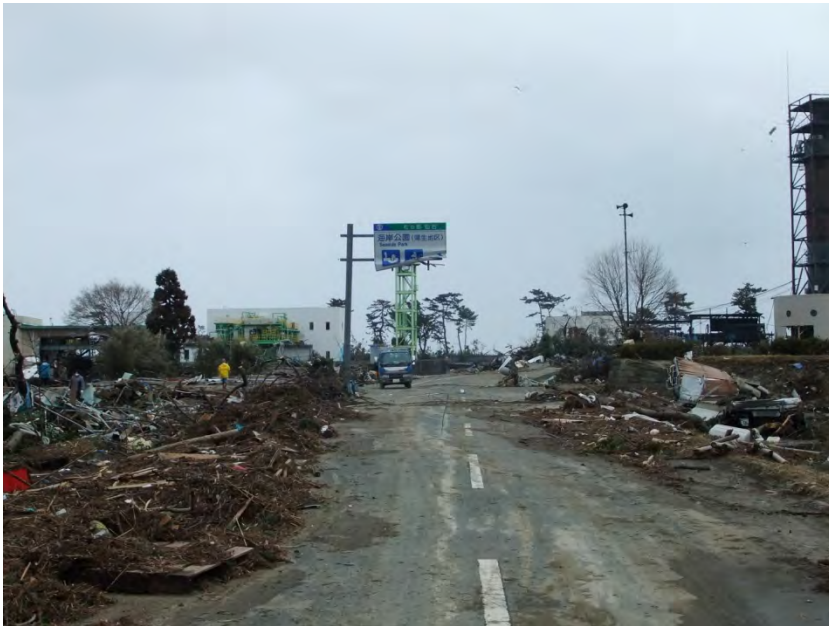
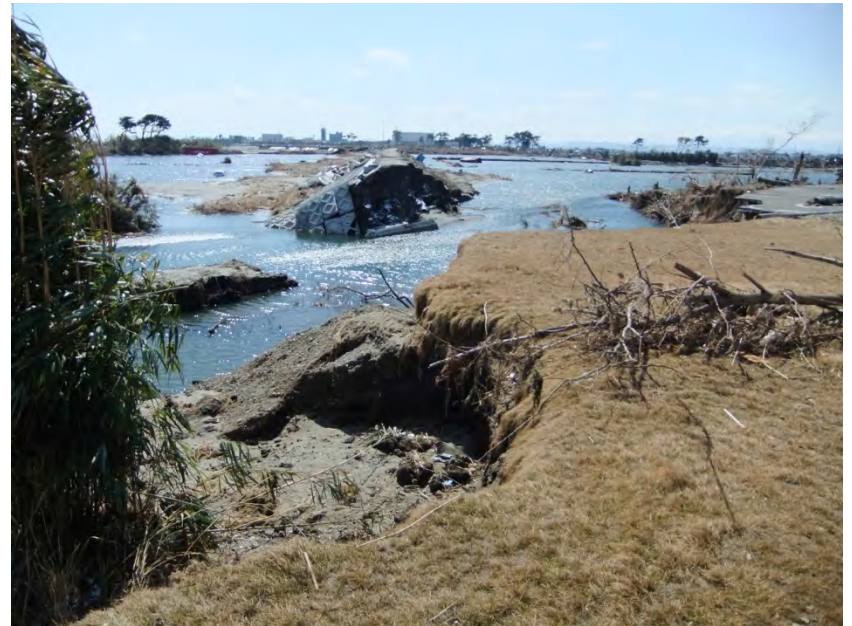
[3] Neighborhood of Nanakita River

- Destruction of sewage works brought hygienic matters to Sendai City
- Tidal flat of Gamou area was buried by sand.
- The mouth of Nanakita River was recently closed due to sand drift by coastal current

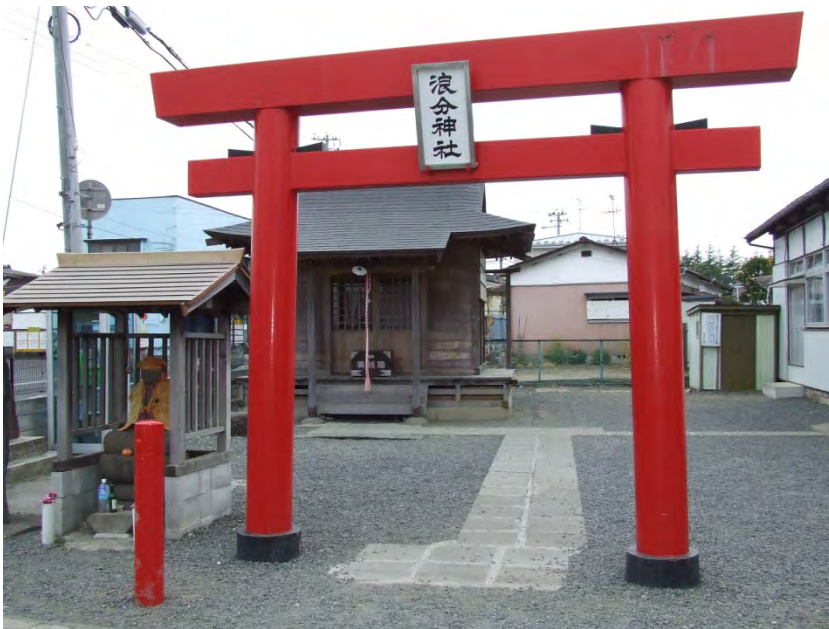
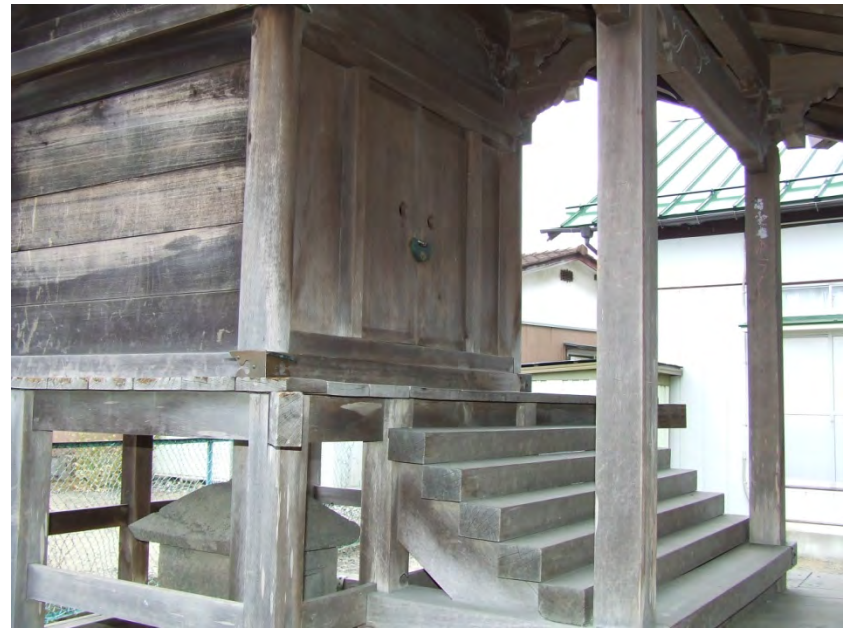
[4] A shrine with tsunami legend

- Name of the shrine (*Nami-wake*, dividing a wave) implies some connection with past tsunamis
- The shrine was established during Edo Period (AD1702), although no historical tsunami has been documented at that time

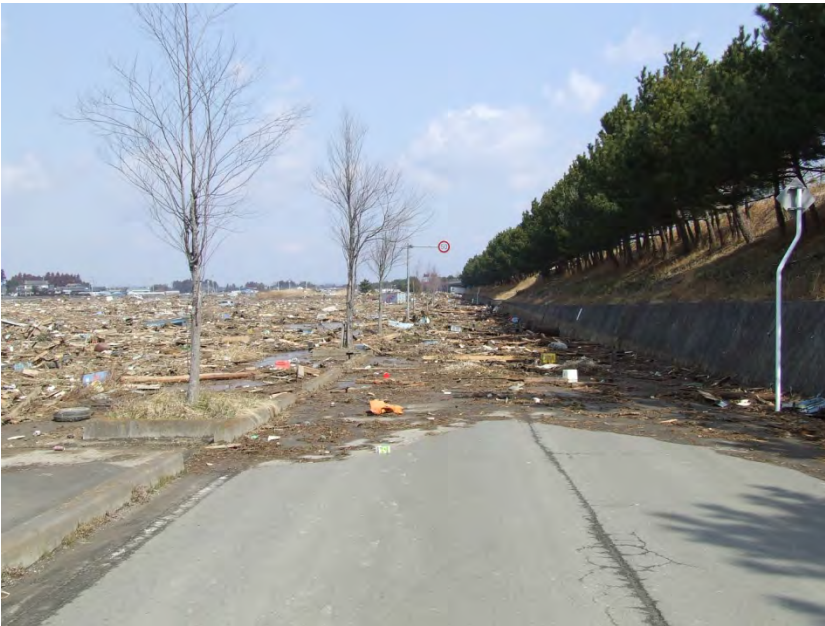
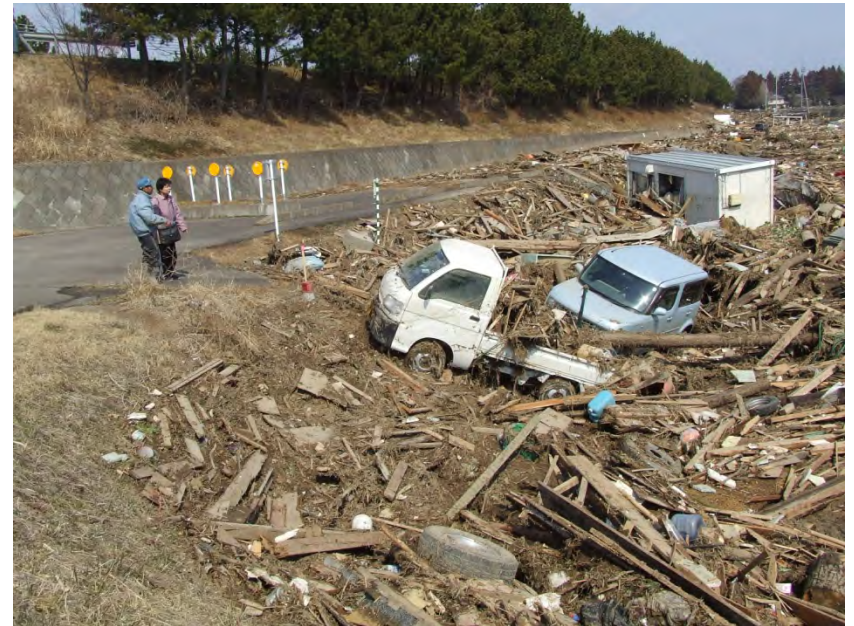
[5] Sendai East Expressway

- Embankment of the roadway worked as a breakwater
- Damages of the east side of the road is quite severe, in contrast to that of the west side

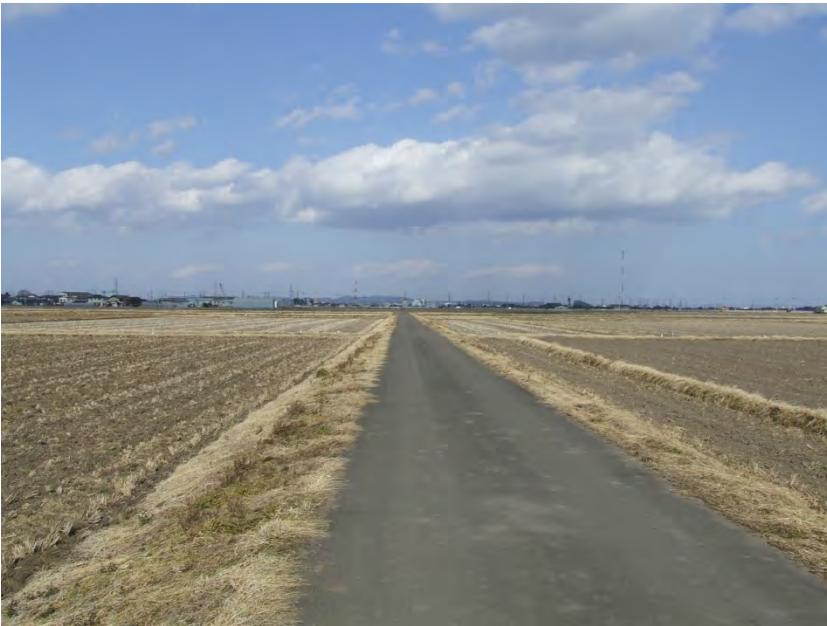
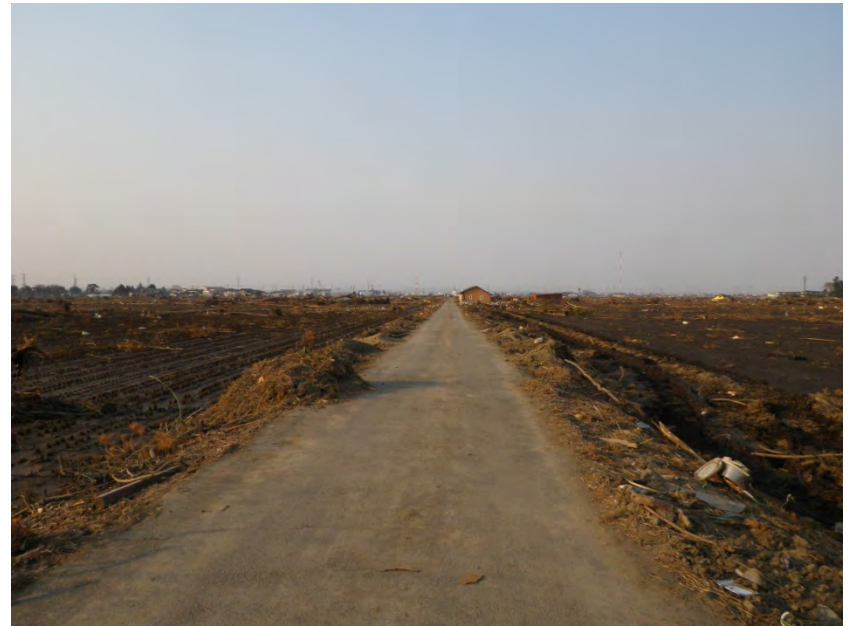
[6] Rice paddies

- Sendai Plain is an alluvium (flood) plain, and people developed the rice paddies on the back marshes
- The AD869 Jogan tsunami deposit can be found around 50cm below the ground surface

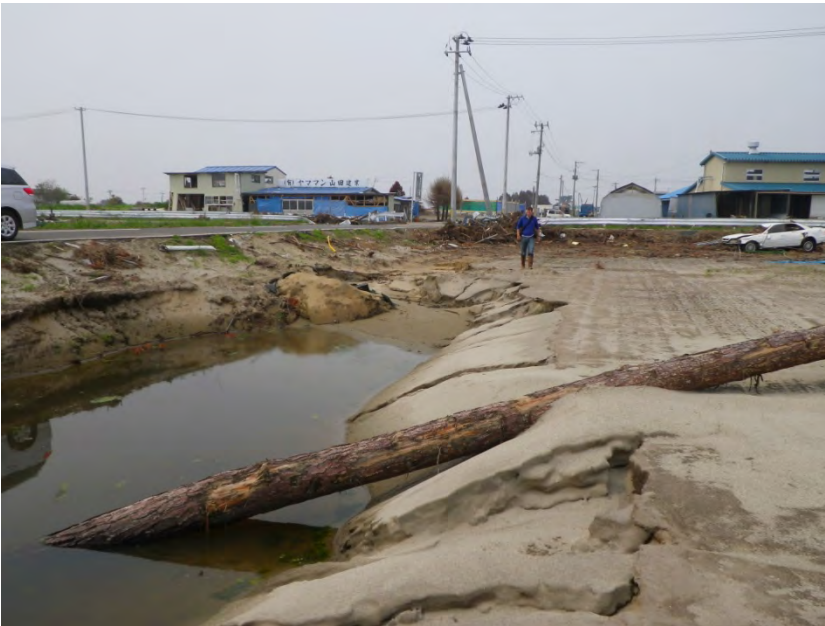
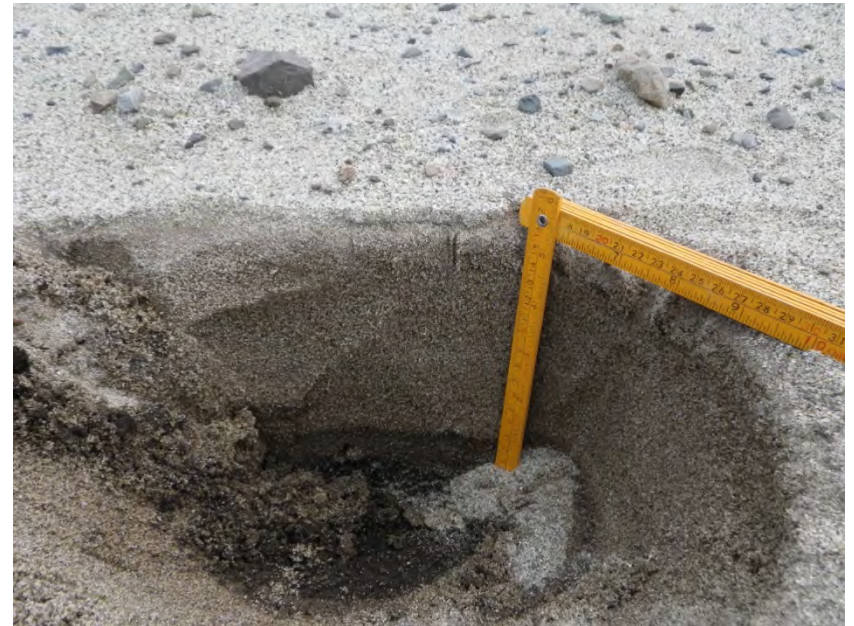
[7] Neighborhood of pond

- Many trenches and holes due to liquefaction and erosion are found along the shore-parallel artificial constructs, such as roadway
- The tsunami deposited a 20-cm-thick sand layer
- Soils were washed out and plow sole of the paddies are exposed

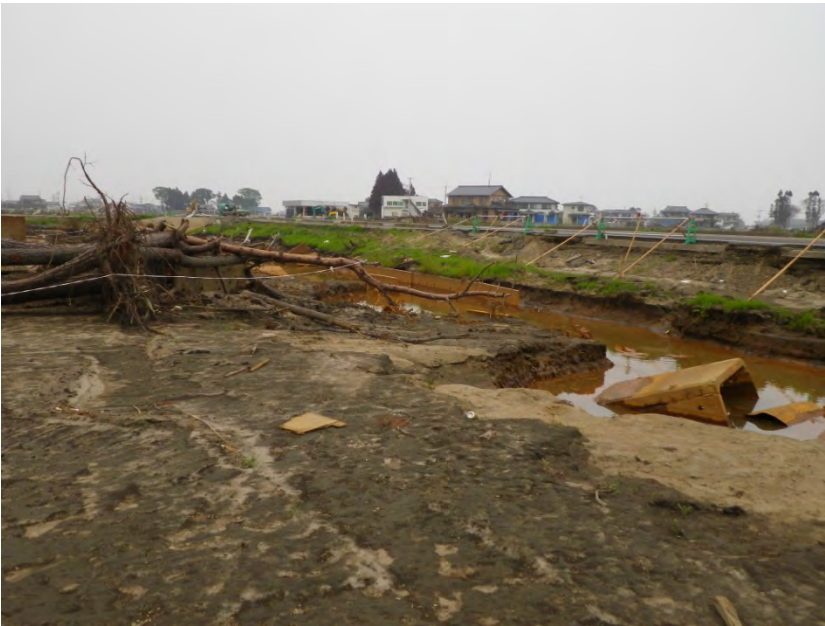
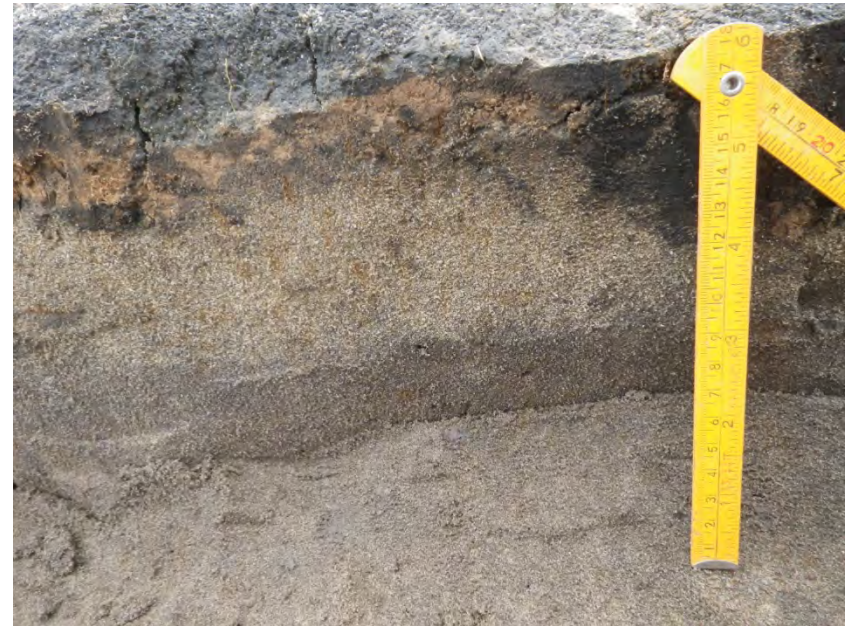
[8] Outcrop of the Jogan tsunami deposit

- The 2011 tsunami excavated the paddies and created many trenches, which is deep enough to reach sediments deposited over 1,000 years ago
- ~~The Jogan tsunami layer can be seen on the wall of a trench~~
- Now the old tsunami deposit is exposed on the surface

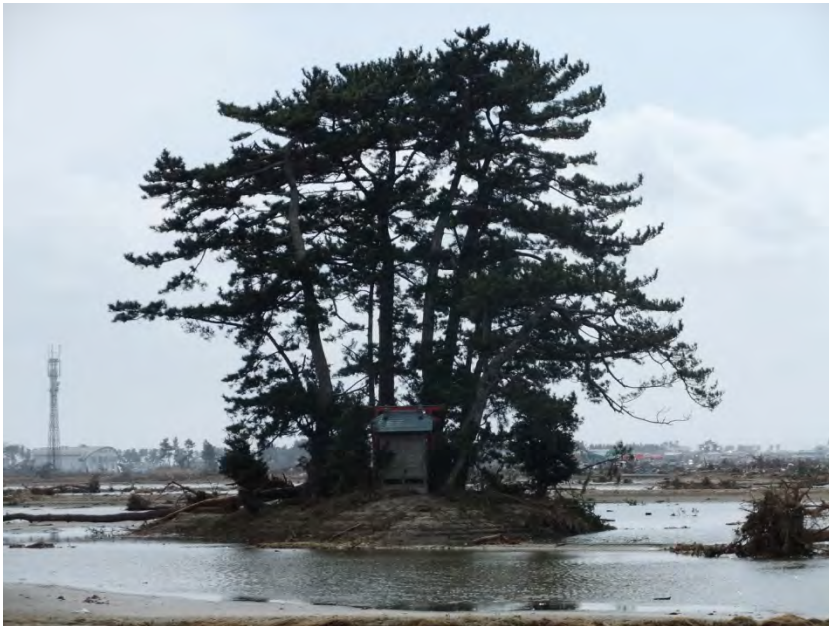
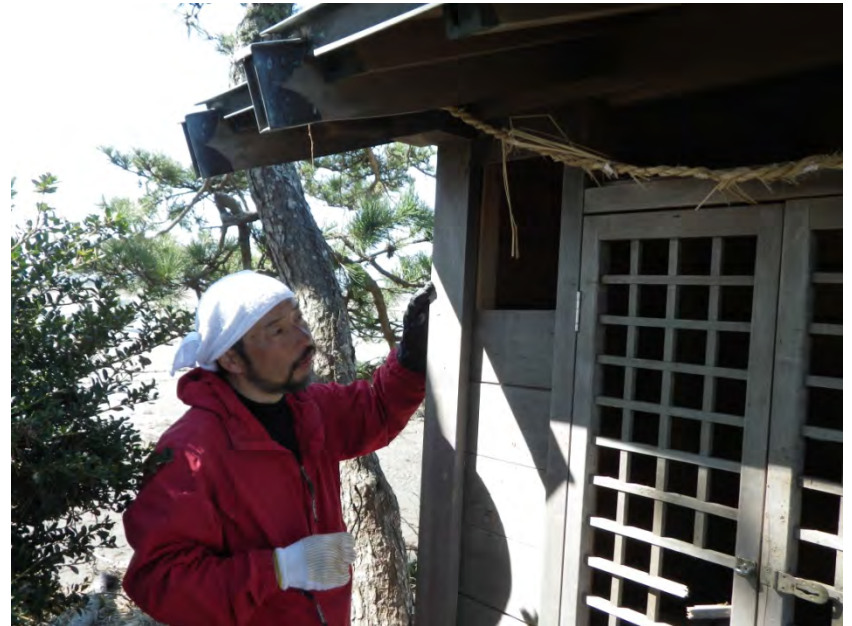
[9] Small shrine

- A small wooden shrine is located at 1.2km from the coast
- Although inundation depth around this shrine is 1.6m (tsunami height of 3m), it survived without any notable damage

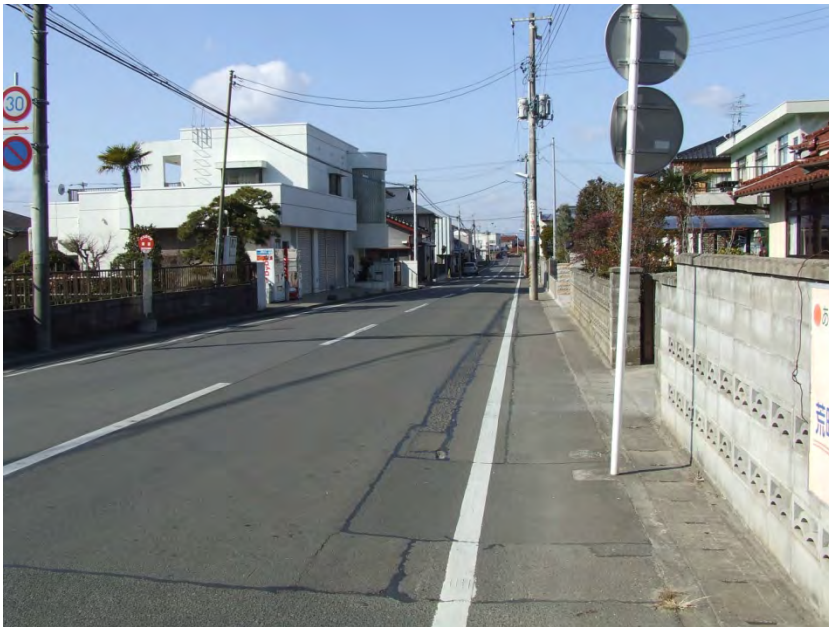
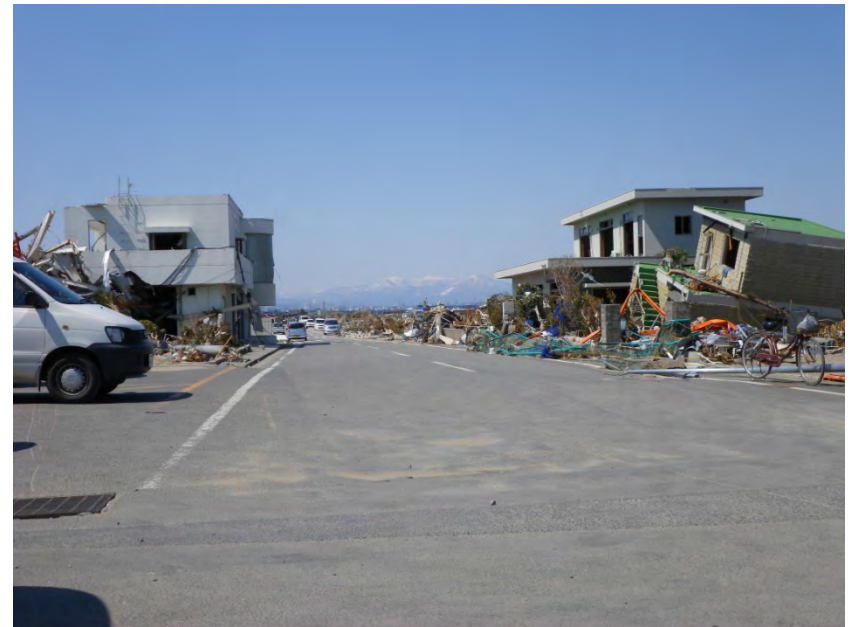
[10] Ruins of Arahama community

- The community was located at 200-300m from the beach
- Almost all houses were washed away (now everything has been removed by clearing work, and what one can see is foundations of the houses)
- Photos below were taken at same locations before and after the tsunami

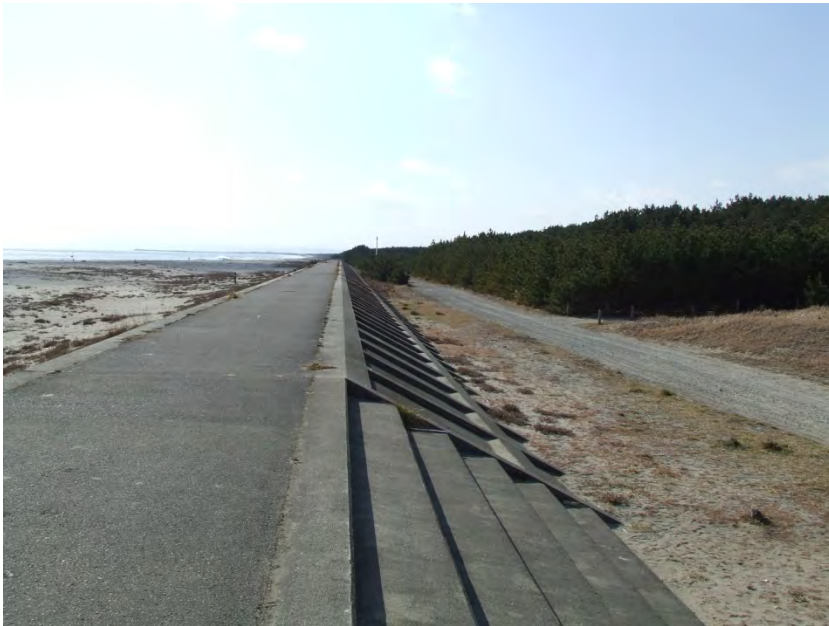
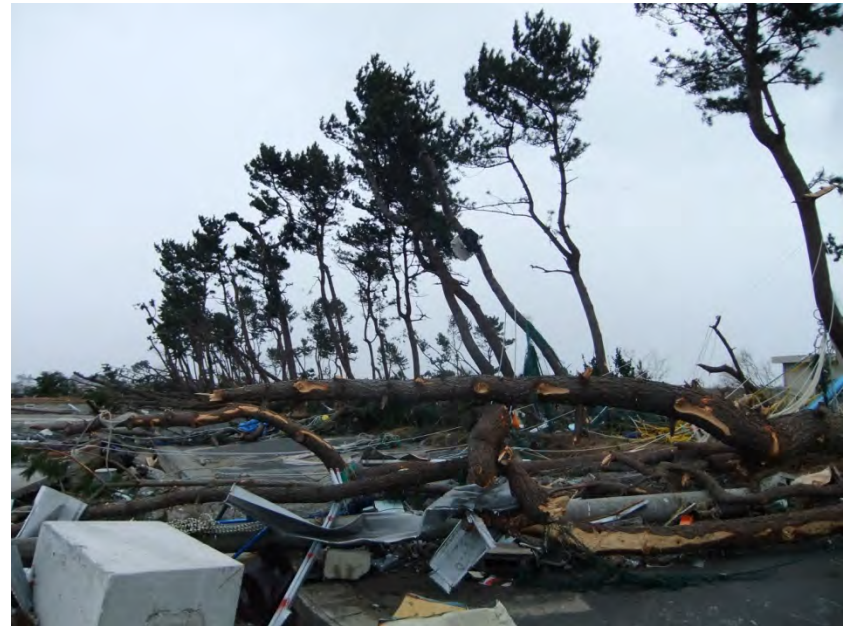
[11] Control forest

- Coastal areas in Sendai Bay was characterized by broad (500-700 m width) forests of pine trees
- They were planted during Edo Period to prevent salt damages
- Many of them were knocked down and were drifted inland by the tsunami

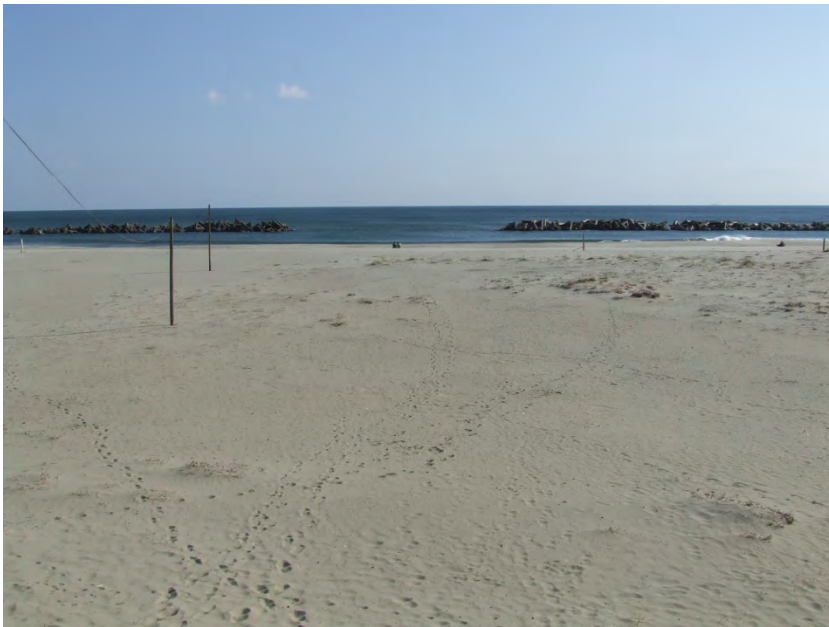
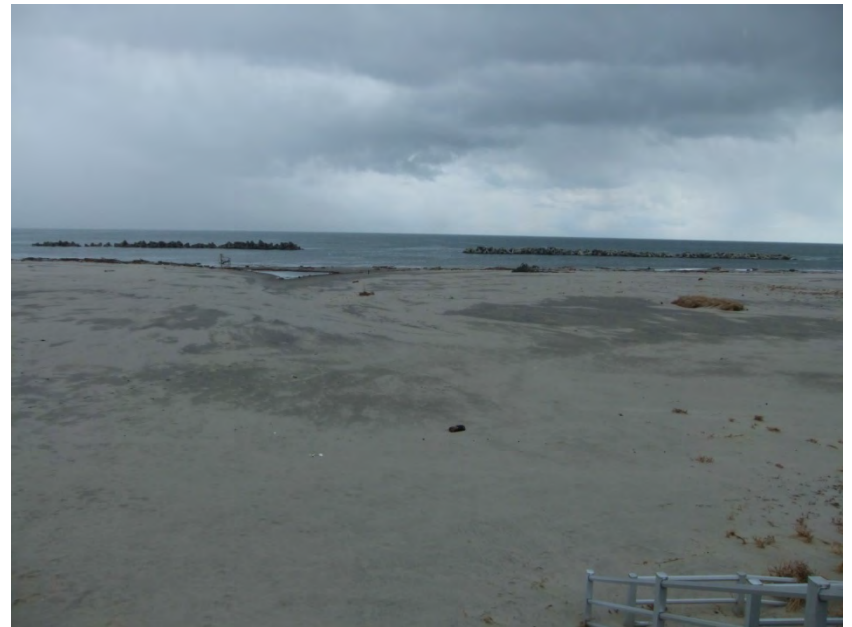
[12] Sandy beach

- Geomorphologic change of the beach side of Arahama community seems to be moderate, in contrast with the damages of the backland
- Breakwaters (blocks) were not moved even the tsunami reached around 10 meters above the sea level

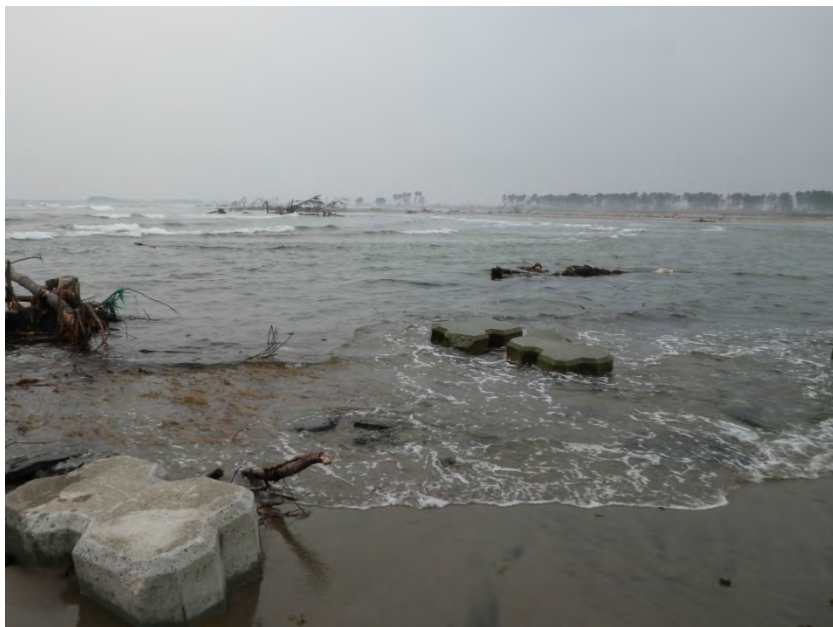
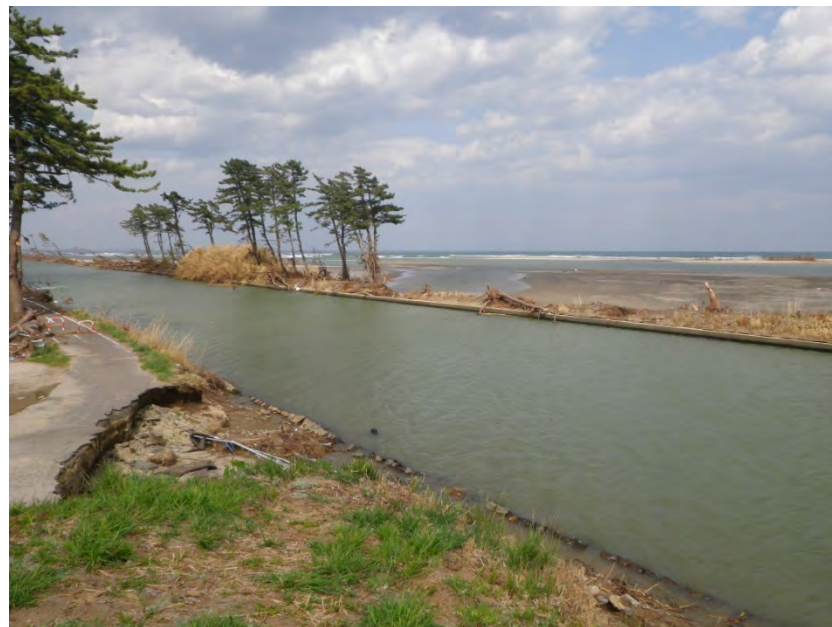
[13] Lagoon (Ido-ura)

- The lagoon was once separated by a 2 km-long sand bar
- ~~The sand bar was completely broken and now the lagoon is connected directly with the open sea~~
- The lagoon is now going to be buried by drifted sands

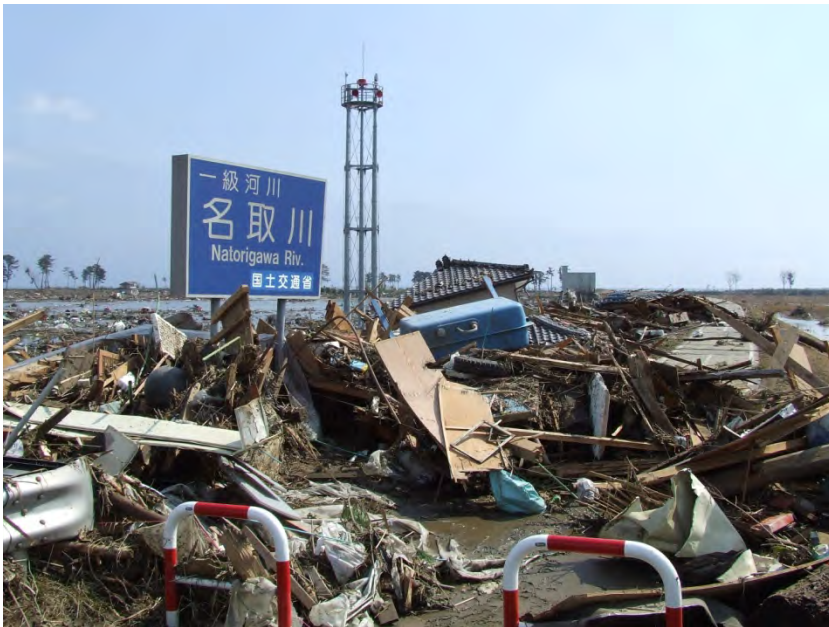
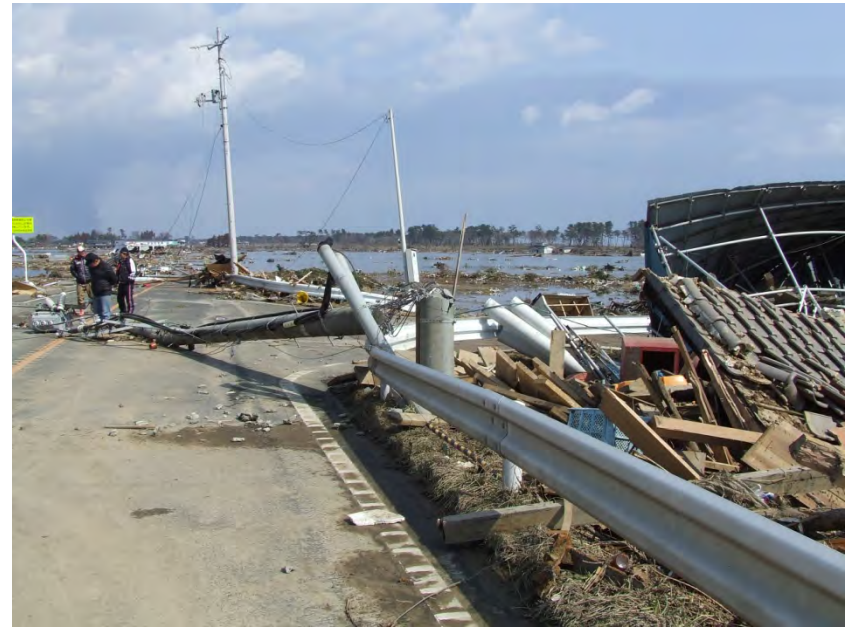
[14] Ruins of Fujitsuka community

- The scene of the tsunami attack and destruction of the community was taken by the aerial-live of NHK
- Flow velocity on land estimated from the video is around 6 m/s (22 km/h)

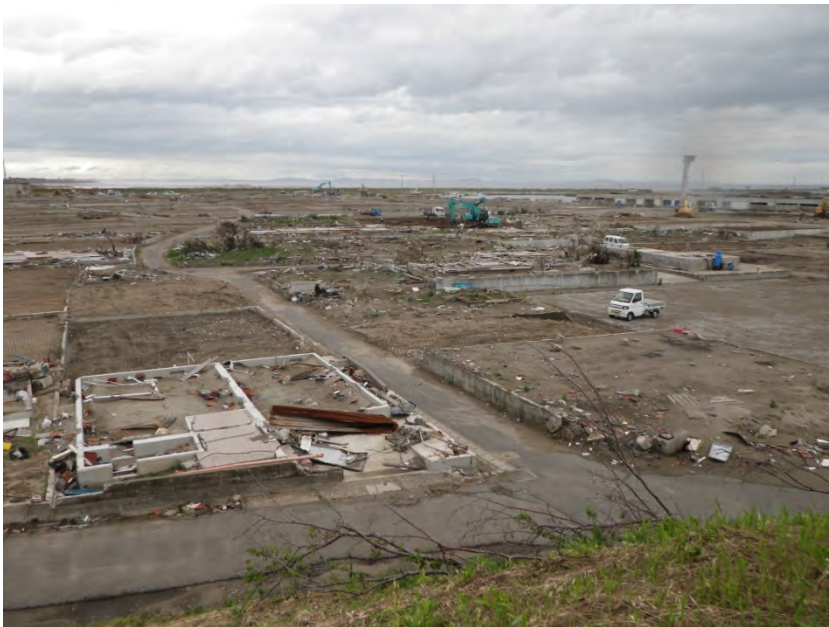
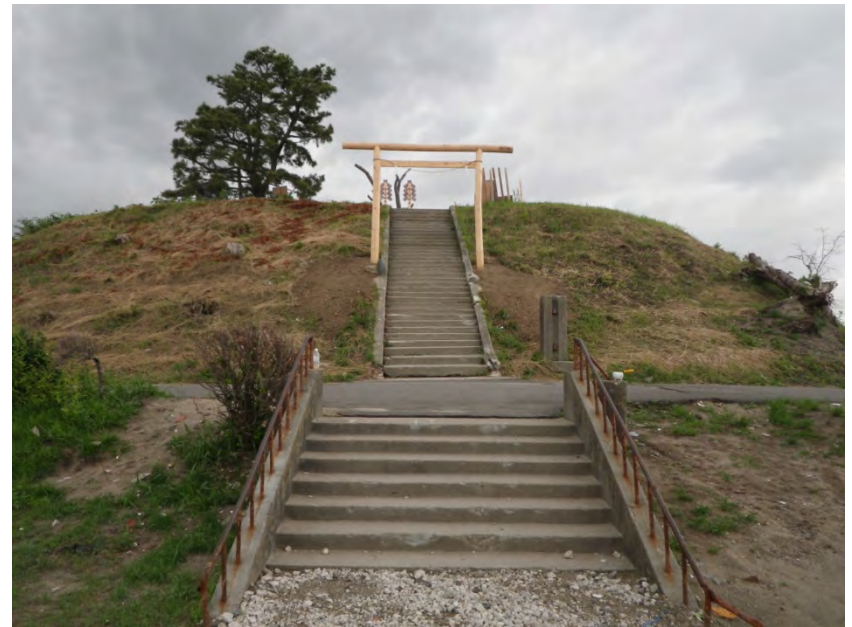
[15] Ruins of Yuriage community

- The fishery town was totally flattened due to the tsunami
- Many fires happened probably due to the gas leak from collapsed houses
- The tsunami flooded the 5-6 m high mound, which was built by dredged sediments from Teizan Canal

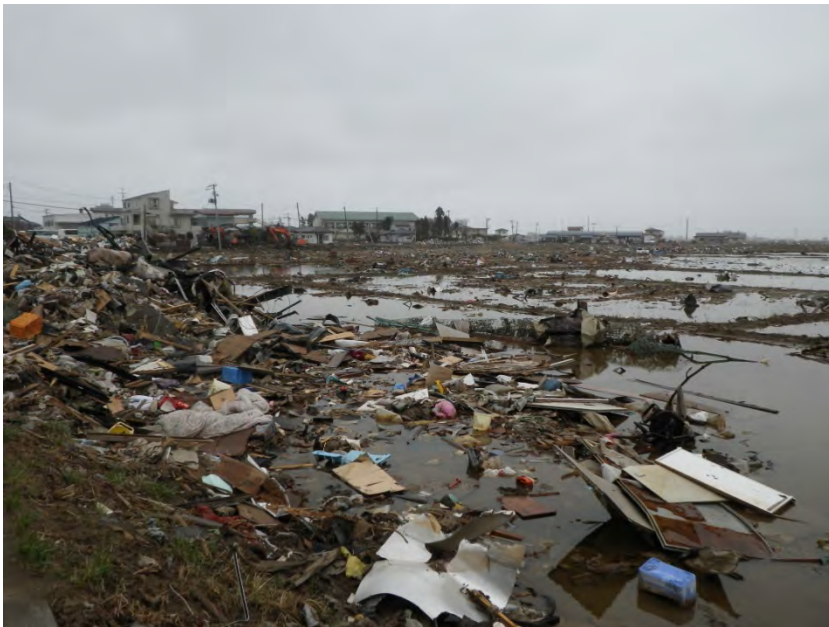
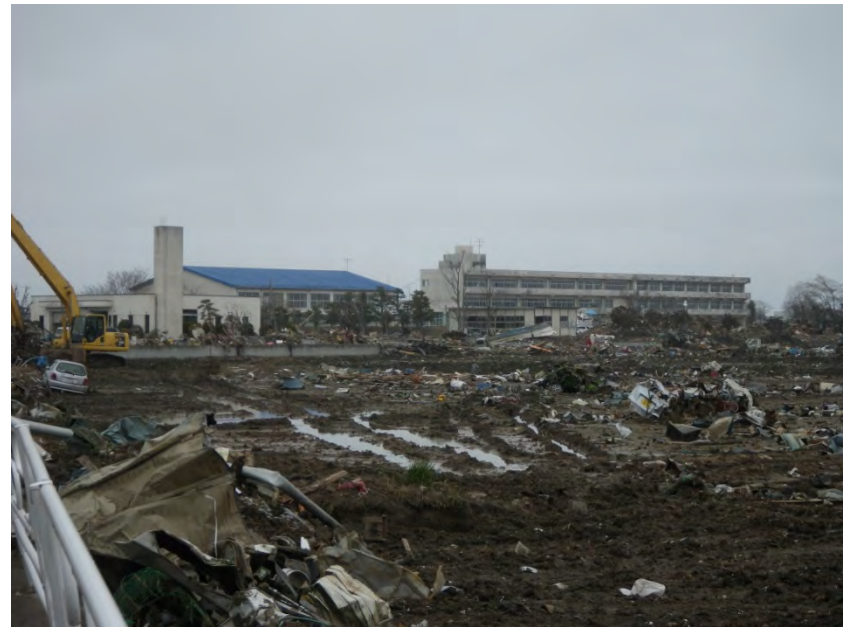
[16] Inland of Yuriage community

- The aerial live also took the scene of the tsunami invasion, which came up with numbers of cars, boats, houses with fire, and debris
- This area was flooded and occupied by longer time by debris and many other things

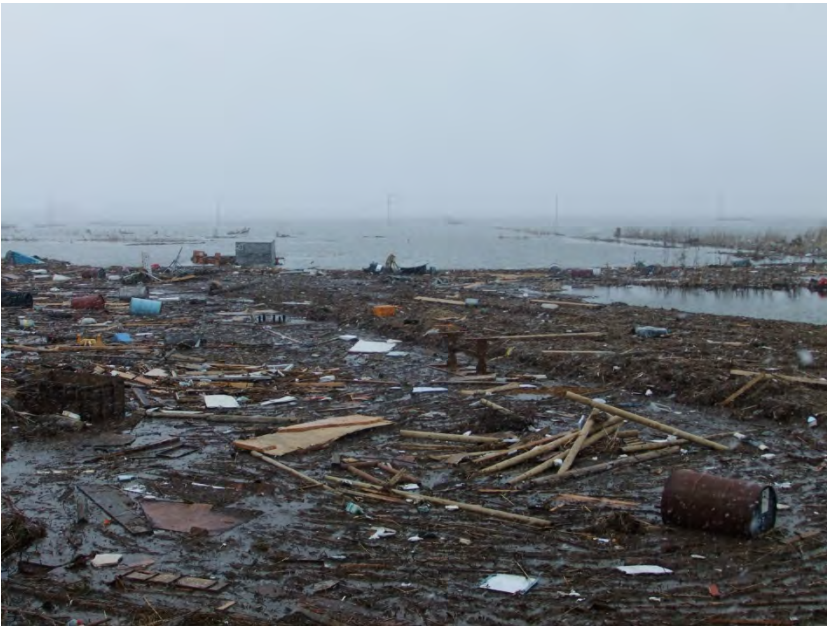
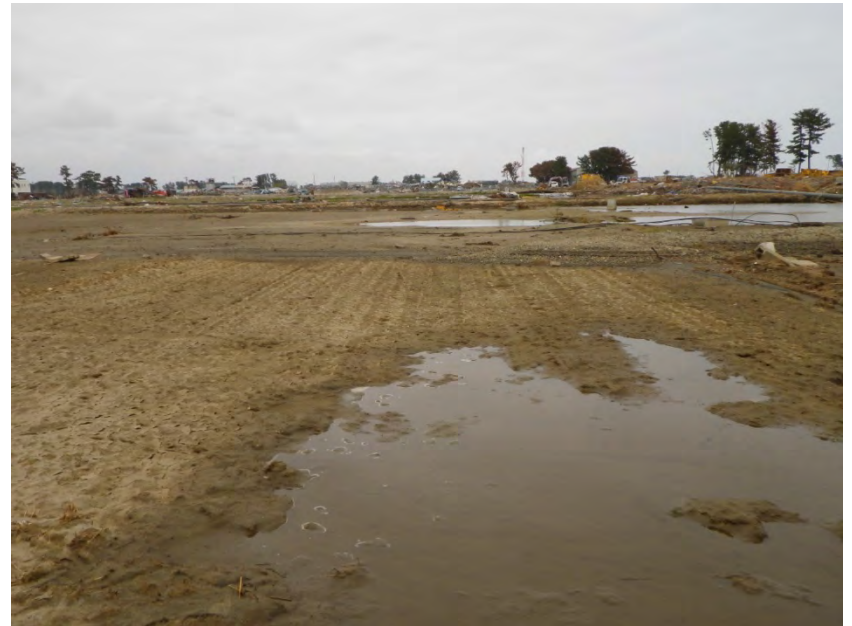
[17] Sendai Airport

- Full-inundation lasted around 2 weeks after the tsunami
- Operation of Sendai Airport was restarted on 1 month after the tsunami (13th April)
- Farmlands are severely damaged by massive erosion and deposition
