Study Trip Report on  
**THE SENDAI GOVERNMENT OFFICE BUILDING #3**  
By: Muhammad Rusli (E-Course)

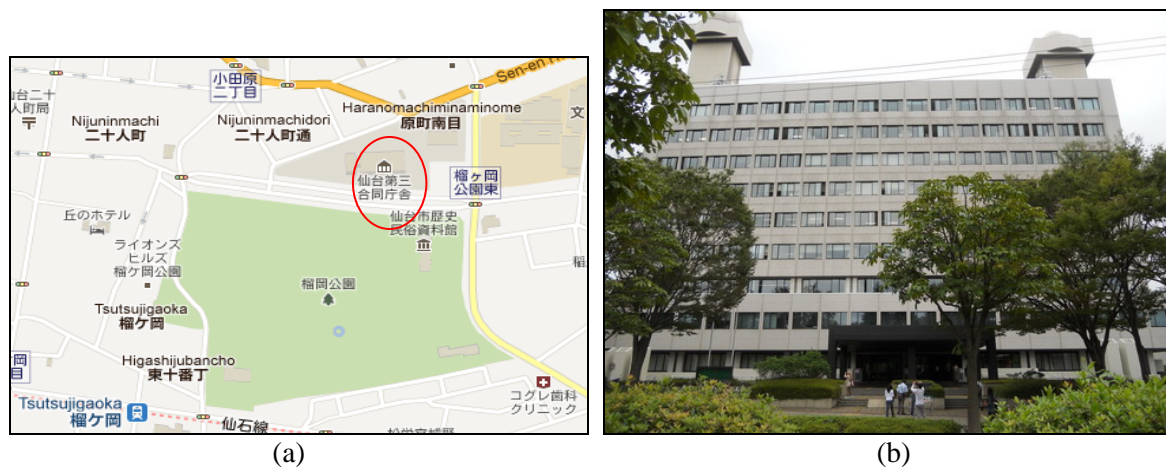
The visit to the Sendai Government Office Building #3 was conducted on Tuesday, September 6, 2011. The Building is addressed at 1-3-15 Gorin, Miyagino-ku, Sendai-shi, located about 470m northeast from Tsutsujigaoka Station. This building was constructed in 1991 and used as a joint office building by the governmental institutions in Sendai City, and the structure consisted of 9 floors which were made from reinforced concrete. In 2008, the building was retrofitted and the base isolator system was installed to enhance its seismic resistant. The 850 base isolators were constructed from the 80% Lead Rubber Bearing (LRB) which was to cover the horizontal building displacement up to 50 cm. The location and the view of the building are represented in Figure 1.

**Figure 1.** The Sendai Government Office Building #3, location (a) and the front view (b)

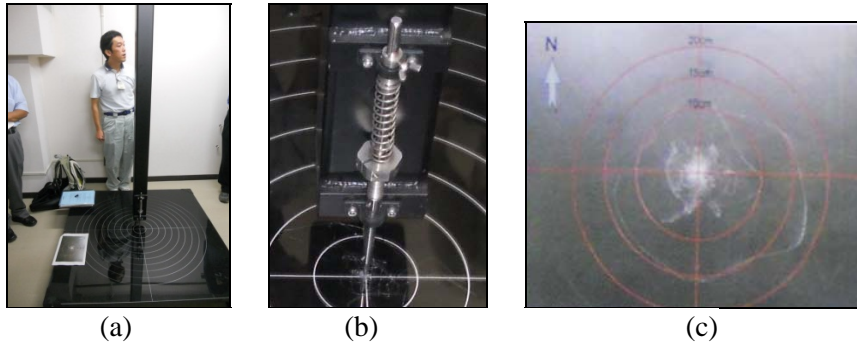
In the basement floor, the visitors were introduced to the displacement monitoring plate that was installed to record the trace of building movement anytime when an earthquake struck. The instrument consists of the needle and the plate. The steel needle with vertical spring is anchored to the main building structure above the base isolator and could move as well as the movement of the building, and the plastic plate with circle scale is anchored to the basement floor below the base isolator to measure the maximum trace directly. The displacement monitoring instruments can be seen in Photo 1.

Mr. Kagaya from the Ministry of Land Infrastructure, Transport and Tourism (MLIT) explained that on March 11, 2011 the plate recorded the building movement due to the mainshock of the off Pacific coast of Tohoku Earthquake 2011 with maximum displacement 18 cm from the center point, some needle on the other places were broken during the shaking caused by the power of the shock or the high acceleration of the vertical motion. After recording the mainshock, the plastic plate was replaced by the new one and then recorded the biggest aftershock on April 7, 2011 with the maximum displacement 11 cm. All of the needles were turn back into the original position after experiencing strong motions, it means that the structure did not suffer any residual displacement, the base isolation system were working properly and still in a good condition.

**Photo 1.** The plastic plate (a), Needle (b), and the trace records of the mainshock of Tohoku earthquake March 11, 2011

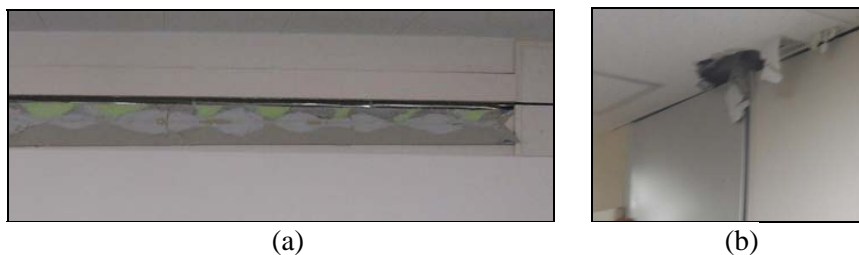
According to the strong motion data that were recorded on the basement, the second, the fourth and the ninth floor, the maximum acceleration of the building was reduced by 50% comparing to that of the ground (on the basement). Although the structural members were safe, some damages were observed on the non-structural elements when the building moved with the maximum velocity up to 40 cm/sec under the mainshock of the Tohoku Earthquake March 11, 2011. Some of the non-structural elements were broken such as the fire resistant material that filled the gap between the top of the basement wall and the bottom of the building, and some parts of the ceiling were also broken caused by collision with the lid of the utility holes which was placed right below the ceiling. The photo of some damages can be seen in Photo 2.

**Photo 2.** Damage on the non-structural elements such as gap filler and ceiling

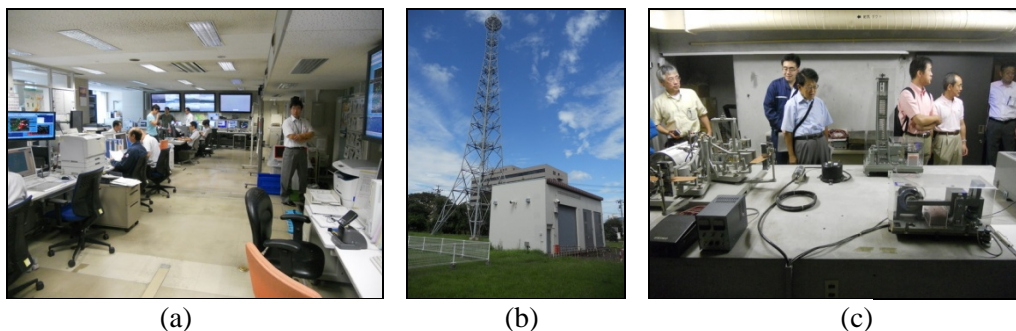
After showing the activity of the JMA office, Mr. Funakoshi led the visitors to the strong motion installation building on the western side of the Sendai Governmental Office Building #3. It was a square reinforced concrete building with the seismograph installed on the base floor about 3 meters below the ground surface. The office room and the strong motion installation are shown in Photo 3.

**Photo 3.** JMA Sendai Regional Office (a), Strong motion installation building (b), and Strong motion instruments (c)

There were many types of the seismograph which were placed on the massive concrete block with the rectangular shape about 150x350x80 cm<sup>3</sup>, from the old types to the new one. The old seismographs were operated from 1960 to 1990 and manually recorded the strong motion to the sheets of paper and archived on the shelves placed in the same room with those seismographs. All of the data on papers had been copied in the microfilm files to save the contents of the data records and to be quickly accessed. Now, the newest seismographs record the data to the computer server, and there are two sensors: one is the main strong motion sensors and the other is used to monitor the noise for correcting the data records.
