INTERNATIONAL INSTITUTE OF SEISMOLOGY AND
EARTHQUAKE ENGINEERING (IISEE)

REPORT OF STUDY TRIP (Niigata & Miyagi Prefectures)

14 – 17 November 2011

Prepared by: Liu Rong

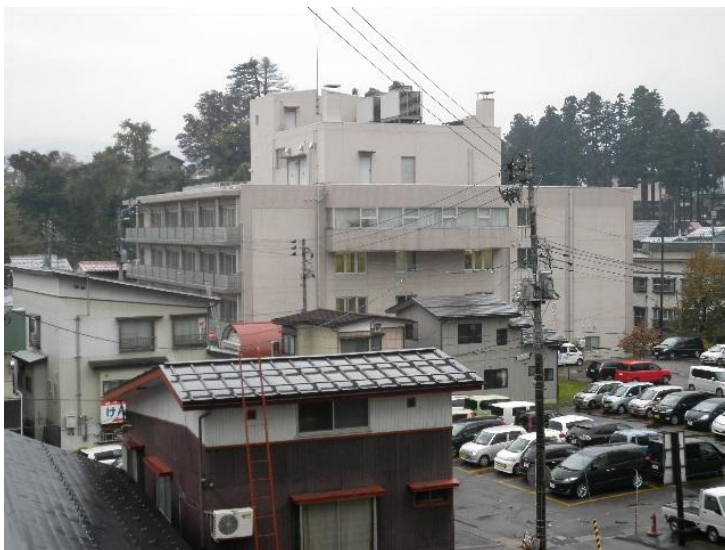
Figure 3. Welfare Nursing Care Center (Suisen-no-ie) of the Ojiya General Hospital

After leaving the Nagaoka Earthquake Disaster Archive Center, we came to the Ojiya General Hospital to learn some knowledge about the base isolation and vibration control structure of building. Ojiya is a small city on the south of Nagaoka, where the Chuetsu Earthquake intensity level reached upper 6. The Ojiya General Hospital is located in the downtown of Ojiya city. In the earthquake, the main building of the hospital located at the edge of a hilltop was severely damaged. But the nearby building Suisen-no-ie (Welfare Nursing Care Center, Fig.3), which just located at the foot of the hill, was almost not affected.

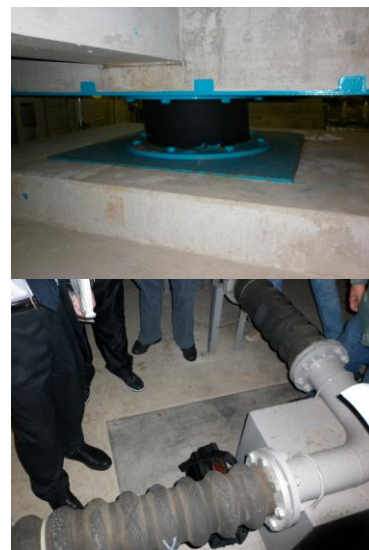
Figure 4. Base isolation system of Suisen-no-ie

In the basement of Suisen-no-ie, structural engineer Mr. Shinozaki introduced the base isolation system of the building (Fig.4). Although I did not learn something about Earthquake Engineering, I and other participants of seismology course were interested in the lecture. Through Mr. Shinozaki's explanation, I basically understood the concept and principle of base isolation structure. Relative to the cost of buildings, this system was not too expensive. But it can be very effective to resist strong motion, and protect buildings.

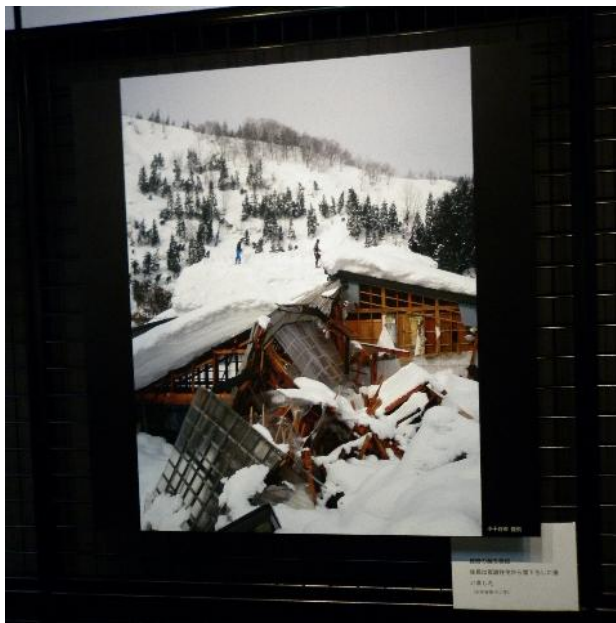
Figure 5. Snow disaster after the 2004 Chuetsu earthquake in Yamakoshi (taken in the Nagaoka Earthquake Disaster Archive Center)

It was about to be winter at that time. According to introduction, the snowfall could reach 3 to 4 meters every year in this place (Fig.5). Therefore, the victims' lives were very difficult. Some people had to eat their expensive Nishikigoi Carps to stave off hunger. Fortunately, the disaster-hit area got help from many parts of Japan in a timely manner. Professional emergency rescue teams, volunteers and relief supplies arrived soon. 1,755 evacuees from Yamakoshi moved into the 631 temporary houses in Nagaoka City. They got meals prepared by volunteers.

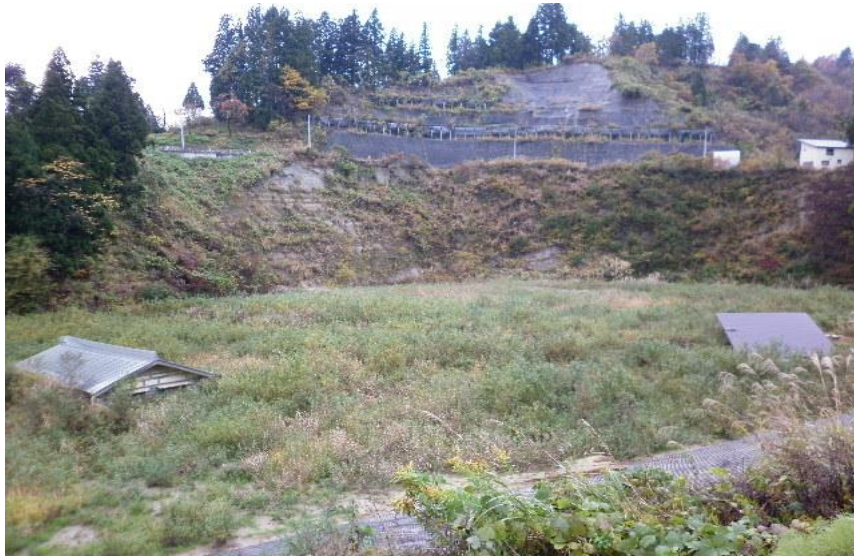
Figure 6. The landslide and barrier lake caused by the Chuetsu earthquake in Yamakoshi Village

Collapse of the housing had been cleared long ago. The roads and tunnels had also been repaired. Even most of the failed slope of the mountain had been reinforced and re-planted vegetation. Wounds caused by the earthquake here were difficult to see now. But we still saw the remains of barrier lakes and landslides (Fig.6). The houses soaked in water in those days had been abandoned for a long time; almost buried to the roof by the soil taken by flood and surrounded by overgrown weeds.

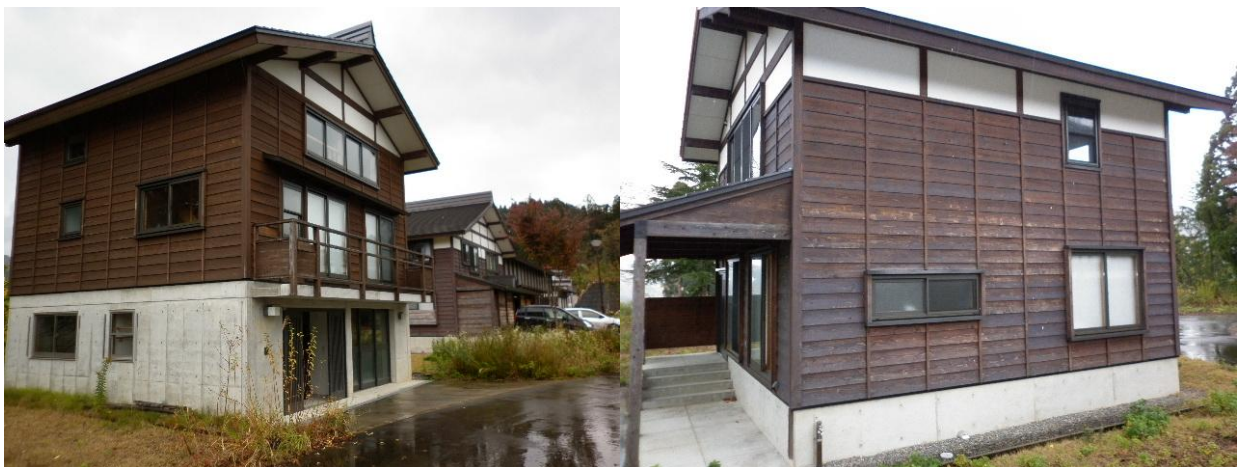
Figure 7. Model units built by government in Yamakoshi

We then visited the model residential houses for the victims (Fig.7). These houses were built by government with excellent quality. Both exterior and interior are very beautiful. And the construction costs are cheap. The residents who cannot afford the construction costs will also be provided financial assistance.

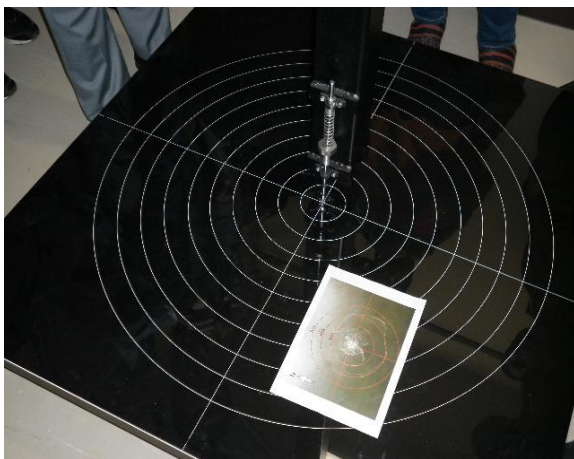
Figure 8. Displacement monitoring plate seismoscope

In the morning of Wednesday, 16th November, we first visited Sendai 3rd joint governmental building. This building was constructed in 1978. In 2007 to 2009, it was retrofitted to install the base isolator system. In the basement floor, we saw a seismoscope that uses a needle to record the trace of building vibration on a plastic plate. In the Tohoku Earthquake, It recorded the maximum displacement 18 cm (Fig.8). According to the staff, some seismoscopes at other places were broken during the shaking caused by the power of the shock. The needles couldn't turn back into the original position.

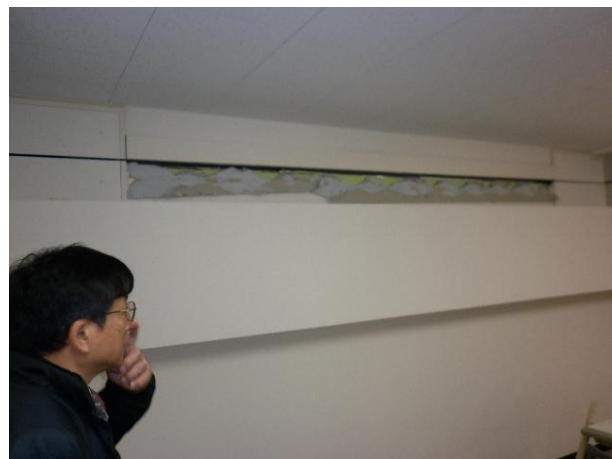
Figure 9. Minor damage of Sendai 3rd joint governmental building

Because of the the base isolator system, the main structural part of this building was almost not affected in the earthquake. Only some of the non-structural elements were damaged such as the fire resistant material (Fig.9).

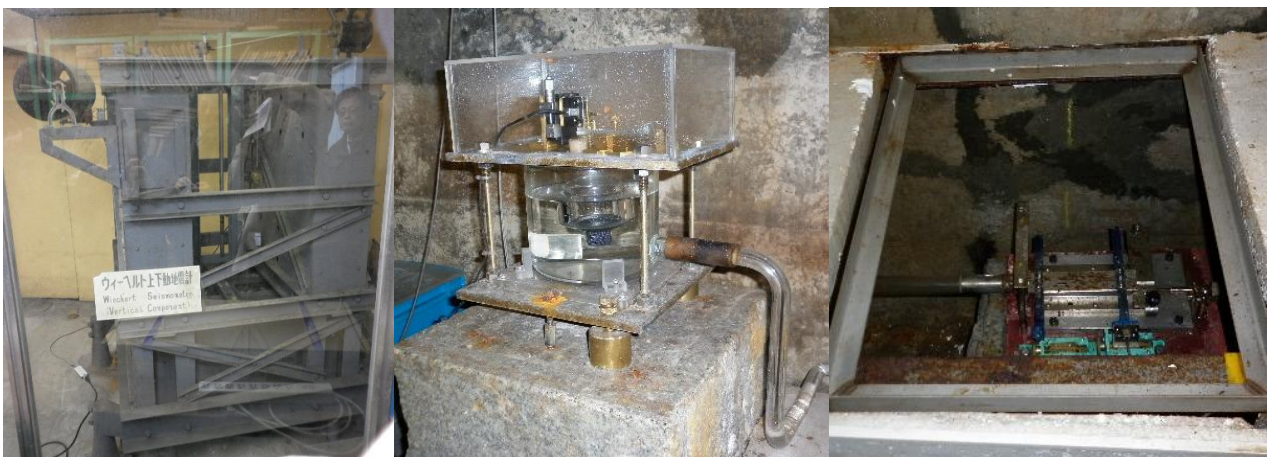
Figure 10. Instruments for earthquake monitoring and crust deformation observation in the Research Center for Prediction of Earthquake and Volcanic Eruption

In the tunnel under the research center at depth of 45m, we saw some crust deformation observations, such as water tube tiltmeter, quartz tube strainmeter, quartz pendulum tiltmeter and so on. Professor Umino explained the principles of these observations to us. My personal focus of work exactly is the crust deformation. The same or similar observation instruments are also used in my city.

(Left: The Wiechert; Middle: Water tube tiltmeter; Right: Quartz tube strainmeter)

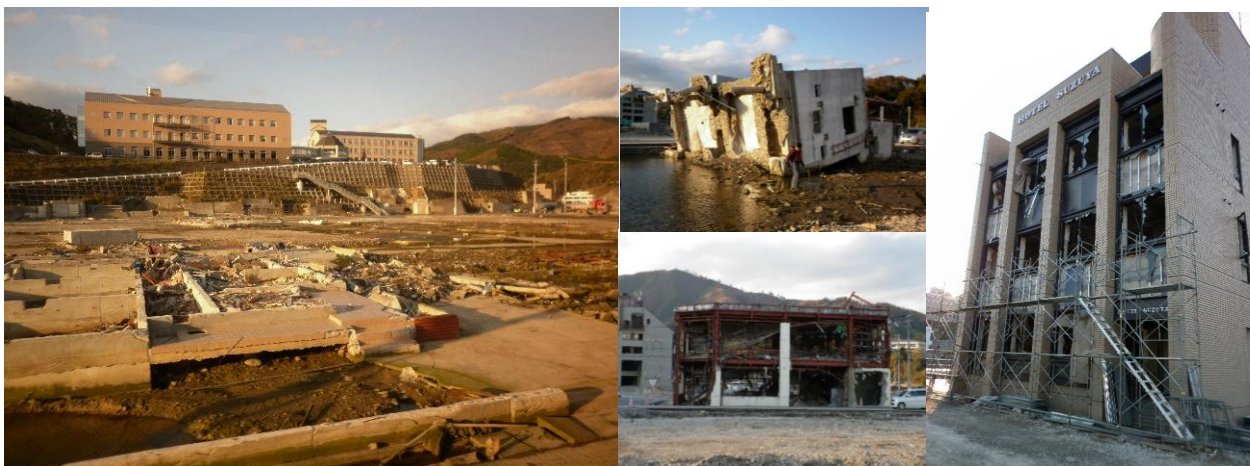
Figure 11. Ruins in the Onagawa town after the tsunami swept through

As shown in left of Figure 11, a hospital on the hill was located approximately 14 meters high from the below ground. Its first floor was all immersed in the tsunami. Most of the buildings near the seashore were completely destroyed by the strong waves, only left their foundations or ruins (Fig.11). Some of the places in Onagawa town were still covered by sea water. Dr. Yokoi told us there were over 1000 people missing, more than 700 confirmed dead in the disaster. Before coming to Japan, I had read a touching story happened here in Chinese newspapers: A director of a fish processing company named Sato saved his workers and 20 female Chinese resident trainees. He evacuated them to higher ground, but he was swept away.

(Left: Residual bases and the hospital on the hill; Middle upper and lower: Completely uprooted and destroyed buildings; Right: A three floors hotel facing the sea was totally inundated)

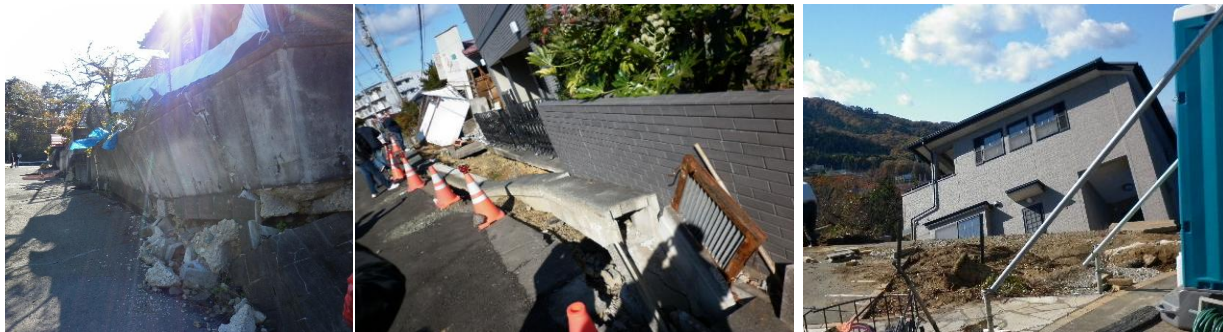
Figure 12. A residential area in Aoba Ward destroyed by the earthquake

In the Aoba Ward of Sendai, we observed the ground failure caused by the quake. The residential area we visited was on a hill. Yokoi Sensei told us the ground of this area was made by earth-fill. The building bases here were not strong enough to resist the severe shake in the Tohoku Earthquake. As shown in Figure 12, the road had split and deformed. The walls along the ramp had tilted or collapsed. Because of the landslide, some houses on the hillside sank and almost tumbled down.
