INTERNATIONAL INSTITUTE OF SEISMOLOGY AND
EARTHQUAKE ENGINEERING (IISEE)

REPORT OF STUDY TRIP (Niigata & Miyagi Prefectures)

14 – 17 November 2011

Prepared by: D.Mungunsuren
S course
(Mongolia)

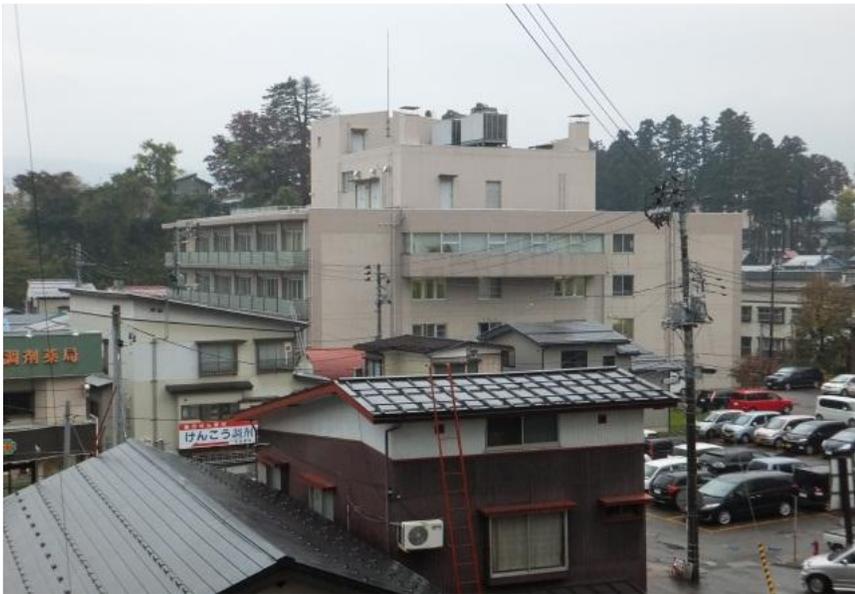
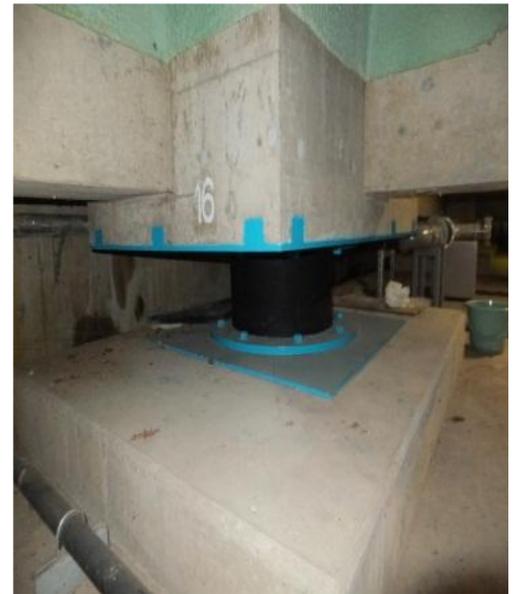
Strong ground motion records were observed from the mainshock and its aftershock at the neighboring base-isolation building, Suisen-no-ie (Welfare Nursing Care Center) (Fig 2(a)). Suisen-no-ie, however, is located at the foot of a hill, while the Ojiya General Hospital is located at the edge of a hilltop. It is likely that input ground motions were different between two buildings. Structural engineer Mr. Y. Shinozaki introduced information about the base-isolation system of the building (Fig 2(b)). I understood that it can be against earthquake forces, I mean this base isolation is most powerful tool of earthquake engineering pertaining to the passive structural vibration control technologies.

Figure2. (a) Overview of the Welfare Nursing Care Center (Suisen-no-ie) of the Ojiya General Hospital, (b) Base isolation system of Suisen-no-ie

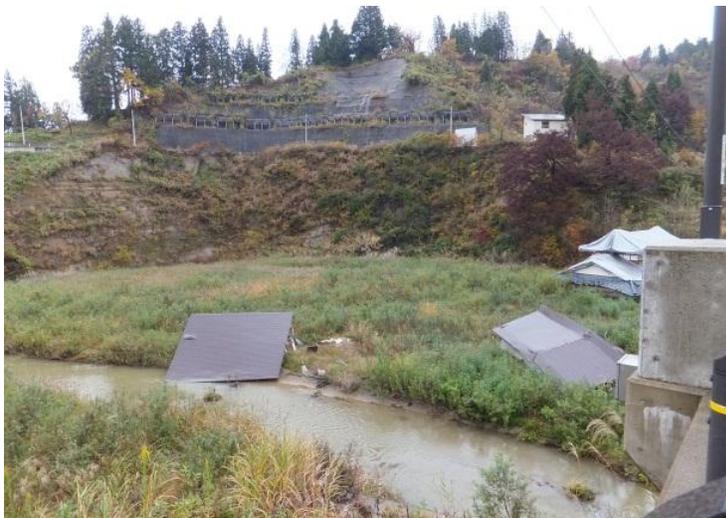
The Mid Niigata Prefecture earthquake caused many landslides and slope failures that accumulated in the Chuetsu region of Niigata prefecture, particularly in the Imo River basin. This area is known to be a zone of frequent landslides (Fig 4). Consequently, heavy damage was caused in the entire basin including disruption of roads and inundation of residential areas near rivers (Nakaide *et al.* 2004). There were reports of damage to the forest on the mountain ridges, because of the Mid-Niigata Prefecture earthquake which occurred in that mountainous area (Sekiguci, 2006).

Figure 4. Landslide caused by the Chuetsu earthquake in Yamakoshi Village.

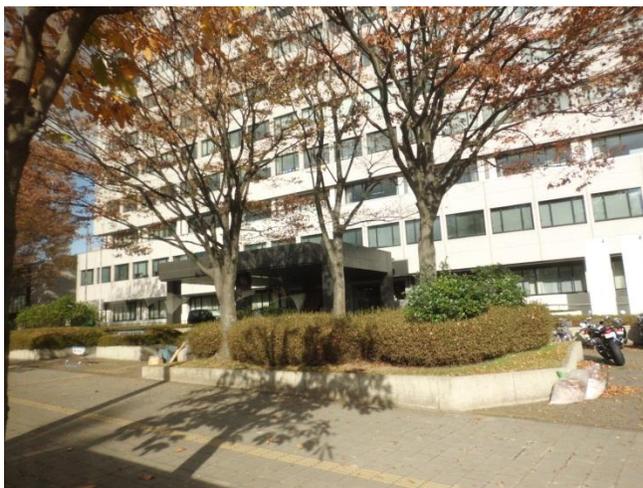
In 2008, the building was retrofitted and the base isolator system was installed to enhance its seismic resistant (Fig 6). In the basement floor, Mr. Kagaya introduced to the displacement monitoring plate that was installed to record the trace of building movement anytime when an earthquake struck.

Figure 6. Overview of Sendai 3rd joint Governmental building.

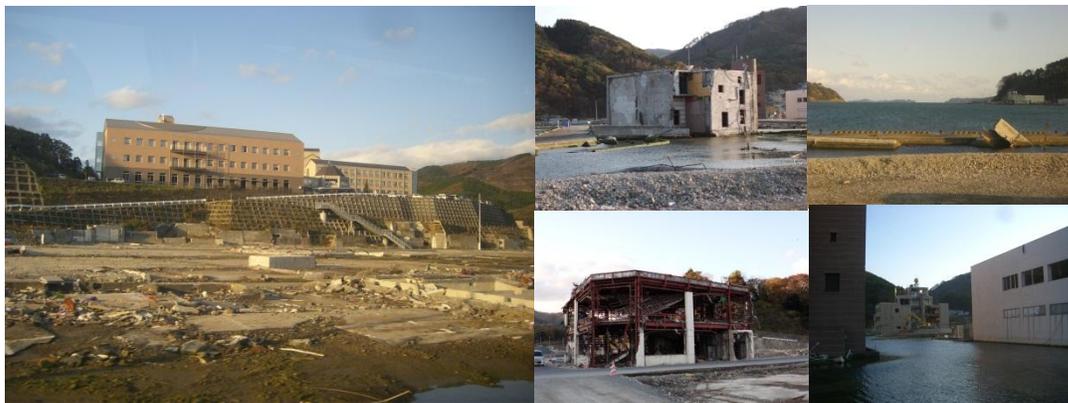
There were at least four pile-supported buildings toppled and /or carried over some distances in Onagawa. Buildings were uprooted, floated several meters away from their original positions. A three storey-hotel fronting the pacific was totally inundated. Cars were like papers crumpled and thrown into small pieces with the strong impact of the tsunami. Roads were subsided as well as the port facilities. Besides the massive destruction it brought to the town, 900 people were killed or missing in Onagawa Town. As shown in Figure 8, the hospital was located approximately 14 meters high from the sea level. Based on our observation, the trees were dried up which reveals that the tsunami reached and inundated the hospital 3 which surpassed the height of the wall surrounding the area of the infrastructure.

Most of the buildings located near the seashore were completely destroyed and drifted by the strong tsunami waves. Figure 6 shows one of the examples of building which was drifted by the tsunami about 70 meters. Most of the roads in Onagawa town especially those near the seashore were no longer visible. The roads were subsided by approximately 80 cm as shown which can no longer be used for transportation. Some of the roads were still covered with tsunami debris and covered with sea water. However, many roads were already built by the government to pave for continuous repair and reconstruction of the devastated town. Display of column steel bars was overturned by the backflow of the tsunami wave.

Figure 8. Heavily damaged buildings at Onagawa city

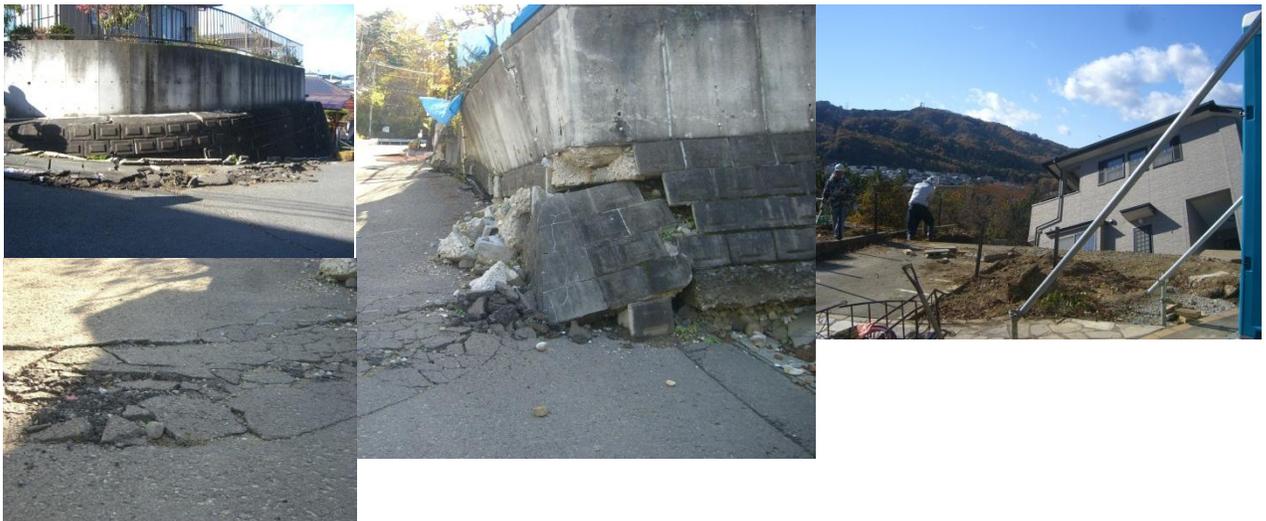
Aoba Ward is one of five wards of Sendai, the largest city in the Tohoku Region of Japan. In these areas, also the damage of houses was caused by ground transformation. There were some roads having split and deformed and some walls tilted and collapsed.

Figure 9. Damage of Retaining Wall, House Movement and Tilting by Sliding and Ground Transformation
