# THE 2011 TSUNAMI AND SCHOOLS IN DAMAGED AREAS

— What We Have Learned Through Regional  
Evacuation Activities from the Tsunami Disaster —

**Kazuoh SEO<sup>1)</sup> and Takashi ODA<sup>2)</sup>**  
**Support Center for Revival in Education**  
**Miyagi University of Education**

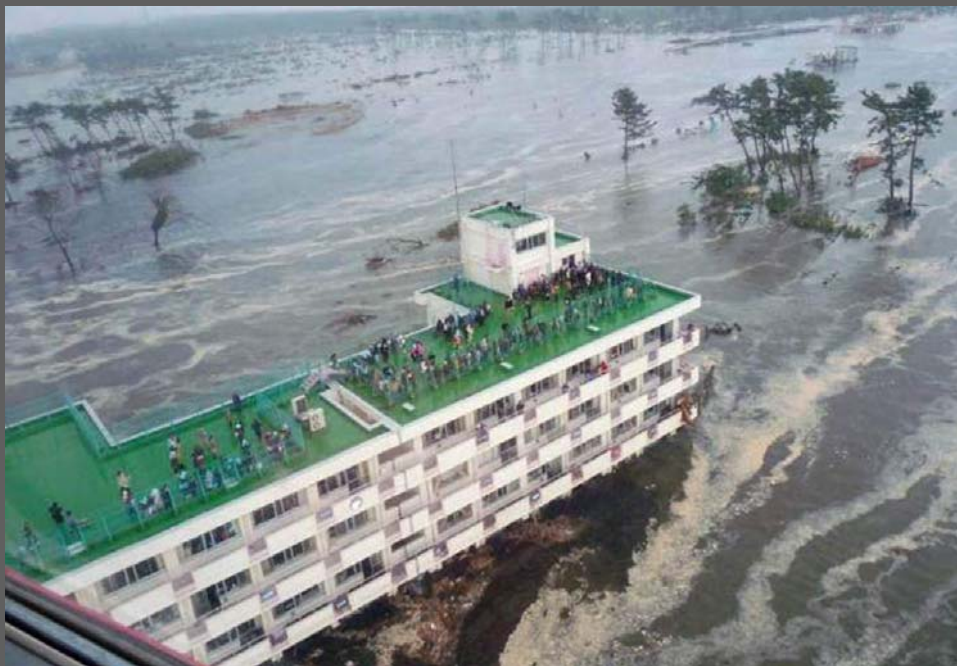
Arahama primary school was the only tall building in Arahama district. Evacuation activity was currently made within school children, teachers and residents in this area. The schoolmaster took the leadership to manage the school building as a temporary refuge. As results, 320 people were rescued.

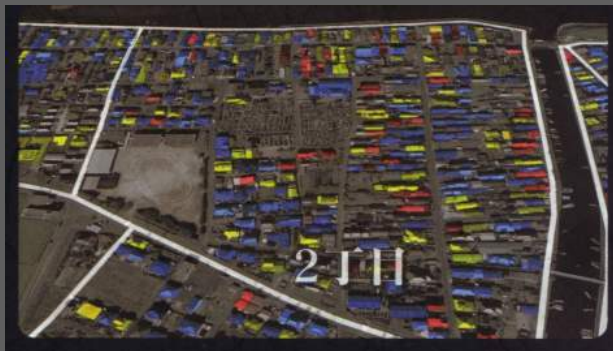
The upper figure shows the damage distribution in Yuriage 2-chome area.

Blue : Houses without victims

Yellow : Houses with victims

Red : Houses whole of families were lost

Through the interviews to 542 people, they confirmed the behaviors of 2,131 people after the earthquake motion attacked the area. Especially the behaviors of 600 people were precisely traced for 70 minutes until the tsunami arrived.

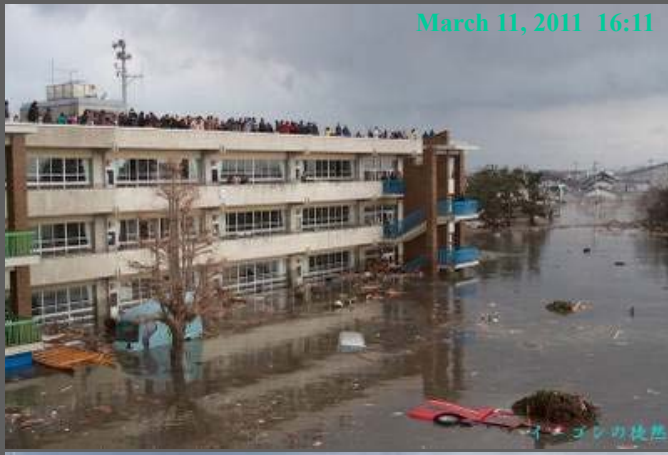
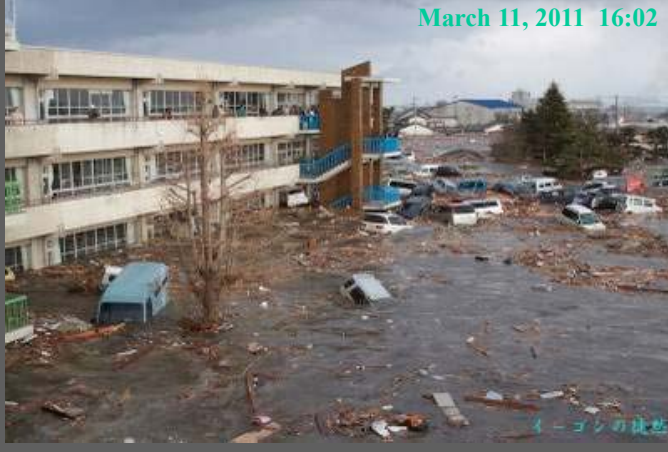
About 1,000 people had successfully evacuated to the Yuriage primary school. The clock in the auditorium shows 14:49, almost the time when the earthquake motion had arrived the school.

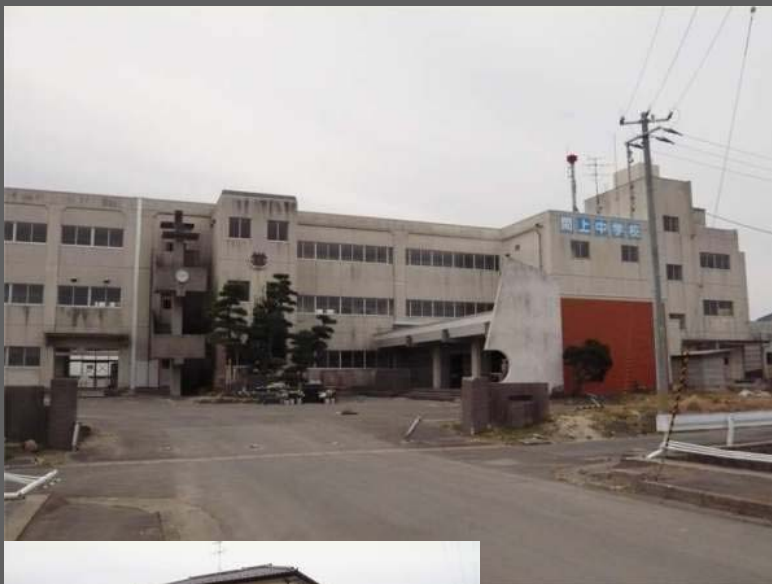
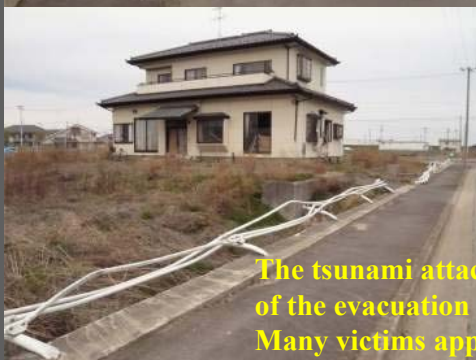
About 800 residents were evacuated and saved in the middle school.

The tsunami attacked here on the half way of the evacuation activities by the residents. Many victims appeared in this reason.

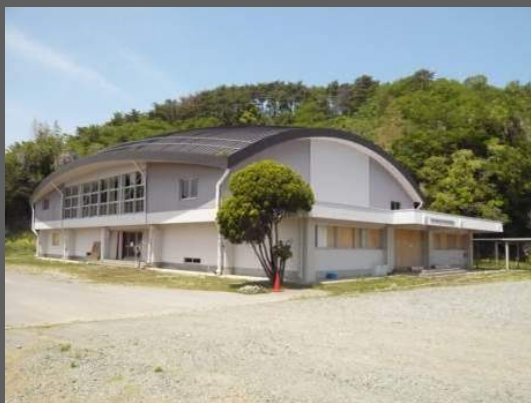
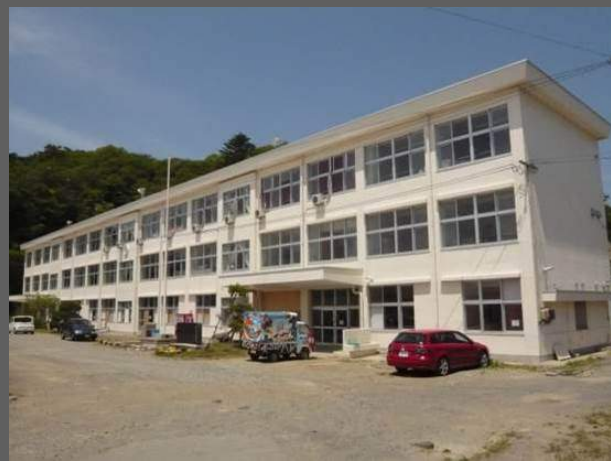
**Photo : June 1, 2013**

As Nobiru Primary School was located 1 km away from the nearest seashore, the school staffs could not estimate disastrous tsunami. They guided evacuated people to the gymnasium, not to the upper floors of the school building. It was merely that they have just followed the emergency guideline. Unfortunately the 5m tsunami attacked the school, and many victims of the tsunami were found in the gymnasium.

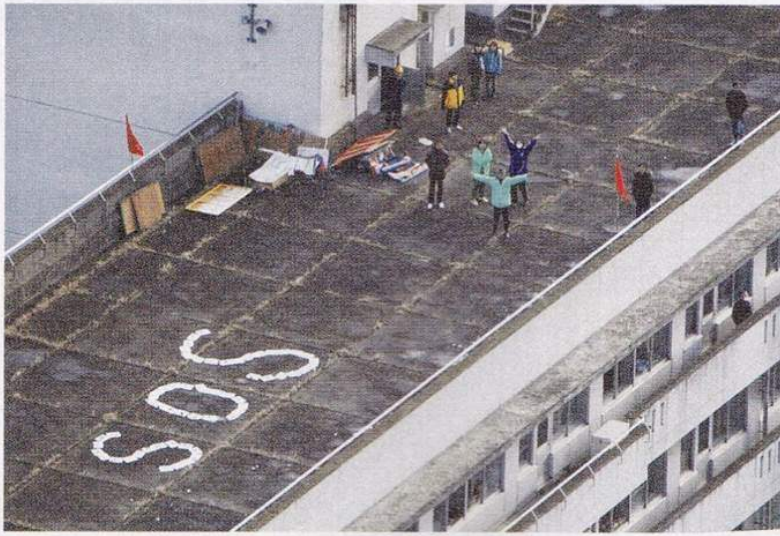
A cameraman of Kahoku-Shinpoh, took this aero-photo in the next morning of the tsunami. The refugees expected to be rescued immediately, because their “SOS” signal was successfully confirmed by a newspaper plane. Unfortunately the refugees had to wait for ten days, as the cameraman couldn’t identify the exact position of this photo. The inundation height of the tsunami was about 3m in this school.

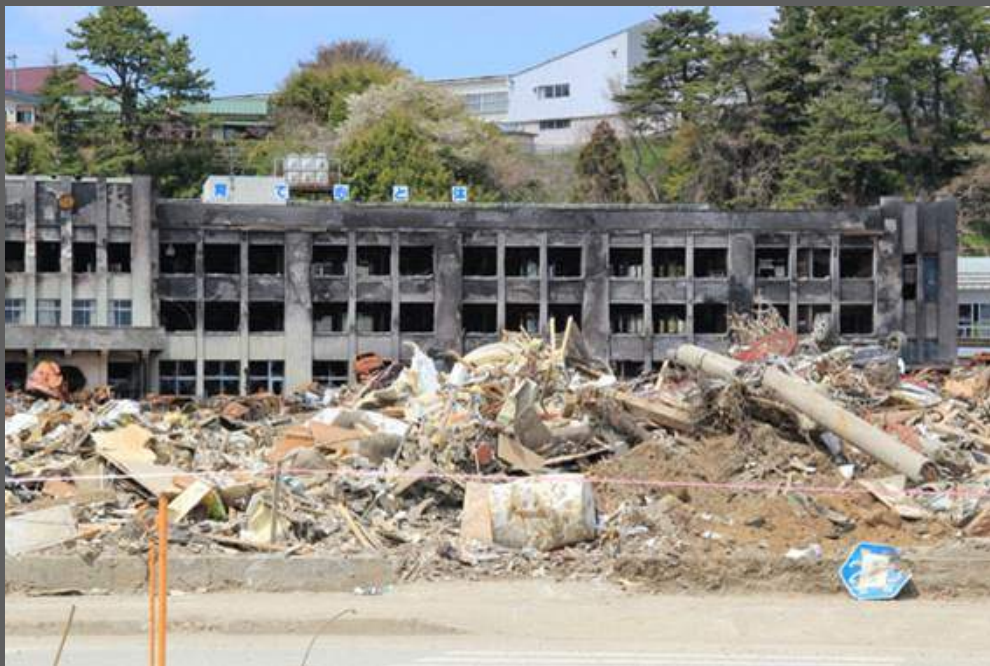
Photo : Aug.11, 2011

The staffs successfully guided the children uphill behind the school before the tsunami attacked the district. Soon the tsunami arrived there with 7m in inundation height. The tsunami brought the fire, but fortunately as results, there was no victims in the school building.

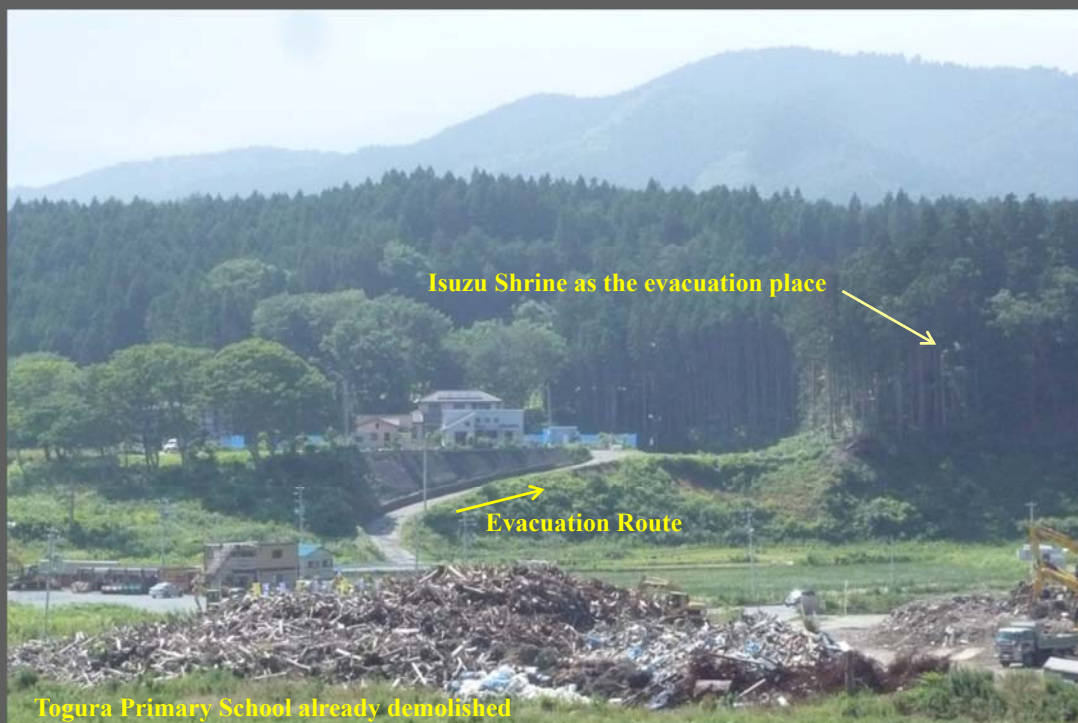
### Togura District in Minami-Sanriku Town

Togura Primary School was attacked by the tsunami with 20m of inundation height. But the school children immediately evacuated toward the neighboring shrine and nobody was killed.

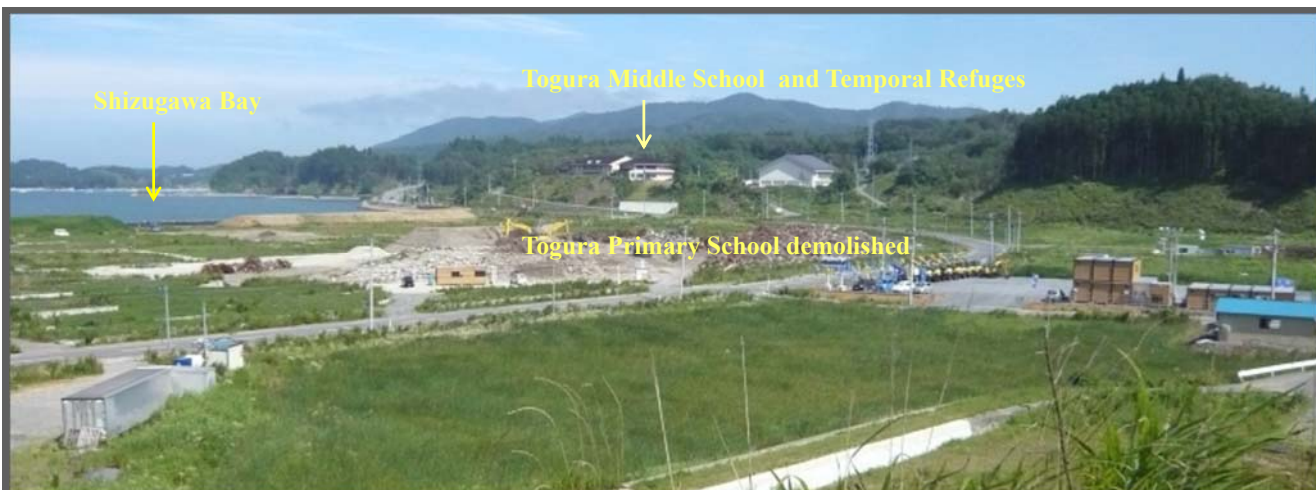
A view of damaged area from Isuzu Shrine

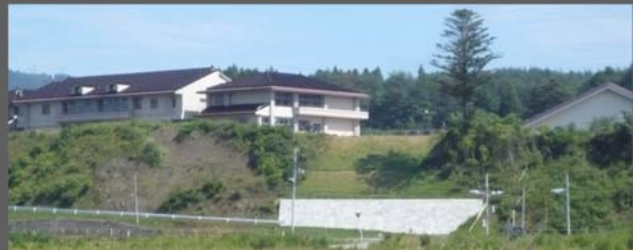
Togura middle school attacked by the tsunami

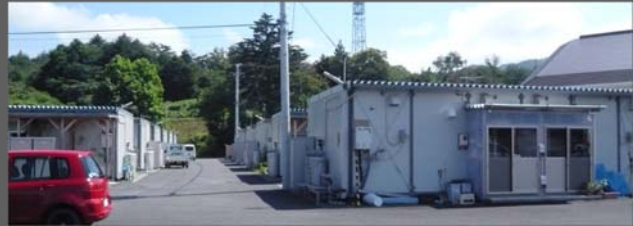
Temporal refuges prepared in the middle school

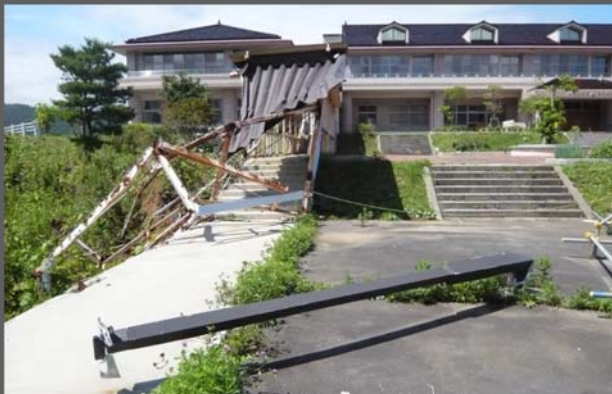
Togura middle school on a hill attacked by the tsunami and not a few people were killed.

← inundation level of the tsunami

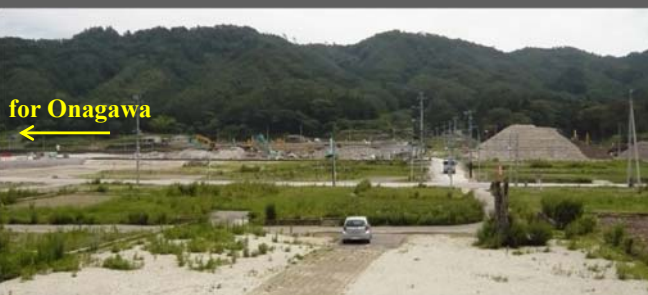
Central part of Ogatsu town

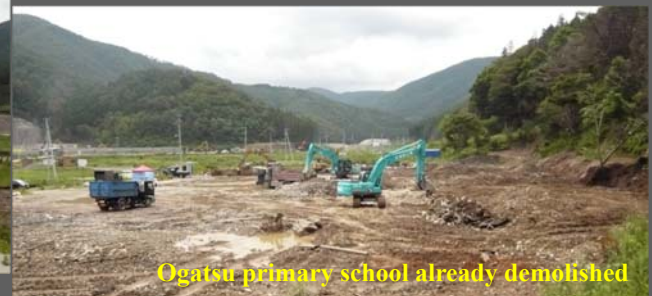
Ogatsu primary school already demolished

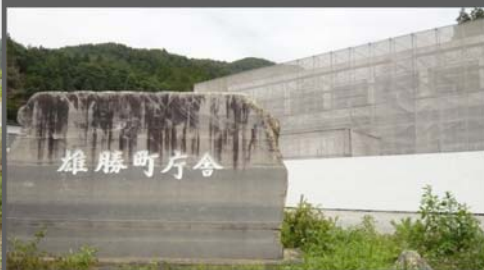
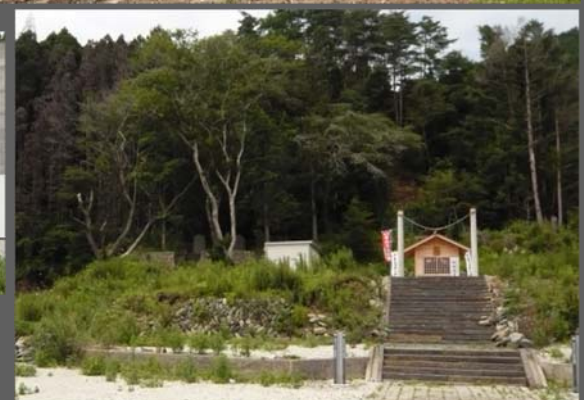
The school children evacuated through the shrine

According to newspapers, school children in Ogatsu district evacuated from the tsunami successfully, but almost nothing remained in the district.

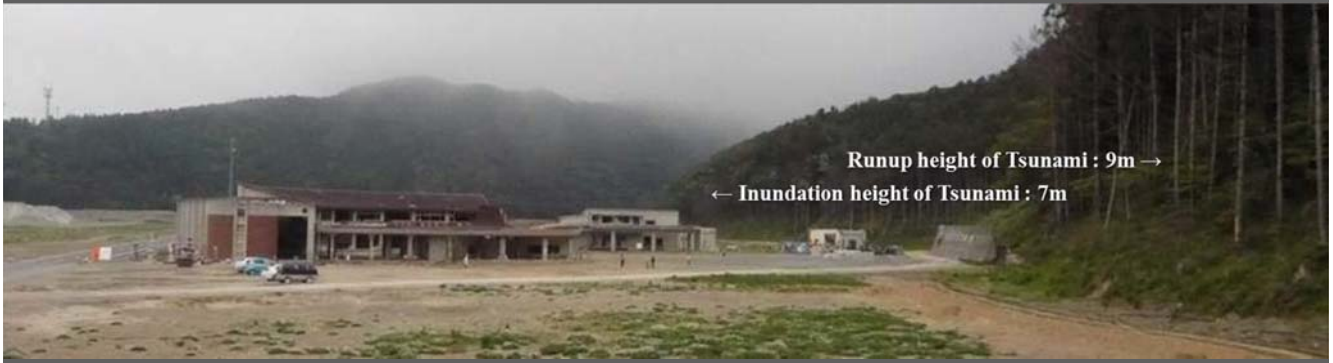
Runup height of Tsunami : 9m →  
← Inundation height of Tsunami : 7m

The school was located along the Kitakami river, but 4km away from the sea. The staffs could not estimate the possibility of big tsunami, and hesitated quick evacuation. After all, the number of victims counted 84 among 119 ( school children; 74 among 108, and teaching staffs; 10 among 11 ).

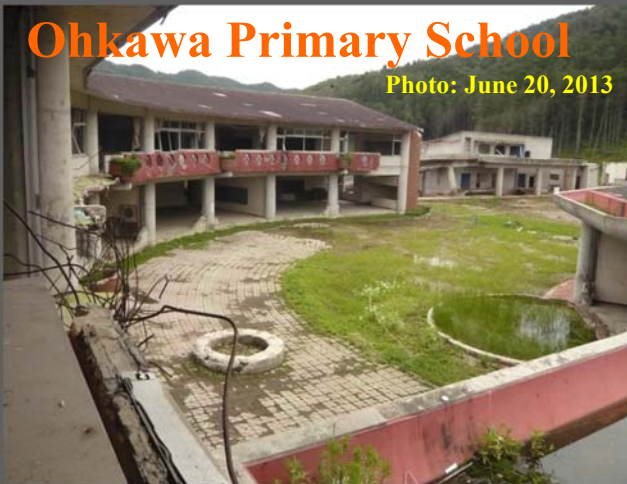
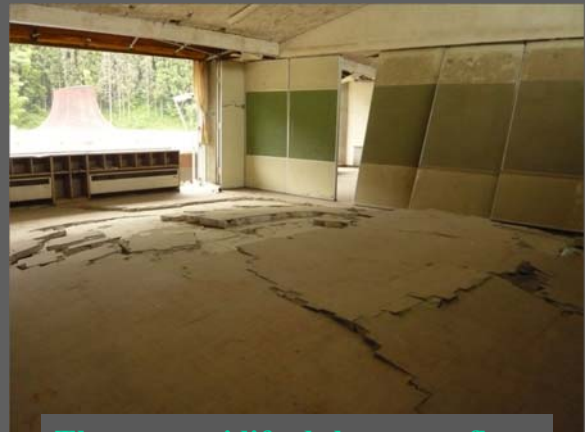
The tsunami lifted the upper floor.

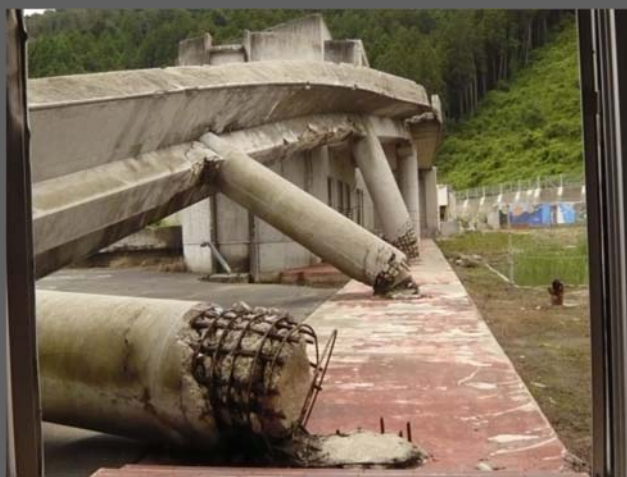
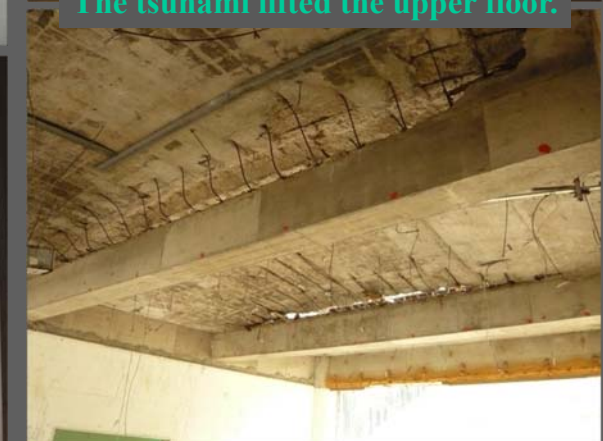
← The both, earthquake motion and tsunami collapsed the structure.
