10iwsr, Sep. 25, 2013

Site specific ground motion characteristics and building damage in Sendai area during the 2011 Tohoku earthquake

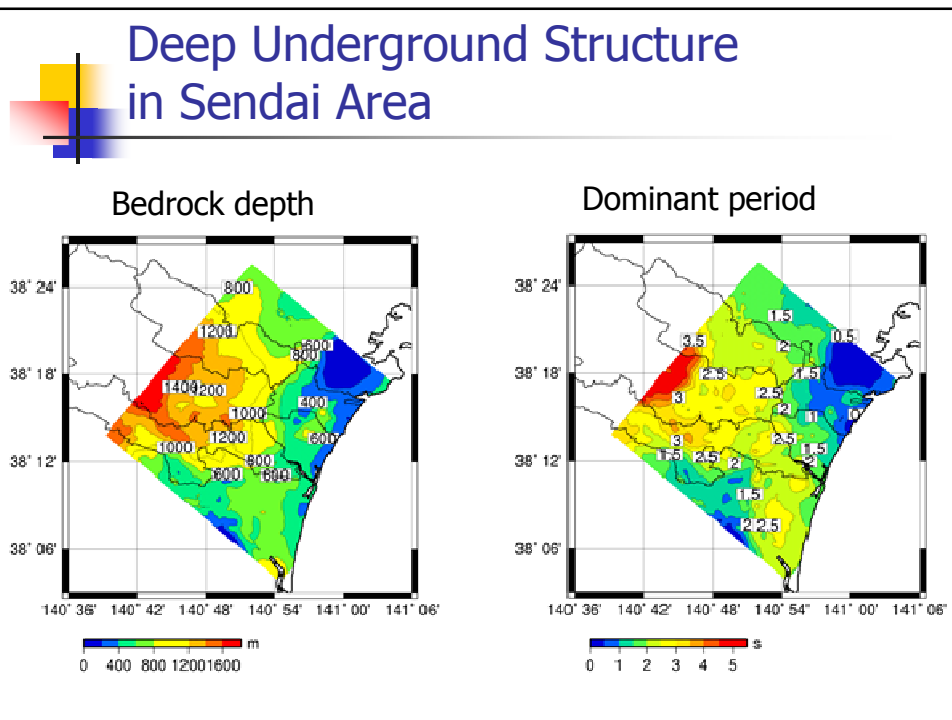
Deep Underground Structure in Sendai Area

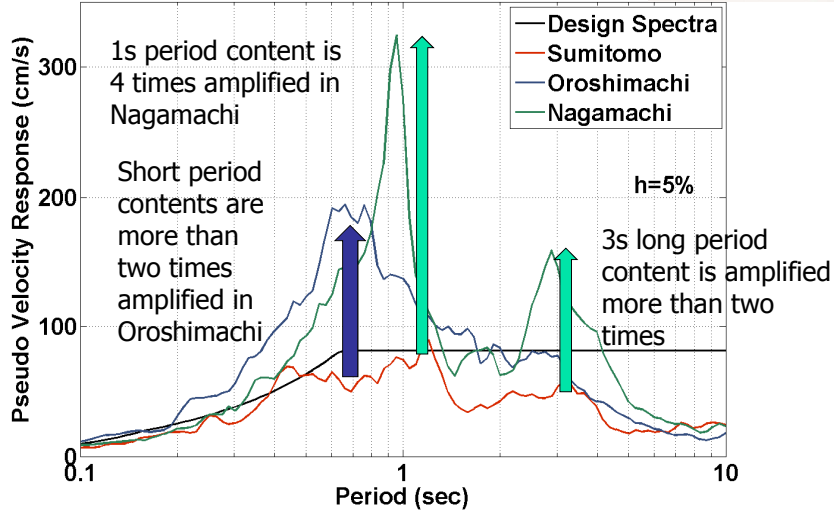
Difference of spectral amplification due to soil conditions

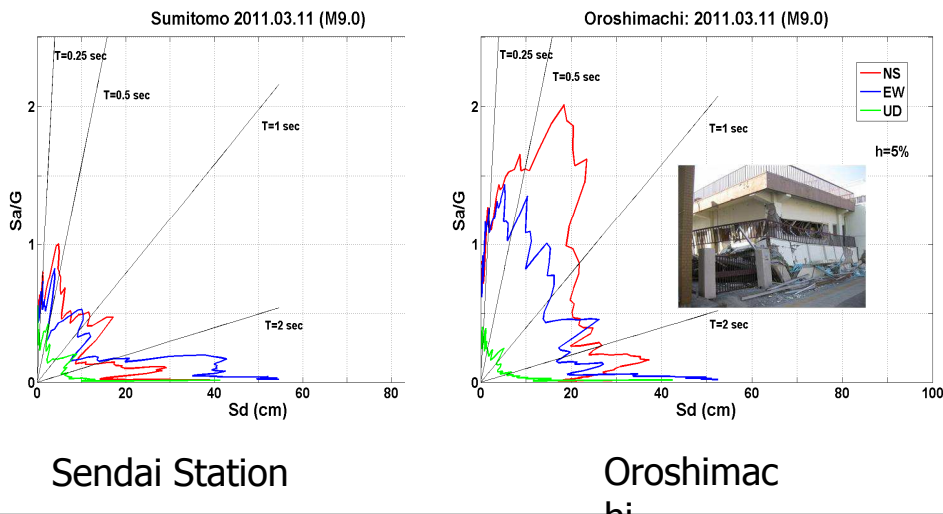
Different Ground Motion Characteristics at Sendai Station (Diluvium) and Damage of Old building on Alluvium site

Sa-Sd Spectra

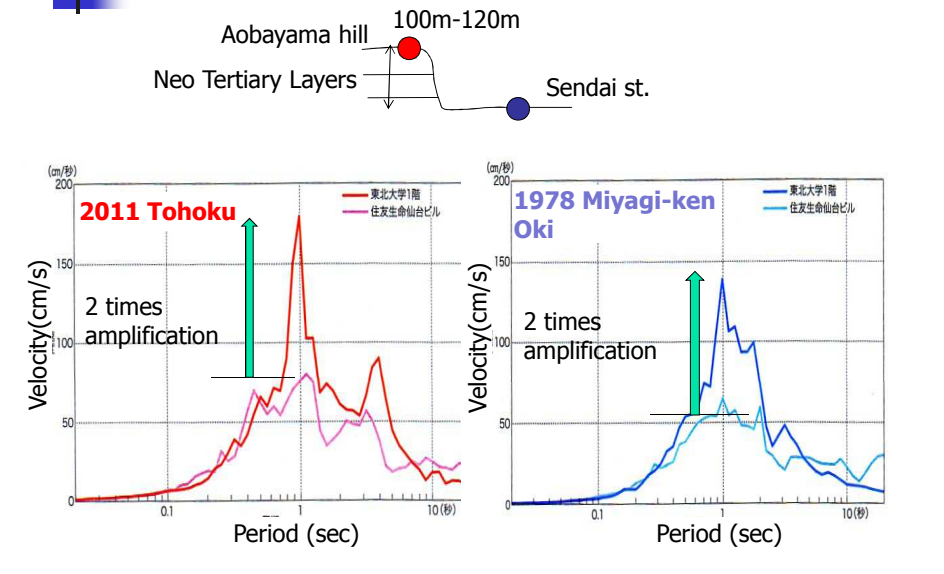
8 and 9 story buildings' damage due to resonance to the amplified ground motion at around 1s period content

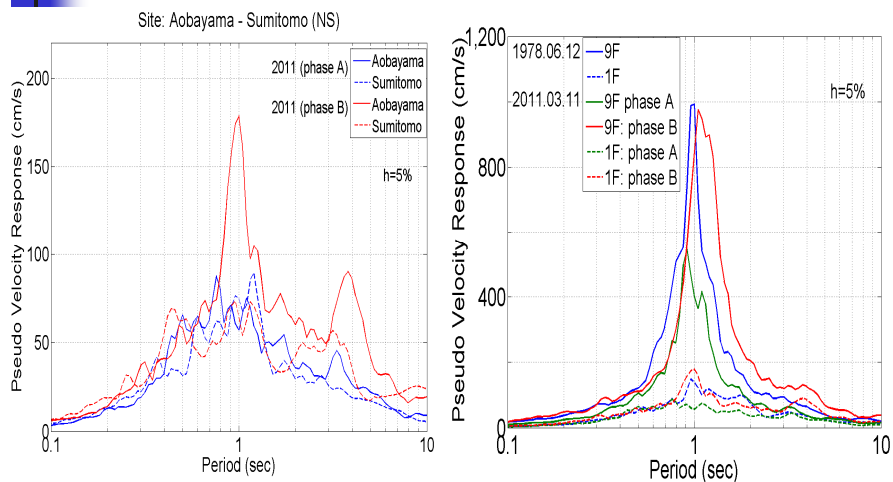
Different spectral amplification for the two phases and resonance of 9-story building at Aobayama hill (NS direction)

Amplification is two times in the 2nd phase, but not amplified in the 1st phase.

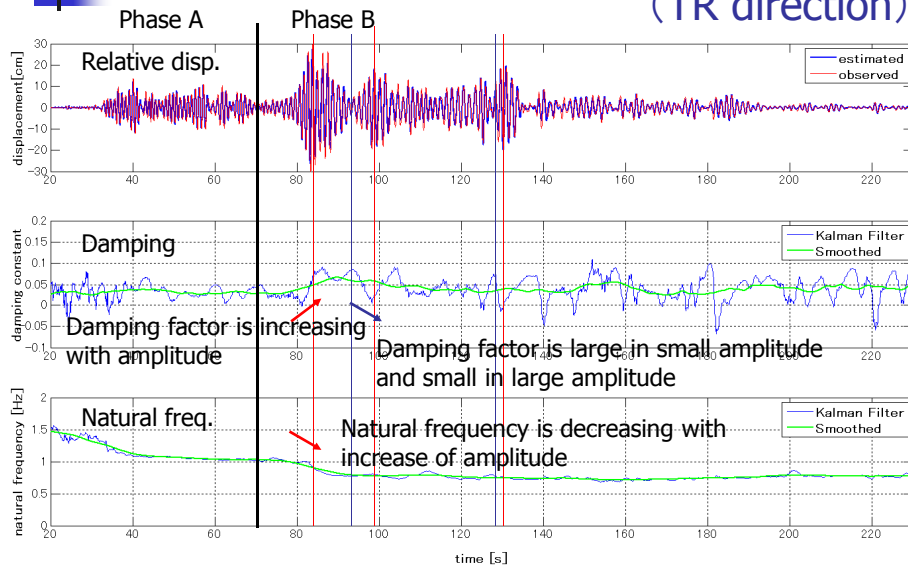
System identification of time dependent dynamic characteristics using Kalman Filter (TR direction)

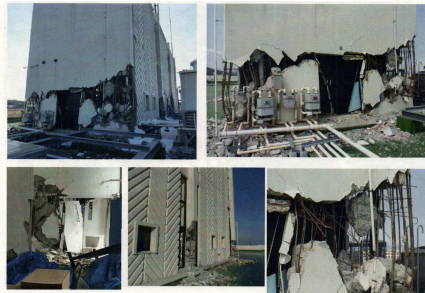
Damage of Pent House

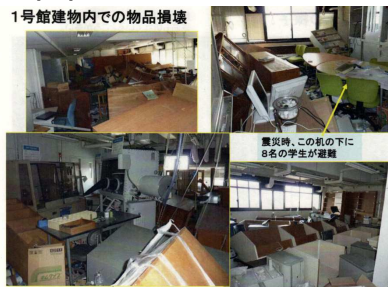
Drop of elevator cargo

Damage of experimental equipments

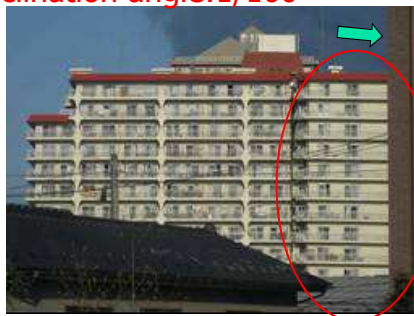
Damage of pile-foundation building condominium building in Takasago

Inclination angle: 1/100

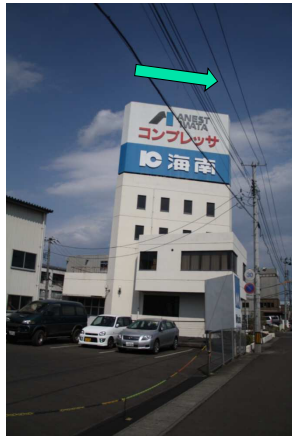
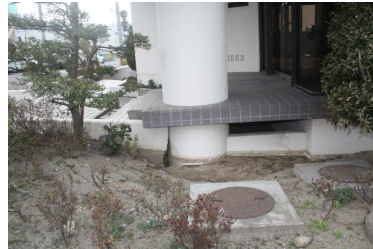
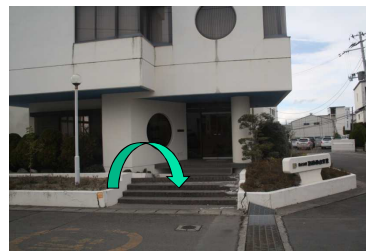
Inclined RC building in Oroshimachi Damage of piles

Construction year: 1983
Pile length: 26m

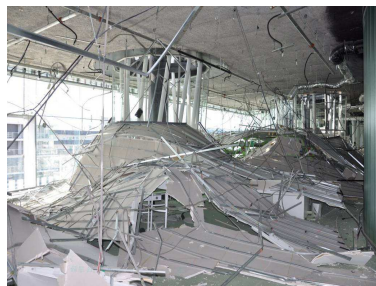
Fall of suspension type ceiling board of large span building

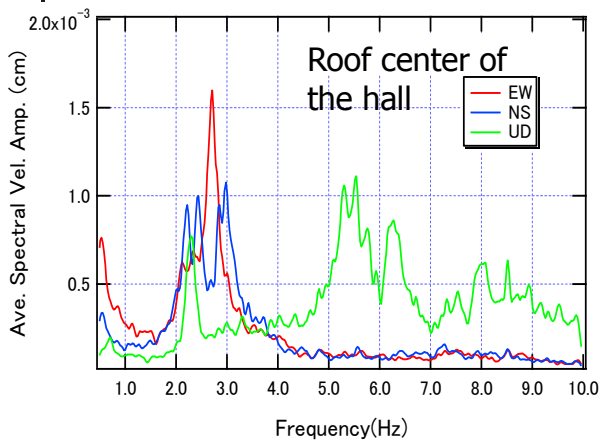
Microtremor measurement at the building with ceiling board damage

- * Vertical motion is largely induced.
- * Building stiffness is relatively high and is escaped from resonance to 1s period content

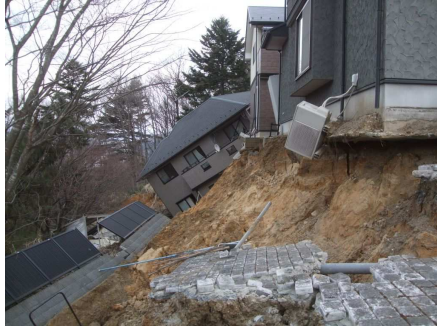
Nishi-Seikaen, Aoba-ku, Sendai

Housing damage by filled soil failure

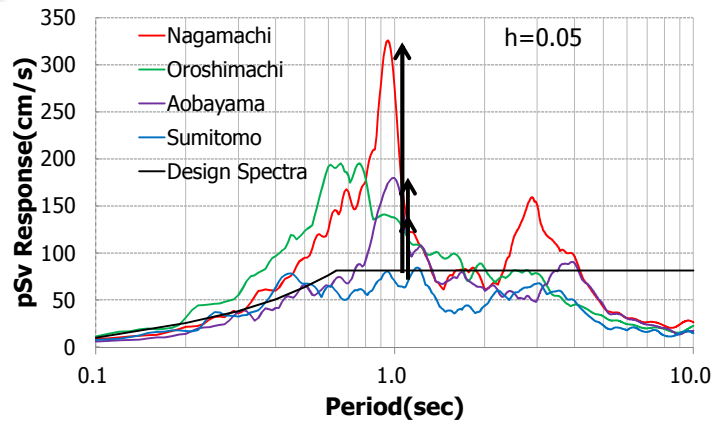
Pseudo Velocity (NS-component)

At around 1s period content, Nagamachi site is amplified by 4 times compared to Sendai station (Sumitomo), Aobayama site is 2 times, and Oroshimachi site is 1.8 times.

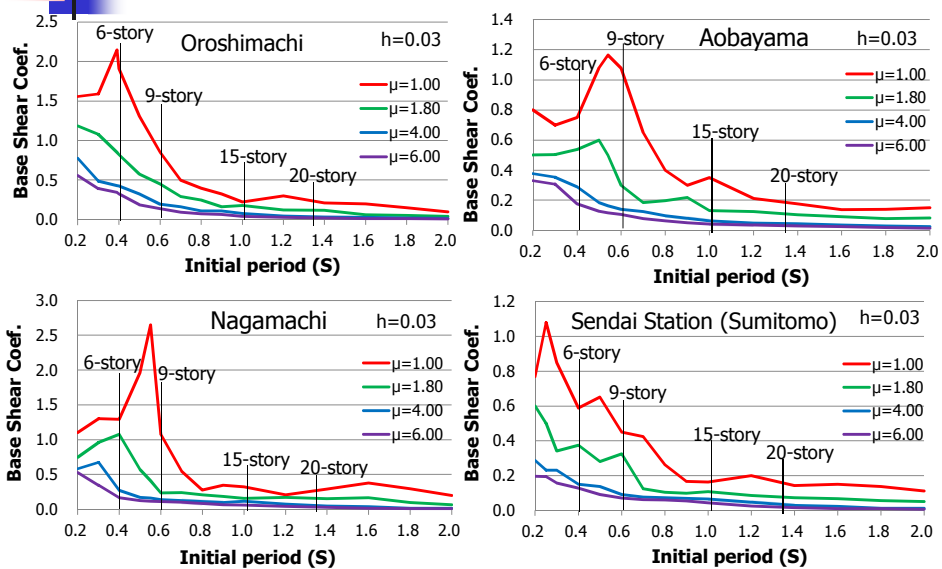
Strength Demand Spectra

Necessary base-shear demand at Nagamachi, Aobayama, and Oroshimachi compared to Sendai Station (Engineering bedrock)

About 3 times differences for 6 to 9-story buildings and
About 2 times differences for 15 to 20-story buildings
