# LESSONS OF RECENT GIGANTIC EARTHQUAKE DISASTERS IN JAPAN

***Taiki SAITO***

Chief Research Engineer,  
International Institute of Seismology and Earthquake Engineering (IISEE),  
Building Research Institute (BRI)

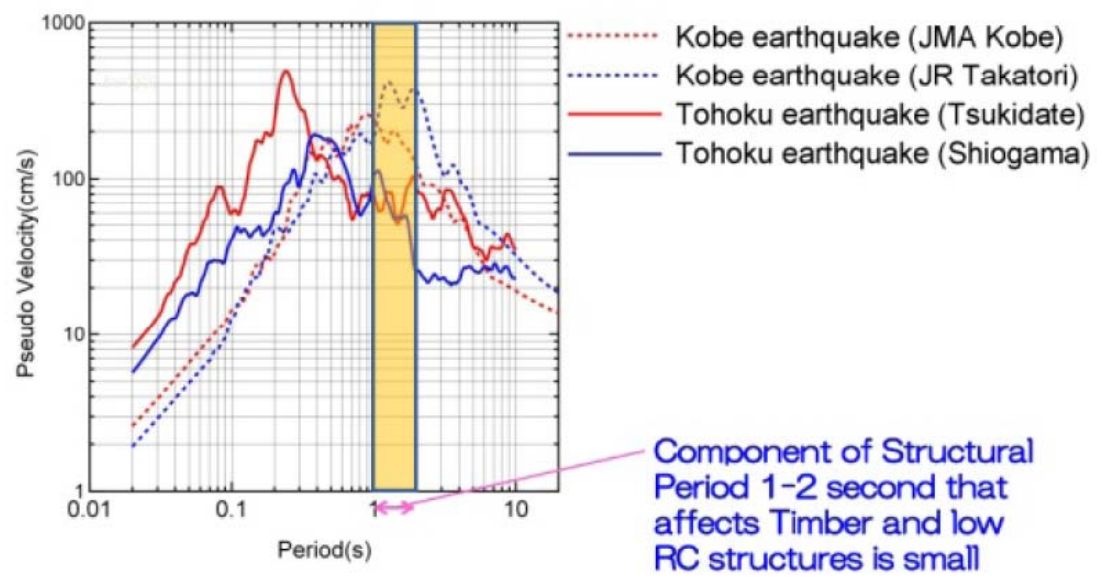
### Comparison between TOHOKU and KOBE Earthquakes

- Component of Short period is dominated at around the epicentre
- Component of the period of 1-2 second that affects structure is small.

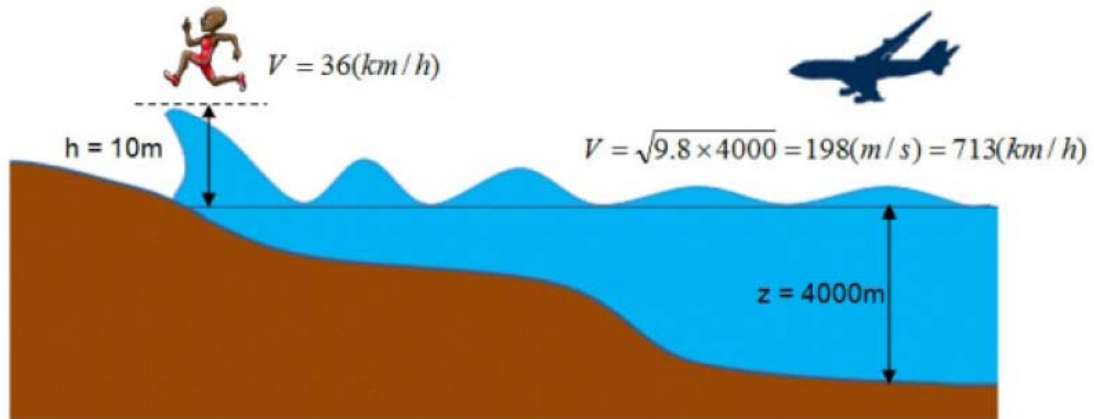
## Tsunami Speed

$$V(m/s) = \sqrt{g(m/s^2) \times (z(m) + h(m))}$$

Where  $g$  : gravity acceleration(=9.8 m/s<sup>2</sup>),  $z$  : depth of water,  $h$ : tsunami height

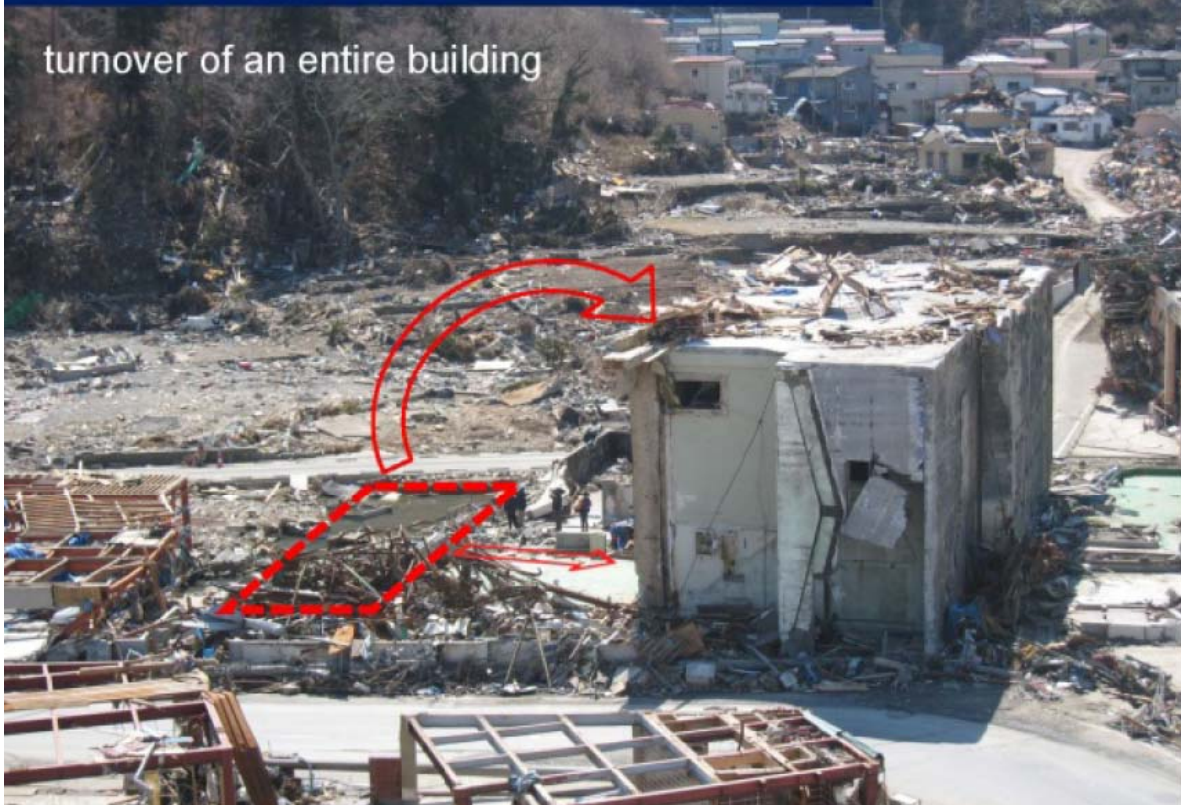
## Typical damage state – RC structure (1)

turnover of an entire building

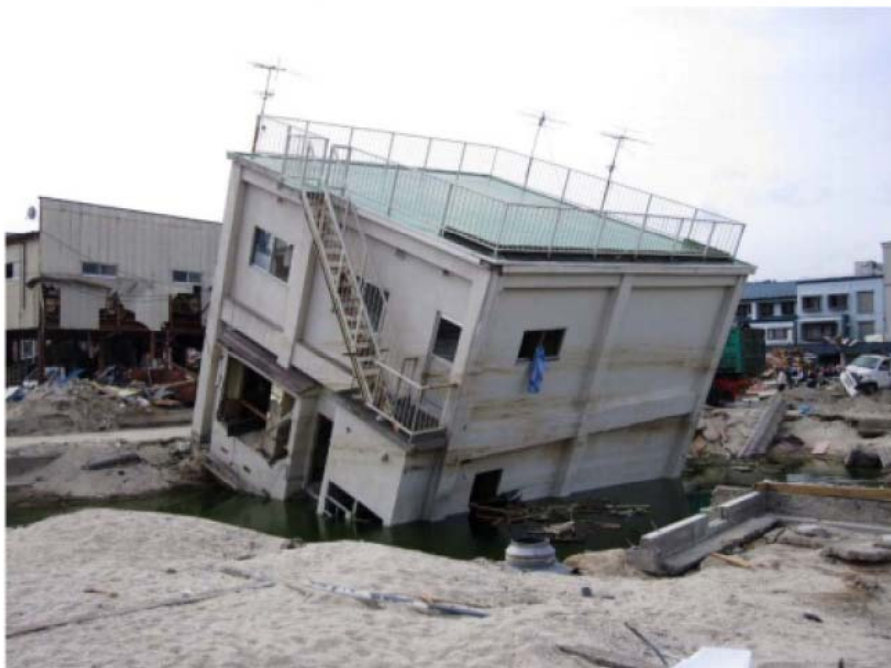
## Typical damage state – RC structure (3)

Entire building suffered from significant sinking following the effect of erosion in the ground.

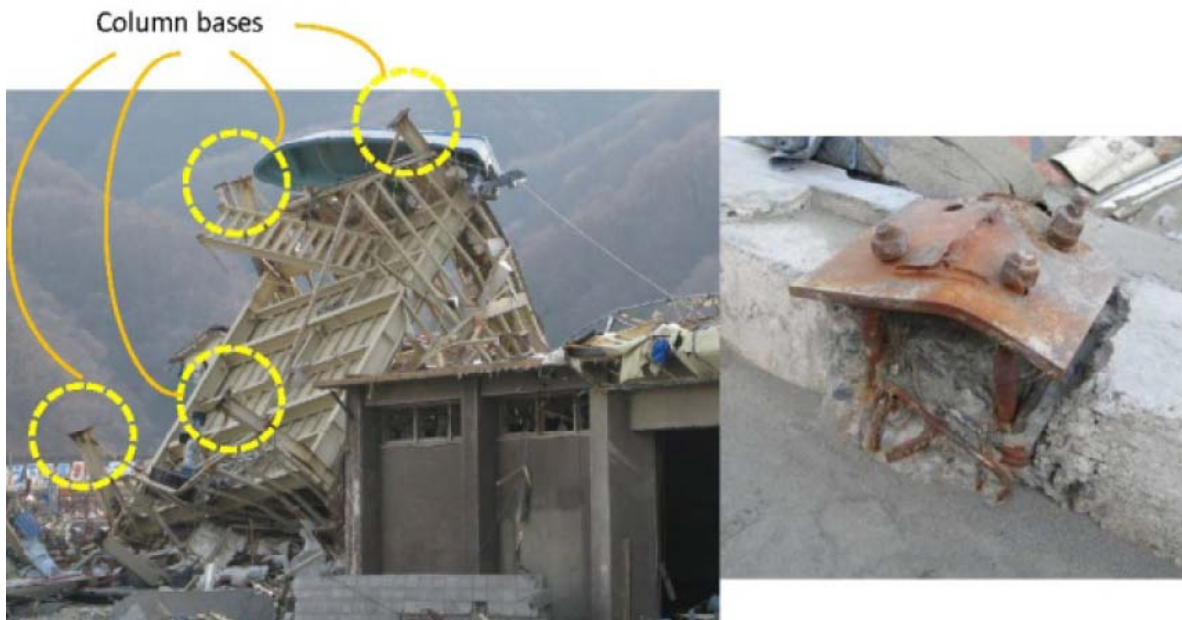
## Typical damage state – Steel structure (1)

Turnover and drift of entire building following the fracture of exposed-type column base

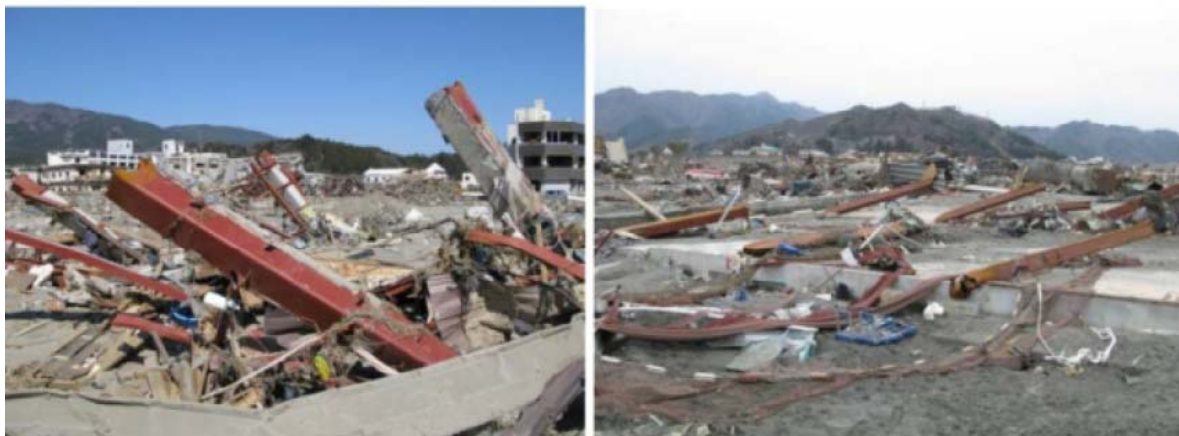
## Typical damage state – Steel structure (2)

- Turnover and drift of entire building following the fracture of column capital
- This type of damage was observed in the buildings whose columns have concrete encased base or imbedded type base.

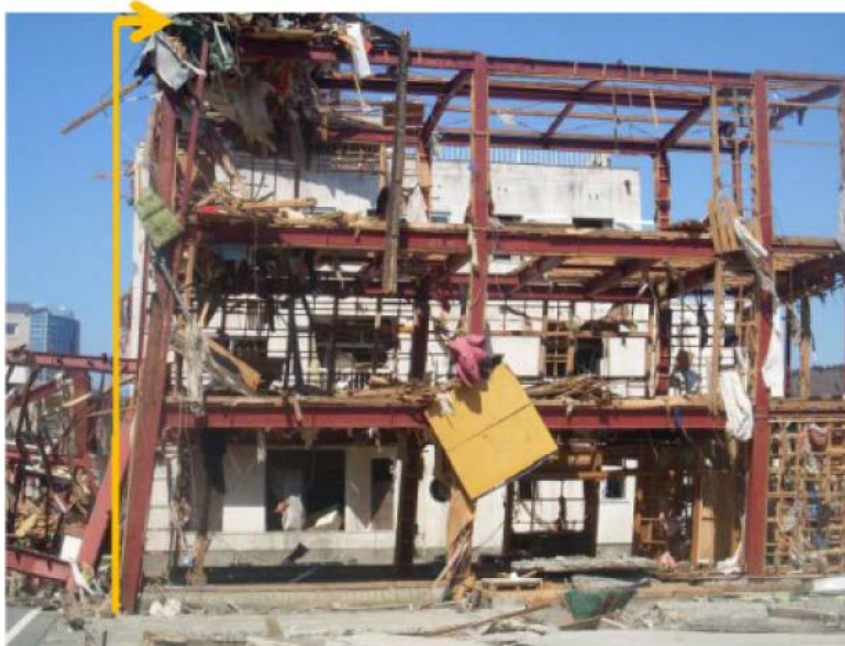
## Typical damage state – Steel structure (3)

Main columns and beams in some buildings are almost intact after all the external claddings were swept away. But they have residual deformation in columns.

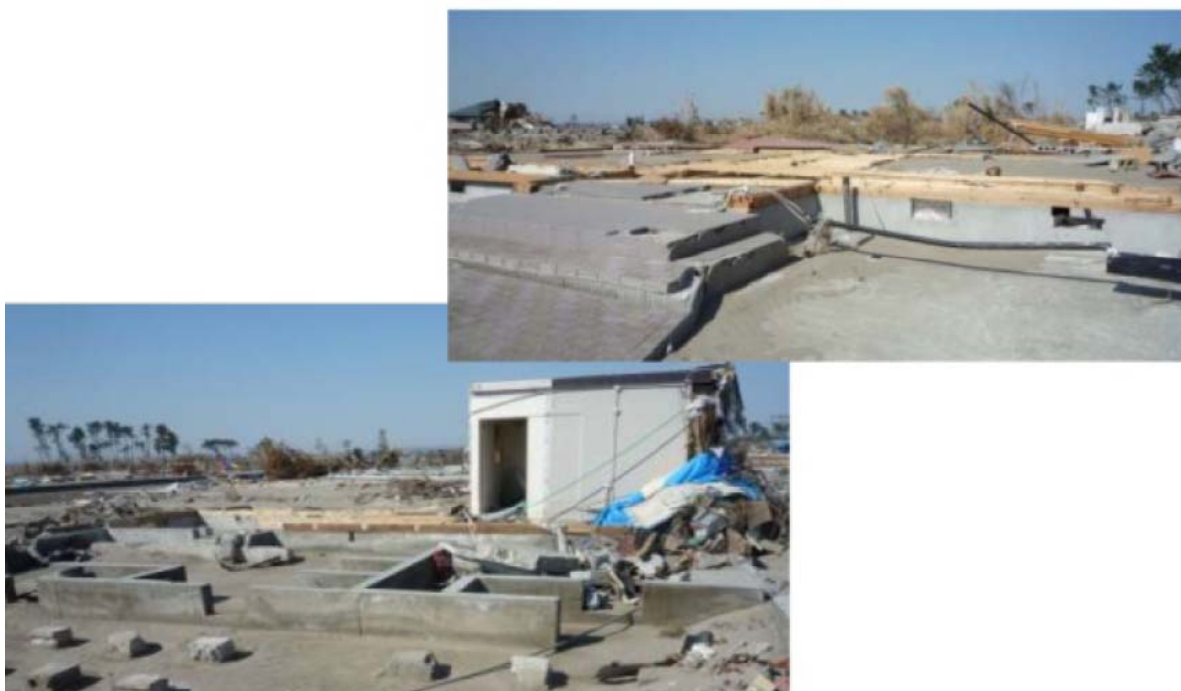
## Typical damage state – Timber structure (1)

Entire buildings are swept away.

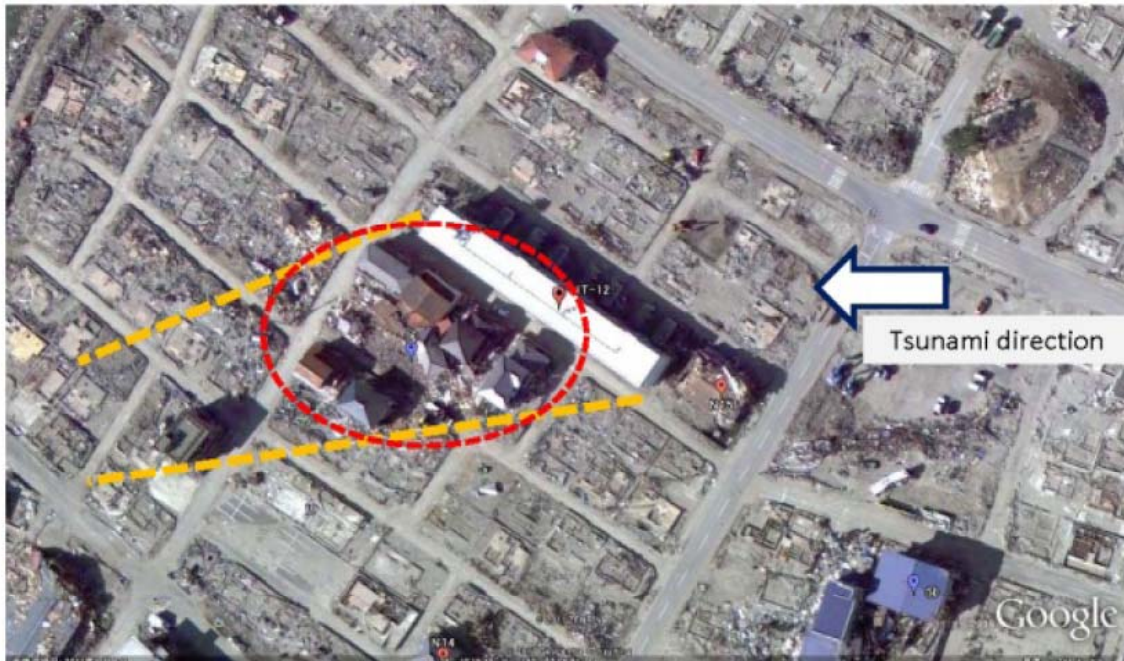
## Typical damage state – Timber structure (2)

If timber structures are located just behind a relative large-scale building, they were not swept away because of the decrease of direct tsunami effect on them.

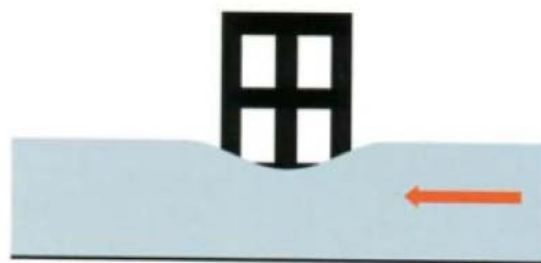
### Normal flow

$v < \sqrt{gD}$  Smooth Tsunami

$V$ ; flow speed  
 $g$ ; gravity acceleration  
 $D$ ; water depth
