Citation: Lamsal, J., K. Kusunoki, and M. Seki (2019), Seismic retrofit of existing residential building in Nepal to functionalize as hospital using ferrocement, Synopsis of IISEE-GRIPS master report.

SEISMIC RETROFIT OF EXISTING RESIDENTIAL BUILDING IN NEPAL TO FUNCTIONALIZE AS HOSPITAL USING FERROCEMENT

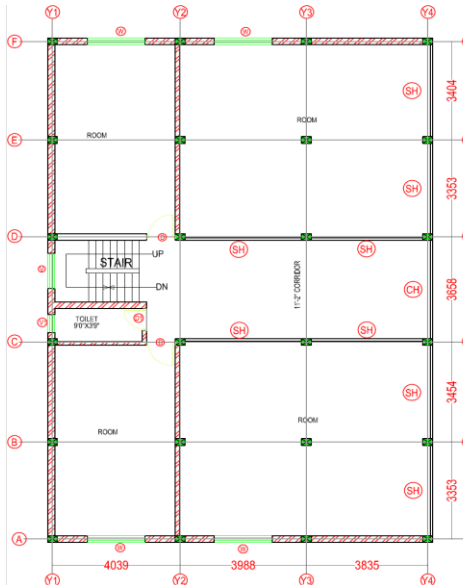
Figure 1. Typical first-floor plan.

Initially, the building was a residential building, and later the ownership was transferred to the hospital. The design loads and performance objectives for the hospital buildings and residential buildings are different. Thus, the building requires retrofitting for changing the functionality. The typical floor plan of the building is given below in the figure1. The brief information and data related to the building are provided below in Table1.

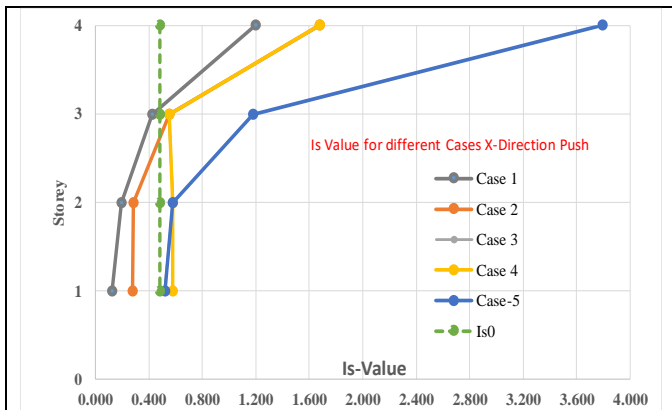
Figure 2. Is values for various cases of evaluation and retrofitting cases.

From the bare frame analysis of the building except for the fourth floor, none of the stories meets the standard seismic demand index (0.48, as per NBC 105). However, when infilled of the existing building strength was considered, then the third and fourth story found to be safe. However, the first and second story still could not meet the standard criteria. Therefore, the lagging strength needs to supply by the retrofitting by ferrocements. Figure 2 illustrates the results of the bare and infilled frame as case 1 and case 2.

The mortar with the strength of 20MPa and steel wire mesh 0.9mm @ 5.45 mm c/c having 415MPa used for ferro lamination. The figure below shows the results of the evaluation of the existing building (case 1 and 2) and retrofitted buildings (case 3 to 5). Here, case 1 and case 2 are an existing bare frame (BF) and existing building considering infill masonry (BM) respectively. By the same way, for the retrofitted cases; case 3 has the retrofit only in the first floor and second floor without disturbing initial plan (FC2-NW), case 4 is same as case 3 but with additional four masonry wall replacing shutter of grid C and D (FC2-AW) and case 5 is same as case 3, but whole walls of third and fourth floors also retrofitted (FC4-NW). The result of retrofitting shows that the I_s value in case of case 5 for the third and fourth floor found to be increased in comparison to that of other it is because of retrofitting in those floors was done only in case 5. The I_s value for case 4 in bottom floor found to increase slightly because of strength due to new masonry walls on the bottom floor. Because of having the same strength to that

of case 5 for the first and second floor, and some strength to that of third and fourth floor for case 4, the line overlapped and could not be visible.

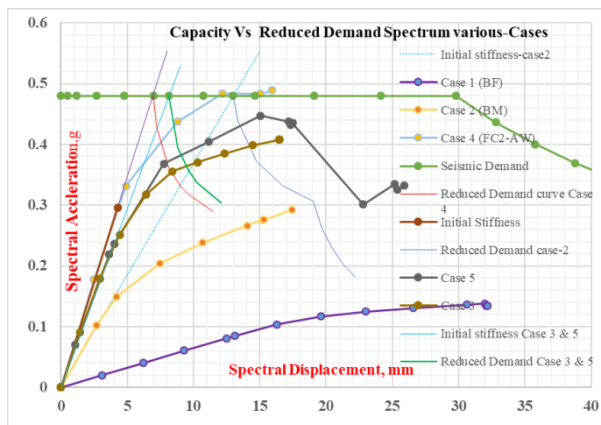
Figure 3. Performance points for various cases.

The figure above shows that at the ultimate state, case 4 has higher strength than that of the other cases. The probable reason is that the addition of walls in the bottom story of case 4 significantly increased the performance of the buildings. Although the story drift for all the cases is within the drift limit of 0.4% (which is considered as Immediate Occupancy (IO) for important building in Nepal). However, in the case of case 4, the inter-story drifts (ID) was found to be evenly distributed and least ID values in comparison to other cases. The values of ID for case 3 and case 4 are almost the same for the third and fourth floor because both have no retrofitting in the upper two floors. However, the ID in upper floors in case 5 seems to be lesser because for this case we have retrofitted the upper two floors, that increased the stiffness of the building. As a result, lesser deformation occurred on those floors. In overall, this study found that just by adding four masonry walls could significantly change the structural performance of the building rather than investing a huge amount of money in the name of retrofitting such as case 5. Figure 5 to 7 the hinge results at the performance point for various cases which was found to be at immediate occupancy state.

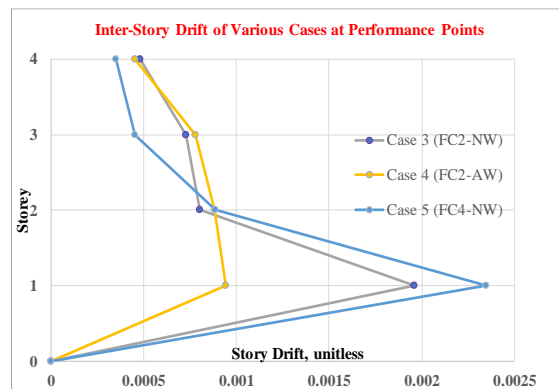
Figure 4. An inter-story drift of various cases at performance point.

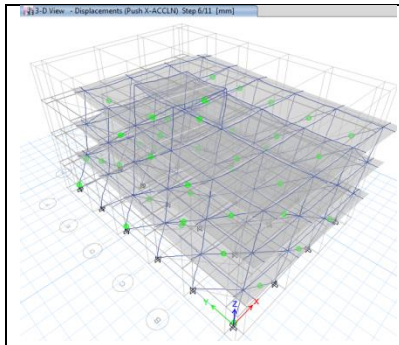
Figure 5. Hinge Results for Case 3 at performance points.

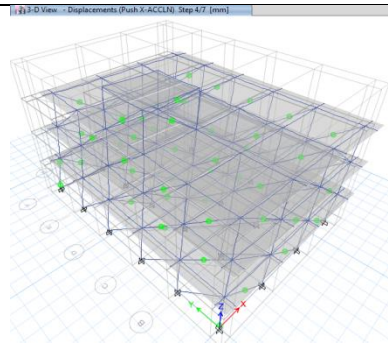
Figure 6. Hinge Results for Case 4 at performance points.

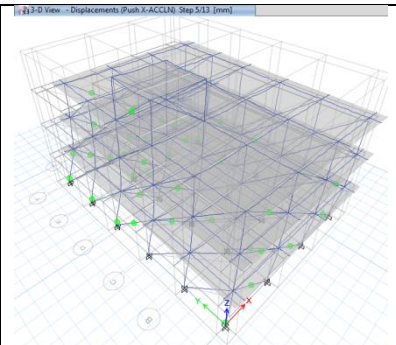
Figure 7. Hinge Results for Case 5 at performance points.

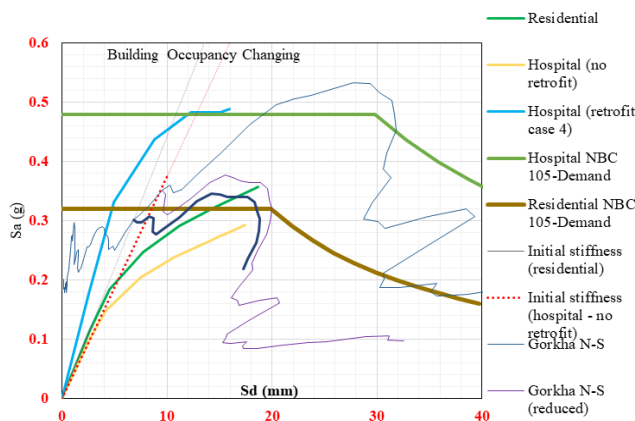
Figure 8. Capacity curve versus NBC & Gorkha earthquake 2015 demand curve for case A, B, and C.

This is the case study, carried out to capture a real scenario (occupancy shifting without taking any strengthening measures for buildings) of Nepal, during the 2015 Gorkha earthquake. Here, as a case study, three different scenarios of a given target building were considered. Case A: If a building is used as a residential building, Case B: If a building of case A is used as a hospital building without retrofitting. (this is the case 2 of the previous section) Case C: If a building of case A is used as a hospital building with retrofitting. (this is the case 4 of the previous section). The LL for residential and hospital building considered as 2.5 and 4 KN/m² respectively whereas for the first and second floor the DL for residential and the hospital are 9 and 10.75KN/m² respectively. The load for the third and fourth floor considered as same being roof floor for both cases. Nonlinear Pushover Analysis was carried out for different cases. The capacity curve of three cases of the building plotted over the demand curve of NBC 105 for hospital and residential buildings as well as the N-S component of the 2015 Gorkha earthquake given in Figure 8. The demand curve for the 2015 Gorkha earthquake was plotted by using View Wave software.

The Figure 8 shows that the building which was occupied as a residential building without being retrofit, had a performance point of (Sd, Sg); (16.5, 0.34g) values and corresponding story drift is given in above Figure 9. The corresponding base shear and displacement for this point is 1603.03 KN corresponding to performance point. The maximum drift corresponding to this point is 0.38%, which is a bit smaller than ID limit 0.4% and this implies that building remains safe during the 2015 Gorkha earthquake. The building seems just satisfying the NBC provision for residential buildings. However, there are many other existing buildings which have poor construction detailing in comparison to this

building. It implies that although the buildings that remain safe during the 2015 Gorkha earthquake are required to retrofit for satisfying the present NBC demand. However, if the building was used without retrofitting as a hospital building, then, in that case, the importance factor of the building is considered as 1.5 because the demand index must be increased by 1.5 times. Because of the increase in building seismic weight due to the change in occupancy load, the capacity of (S_a, g) decreased. Because of this, the building could neither satisfy the 2015 Gorkha earthquake demand nor requirements of hospital buildings as per NBC 105. This building will collapse if the same scale earthquake as the 2015 Gorkha earthquake occurs.

However, if we can do a retrofit for the buildings as per the intended occupancy to satisfy the NBC provision, the building could be safer. The retrofitted building was found to fulfill the 2015 Gorkha earthquake demand almost linearly within the elastic region without any damage. The building also found to satisfy the hospital demand as per codal provision. Therefore, a retrofit is an urgent need for changing the occupancy of the buildings.

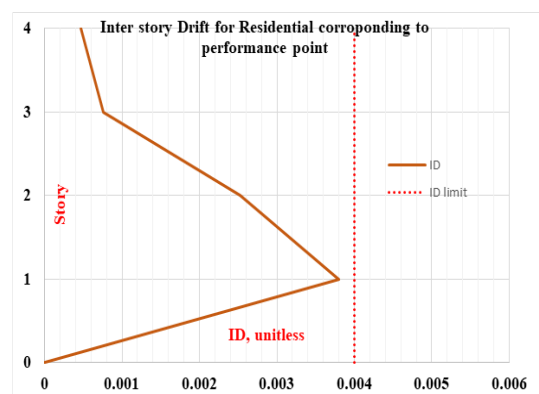
Figure 9. ID for residential building (case A) corresponding to performance Point.
