# DYNAMIC BEHAVIOR OF TRADITIONAL COMPOSITE MASONRY BUILDINGS IN BHUTAN

**Kunzang Tenzin<sup>1</sup>**  
MEE21713

## ABSTRACT

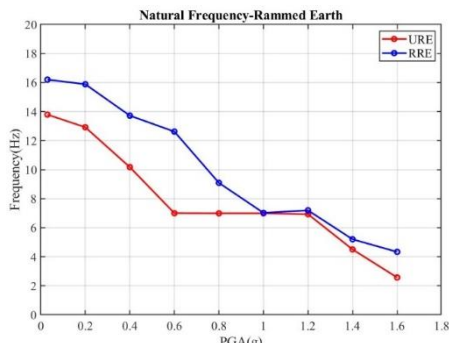
Figure 4. Natural Frequency of rammed earth

The variation of natural frequencies of rammed earth specimen (URE & RRE) at each input PGA is shown in Figure 4. The natural frequencies decreased with the increase in input ground motion due to the degradation of stiffness caused by damages. The natural frequency of the unreinforced rammed earth specimen before the test was 13.79Hz and for retrofitted was 16.2Hz. The frequency dropped to 3.17 Hz and 4.33Hz respectively for URE and RRE at the last test with the specimen showing varying range of damages on the walls.

The experimental results show that natural frequency of the specimens decreases with an increase in nominal PGA, reflecting the degradation of stiffness due to damage. Comparing the natural frequencies, the retrofitted models showed a higher value than unreinforced models. The proposed retrofitting measures improved the seismic performance of the structures by preventing the occurrence of cracks and limiting the damage propagation.

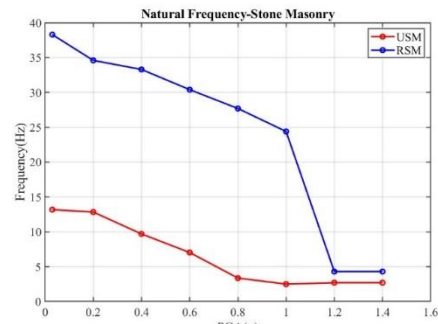
Figure 5. Natural frequency of stone masonry

The change of natural frequency for stone masonry specimen is shown in Figure 5. The natural frequency of the unreinforced stone masonry before the test was 13.18 Hz. The natural frequency dropped to 2.5Hz at nominal PGA of 1.4g with several diagonal shear cracks on the walls. The natural frequency of the retrofitted stone masonry was 38.26 Hz. The natural frequency dropped suddenly to 4.3 Hz at nominal PGA of 1.4g with large shear cracks on the side walls.

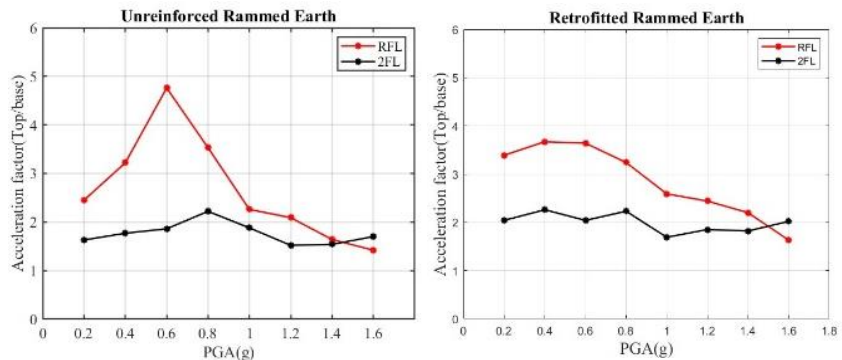
Figure 6. Rammed earth specimen (URE & RRE)

The acceleration factors at the roof level varied more than the second-floor level, which was caused by irregularity of walls in upper floors. While at second floor level the variation is less indicating the proper distribution of stiffness by wall in all sides. The acceleration factor for rammed earth specimen is shown in Figure 6. The value shows decrement after 0.6g at roof level of URE is due to more crack occurrence with increased PGA. In the retrofitted specimen the acceleration factors gradually decreased. At second floor level the changes in the factors are not large in both specimen which is due to proper distribution of stiffness by walls in lower floor.

The variation of the acceleration factors at different floor levels indicates the distribution of lateral stiffness. Furthermore, acceleration factors also reflect the damage condition on the structures and usually when damages are increasing the stiffness is reducing leading to elasto plastic phase resulting in lower acceleration amplification factor at above floors.

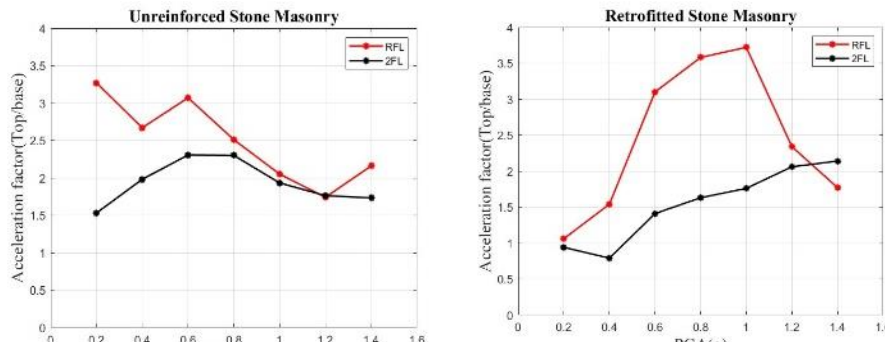
Figure 7. Stone masonry specimen (USM & RSM)

floor the factor increases gradually till 0.6g in USM and then drops with occurrence of cracks on the wall whereas in RSM the factors increase till the end of test indicating less damages and proper distribution of stiffness by walls at lower floor.

Figure 5 shows the acceleration factors of the stone masonry specimen. The acceleration factor at the roof level showed a decreasing trend in USM whereas in RSM the factor increases, and peak response was recorded at nominal PGA of 1.0g. At second

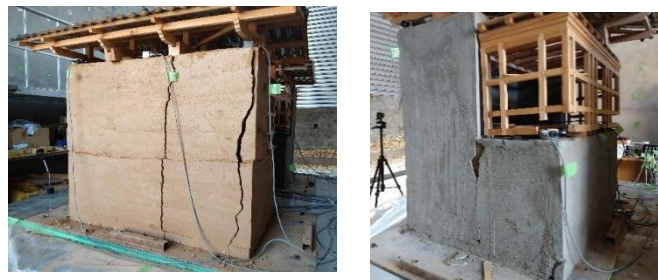
Figure 8. Rammed earth (URE & RRE)

The structural system under the study shall be considered as box system. The in-plane wall develops shear resisting mechanism while out of plane walls develops bending or flexure mechanism. The in-plane wall provides the lateral resistance by their self-weight and resist the force transmitted by out of plane to wall during the earthquake excitation. Due to higher flexure moment at the end of in plane wall, corner cracks are induced to structure. While the shear failure in plane wall with diagonal cracks are due development of principle tensile stress because for lateral and vertical load. Due to opening in the front façade at second floor level the in-plane wall is reduce to half which accordingly the shear strength is also reduced. Therefore, the cracks started at the junction of 2fl and propagated to lower floor and lots of cracks at the corners.
