Citation: Bhattarai, Y., T. Aoki, M. Miyamoto (2021), The simplified seismic performance evaluation of the stone masonry houses and seismic band's effects to prevent the seismic failure, Synopsis of IISEE-GRIPS Master's Thesis.

THE SIMPLIFIED SEISMIC PERFORMANCE EVALUATION OF THE STONE MASONRY HOUSES AND SEISMIC BAND'S EFFECTS TO PREVENT THE SEISMIC FAILURE

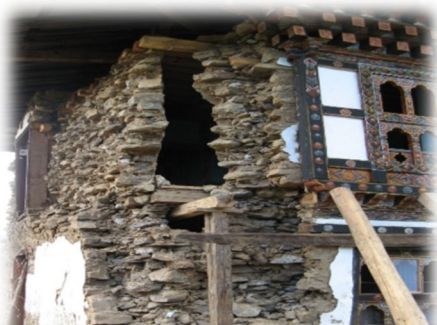
Figure 1. Damage of stone masonry houses during an earthquake

Bhutan is a small landlocked country with 20 different districts. Almost all districts have public essential masonry infrastructures with stone and other materials such as bricks, adobe, rammed-earth, etc. Bhutan's main existing masonry structures are Random Rubble Stone Masonry with mud mortar. Those essential structures are administrative buildings, monasteries, school buildings, health infrastructures, office buildings, and rural houses, which were highly exposed to seismic risk. In the 2009 and 2011 earthquakes, 4950 and 6977 masonry structures were damaged respectively across the country, Fig-1.

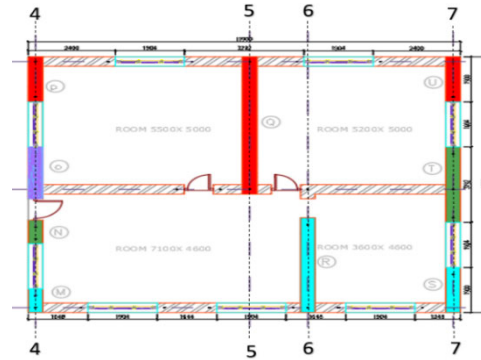
Figure 6. Walls for seismic diagnosis Y-direction

The seismic diagnosis in-plane as per Fig-6, calculated. According to the design practice in Bhutan, the ground motion during an earthquake is considered 0.36g as per the seismic zone 'V' of IS code. The wall thickness is adequate; however, the seismic intervention components such as cornerstone, through/bonding stone, and the proper bonding of the masonry wall are necessary to avoid the unpredictable cracks and separation from the orthogonal direction during the strong ground motion.

The out-of-plane seismic diagnosis was carried out in each wall in X-direction and Y-direction as per the plan Fig-5 and Fig-6. The ultimate Moment (M_{sm}) is the maximum Moment of the masonry wall,

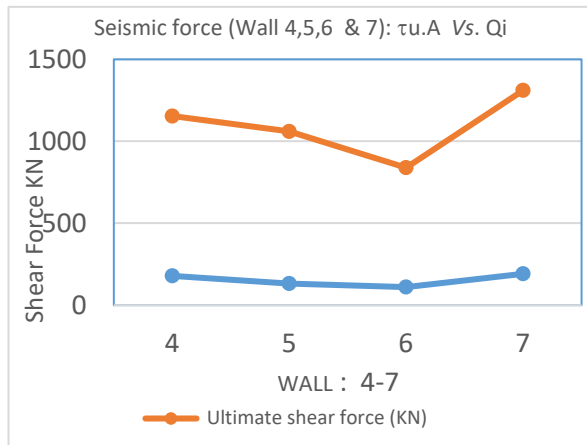
Figure 7. The graphical representation of design and ultimate shear force (Wall 4-7)

The analysis shows that the walls are safe against in-plane seismic action Figure-7. However, the mortar joint may vary the actual tensile and shear strength of the stone masonry wall. The random rubble stone masonry does not have proper stone shapes; When the cement mortar goes inside, the rubble masonry will have a different thickness within the short span of the wall with various shapes of the stones. Therefore, the primary failure modes can occur within the cement mortar and stone rubble interface (Vasconcelos and Lourenço, 2009).

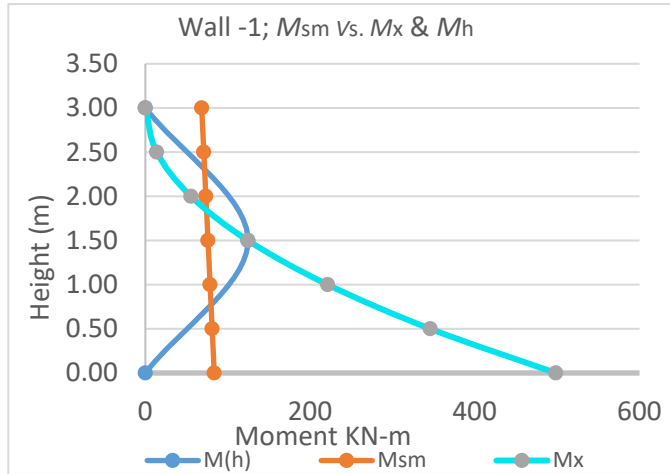
Figure 8. The Moment M_h and M_x compared with ultimate bending Moment M_{sm} (Wall-1)

The end of the walls is assumed hinged and the Moment is calculated and compared. Figure-8 shows that Moment is beyond the ultimate Moment, which is not safe. And secondly, moment distribution (M_x) is checked against each wall Figure-8, Which shows that it is beyond the ultimate Moment in each wall, and it is not safe.

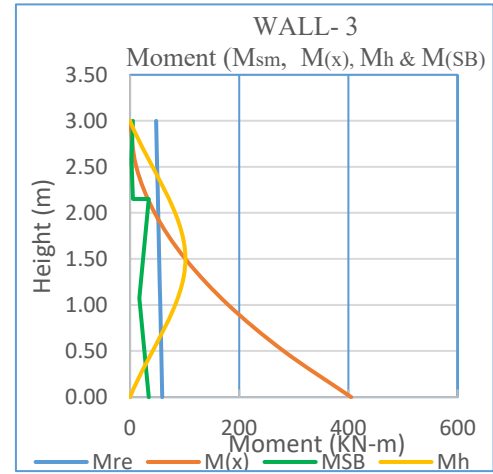
Figure 9. The all Moment M_x , M_h , and M_{sb} compared with ultimate Bending Moment M_{sm} (Wall-3)

Finally, The Moment (M_{SB}) is checked considering three levels of the walls were fixed conditions with the seismic bands in Figure-9. The result shows the possibility of the seismic bands to prevent walls from overturning in the out-of-plane direction during seismic action.

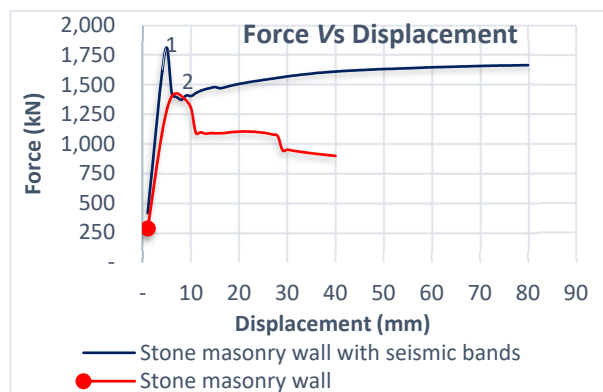
Figure 11. Graph representing FEM Results

Figure 10 shows the model for FEM analyses. Figure 11 shows the analysis results for force-deformation relationships. According to this figure, the wall with seismic bands carries a shear strength instantly 27% higher than the typical random rubble stone masonry. The analysis stopped while displacement was 40mm and 80mm for typical stone masonry and stone masonry with seismic bands, respectively; the loading capacity difference at the analysis stopped is 85%.The typical stone masonry started forming

the shear crack from the edge of the openings, and the load gradually dropped after reaching the maximum of 1426.49KN. The displacement was 7.0 mm at the failure point. The stone masonry wall with a concrete seismic band attained the maximum load of 1809.24 KN with a displacement of 5mm.

Suddenly, loading dropped to 1373.43 KN with a displacement of 8 mm. Gradually, the load increased to 1665.61KN with displacement up to 80mm and stopped the analysis.
