LESSONS OF RECENT GIGANTIC EARTHQUAKE DISASTERS IN JAPAN

Taiki SAITO

International Institute of Seismology and Earthquake Engineering (IISEE),

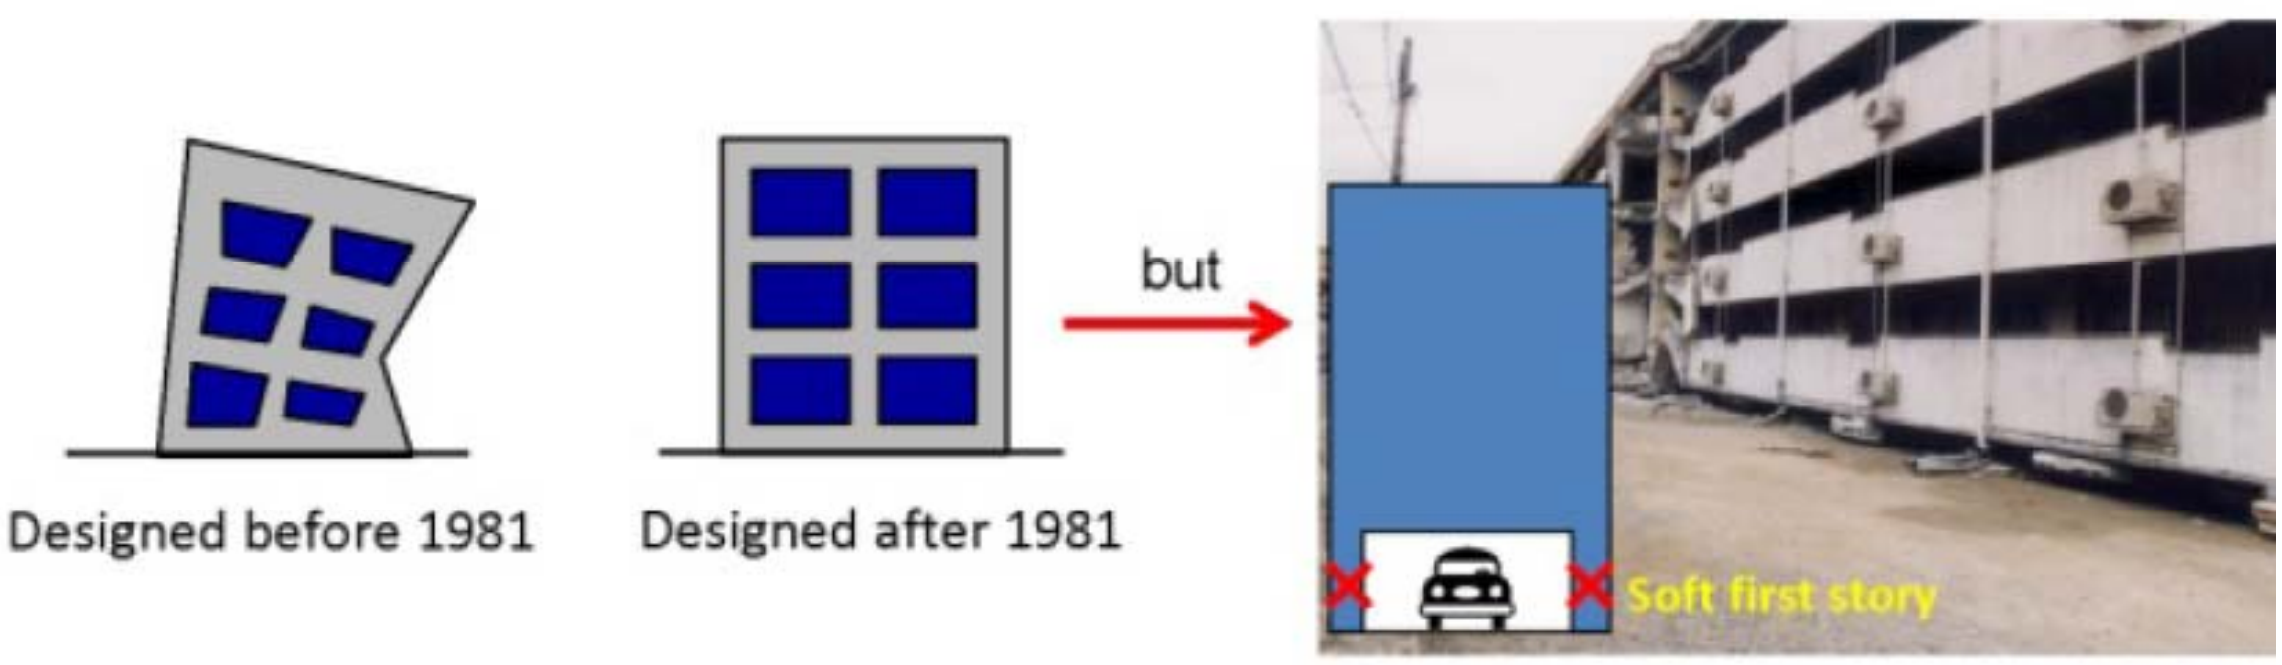
1995 Great Hanshin-Awaji Earthquake

Collapse of buildings designed after 1981

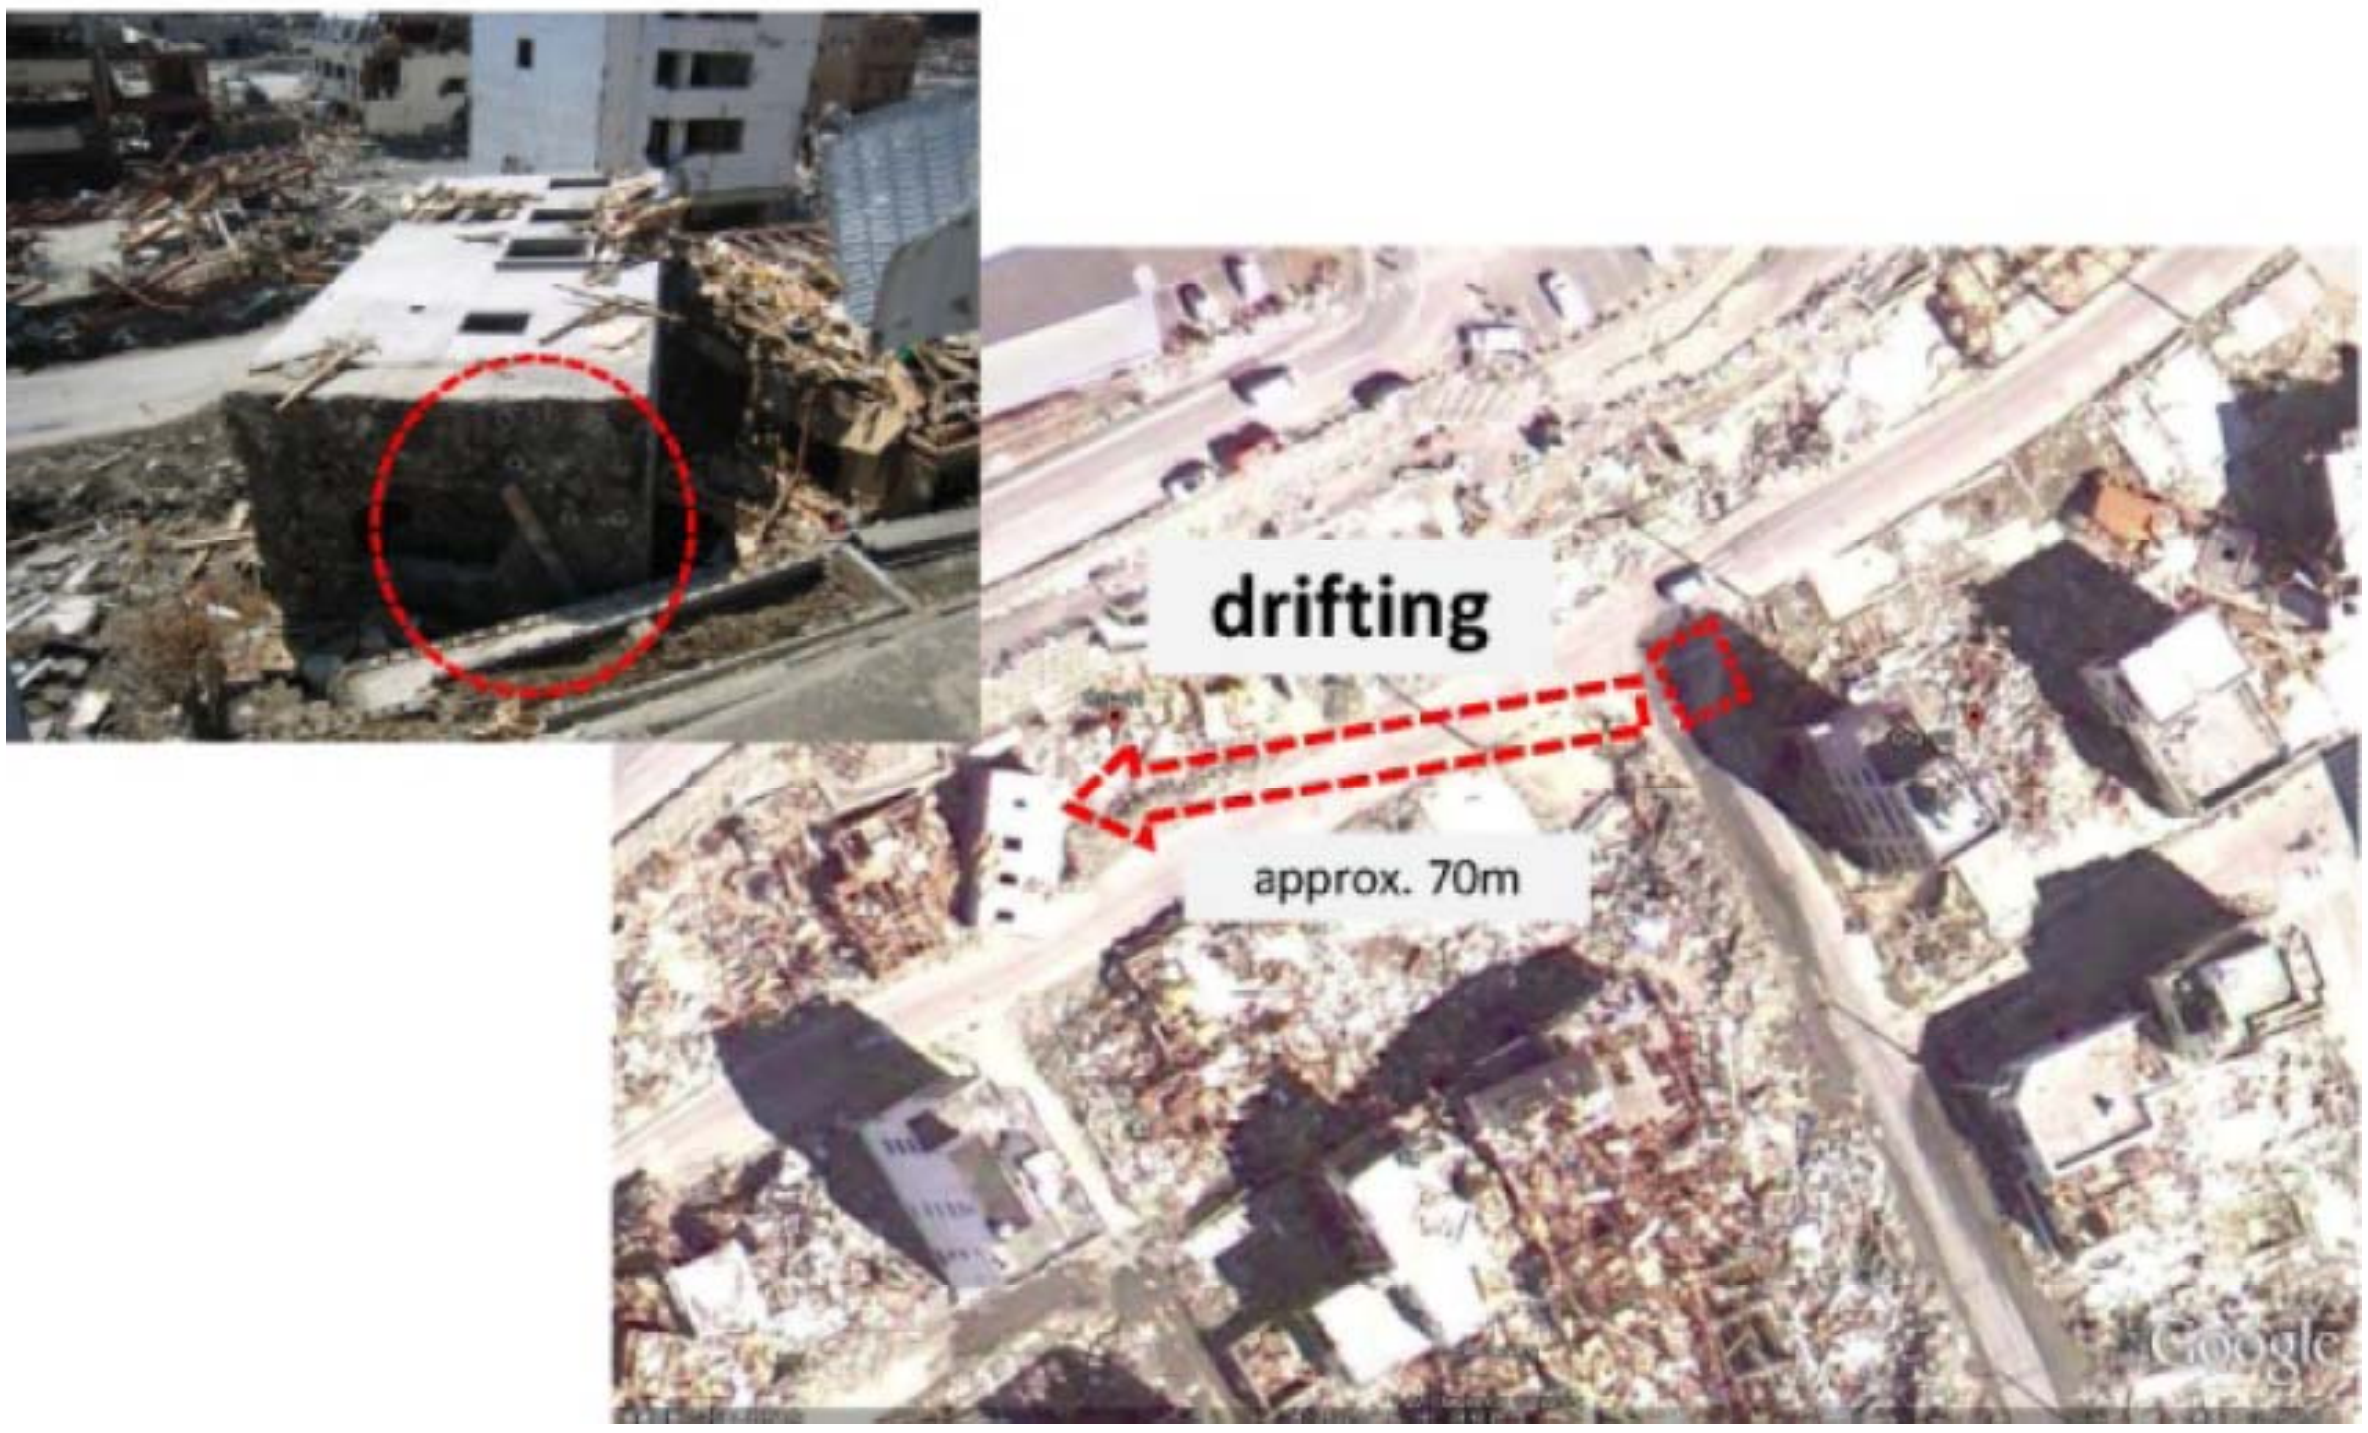
Typical damage state – RC structure (2)

- turnover and drift of an entire building

Entire building suffered from significant sinking following the effect of erosion in the ground.

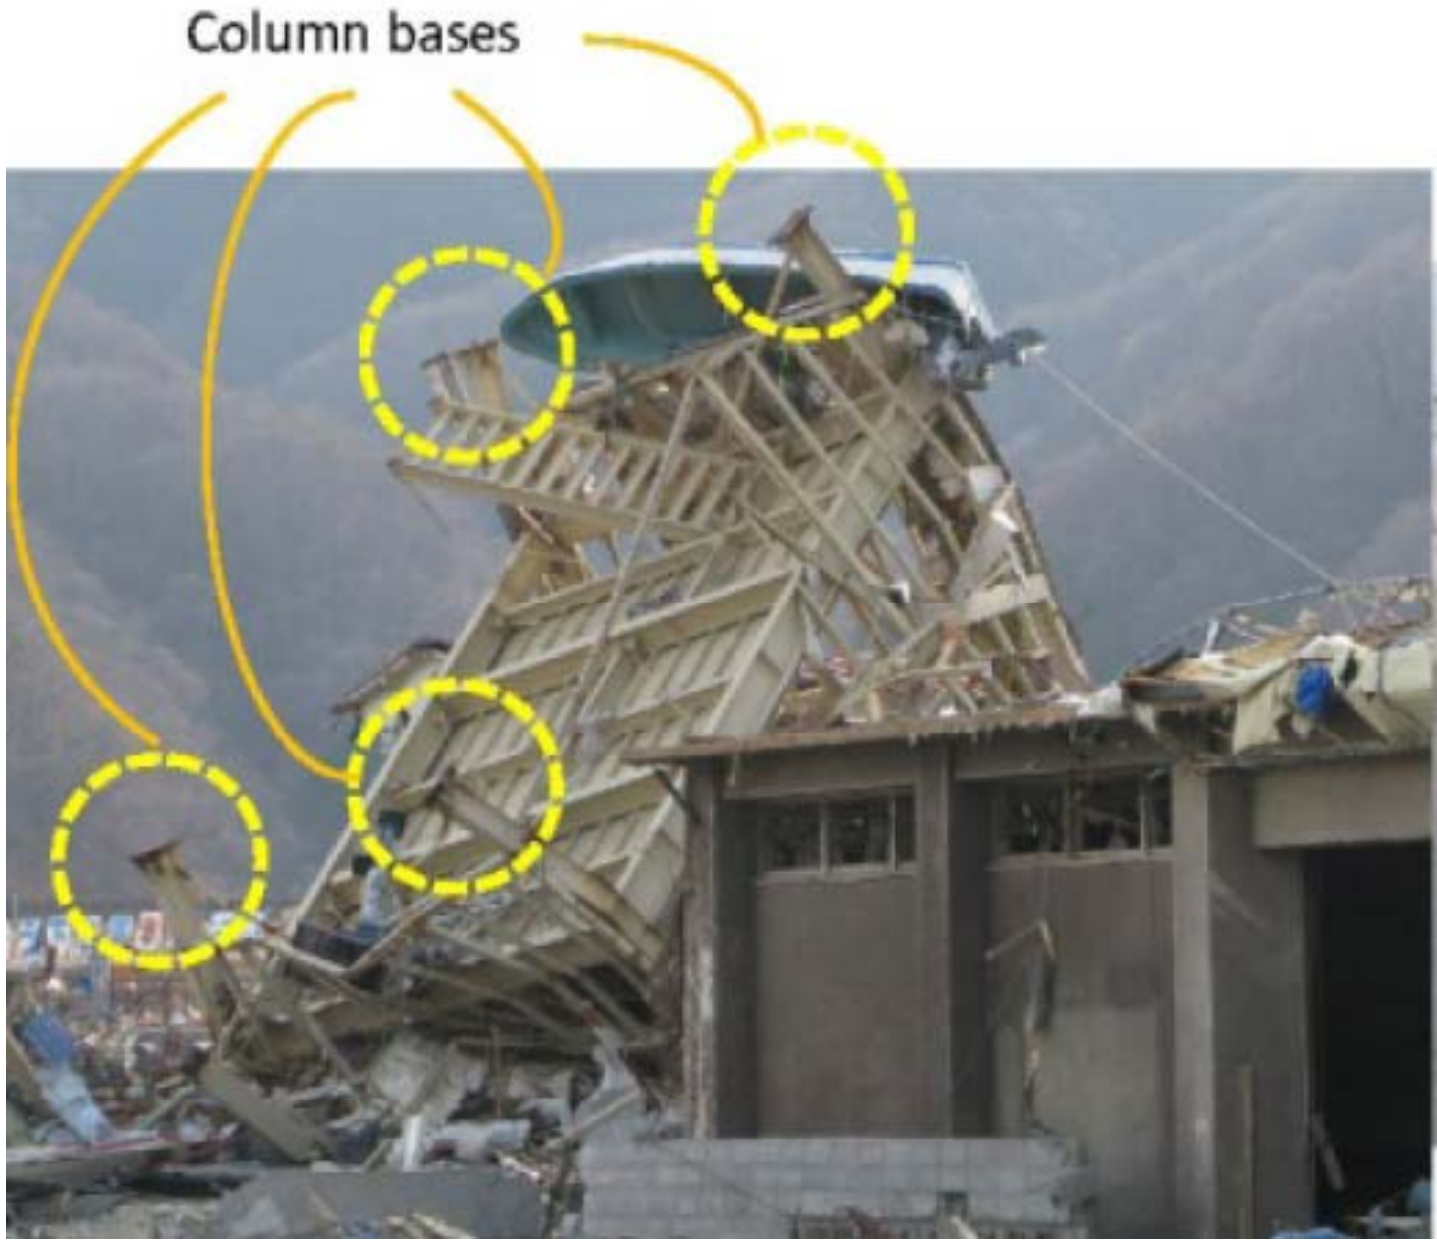
Typical damage state – Steel structure (1)

Turnover and drift of entire building following the fracture of exposed-type column base

- Turnover and drift of entire building following the fracture of column capital
- This type of damage was observed in the buildings whose columns have concrete encased base or imbedded type base.

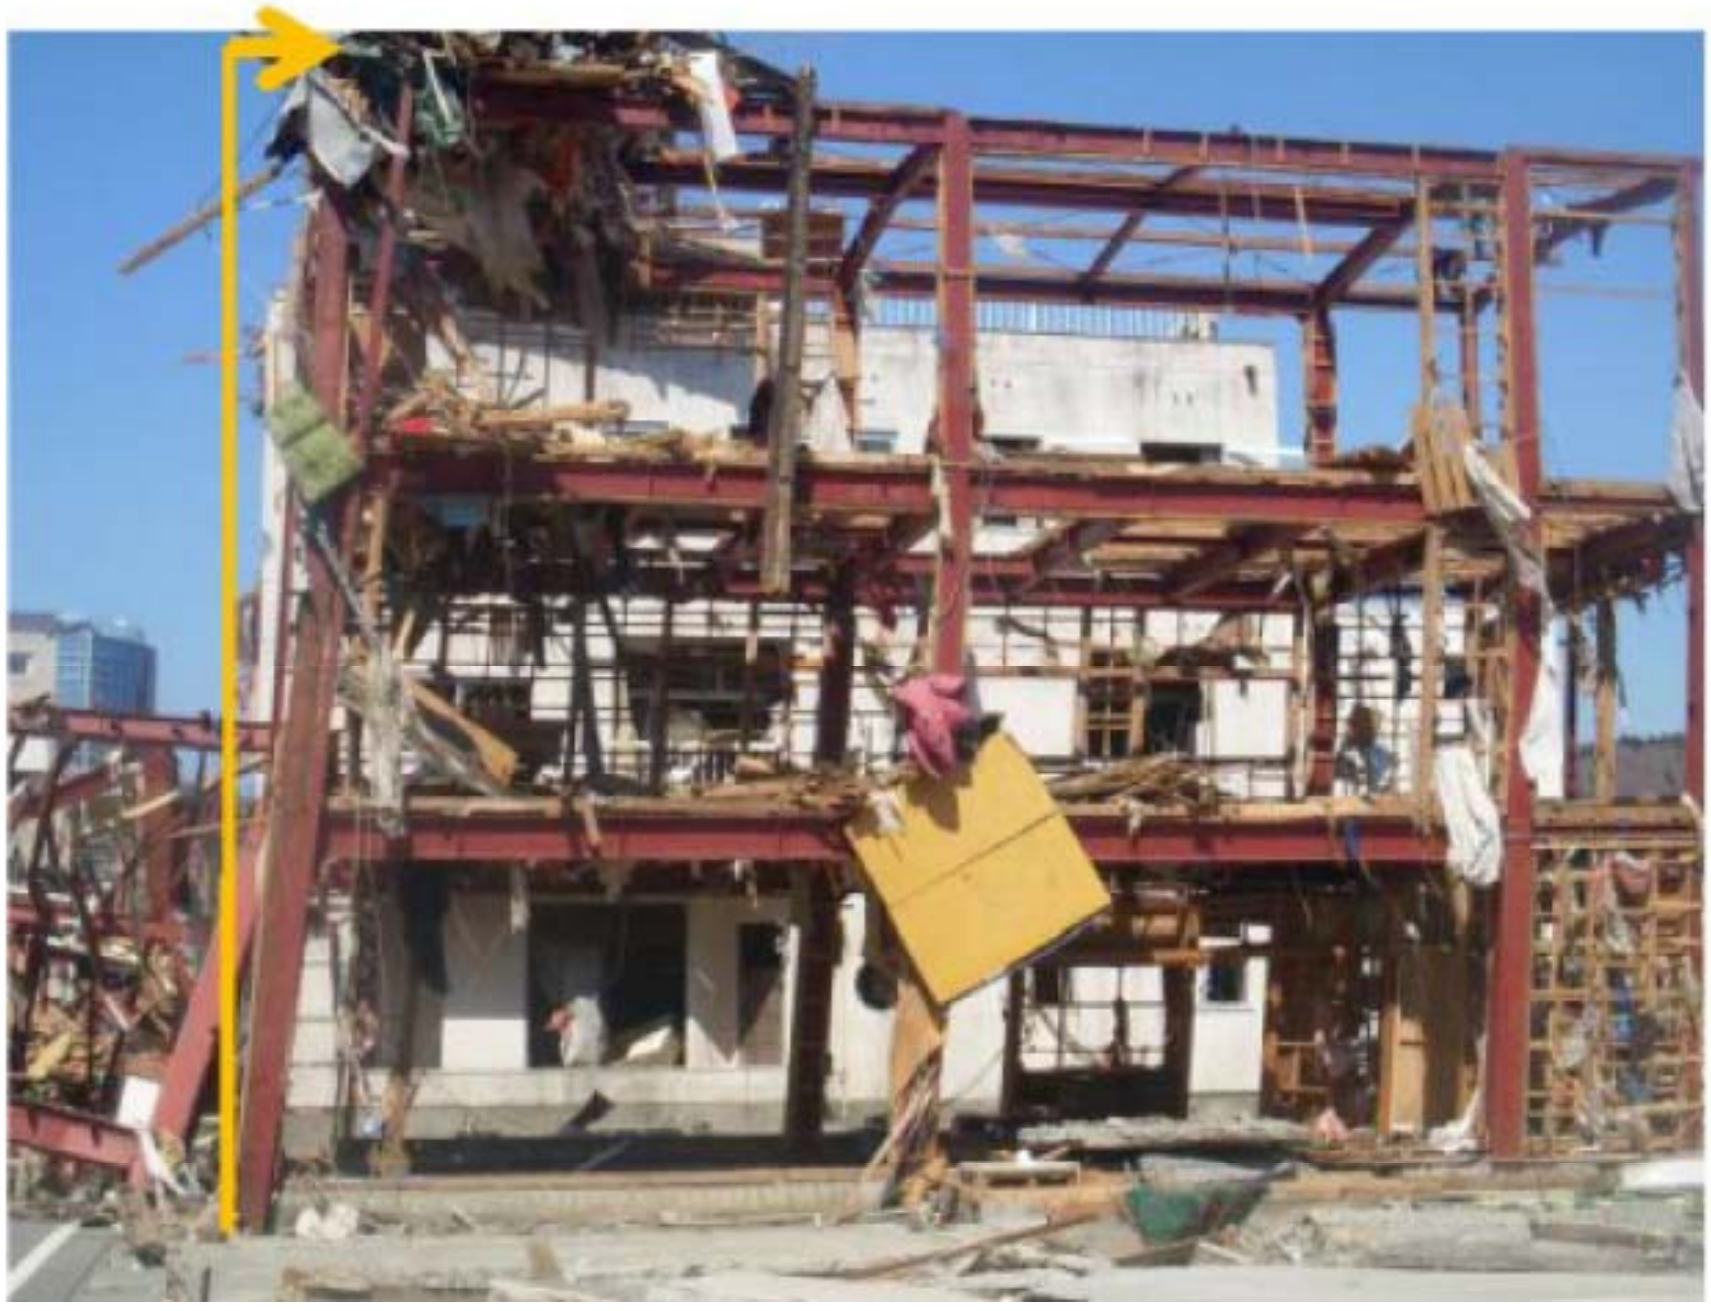
Typical damage state – Steel structure (3)

Main columns and beams in some buildings are almost intact after all the external claddings were swept away. But they have residual deformation in columns.

Entire buildings are swept away.

If timber structures are located just behind a relative large-scale building, they were not swept away because of the decrease of direct tsunami effect on them.
