INTERNATIONAL INSTITUTE OF SEISMOLOGY AND
EARTHQUAKE ENGINEERING (IISEE)

REPORT OF STUDY TRIP (TOHOKU)

10-14 JULY 2011

TSUNAMI DISASTER MITIGATION

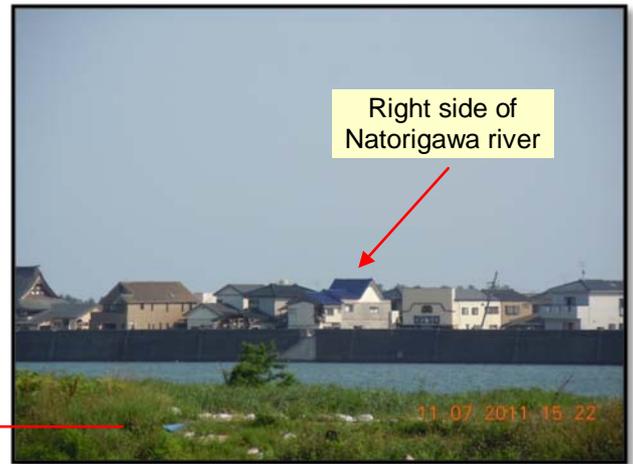
Figure 3 (Photo taken by Mazni Azis)

At the Natorigawa river I asked a question to Dr. Sugawara about the different effect of the tsunami at the left and the right sides of the river, because the right side seemed to be less damaged than the left side. Dr. Sugawara said that it was probably because the river and the dike at the right side of the river is higher compare to the left side (Figure 3 and Figure 4). In addition, he said that the right side was also suffered from the tsunami but it was only the first floor of building.

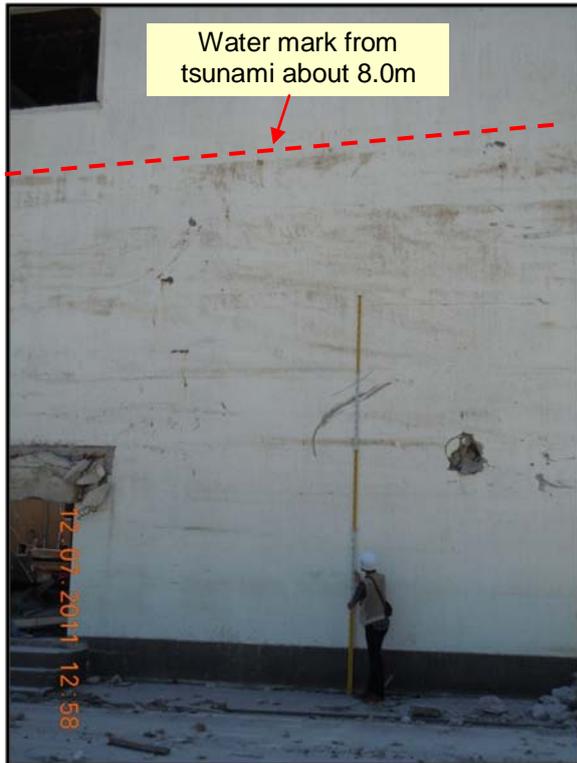
Onagawa was heavily damaged and I saw many buildings collapsed and destroyed by the tsunami. According to the witnesses, residing wave was also strong in this area. Many people did not want to live here again because of the trauma of the tsunami. I asked Prof. Okazaki's opinion about the time needed to recover this area. He said it may take 2-3 years to be reinstated as it was very terrible destruction. Onagawa Tsunami Memorial Park and Onagawa Tsunami Memorial Museum will be built to mark the terrible tsunami disaster and to educate people about the impact of the tsunami in this area. Four damaged buildings will remain as the Onagawa Tsunami Memorial Park. Onagawa Tsunami Memorial Museum proposed by Prof. Shuto as a sign of place near to tsunami run-up. For myself, it was very surprising to see the situation in Onagawa in which buildings were destroyed, turned over and some of them moved up to 70m by tsunami wave although they were constructed using the RC structure.

Figure 8: Building moved about 70m (Photo taken by Mazni Azis)

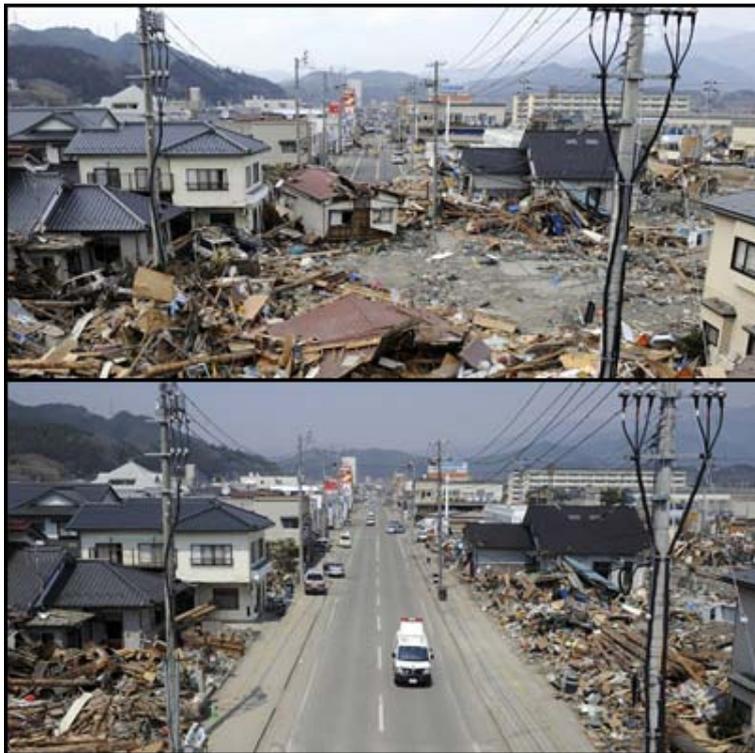
Figure 12: This pair of before-and-after photos shows the removal of tsunami destruction and debris covering the road in Ofunato city, Iwate prefecture on March 14, 2011, three-days after the tsunami disaster and after the road was cleaned of debris, on April 15, 2011. (Toshifumi Kitamura/AFP/Getty Images) <http://www.theatlantic.com/infocus/2011/04/japan-earthquake-the-long-road-to-recovery/100047/#img24>
