VAN EARTHQUAKE, TURKEY 2011

Dr. Nazan KILIÇ
Earthquake Department

23 October 2011 Van Earthquake

International Video Conference on Reconstruction of Safer Houses
after Earthquake Disasters
22 February 2012

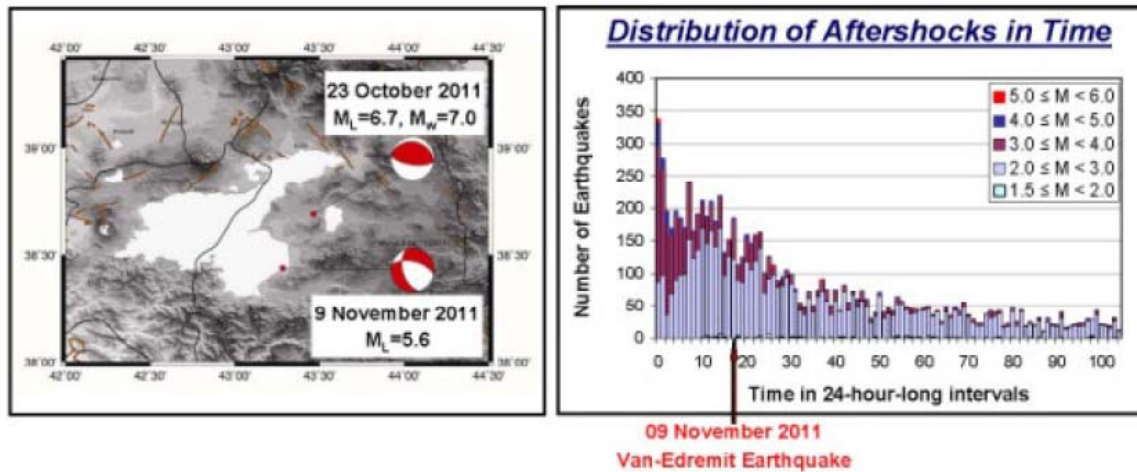
As a result of 23 October and 9 November 2011 earthquakes, 644 people lost their lives whereas 292 people were saved alive from the debris.
