LESSONS LEARNT FROM DAMAGE TO BUILDINGS BY BOHOL EARTHQUAKE AND TYPHOON YOLANDA 2013 IN THE PHILIPPINES

Tatsuo Narafu¹, Toyokazu Shimizu², Yasushi Sanada³, Yukio Tamura⁴, Noriyuki Mita⁵,
Susumu Takahashi⁶, Hayato Nakamura¹, Atsuko Itsuki¹

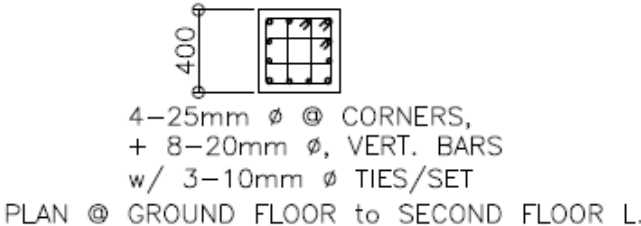
Figure 29 Description of design of section of beams in usual drawings

As to design of section of columns or beams, most of them have no description on position of rebar (Figure 29). The designed position could be figured out only when description of concrete cover thickness in another sheet of drawings is referred. These may lead workers without enough technical knowledge to think number of rebar is significant but position in not in that way, which might invite
