# **Report on the Damage Investigation of the 2001 Atico Earthquake in Peru**

**Koichi KUSUNOKI**

**Senior Researcher  
Building Research Institute of Japan**

April 2002

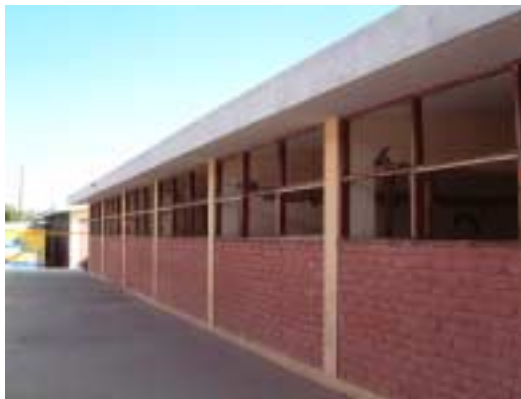
**Picture 2.1.2-1.** Appearance of schoolhouse. One-storied, brick spandrel wall.

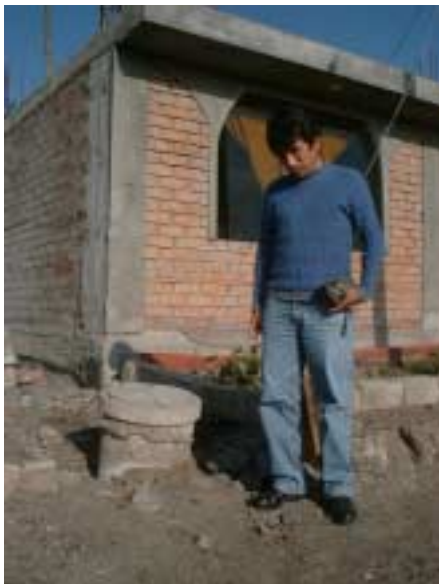
Digging to a depth of 1 m creates a stream, since the water table is only 80-100 cm below the soil surface. This district has the lowest elevation in Arequipa, and is close to a river. Several active volcanoes, including Mt. Misti, are near this area, where granite is quarried. Dwellings leaned towards the river due to outflow of soil following liquefaction.

**Picture 2-1-3-1.** Elevated manhole due to liquefaction.

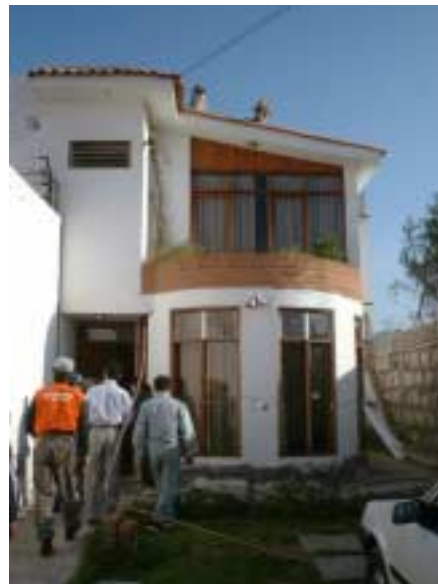
**Picture 2-1-3-2.** Full view of a building affected by liquefaction.

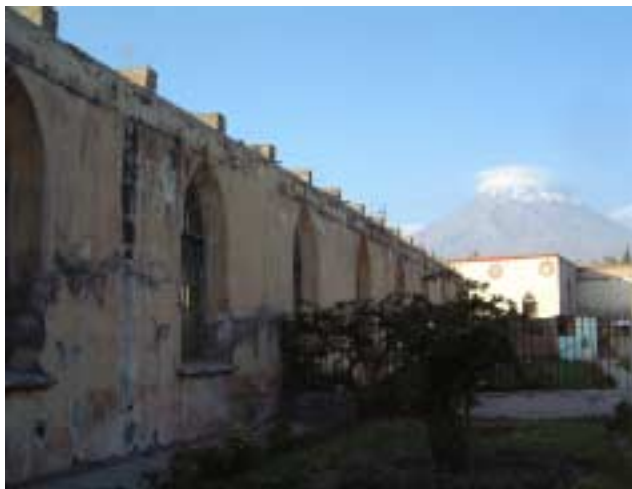
This hospital is located in the central area of Arequipa City. This is a one-storied sillar building. Story height is 5-6 m. Wall thickness is about 80 cm. Major damage includes collapse of walls at the corners of the building, damage to joints of upper openings in the longitudinal direction, and damage to parts where buildings are adjacent to each other. A beam in the span direction was added to the roof after the hospital was damaged by an earthquake in 1960.

**Picture 2-1-4-1.** Appearance of the building. Masonry, unique window shape. Beam added to the roof.

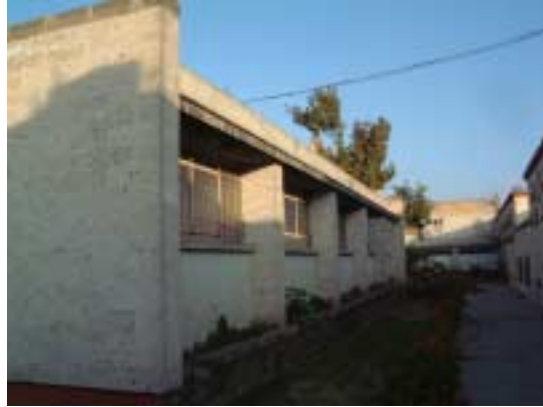
Another newly constructed sillar building within the same lot was intact.

**Picture 2-1-4-4.** New masonry building.

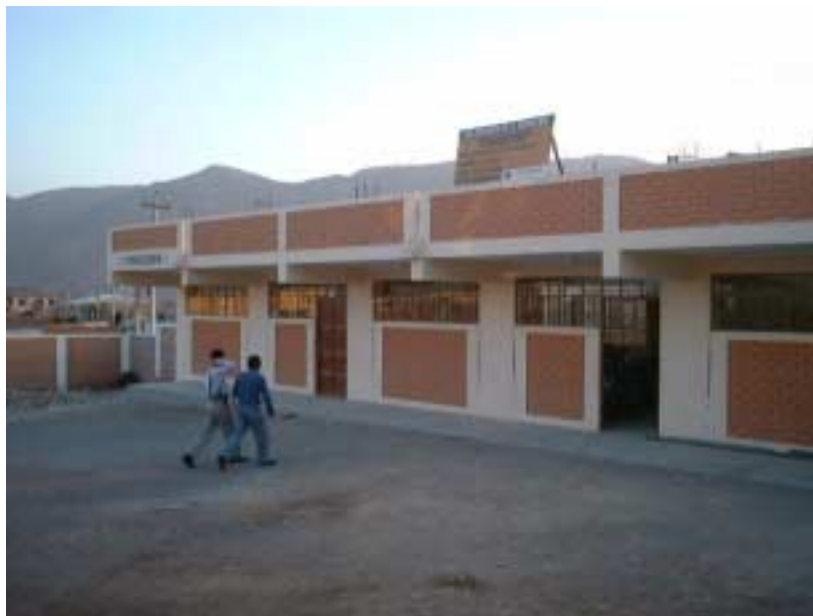
**Picture 2-1-5-1.** Full view of the building constructed in 1995. It was intact.

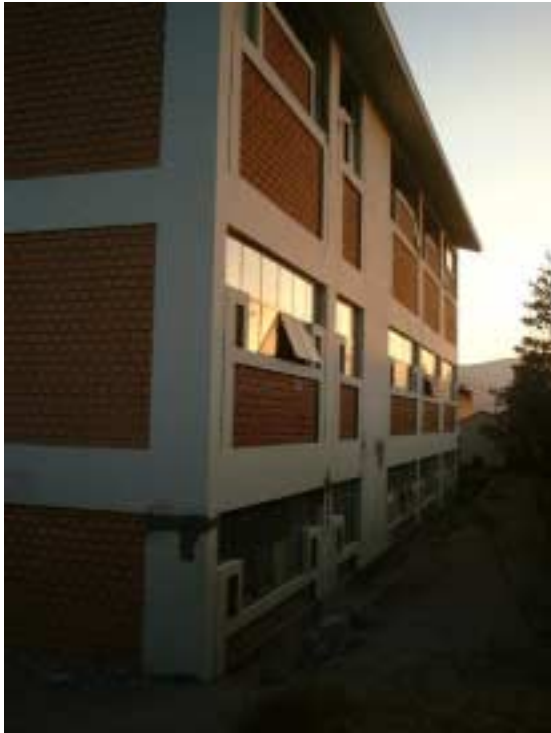
Two schoolhouses were constructed in 1993 and 1995, respectively. The one constructed in 1993 is three-storied and RC-framed. The other is one-storied and RC-framed. The latter was intact but the former suffered slight damage. Although hollow bricks were used for nonstructural walls and spandrel walls in the former schoolhouse, they had collapsed out-of-plane because no reinforcement was provided within the walls. In both buildings, there were 3 cm wide slits around nonstructural walls revealing the insulating foam inside. The columns were intact.

**Picture 2-1-5-2.** Full view of the schoolhouse constructed in 1993.

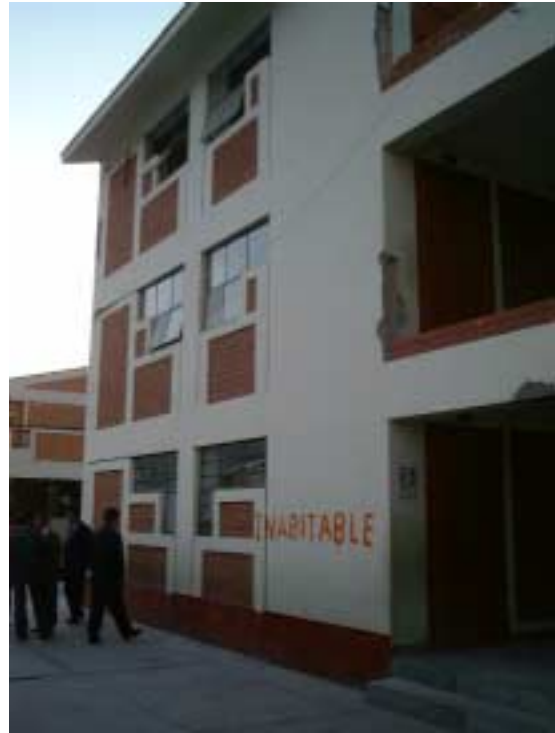
**Picture 2-1-5-3.** On the near right, the hollow brick walls of the second and third floors can be seen to have collapsed.

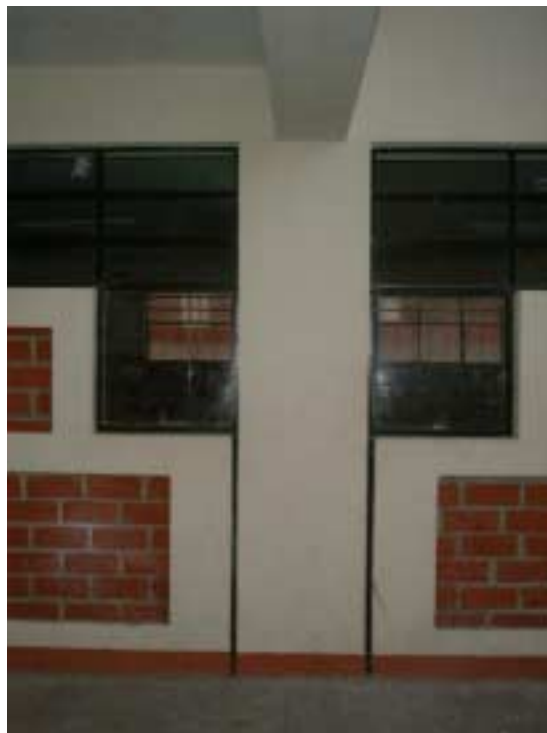
**Picture 2-1-5-4.** Slit (black part) between the wall and the structural column.

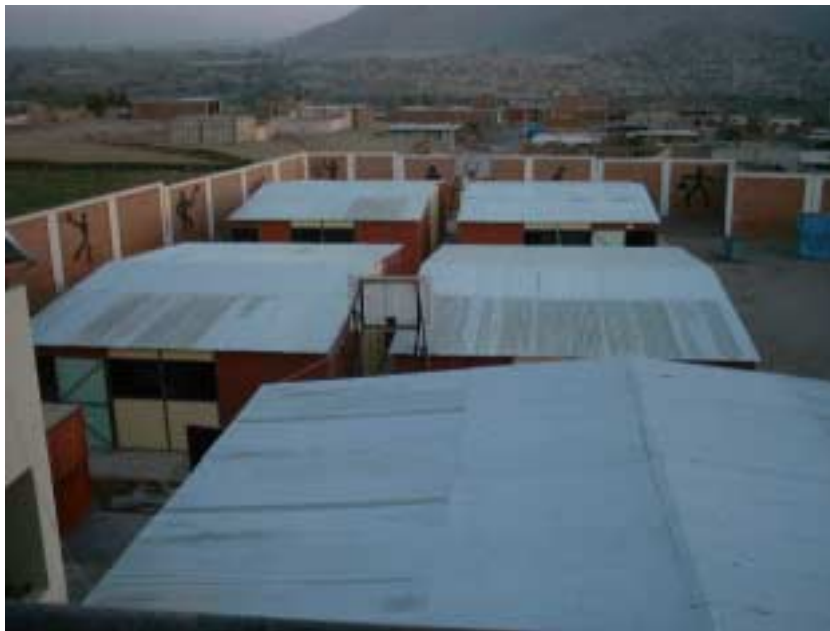
**Picture 2-1-5-6.** Classes are now being held in a temporary school building constructed on the playground.

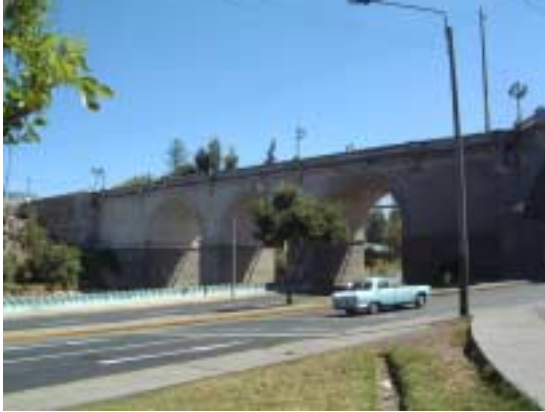
This masonry bridge crosses the river, which runs past the Centro (the central part of the old town) in Arequipa City. Displaced stone blocks used for the balustrade, ripples in the road surface, and cracks on the surface indicating extension in the crosswise direction can be seen. A loosened joint in the upper arch can also be observed. The lowermost foundation part of the bridge was intact.

**Picture 2-1-6-1.** A bridge near Centro. Masonry arched bridge.

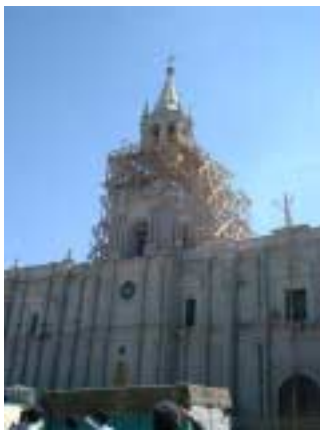
**Picture 2-1-7-2.** Tower under repair.

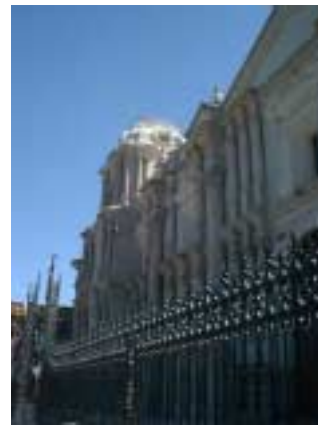
**Picture 2-1-7-3.** Partially collapsed tower.

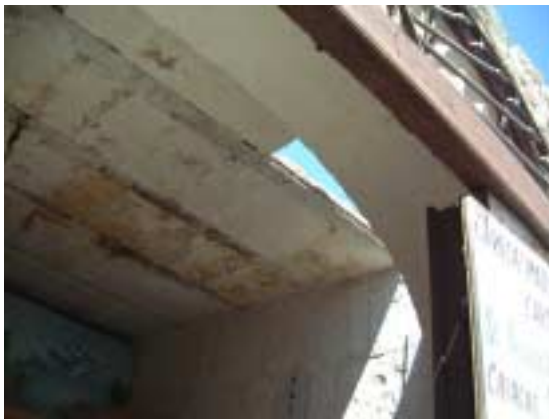
**Picture 2-1-8-3.** Structure of the top floor roof. Steel rail and sillar roof.

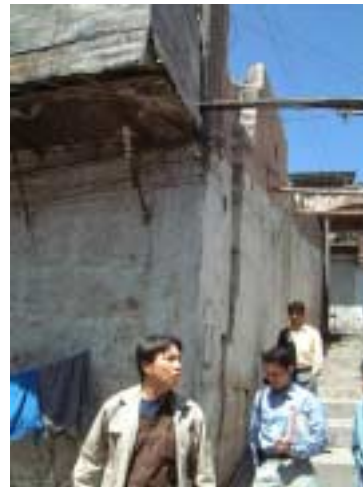
The roof of the top floor and the roof arch between buildings fell to the ground. There were many cracks, probably due to the earthquake, and loosening of joints.

**Picture 2-1-8-4.** Falling roof arch. Out-of-plane deformation of masonry wall with falling arch.

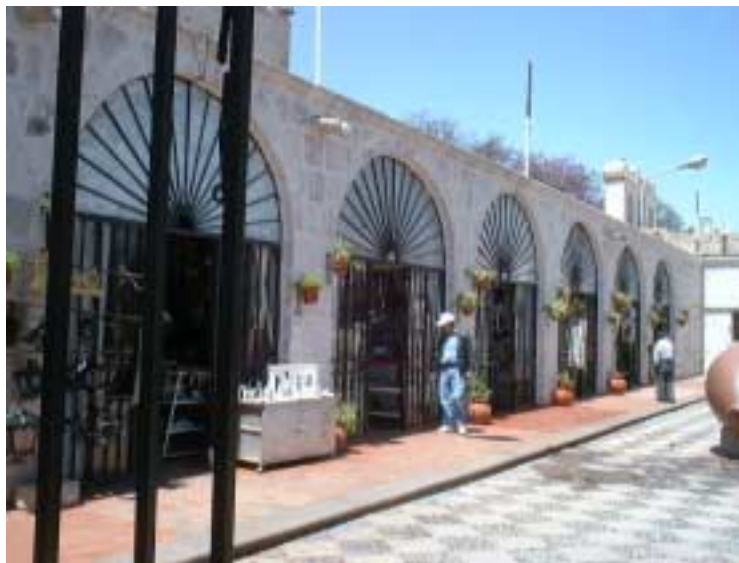
**Picture2-1-9-2.** Sillar blocks were used as structural elements.

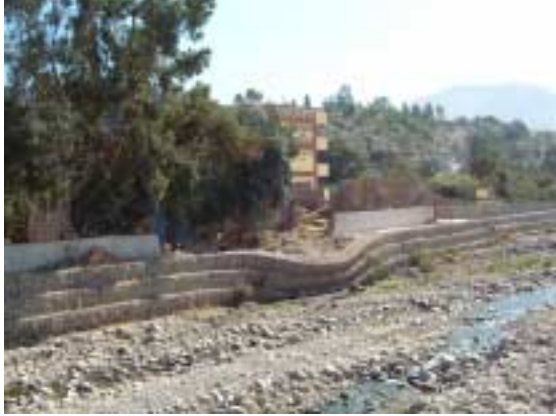
The revetments of the river running through Moquegua City moved toward the river. It was difficult to ascertain from a distance; however, it can be assumed from the state of deformation that the revetment was constructed using gabions.

**Picture 2-2-2-1.** Deformation of the revetments.

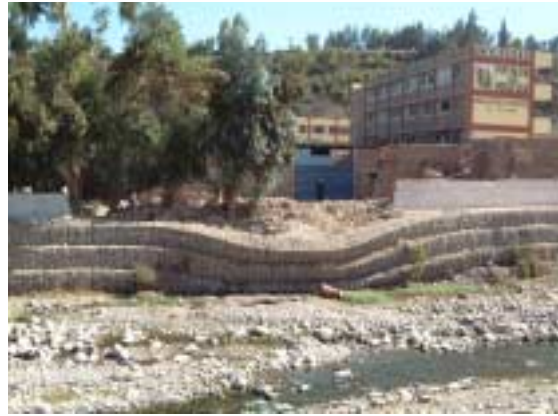
**Picture 2-2-2-2.** Deformation of the revetments.

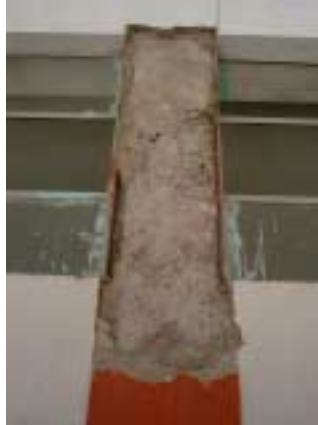
**Picture 2-2-3-3.** Short column. Wide space between lateral reinforcing bars.

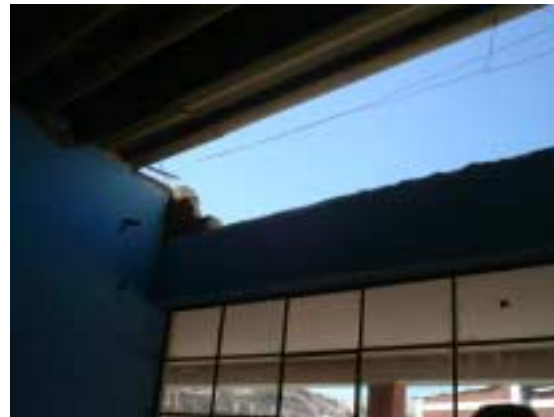
**Picture 2-2-3-5.** Some of the roof supports collapsed.

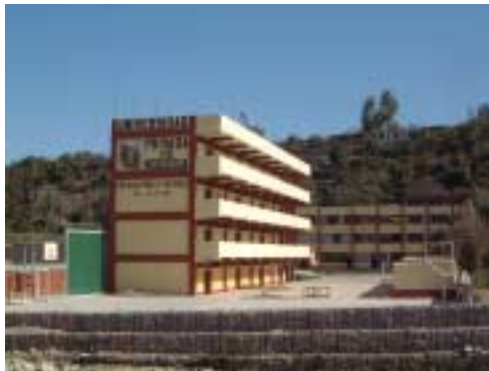
Constructed in 1995 with a 7 x 2 span. Its stretcher has an anomalous span length. Most columns in the northern part of the first floor show shear failure. The ground had been dug up to inspect the foundations.

**Picture 2-2-4-1.** Appearance of the building.

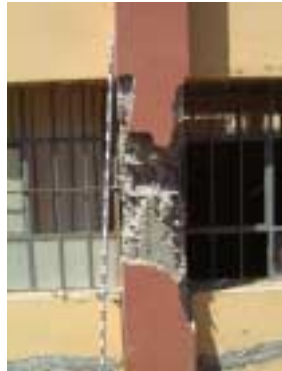
**Picture 2-2-4-2.** Damaged column.

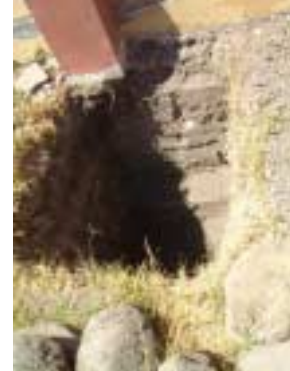
**Picture 2-2-4-3.** Soil investigation.

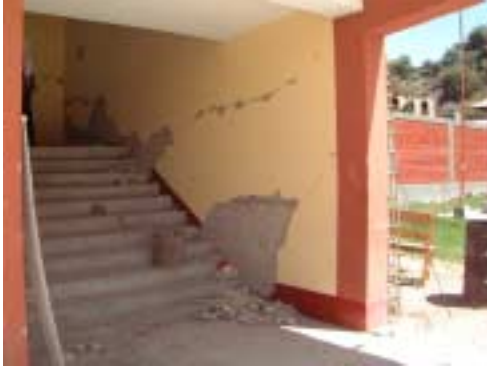
Hollow brick walls are infilled into RC frames. The building was constructed in 1991 with a 9 x 1 span. Two spans to the north side had separated with expansion joint. It was thought that this separation resulted due to the rigidity of the staircase. There was also a plan for the building to be extended upward. All partition walls consisted of bricks. Shear failures were observed over doors on partition walls and in decorative beams in corridor walls. There was a window in the upper part.

**Picture 2-2-4-4.** Brick wall of the staircase.

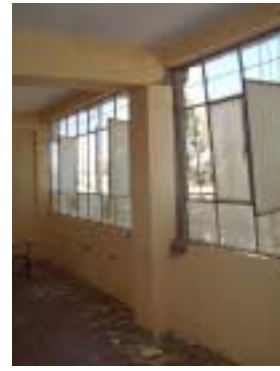
**Picture 2-2-4-5.** Damaged long column.

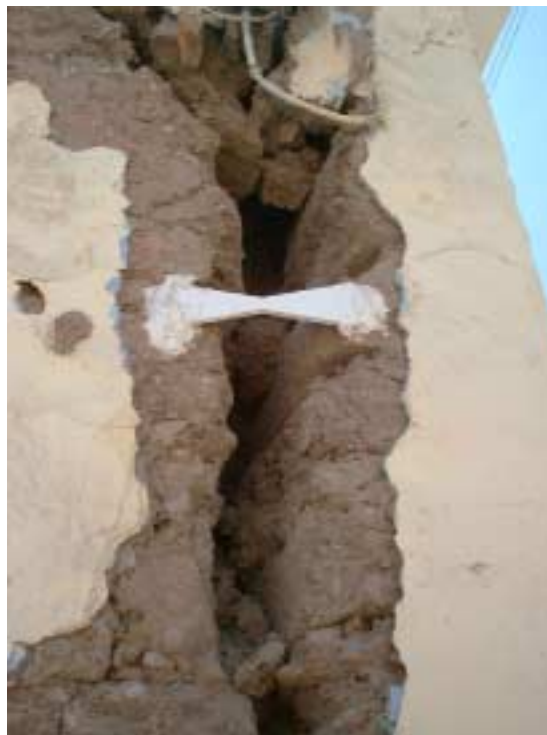
**Picture 2-2-5-5.** Equipment for measuring increases in crack width, installed by INC.

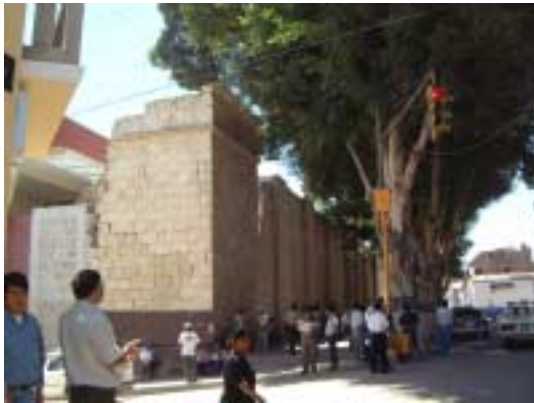
This is the façade of a building constructed in 1792. It also suffered damage from the earthquake of 1868, in which the back surface of the wall was removed. Damage from this earthquake was not too serious: some of the sillar blocks in upper wall toppled. However, a bench is still in place beneath the part where some

sillar blocks fell, and people still sit on the bench. This is extremely dangerous because of the risk of more falling objects. We informed INC of this.

**Picture 2-2-6-1.** Full view of the wall.

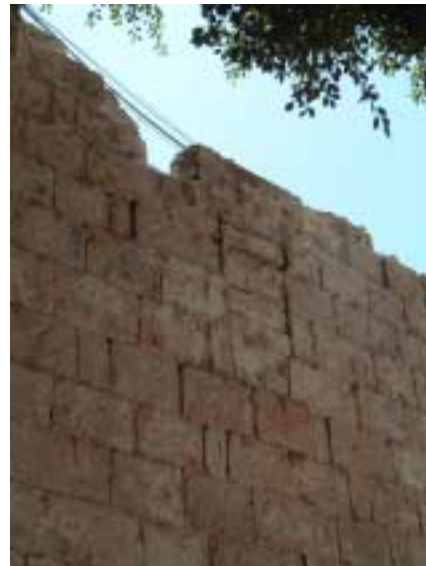
**Picture 2-2-6-4.** Displaced upper wall.

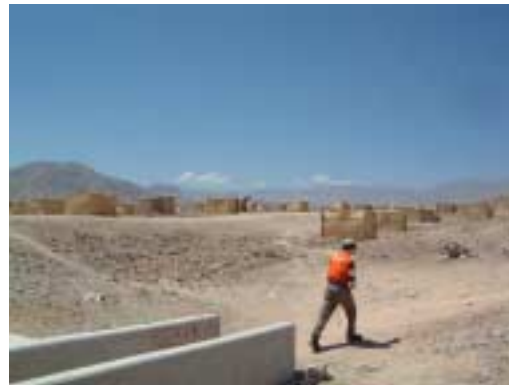
It is planned to move the population from the seriously damaged San Francisco District to the Pampa de Chanchan district. However, its expandable clay soil is now under survey and measures are being discussed. Problematic illegal occupancy has already occurred. Some people have already obtained homes in other districts and rent illegally occupied dwellings to others. Roads to the center of the city are under construction in the area.

**Picture 2-2-8-2.** Illegal occupancy.

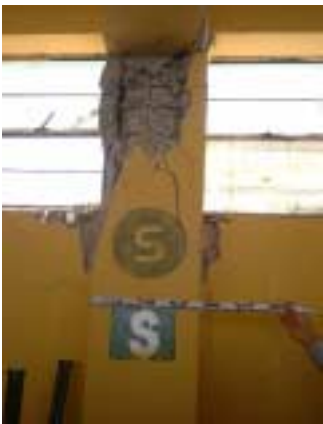
**Picture 2-3-4-4.** Shear failure of the column on the window side about 35 cm in width.

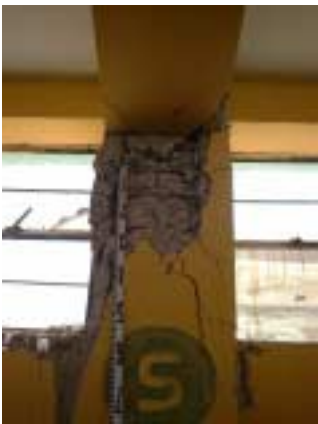
**Picture 2-3-4-5.** The space between the lateral reinforcing bars of the shortened column measured about 12 cm.

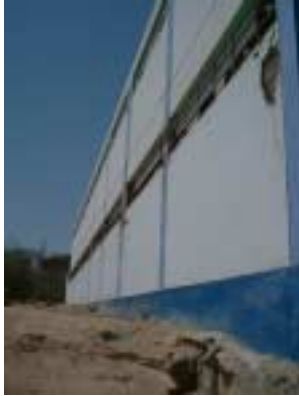
**Picture 2-3-4-6.** Most columns on the window side of the first floor show shear failure due to their shortness.

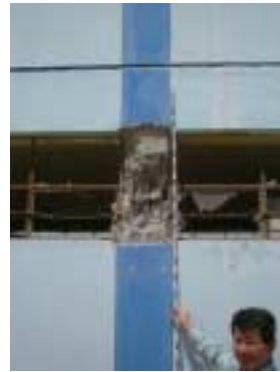
**Picture 2-3-4-7.** The outside of column on the window side. This column has few lateral reinforcing bars.

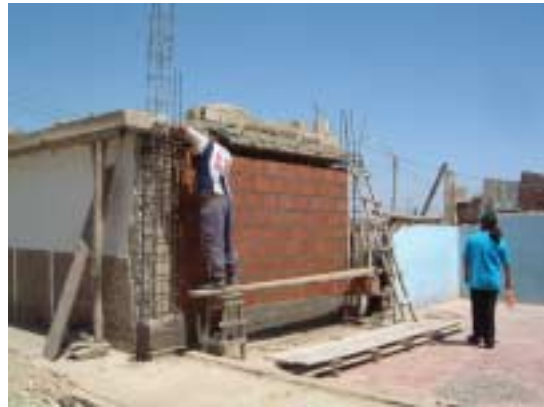
Some brick buildings were under repair work.

**Picture 2-3-5-4.** Repair work nearby.
