**STUDY TRIP TO ITAKO CITY**

A Technical Report

**By MARTINEZ BRAVO Delvin Abdiel (MEE10515)**

**Disaster Management Policy Program (2010-2011)**  
**(Earthquake Engineering)**

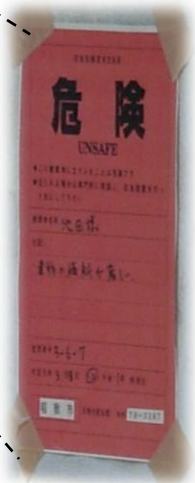
**Photo 8a) and 8b). Settlement of the building.** Due to liquefaction phenomenon, several building suffered severe settlement like this building of two stories at Inashiki city. The settlement was around 1.8m, this is enough for become useless the building, the message in front side (8b) indicate that the building is “UNSAFE”. This message was collocated after the earthquake by the inspector from the local government.
