INTERNATIONAL INSTITUTE OF SEISMOLOGY AND
EARTHQUAKE ENGINEERING (IISEE)

REPORT OF STUDY TRIP (TOHOKU)

14 – 18 November 2011

Prepared by: Nur Intan Irzwanee Nurashid
T course
(Malaysia)
5/12/2011

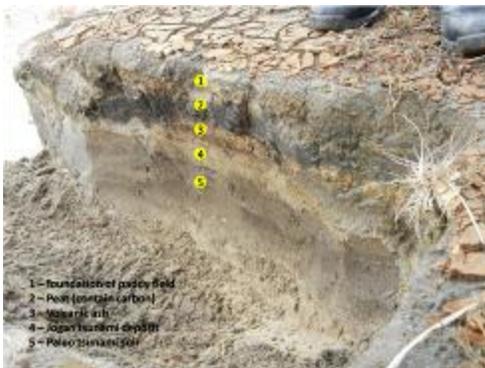
After that we visited Arahama area, the most devastated area, accompanied by Dr. Suguwara. He guided us visiting around the inundation area. The first place we stopped by was a paddy field for sediment observation purposed. This point located within 4 km of the inundation area and totally destroyed by the tsunami in March 2011. After 8 months it was still undergoing reconstruction process. We found the deposit of the 869 Jogan tsunami below the volcanic ash from the 11,000 –

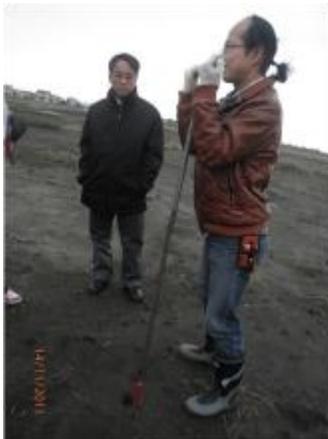
Figure 1.4. Hand Auger.

We moved forward to another paddy field located about 2.7 km from the coastline for another sediment observation. Hand auger was used to dig up some soil. We found the 869 Jogan deposit and a layer of older tsunami deposit beneath. It is believed to be a tsunami soil of the tsunami that occurred 2000 year before the Jogan tsunami. The layer below was unidentified except for the grey layer at the bottom part identified as paleo soil which contained rice paddy field.

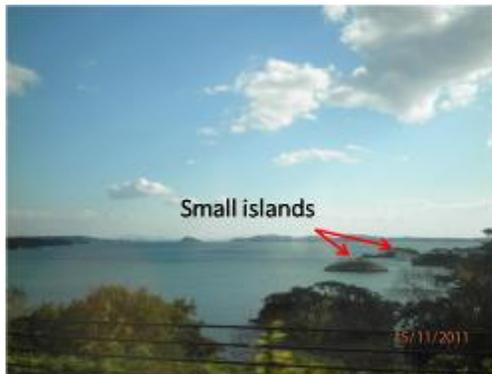
On the second day, we visited Matsushima. It is a group of islands in Miyagi prefecture. The area was protected by its natural geography and suffered less damaged from the tsunami of the Tohoku Earthquake. The observed tsunami height was from 1 – 2 m. The evacuation area was about 500 meters from the coastline and the signs were found on the sidewalk.

Figure 2.1. Small islands in Matsushima which reduced the tsunami impact.

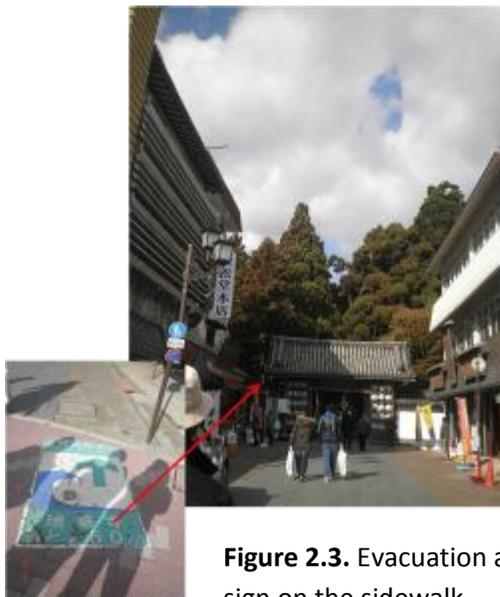
Figure 2.3. Evacuation area sign on the sidewalk.

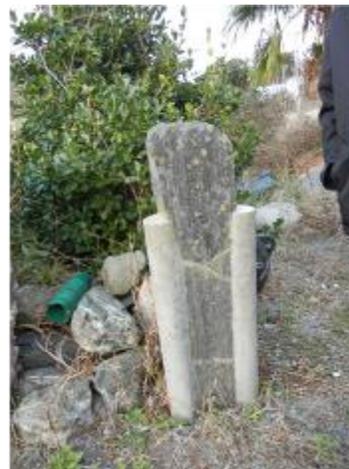
In Ofunato Bay, we found a broken monument of 1933 Showa Sanriku tsunami. About 200 m away we found a monument of 1896 Meiji Sanriku tsunami still intact on the ground. The area was inundated during the tsunami in March 2011.

Figure 3.3. The 1896 Meiji Sanriku tsunami monument in Ofunato Bay.

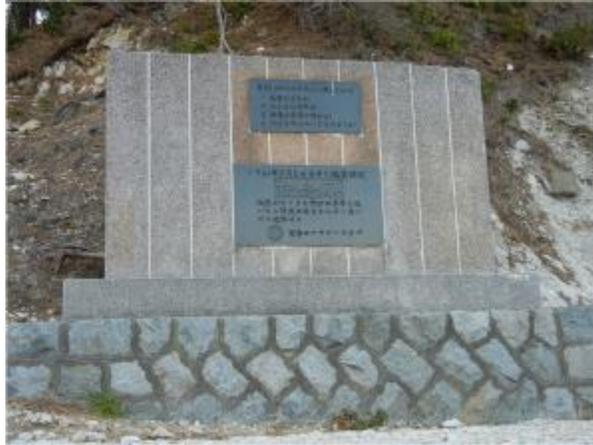
Figure 4.2. 1933 Showa Sanriku tsunami in Jodogahama Beach.

In Jodogahama beach area, 2 monuments were here as the evidence this area was hit by Showa Sanriku and Chilean tsunami in 1933 and 1960 respectively. Jodogahama beach was also damaged by tsunami in March 11, 2011. The place now has been restored and no debris can be found here. However the trace of water level can be seen from the hills and trees nearby.

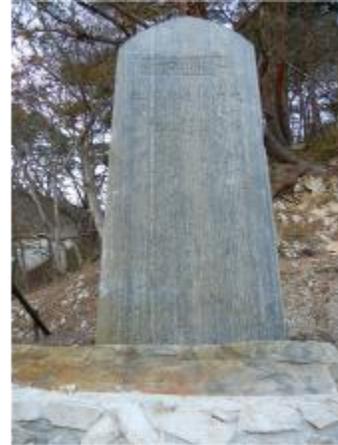
Figure 4.3. 1960 Chilean tsunami in Jodogahama Beach.

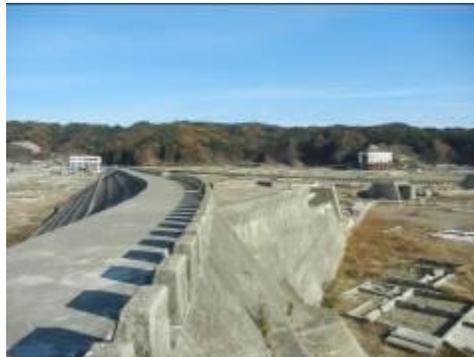
On the final day, we visited Taro area in Iwate Prefecture. The town had two 10 meter tall seawalls to prevent flooding from tsunami. The seawalls were designed to divert tsunami water to the side of the town, so that the damage of the residential area was minimized from tsunami as high as 15 m. However, the seawall did not protect the town when an earthquake and tsunami struck Japan on 11 March 2011 with a height estimated from 12 m to 37.9 m. The residential area was totally destroyed and the areas now are in clearing process. There were a few buildings still standing only with its outer frame intact. One of them is Taro Kanko Hotel.

Figure 5.1. Embankment in Taro.

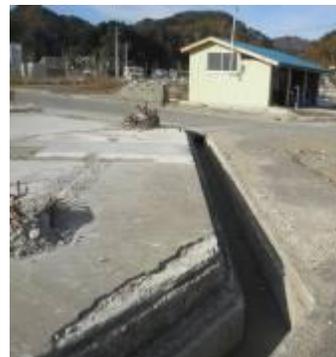
Figure 5.2. The road in Taro was designed for easier evacuation.

We went up to the higher ground which had been designed as the evacuation place in this area. According to the local resident that we met there, about 40 – 50 peoples came here for evacuation. The road in this town had been designed in such a way to make it easier for evacuation. It didn't have this normal 90 degrees corner instead it was built as in diamond shape to make the road bigger for easy evacuation escaped (Figure 5.2). We went to the Taro Kanko Hotel to have a better look of the damaged. Damaged can be observed up until level 3 of the building, which was about 12 m from ground level.
