Citation: Leger, V., T. Azuhata (2022), Structural performance evaluation of cyclone resilient houses damaged due to tsunami after the January 2022 Hunga Tonga – Hunga Ha'apai volcanic eruption, Synopsis of IISEE-GRIPS Master's Thesis.

# STRUCTURAL PERFORMANCE EVALUATION OF CYCLONE RESILIENT HOUSES DAMAGED DUE TO TSUNAMI AFTER THE JANUARY 2022 HUNGA-TONGA-HUNGA-HA'APAI VOLCANIC ERUPTION

Victorina Stephanie Nodis LEGER<sup>1</sup> MEE21714 Supervisor: Tatsuya AZUHATA<sup>2</sup>

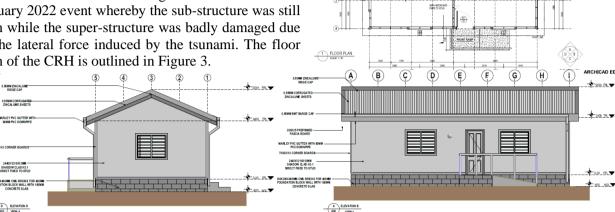
The Cyclone Resilient House is a 2-room timberframed structure on RC slab and foundation. It is designed to 70m/s design wind speed and in Wind Region C high cyclonic areas. The shear wall panels of the structure are the focus of the analysis in this research based on the damages occurred after the January 2022 event whereby the sub-structure was still firm while the super-structure was badly damaged due to the lateral force induced by the tsunami. The floor plan of the CRH is outlined in Figure 3.

Figure 3: Floor plan and elevation of the CRH

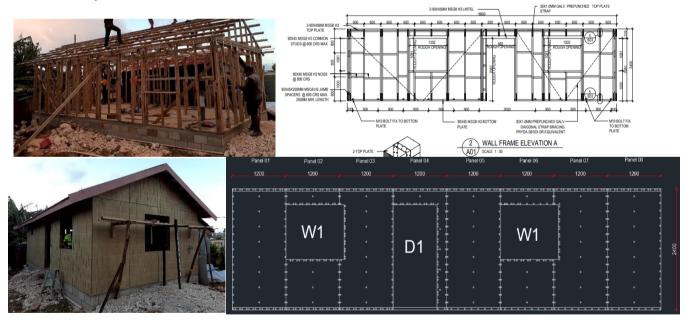
The structure of the timber shear wall comprises of three things: timber frame, plywood cladding and the nail for connections of the two. The timber-framed structure is based on the Australia Standard AS1720-1997. This 100mm x 50mm sized timber is framed according to Figure 4 for each wall sections in both x and y directions.

Figure 4: Shear walls from timber framed to bracing and nailed connections to timber panels

- i. Shear walls capacity depends mainly on the nail-joint properties although not specifically enforced in the construction of the CRH. Increasing the number of nail joints leads to increasing the shear wall racking capacity.
- ii. CRH can also be used as an Earthquake Resilient House.
- iii. CRH is not safe for tsunami when the tsunami inundation depth exceeds 1m. CRH should not be recommended to build at coastlines because of its vulnerability to tsunami disaster.
- iv. Alternatives in place to substitute for CRH in the case of tsunami shelter reconstructions.
- v. Cost review analysis of different type of structures.

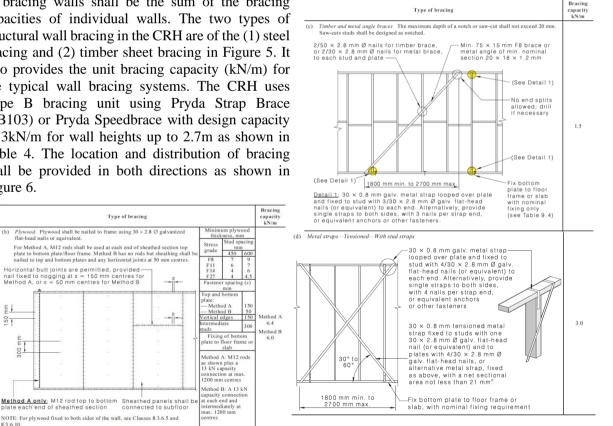
of bracing walls shall be the sum of the bracing capacities of individual walls. The two types of structural wall bracing in the CRH are of the (1) steel bracing and (2) timber sheet bracing in Figure 5. It also provides the unit bracing capacity (kN/m) for the typical wall bracing systems. The CRH uses Type B bracing unit using Pryda Strap Brace (SB103) or Pryda Speedbrace with design capacity of 3kN/m for wall heights up to 2.7m as shown in Table 4. The location and distribution of bracing shall be provided in both directions as shown in Figure 6.

Figure 6: Length of Wall bracing – timber panel
