Seismic and Tsunami Damage on Building Structures Caused by the 2011 Tohoku Japan Earthquake

MIDORIKAWA Mitsumasa
Hokkaido Univ.

Damage to Buildings Caused by Ground Shaking and Tsunami

Summary of damage reconnaissance by the Steel Structures Committee of AIJ

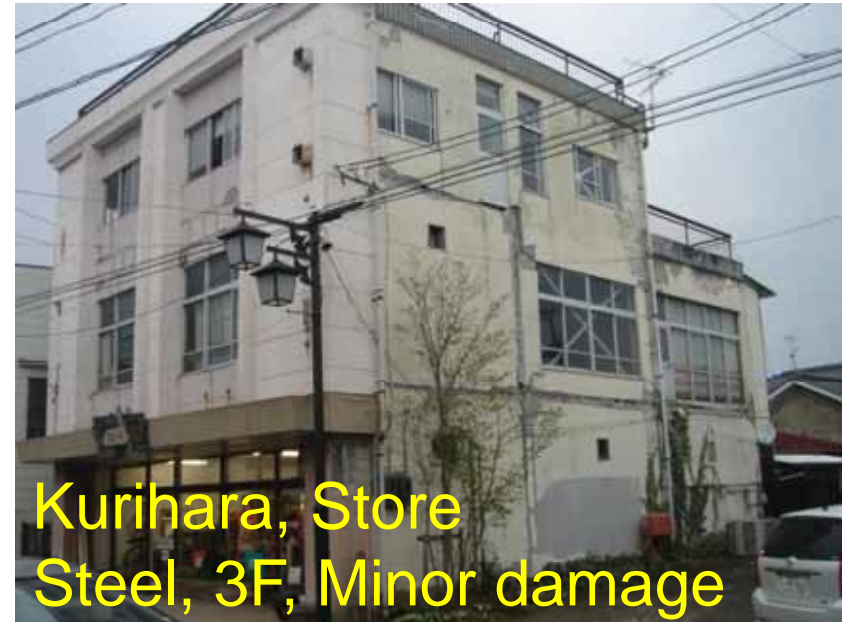
Kurihara, Store
Steel, 3F, Minor damage

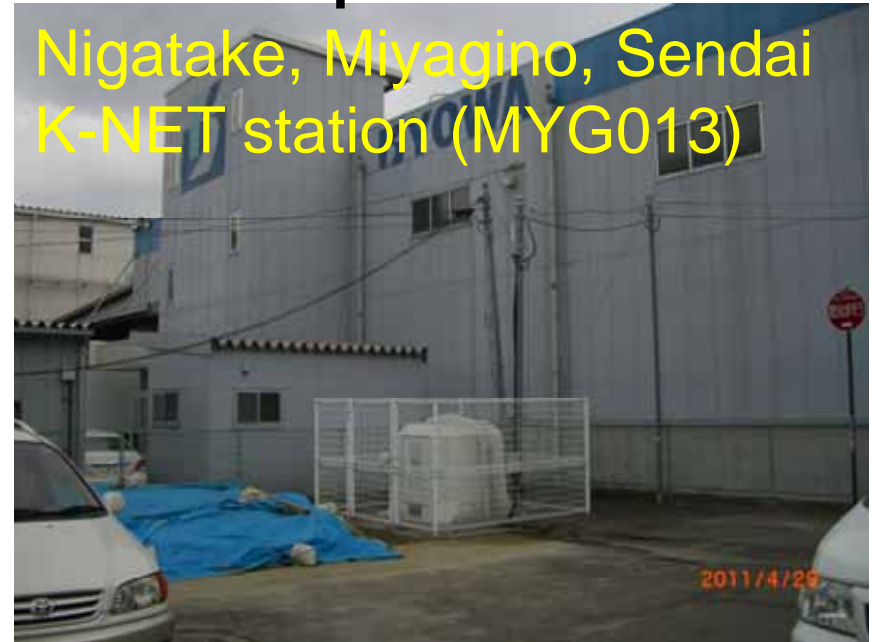
Nigatake, Miyagino, Sendai
K-NET station (MYG013)

Leaned by liquefaction

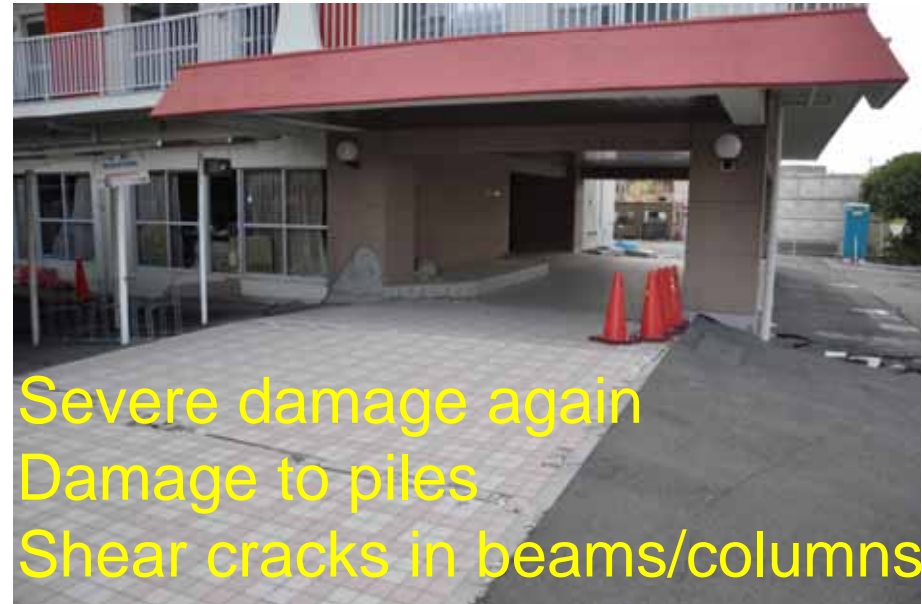
Sunny Heights Takasago (SRC, 14F, 189 units)-1

Fukumuro, Miyagino, Sendai
Apartment, SRC, 14F
Completed in 1976
Damaged by 1978 Earthquake
Two piles (24m) repaired

Severe damage again
Damage to piles
Shear cracks in beams/columns

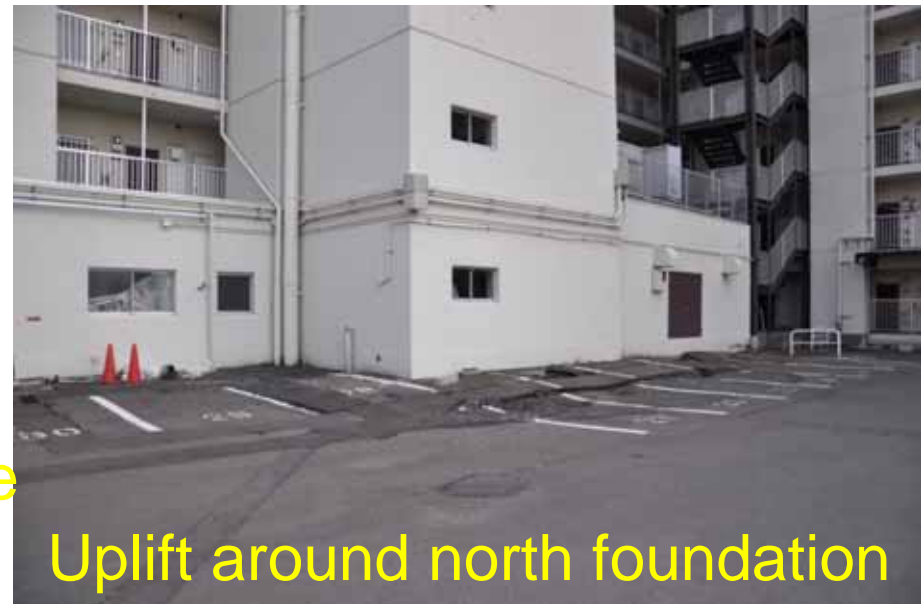
Uplift around north foundation

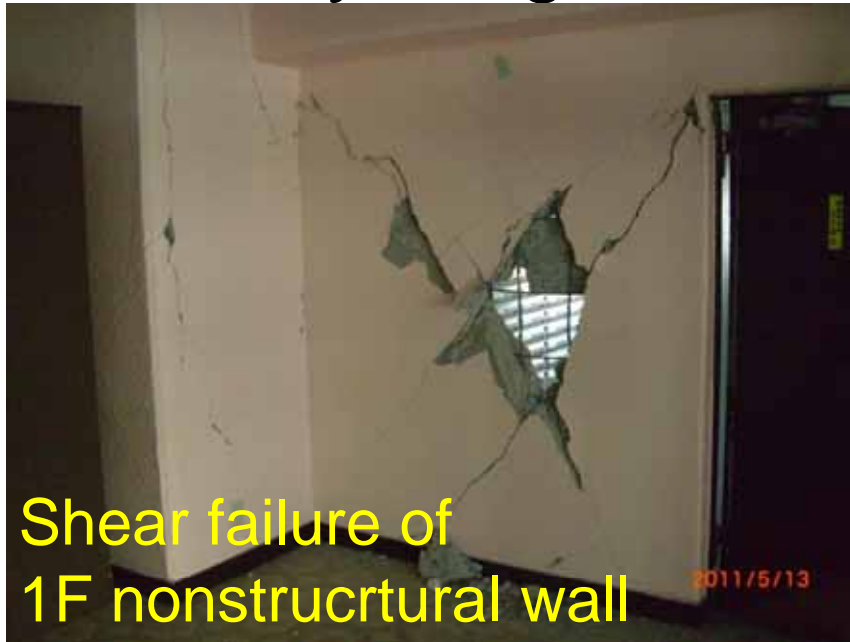
Sunny Heights Takasago (SRC, 14F)-3

Shear failure of
1F nonstructural wall

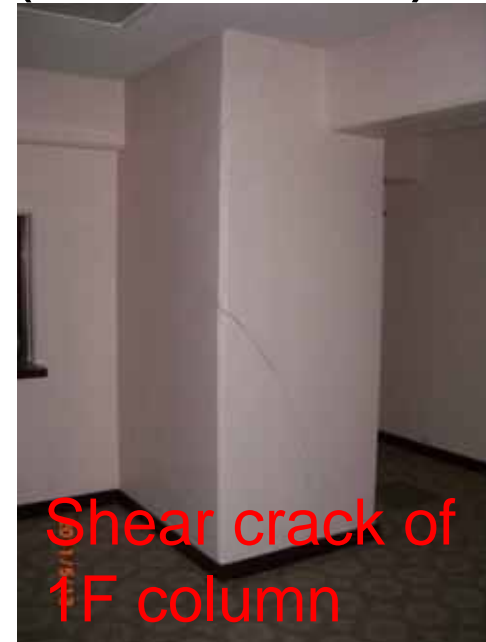
Shear crack of
1F column

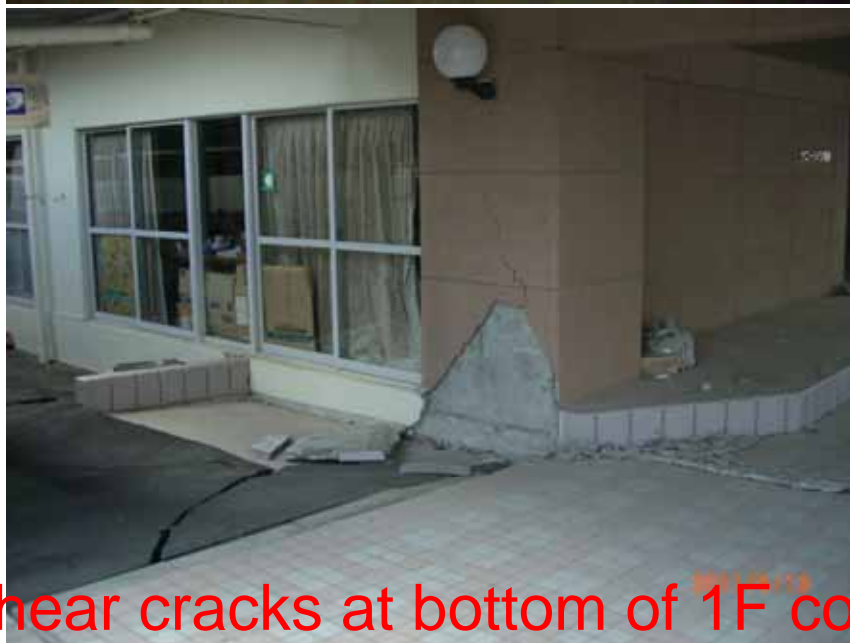
Shear cracks at bottom of 1F column

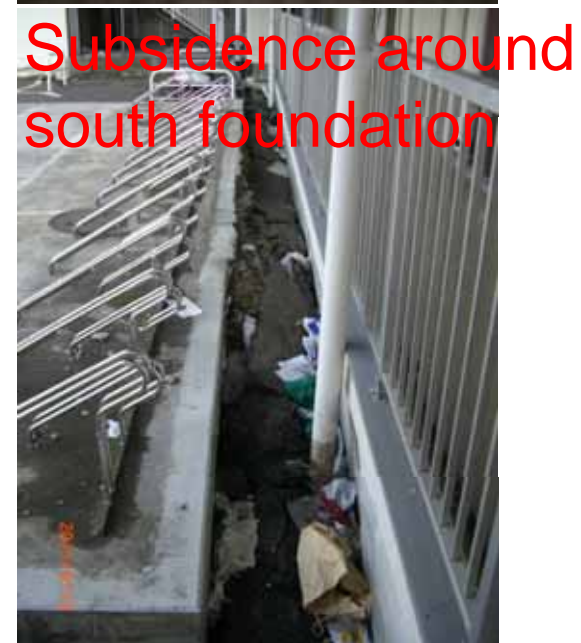
Subsidence around
south foundation

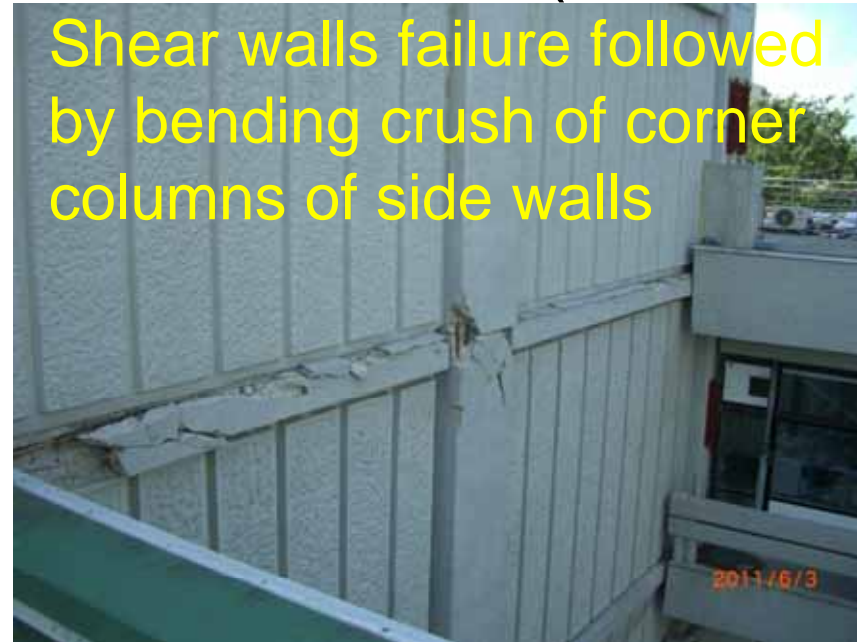
Tohoku Univ. (SRC, 9F)-3 Civil Engrg. & Architecture

Shear walls failure followed by bending crush of corner columns of side walls

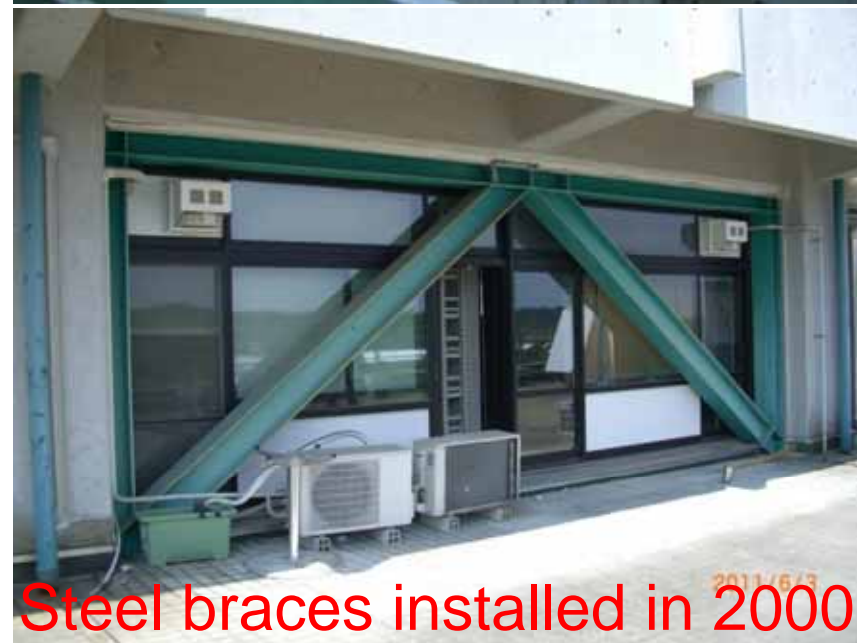
Steel braces installed in 2000

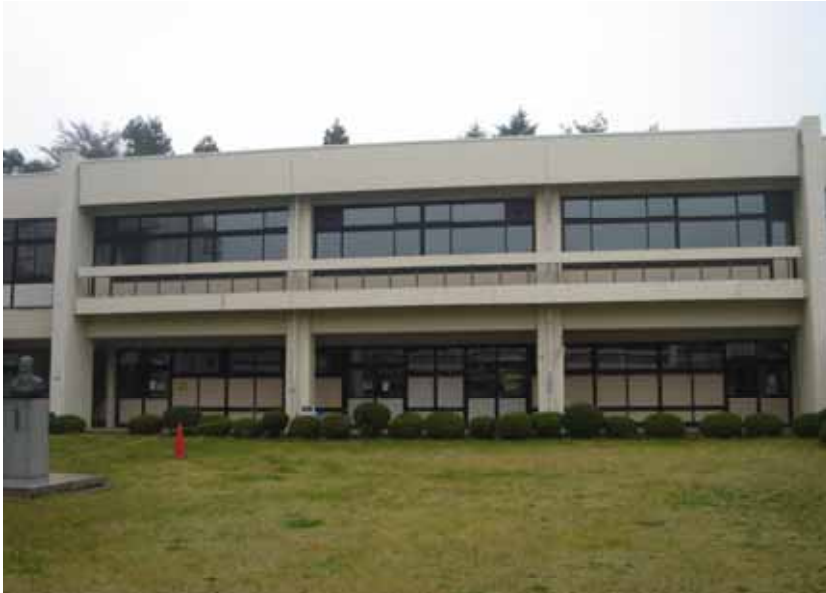
Tohoku Univ. (RC, 2F) Electrical Engrg. & Applied Physics

Aoba, Sendai
School, RC, 2F
Completed in 1966

Shear failure of
first story columns

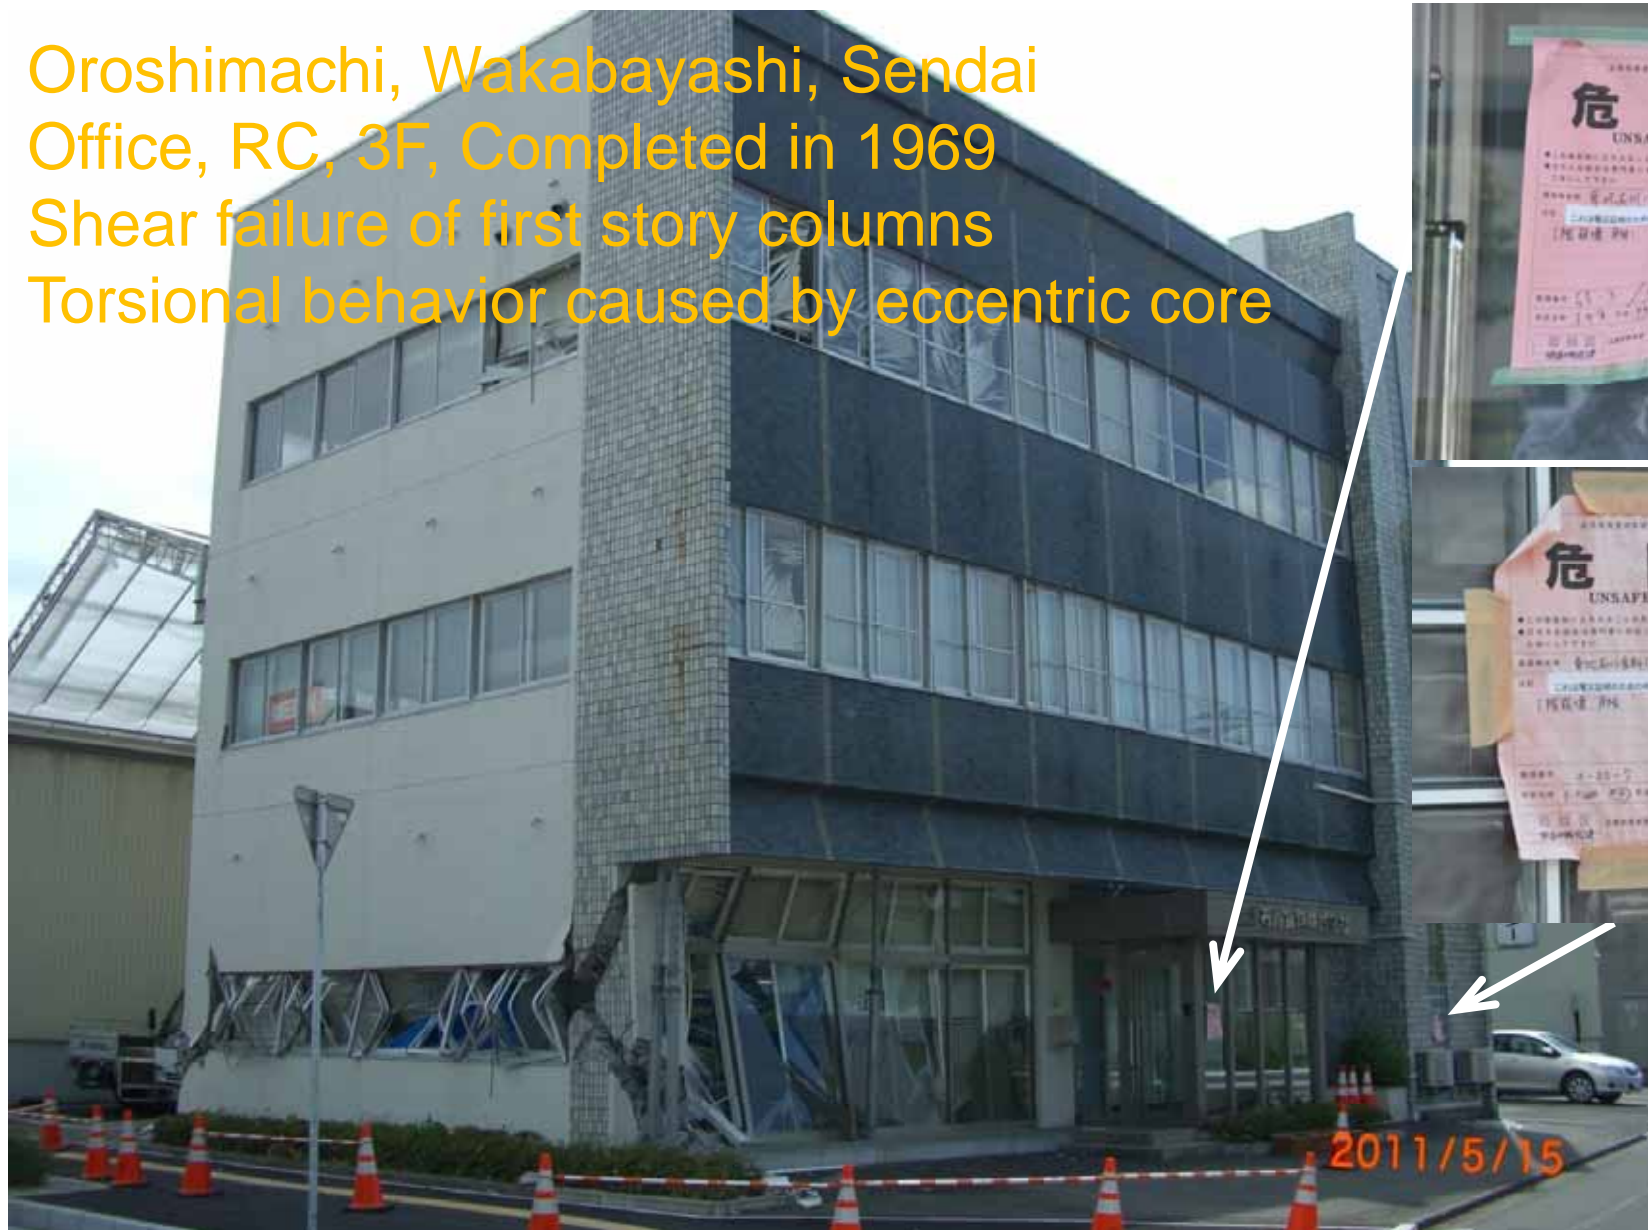
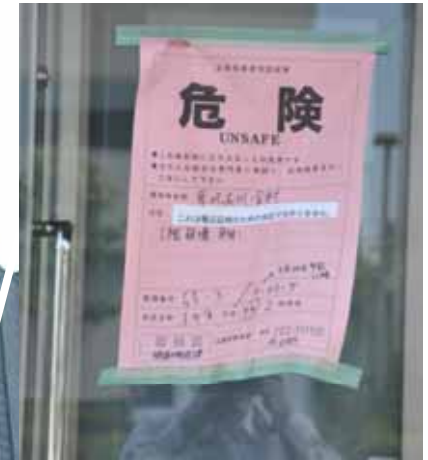
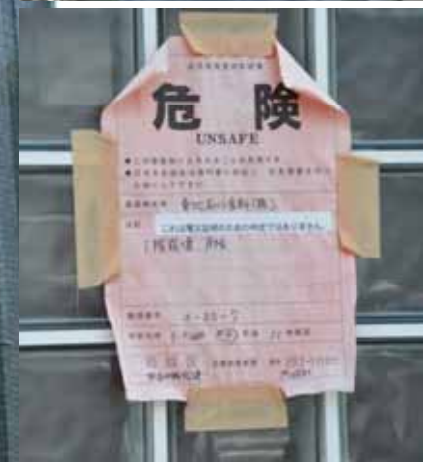
Severe damage to RC Building (3F) 1-1

Shear failure of first story columns

Torsional behavior caused by eccentric core

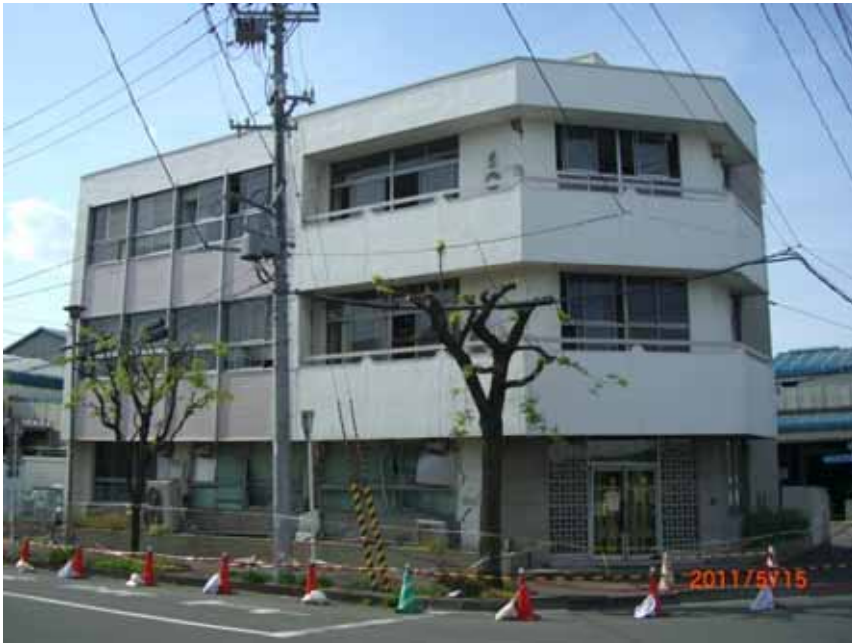
Severe Damage to RC Building (3F) 2-1

Higashimiyagino, Miyagino, Sendai
Office, RC, 3F
Shear failure of first story columns

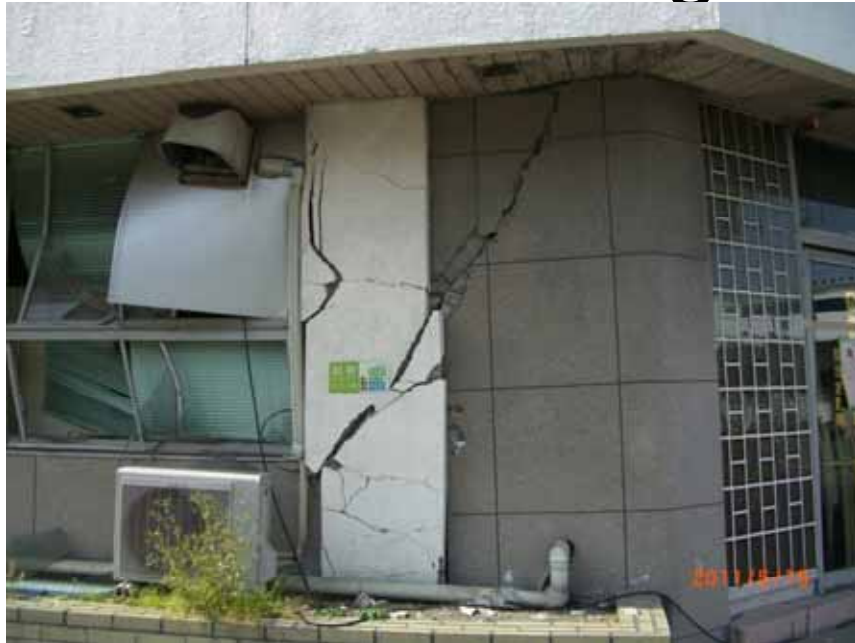
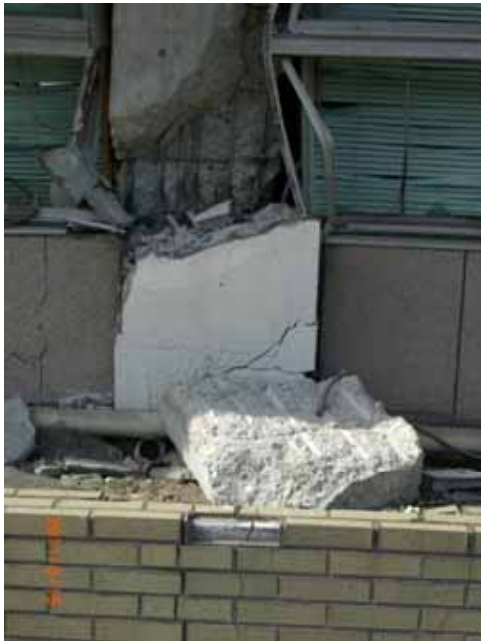
Severe Damage to RC Building (3F) 2-2

Longitudinal bars & tie:
round bars

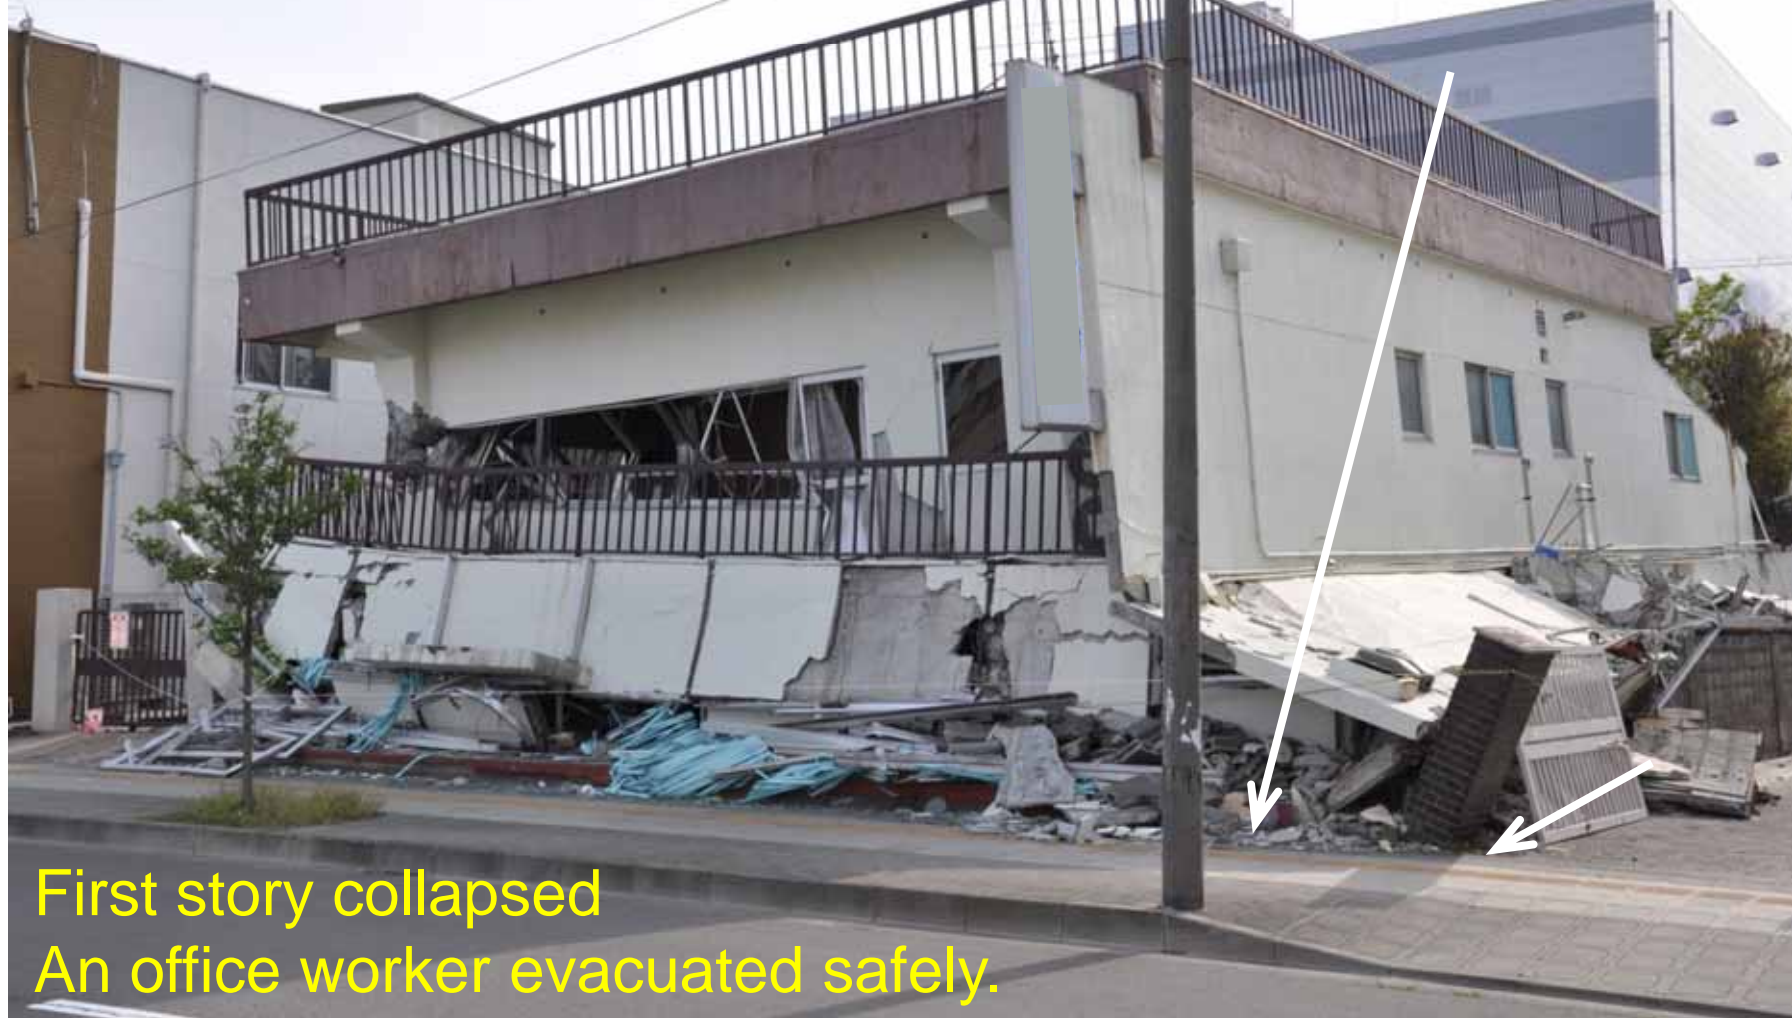
Collapsed RC Building (2F) 3-1

Oroshimachi, Wakabayashi, Sendai
Office, RC, 2F, Completed in 1969

First story collapsed
An office worker evacuated safely.

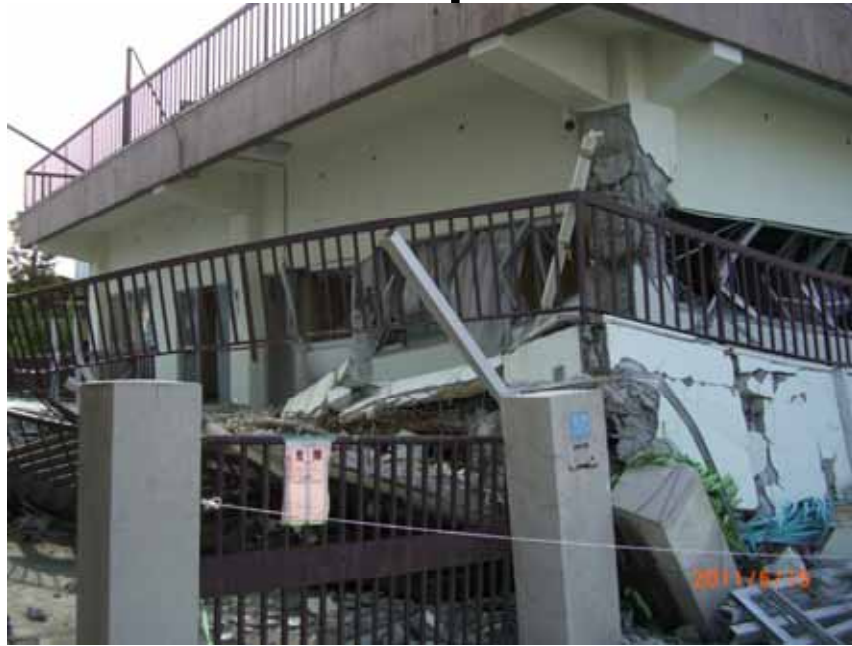
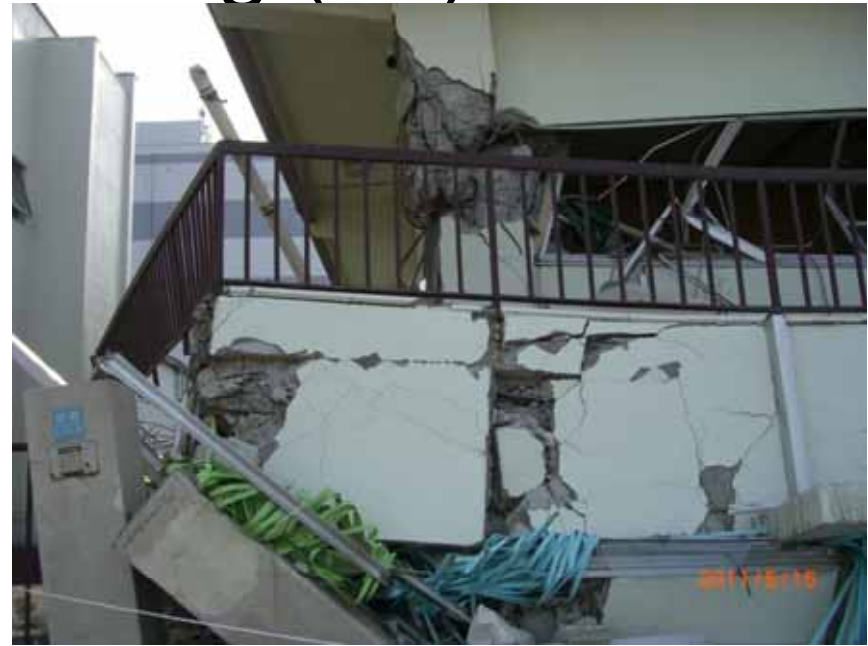
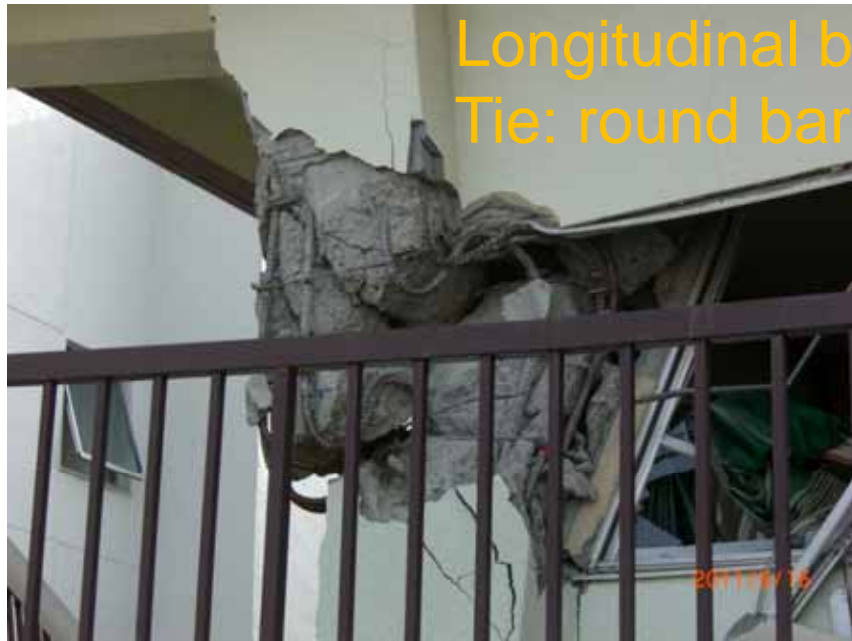
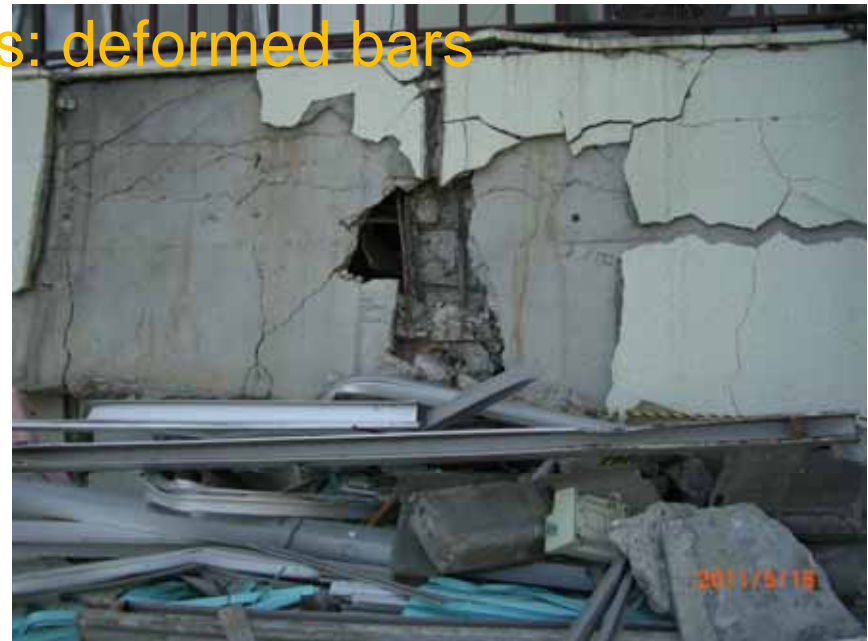
Collapsed RC Building (2F) 3-2

Longitudinal bars: deformed bars
Tie: round bars

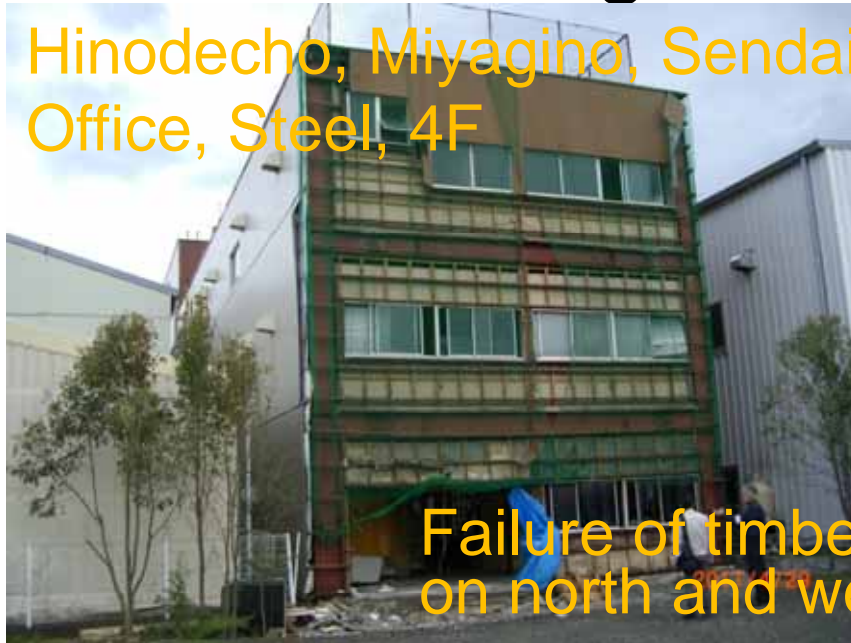
Severe Damage to Steel Building (4F) 2-1

Failure of timber lath-and-mortar cladding
on north and west sides

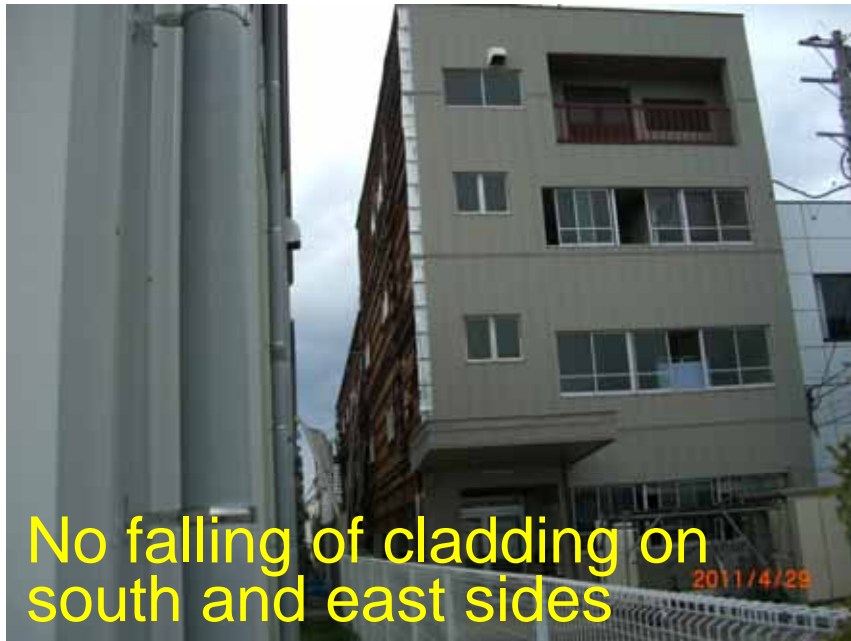
No falling of cladding on
south and east sides

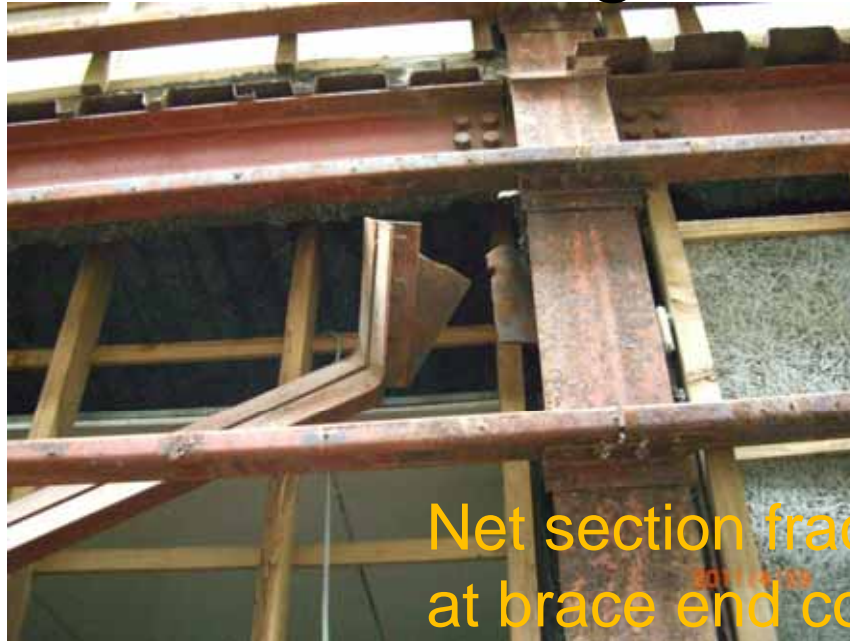
Severe Damage to Steel Building (4F) 2-2

Net section fracture of gusset plate
at brace end connection

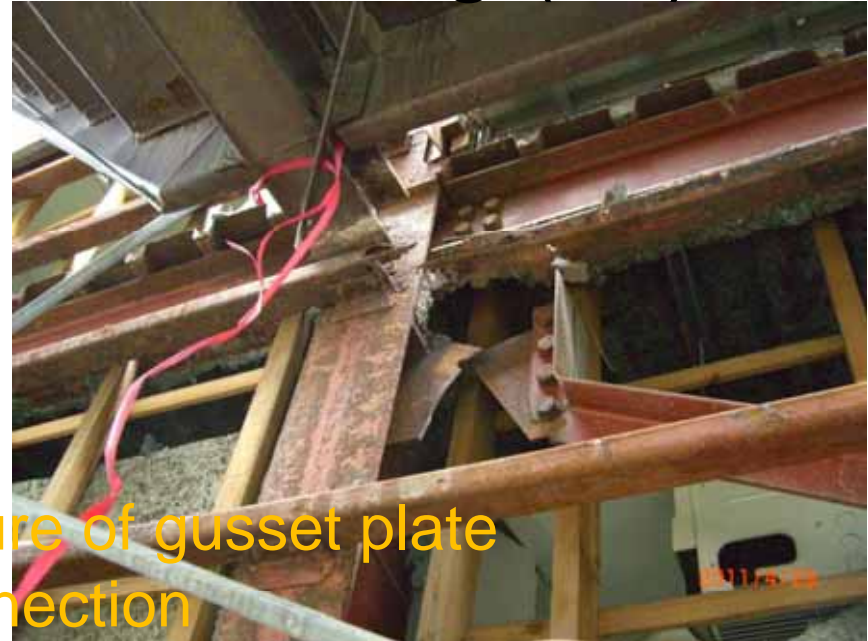
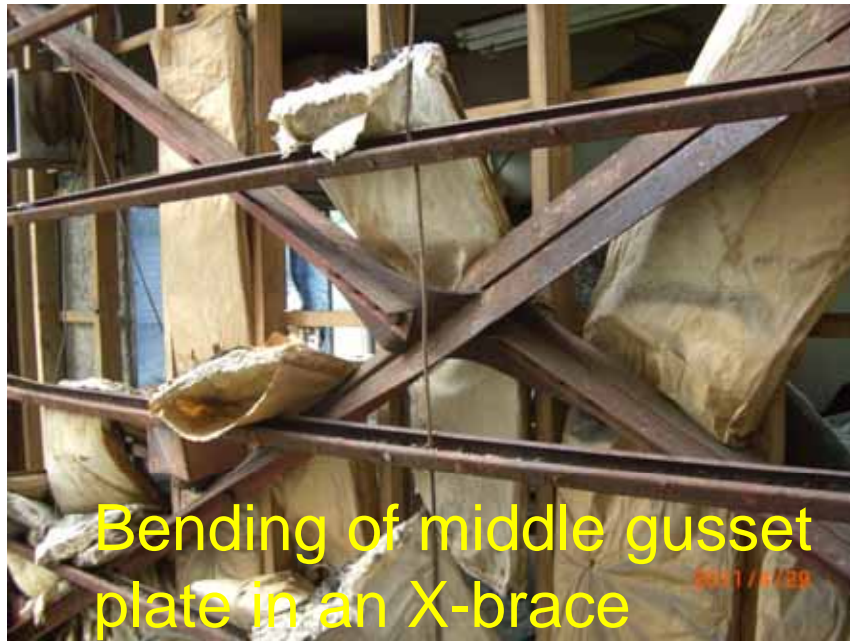
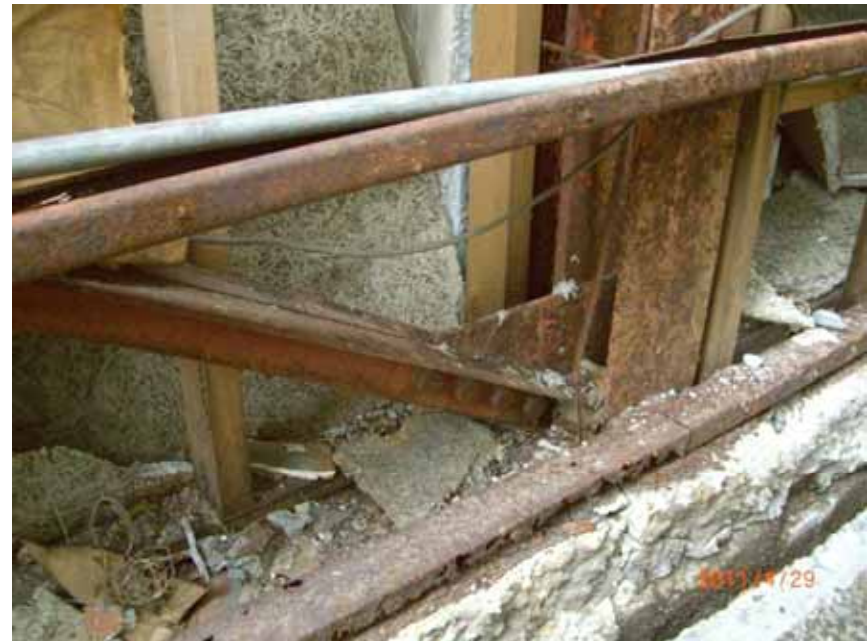
Bending of middle gusset
plate in an X-brace

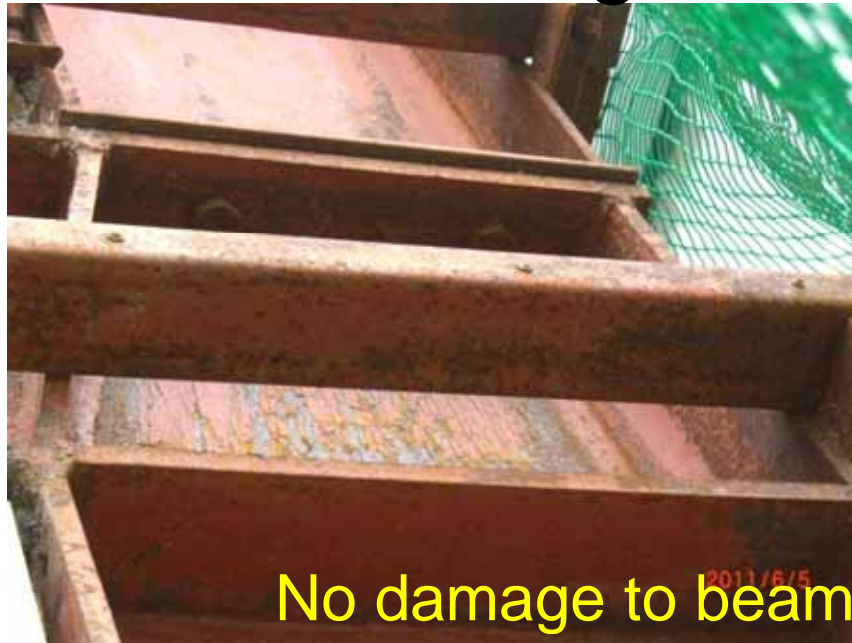
Severe Damage to Steel Building (4F) 2-3

No damage to beam-to-column connections

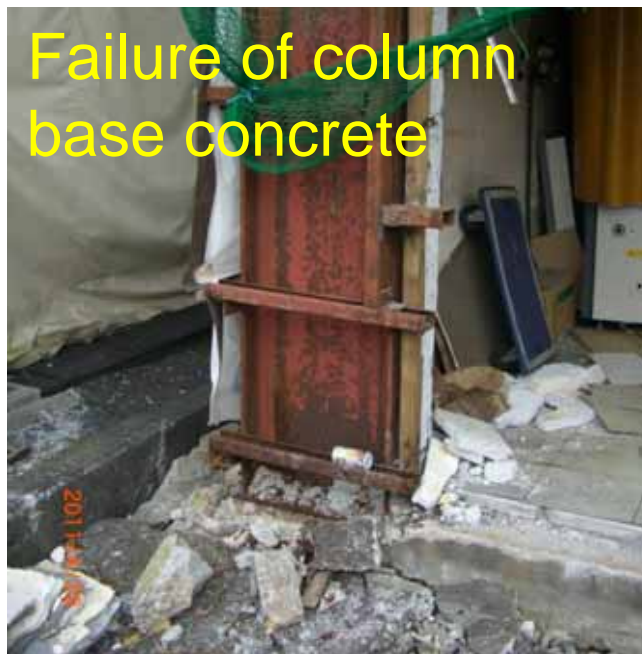
Failure of column
base concrete

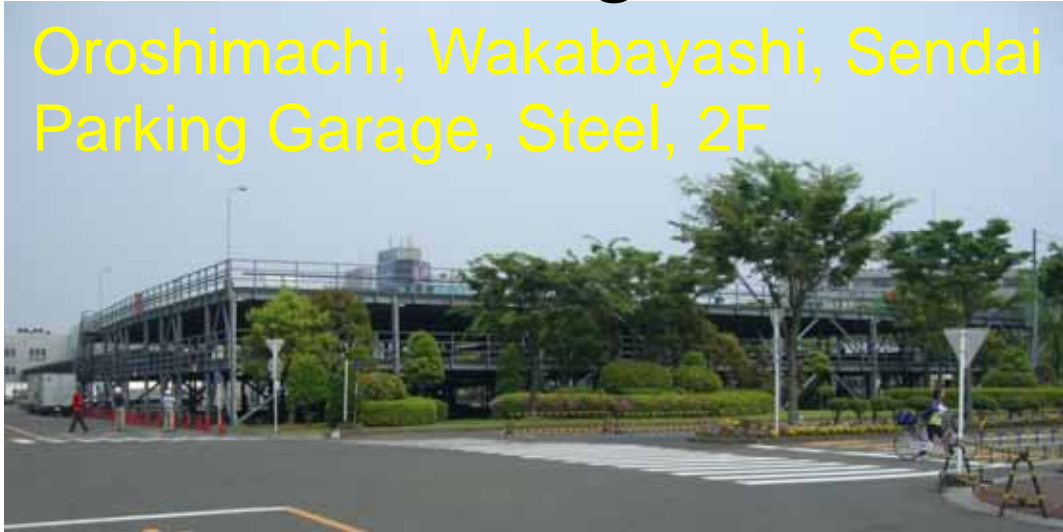
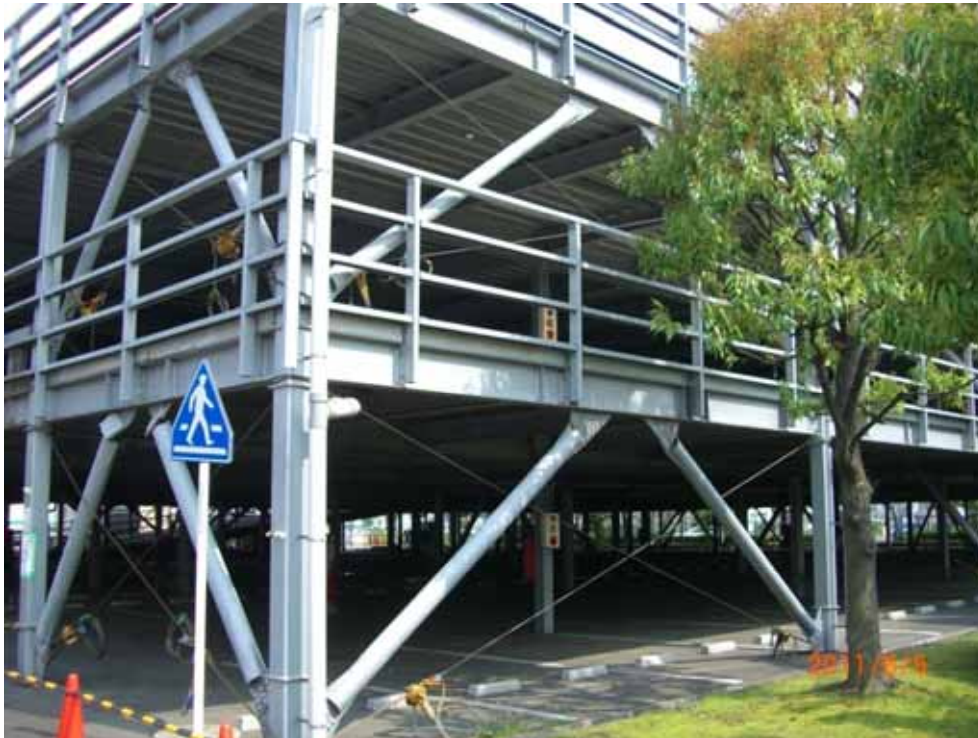
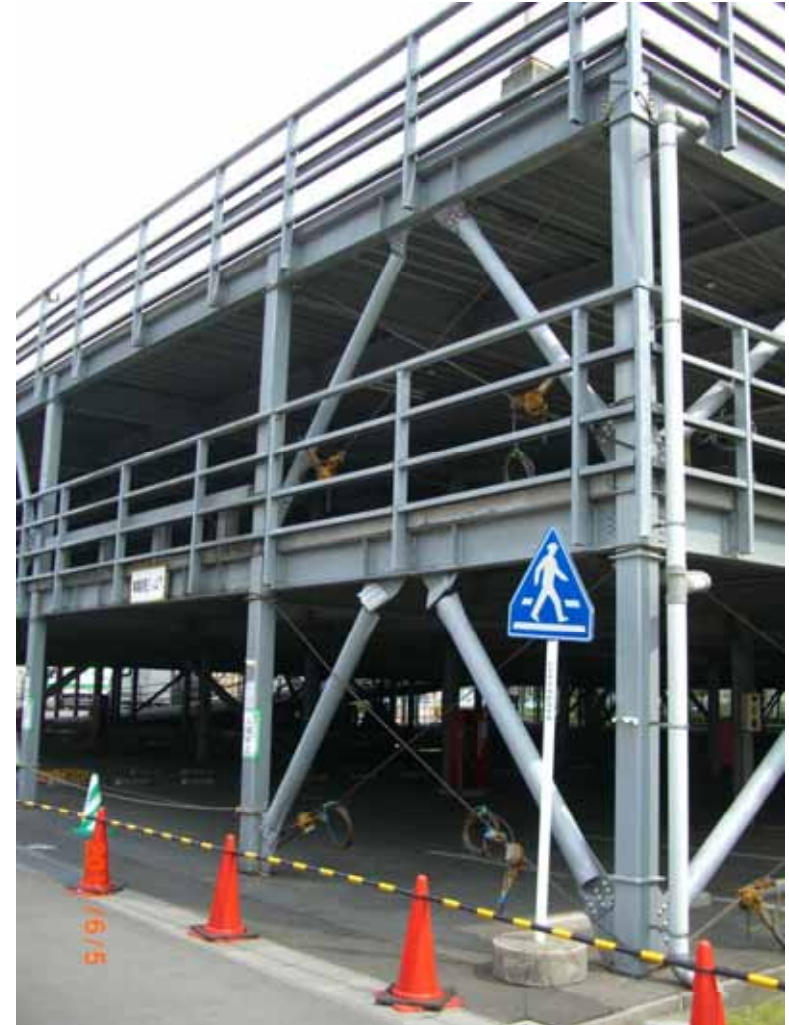
Severe Damage to Parking Garage (2F) 5-1

Oroshimachi, Wakabayashi, Sendai
Parking Garage, Steel, 2F

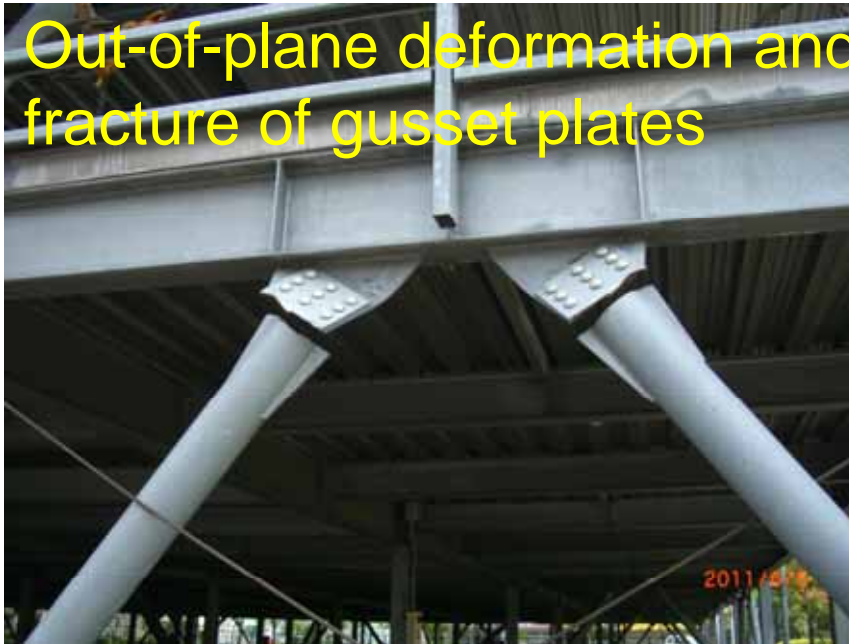
Severe Damage to Parking Garage (2F) 5-2

Out-of-plane deformation and fracture of gusset plates

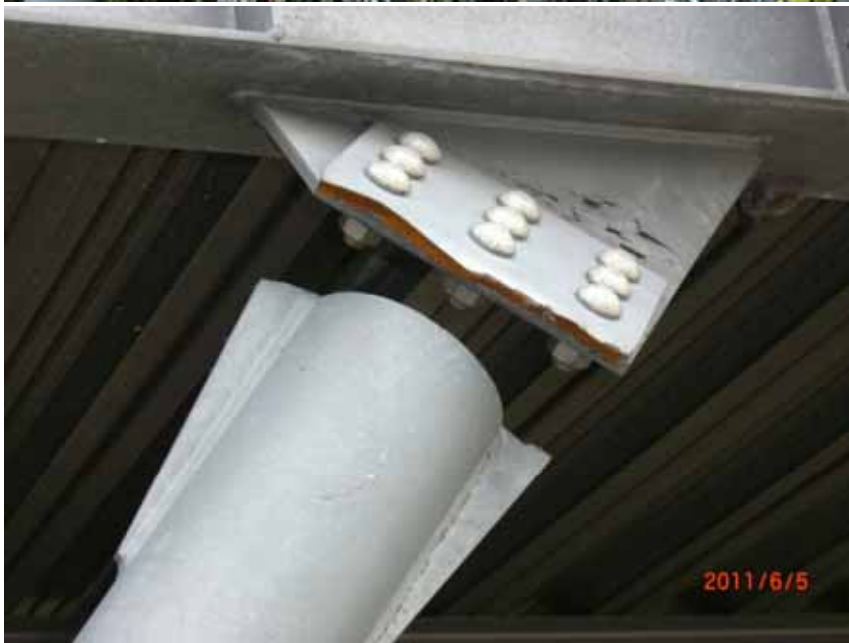
Most of gusset plates fractured in east-west direction.

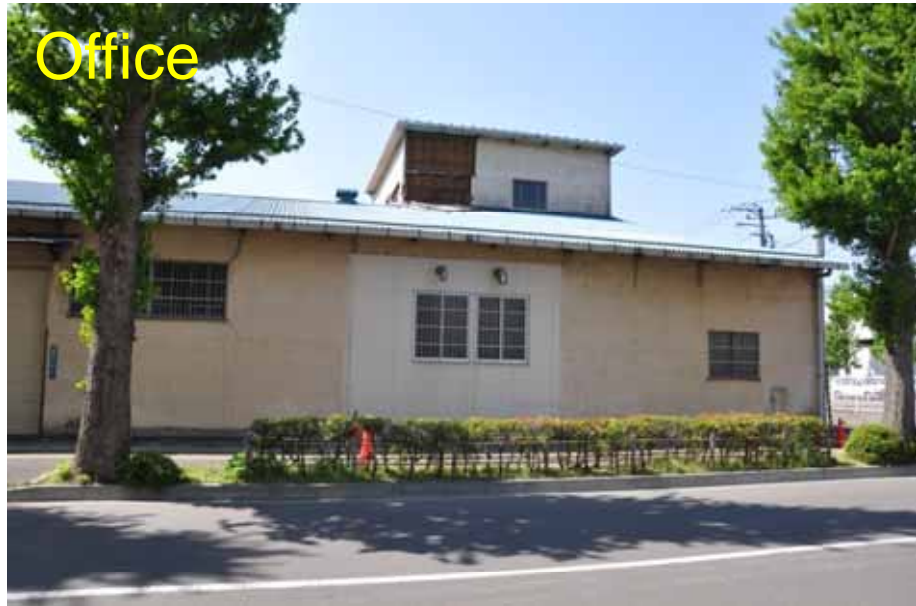
Office

Many old-type lath-and-mortar

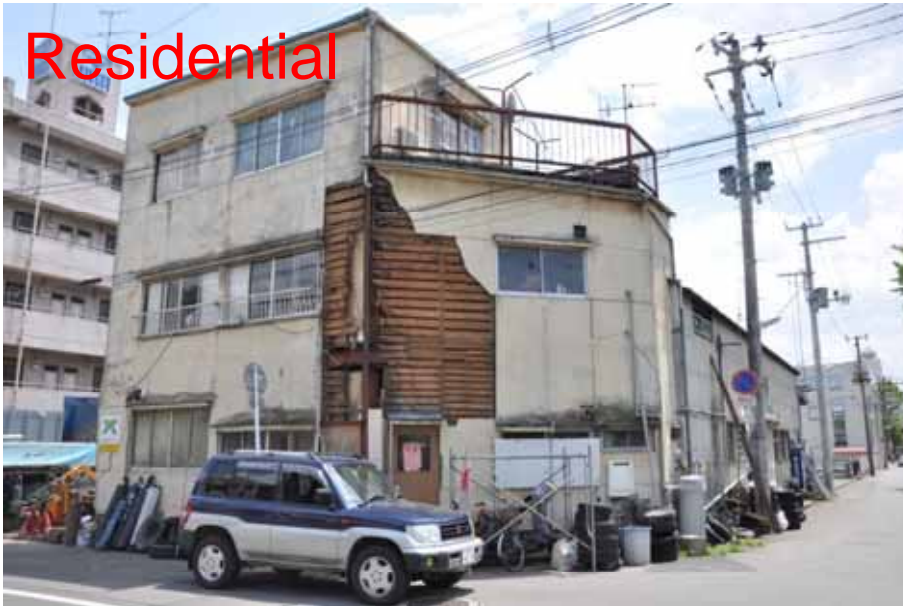
Residential

Many old-type lath-and-mortar

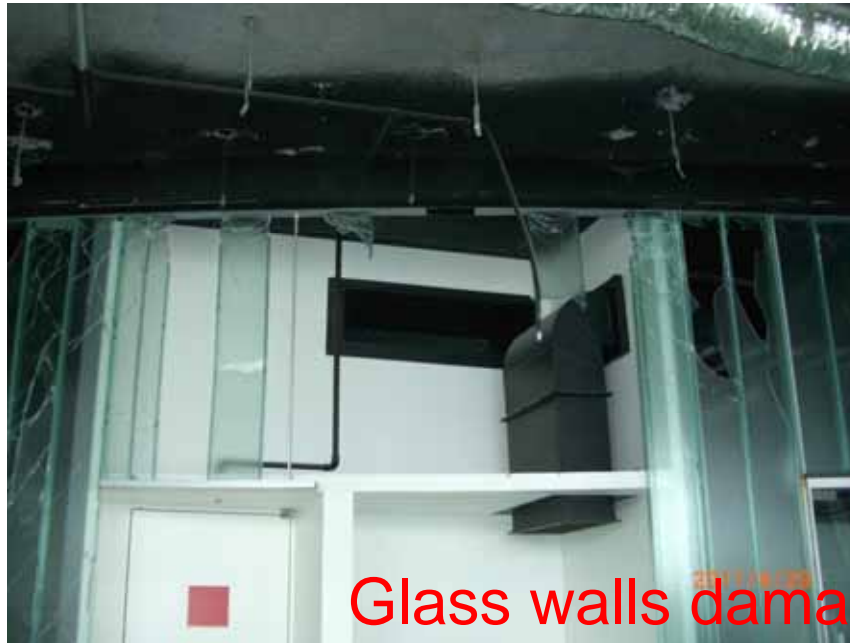
Nonstructural Damage to Steel Building 3-2: Sendai Mediatheque

Glass walls damaged by fallen ceiling (7F)
