Seismic and Tsunami Damage on Building Structures Caused by the 2011 Tohoku Japan Earthquake

MIDORIKAWA Mitsumasa
Hokkaido Univ.

Damage to Buildings Caused by Ground Shaking and Tsunami

Summary of damage reconnaissance by the Steel Structures Committee of AIJ

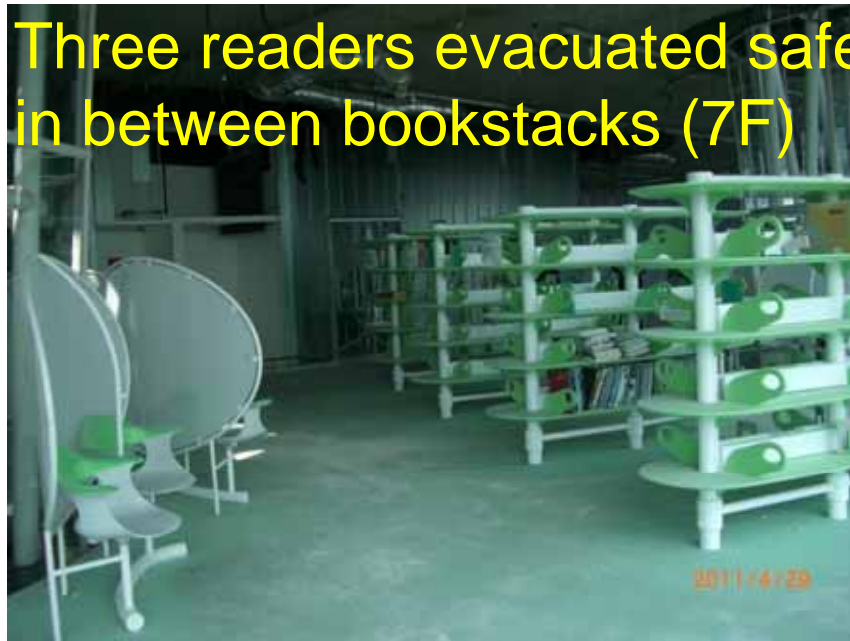
Three readers evacuated safely in between bookstacks (7F)

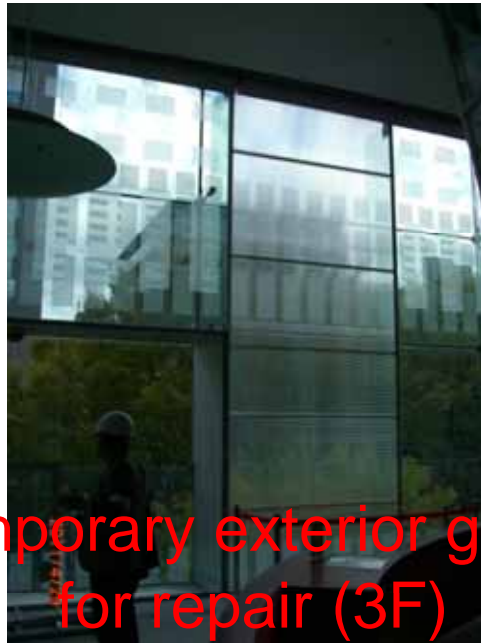
Nonstructural Damage to Steel Building 3-3: Sendai Mediatheque

Temporary exterior glass
for repair (3F)

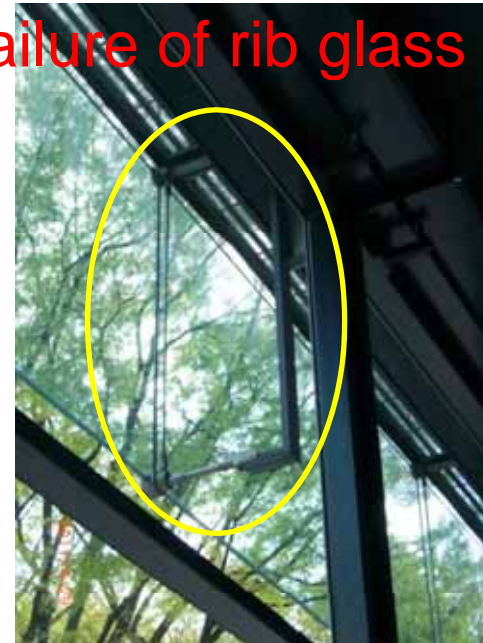
Failure of rib glass (1F)

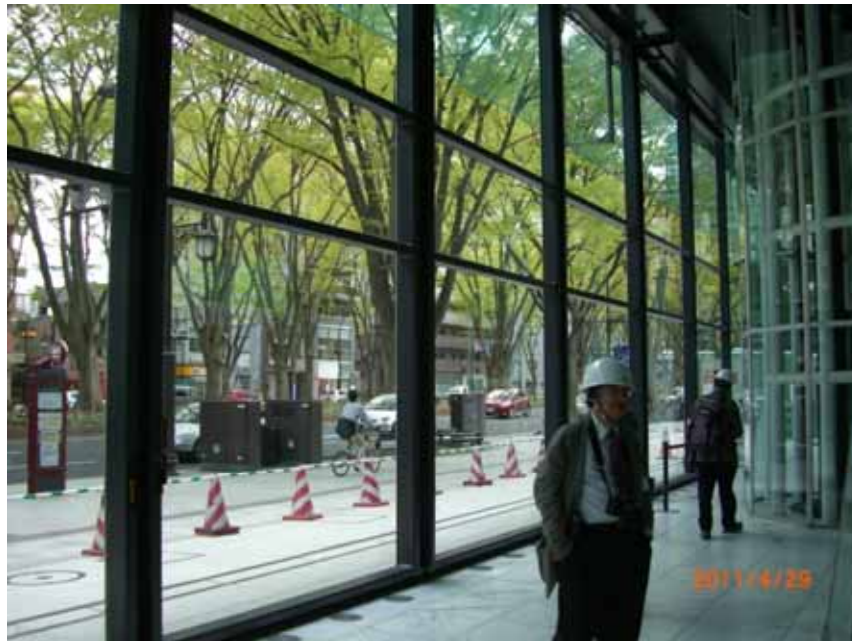
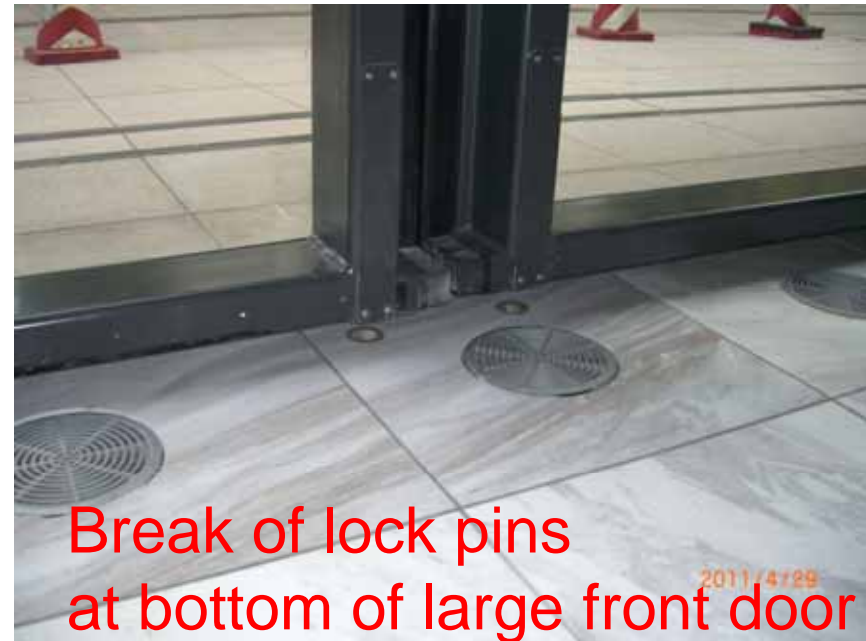
Break of lock pins
at bottom of large front door

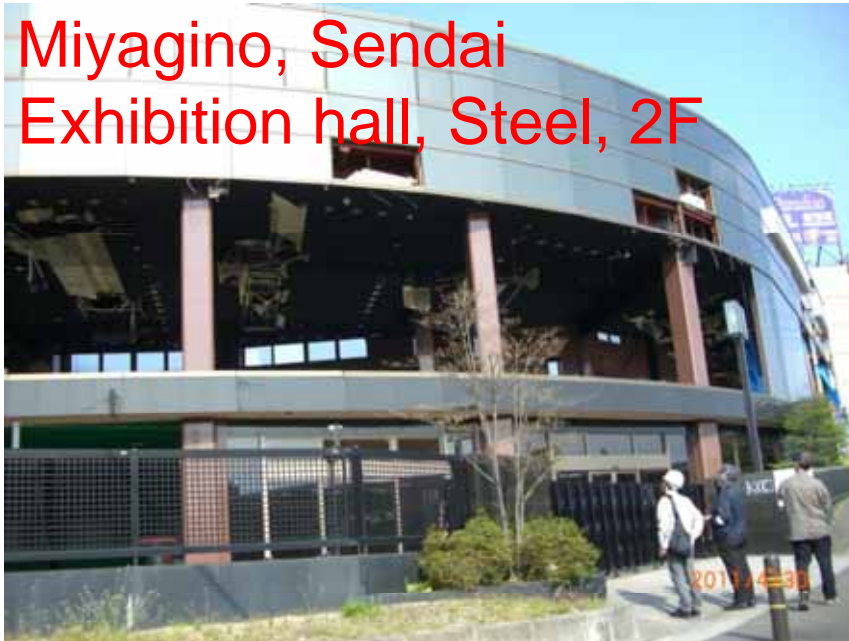
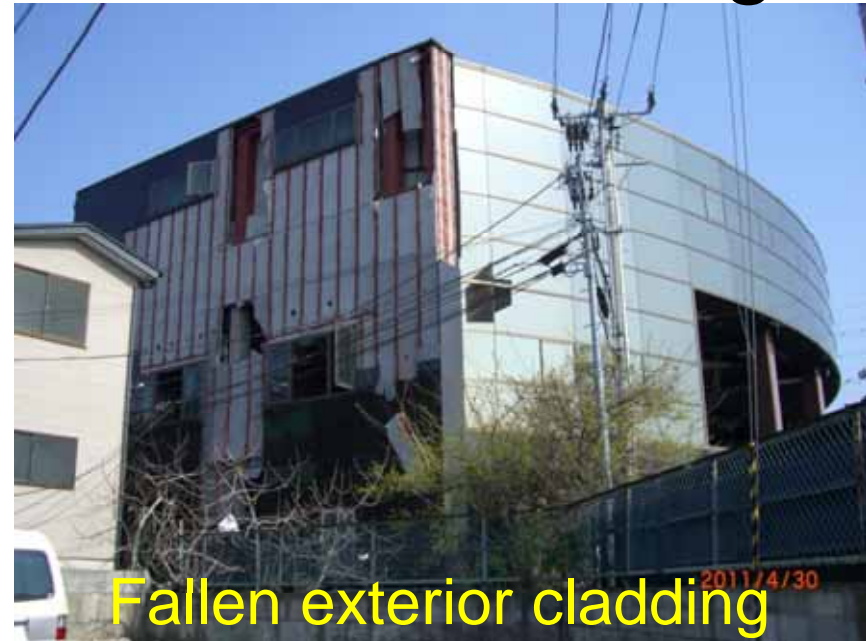
Fallen exterior cladding

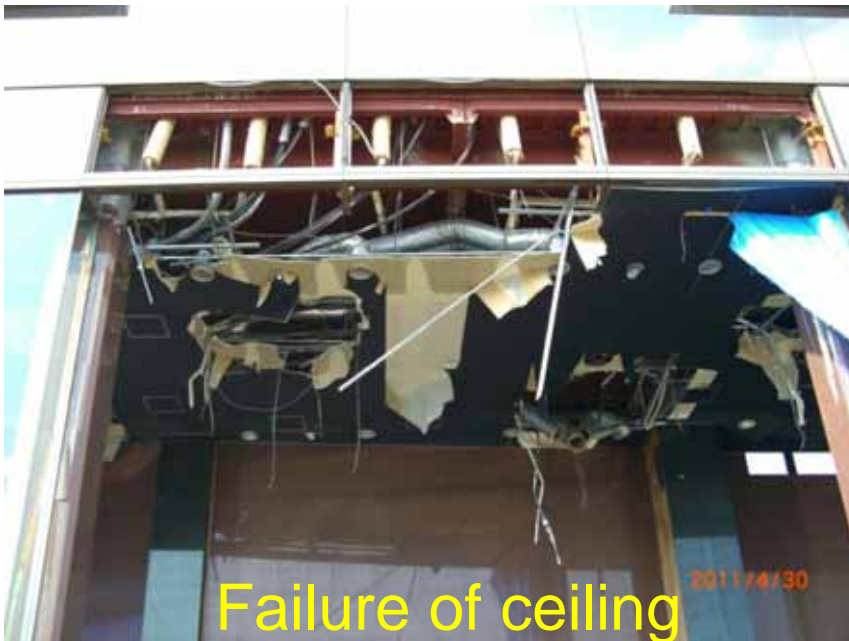
Failure of ceiling

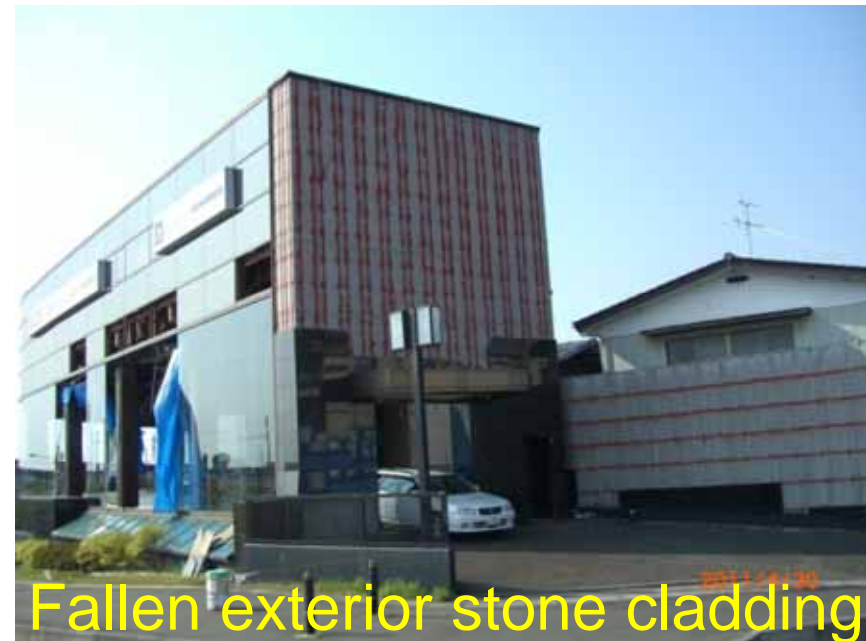
Fallen exterior stone cladding

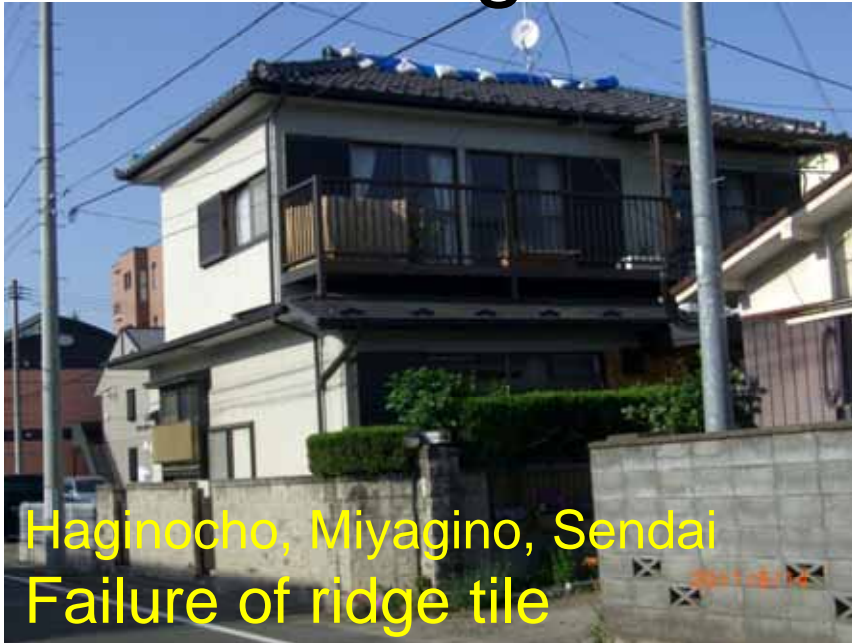
Haginocho, Miyagino, Sendai
Failure of ridge tile

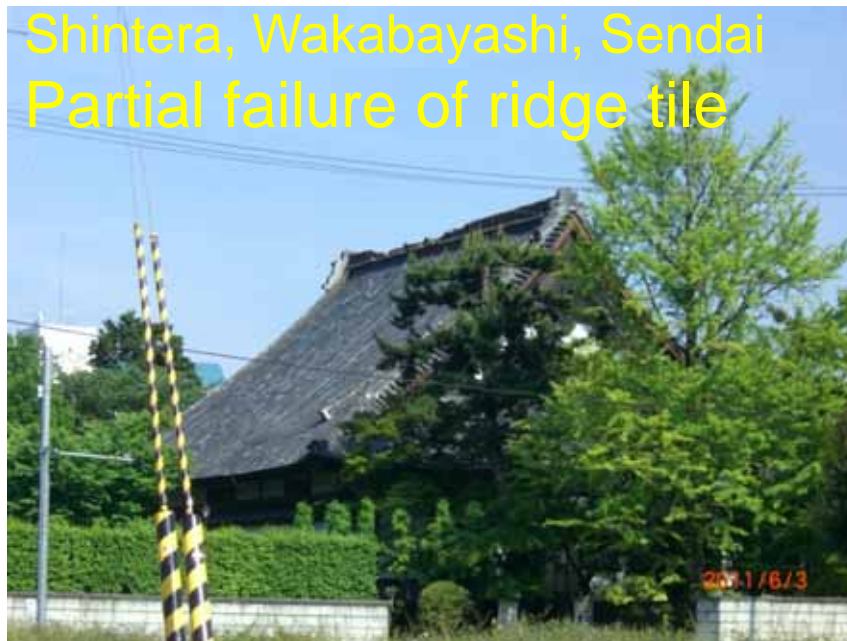
Shintera, Wakabayashi, Sendai
Partial failure of ridge tile

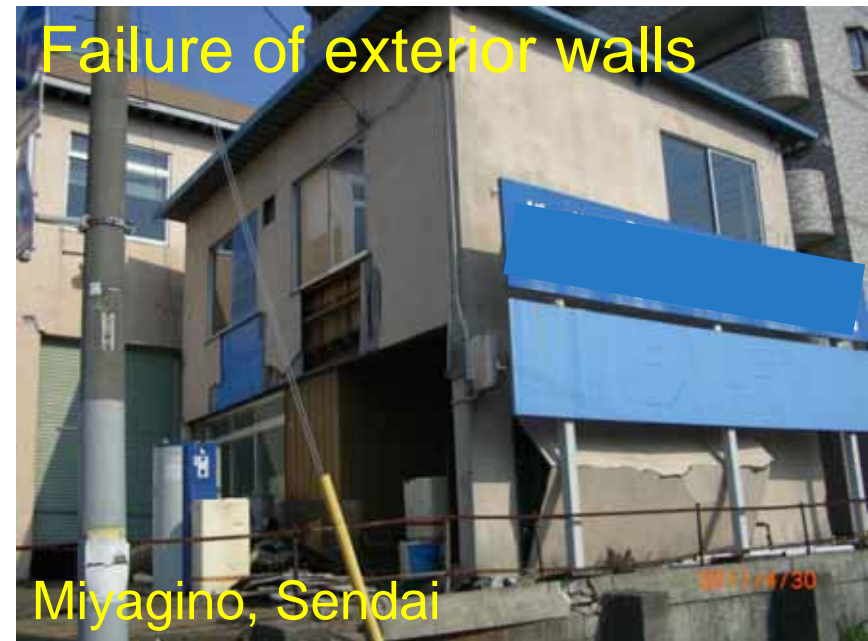
Miyagino, Sendai

Failure of exterior walls

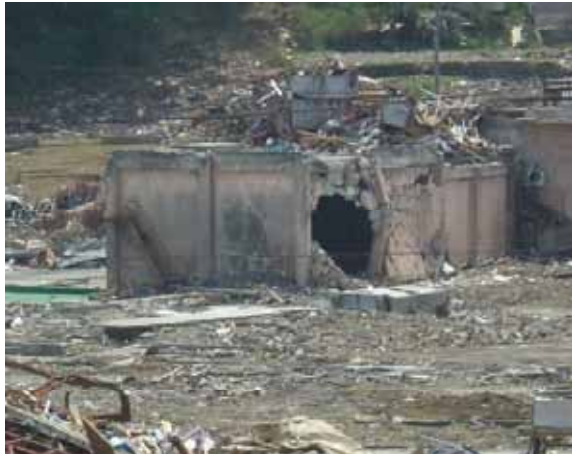
Toppling

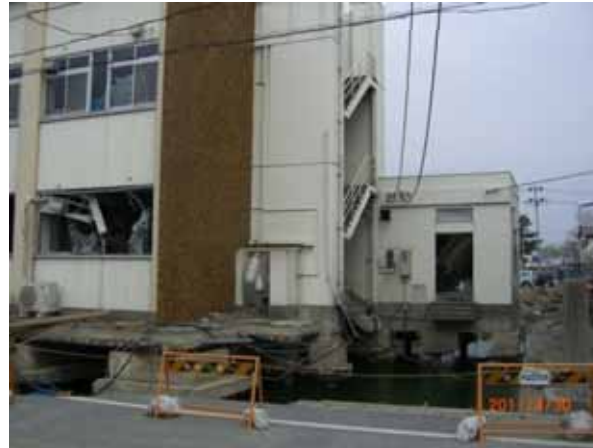
Scour

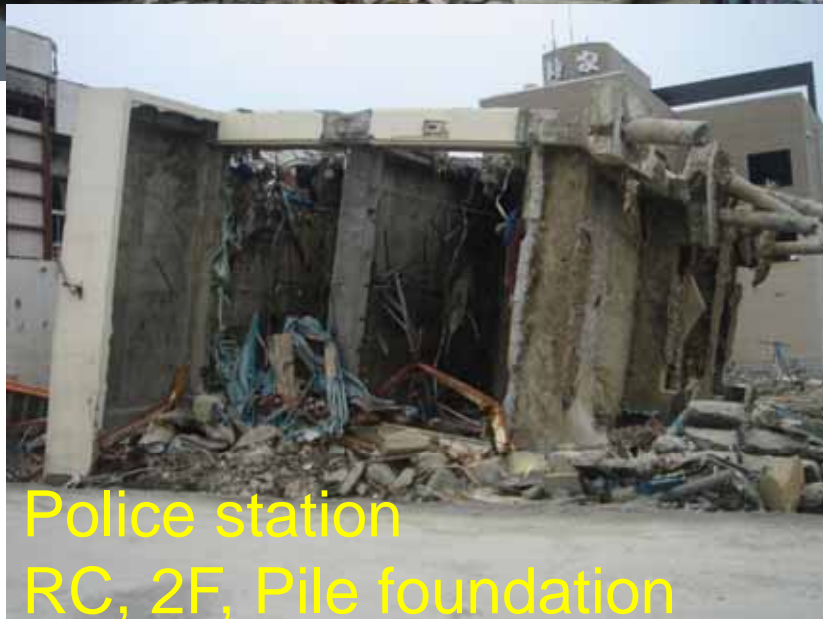
Police station
RC, 2F, Pile foundation

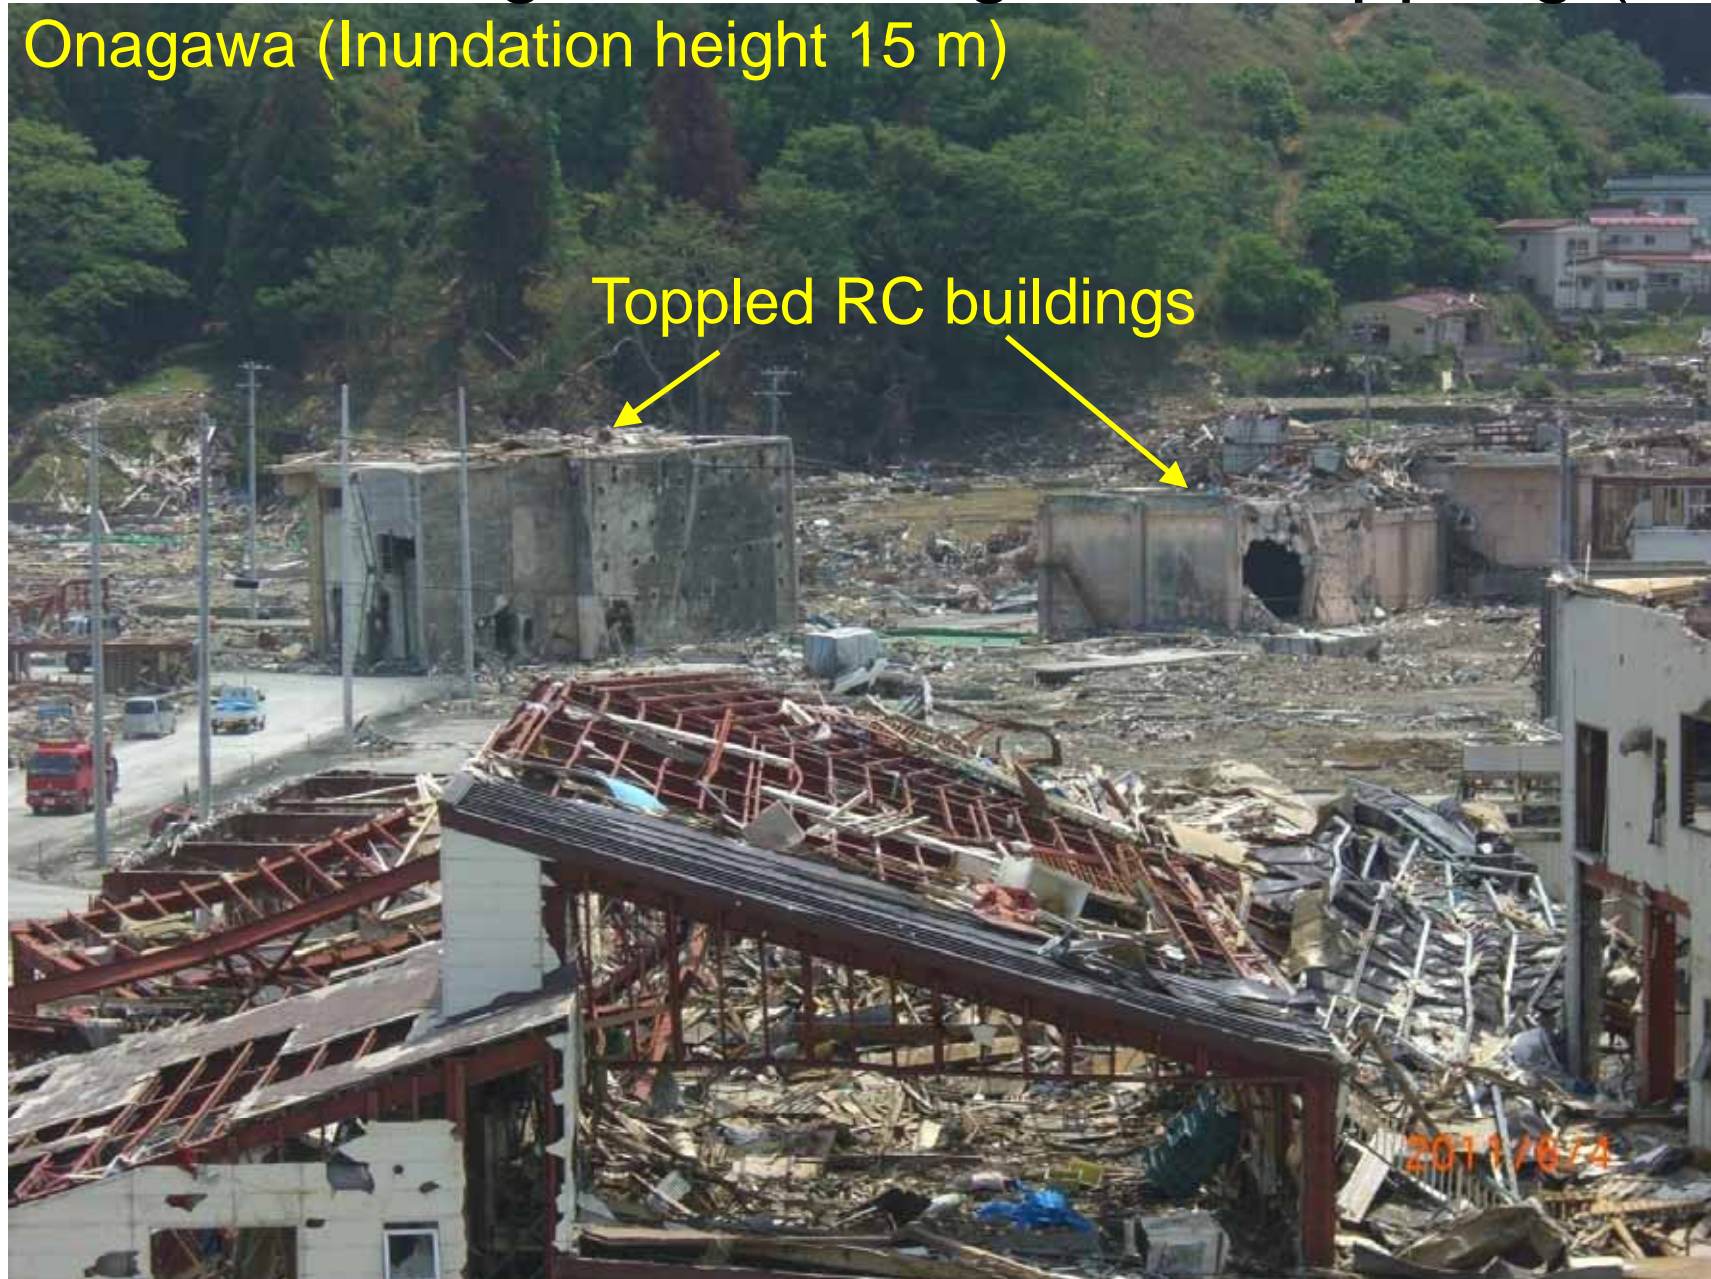
Tsunami Damage to Buildings 2-6: Toppling (RC)

Onagawa (Inundation height 15 m)

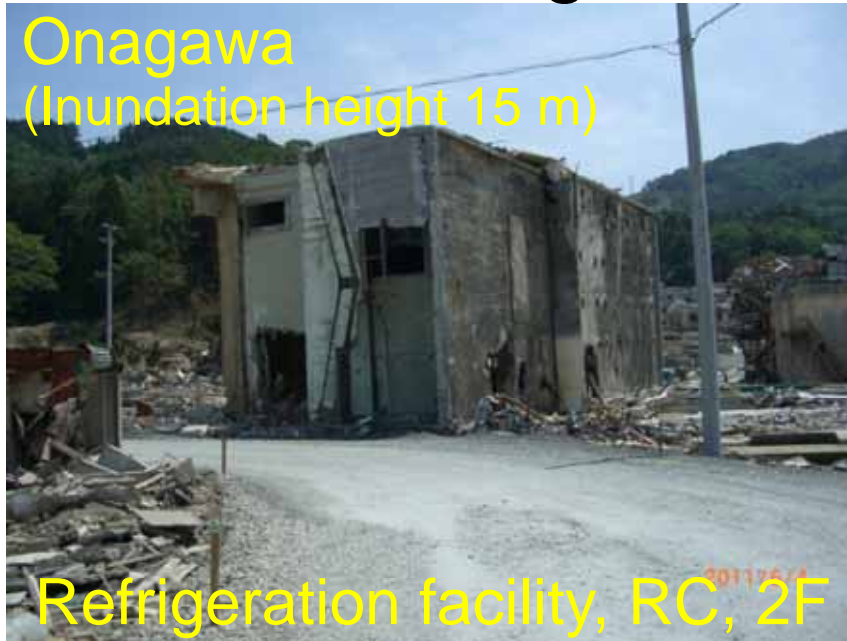
Refrigeration facility, RC, 2F

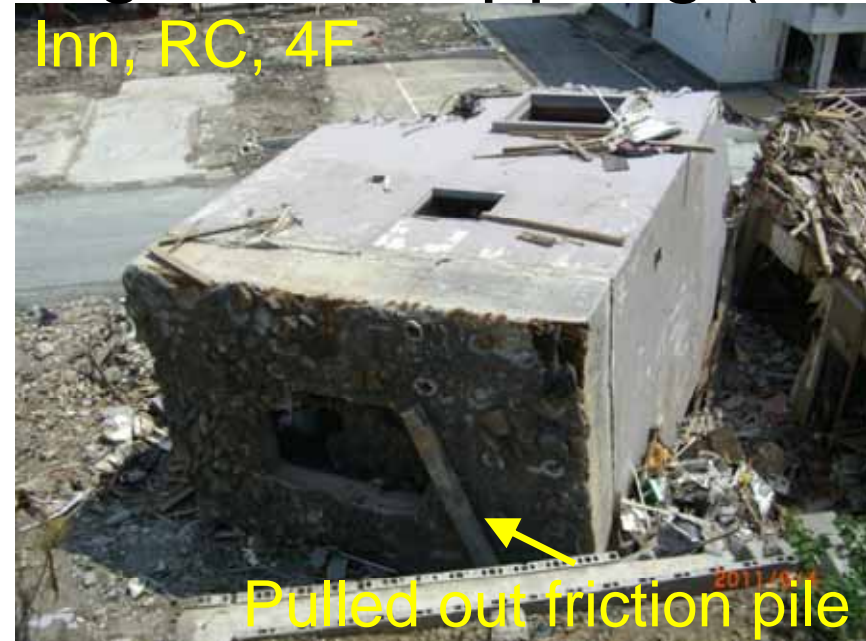
Inn, RC, 4F

Pulled out friction pile

Distance shifted by 70 m

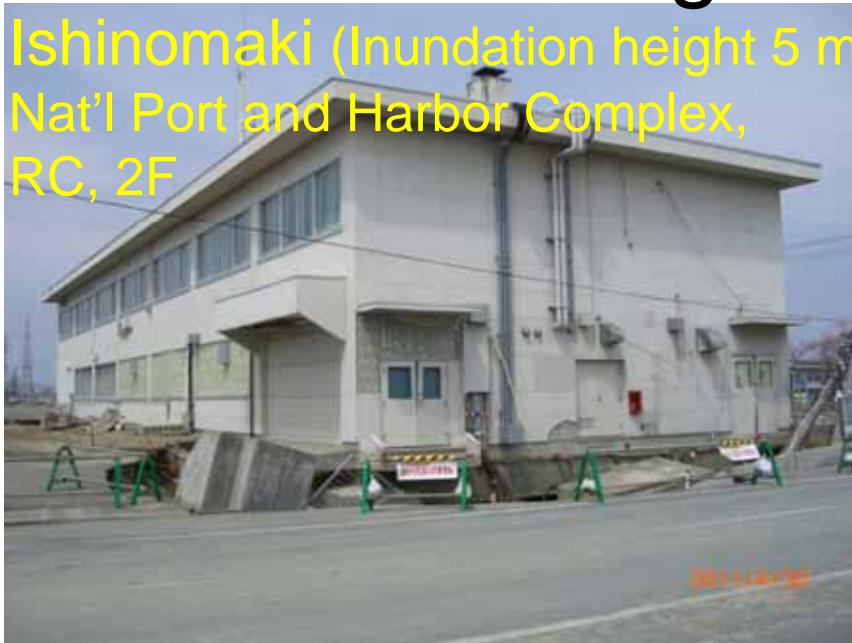
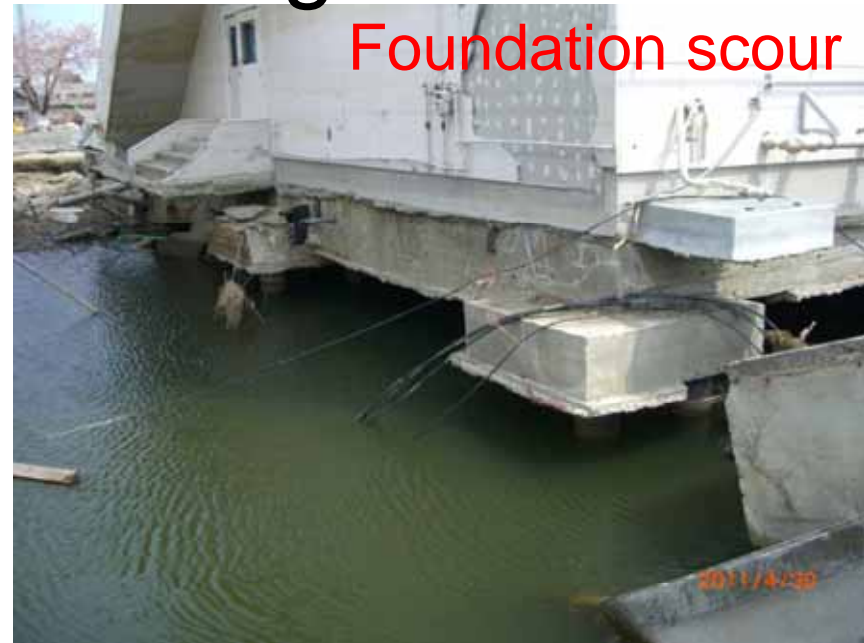
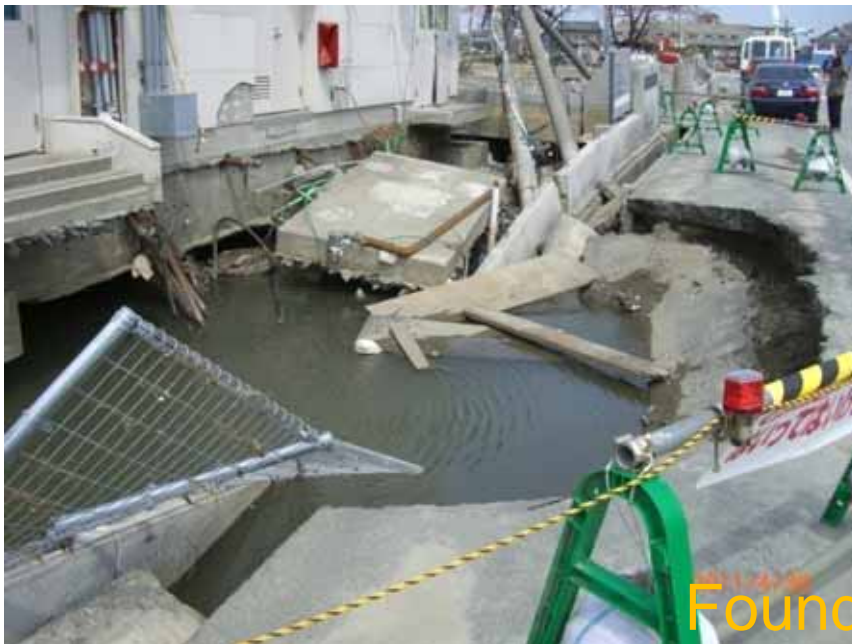
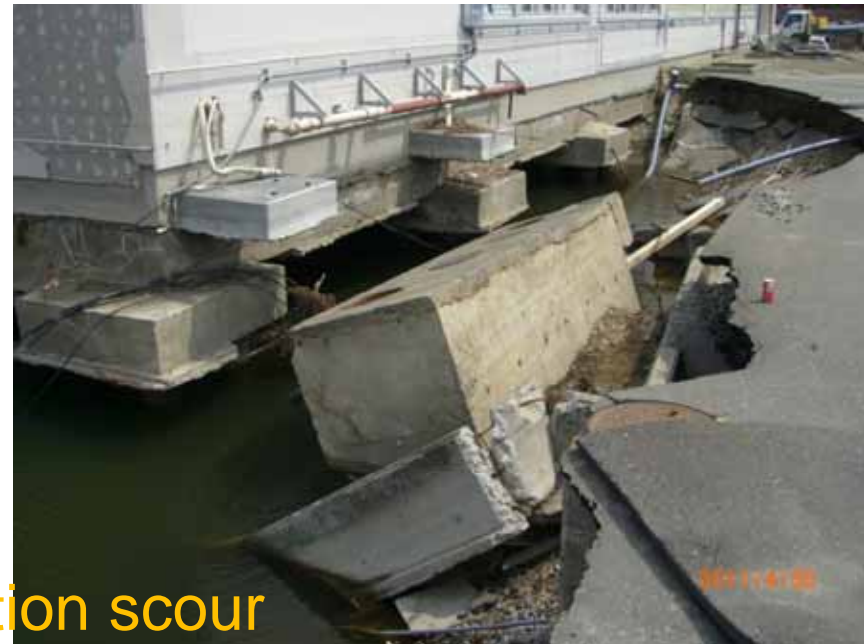
Tsunami Damage to Buildings 3-1: Scour

Ishinomaki (Inundation height 5 m)
Nat'l Port and Harbor Complex,
RC, 2F

Foundation scour

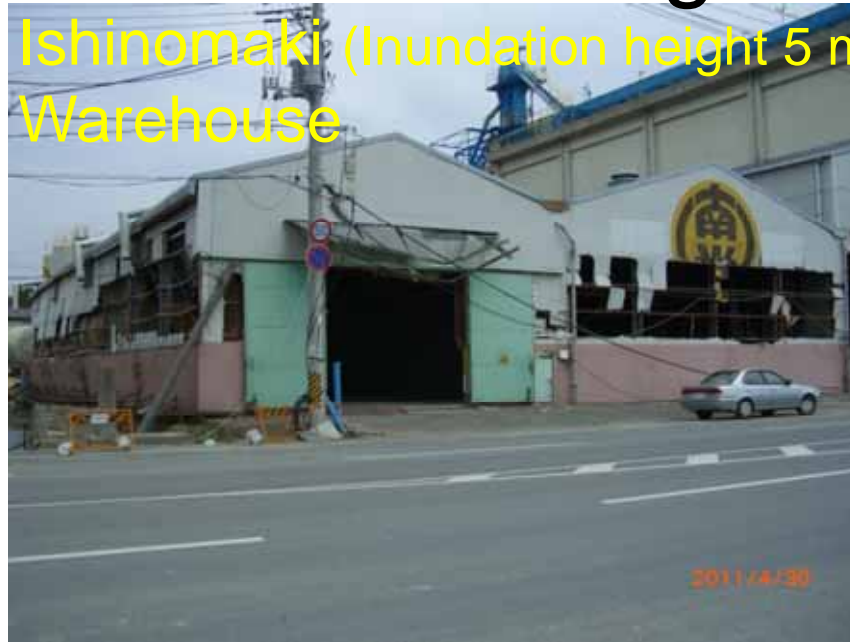
Foundation scour

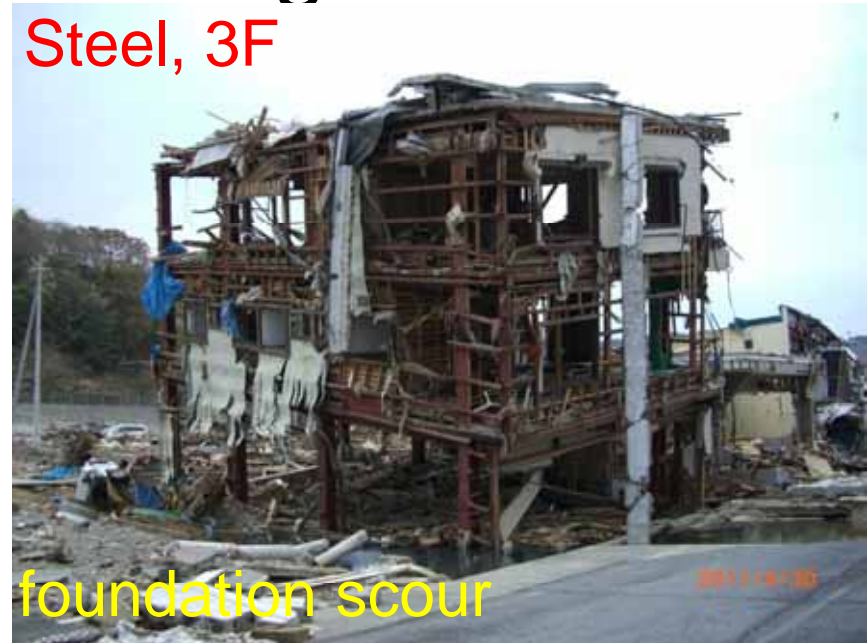
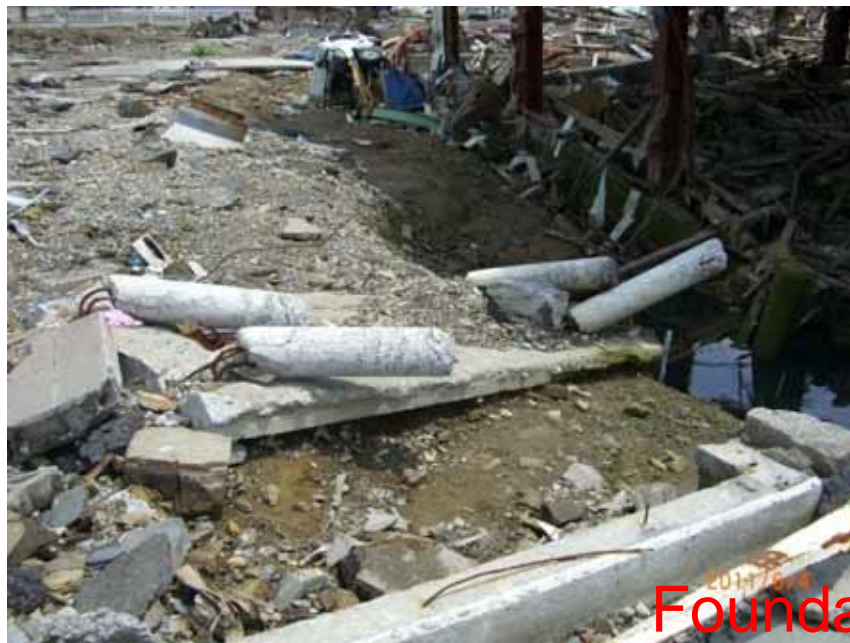
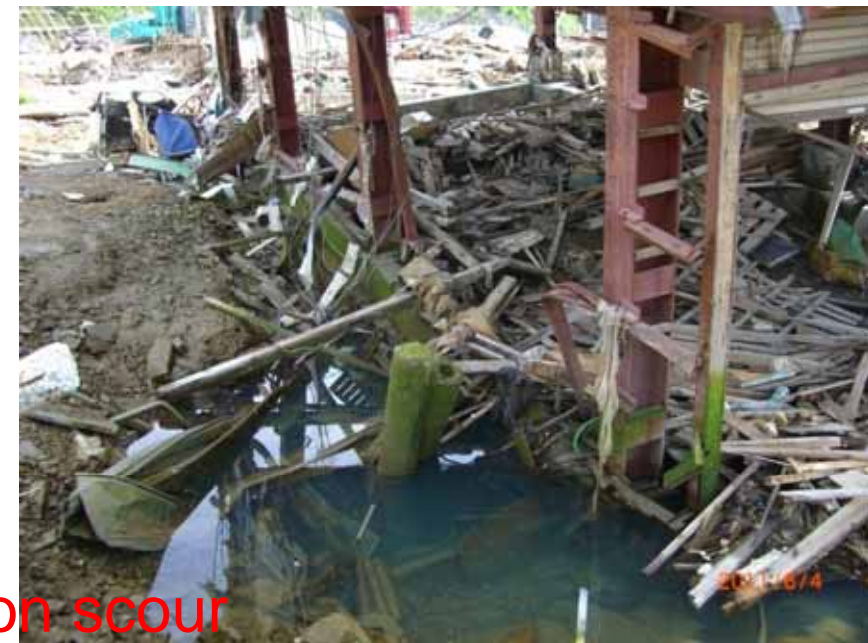
Tsunami Damage to Buildings 3-3: Scour

Onagawa (Inundation height 15 m)

Steel, 3F

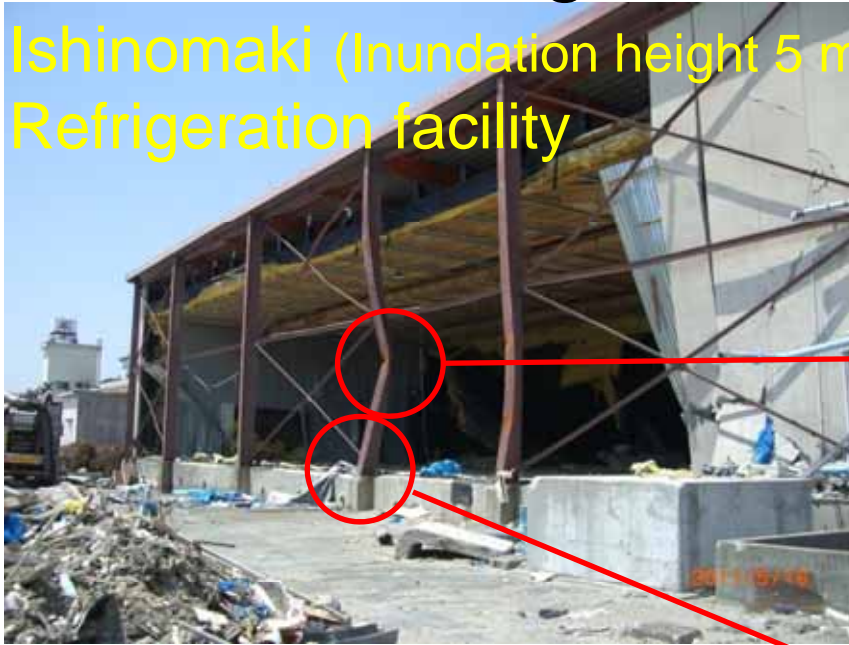
Large local deformation

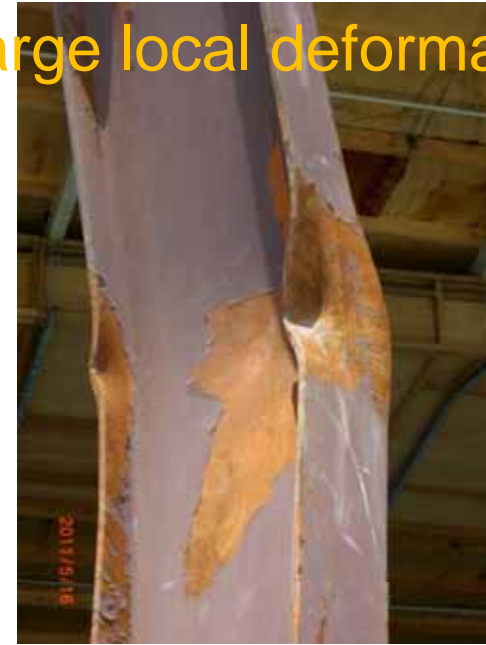
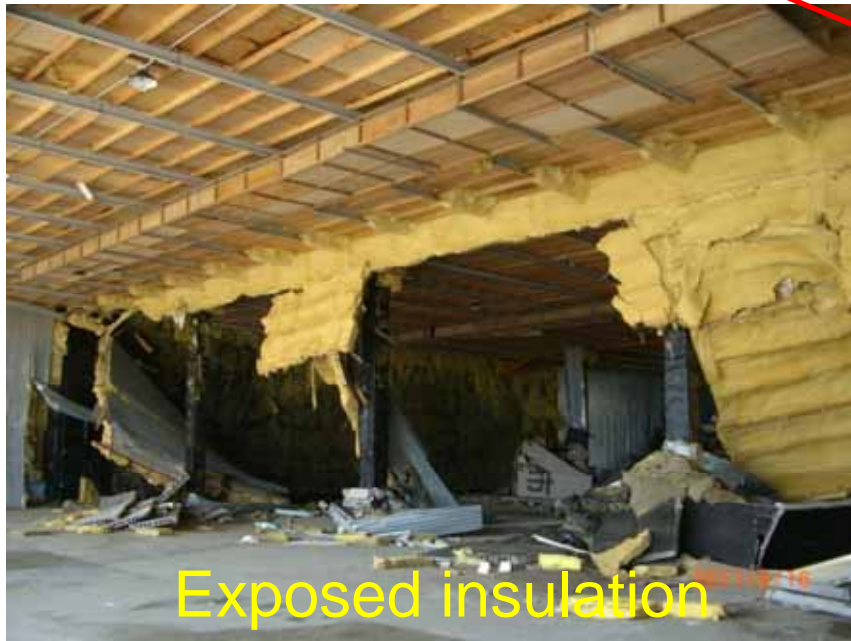
Exposed insulation

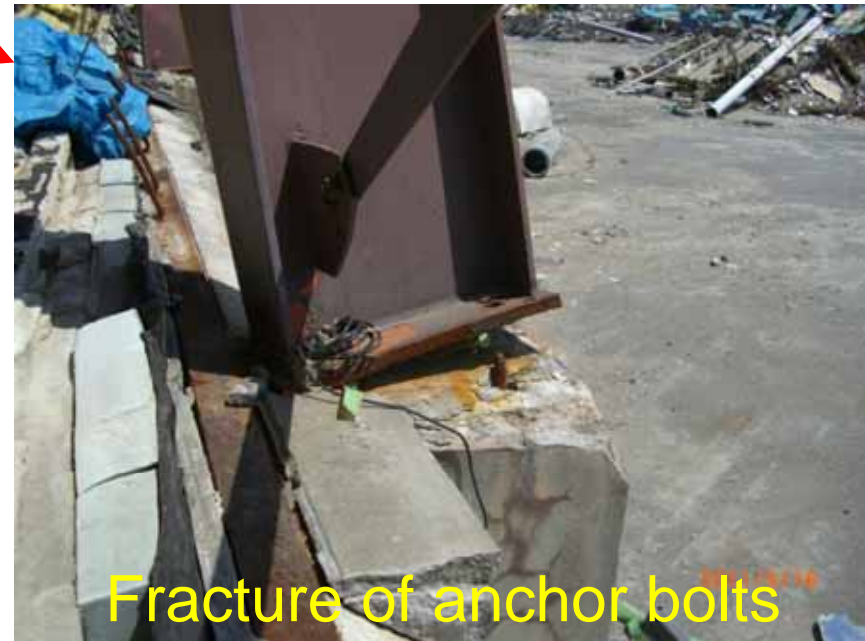
Fracture of anchor bolts

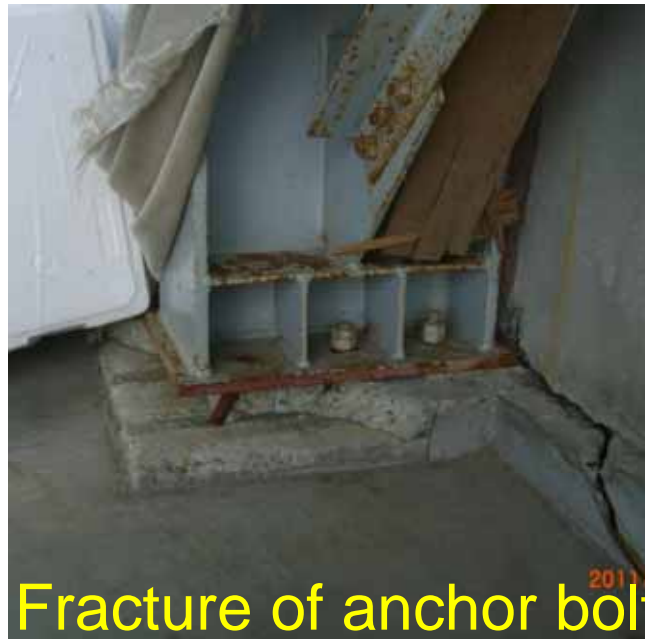
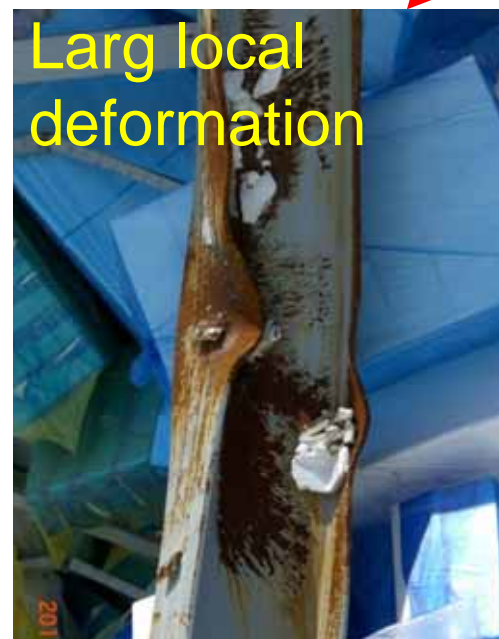
Large local deformation

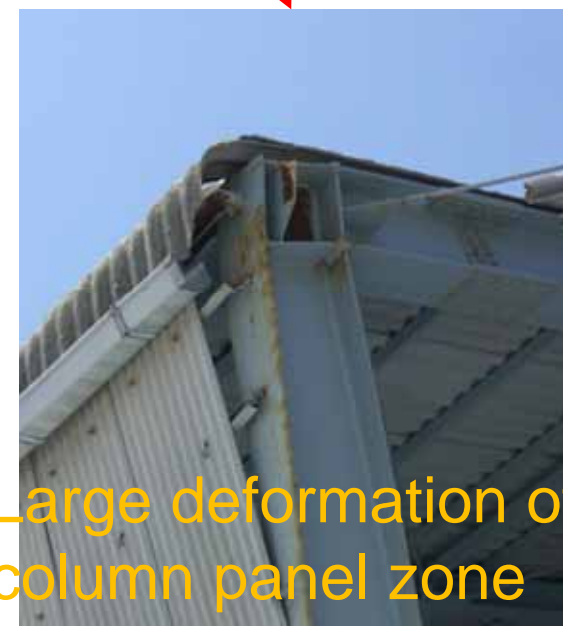
Large deformation of column panel zone

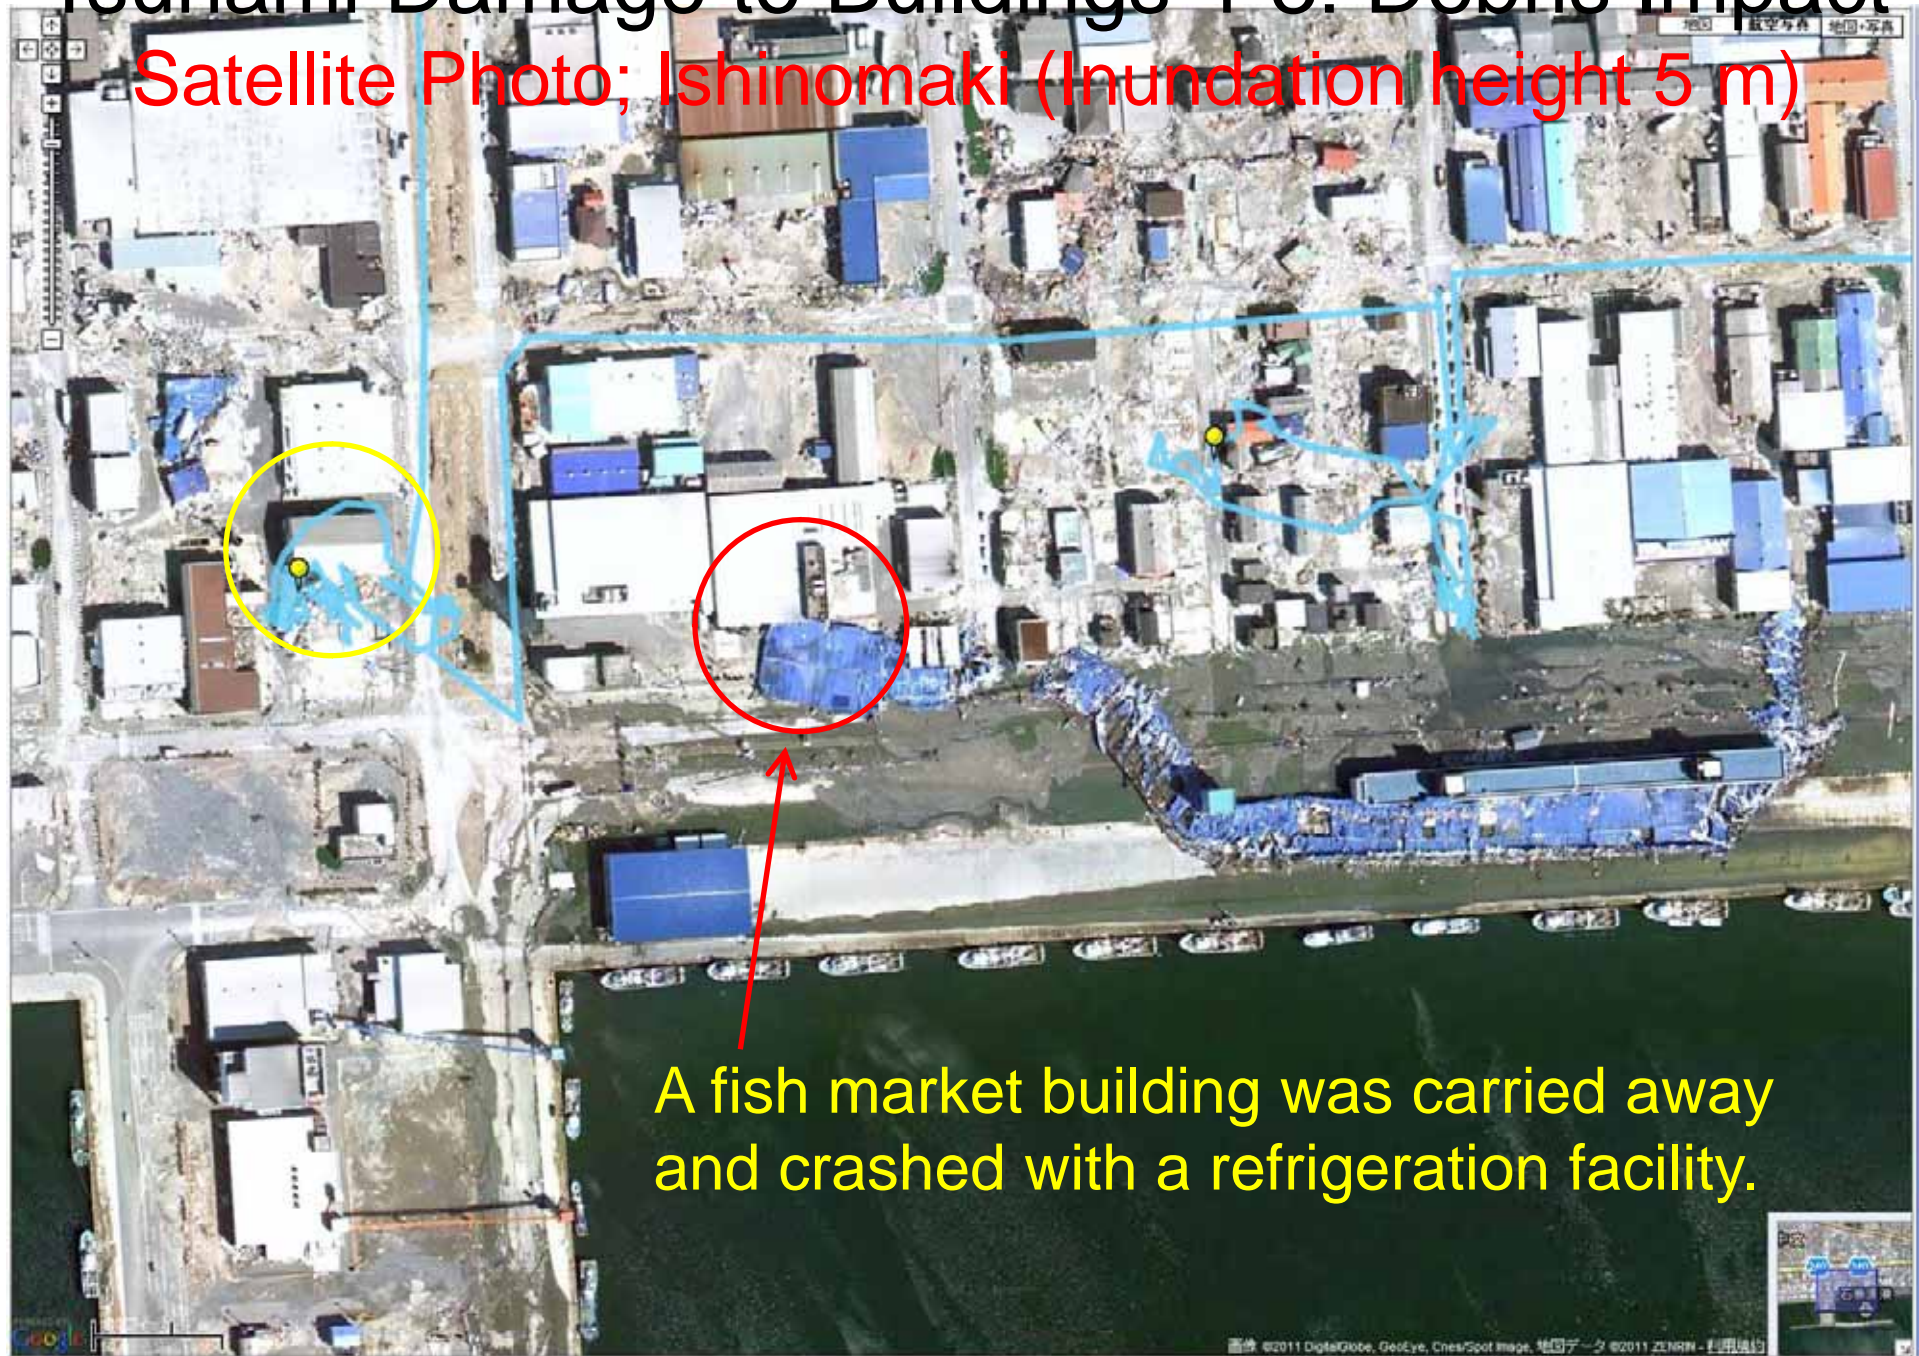
Tsunami Damage to Buildings 4-3: Debris Impact

Satellite Photo; Ishinomaki (Inundation height 5 m)

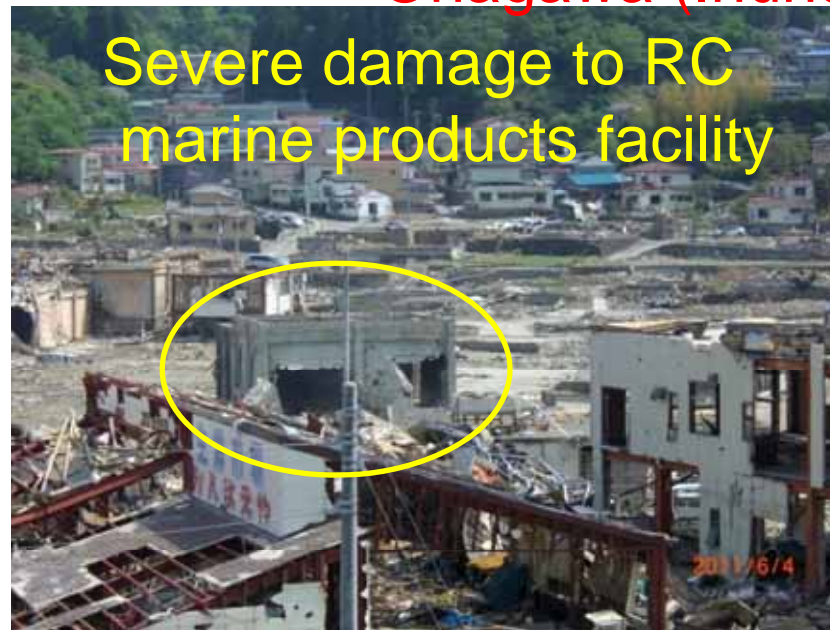
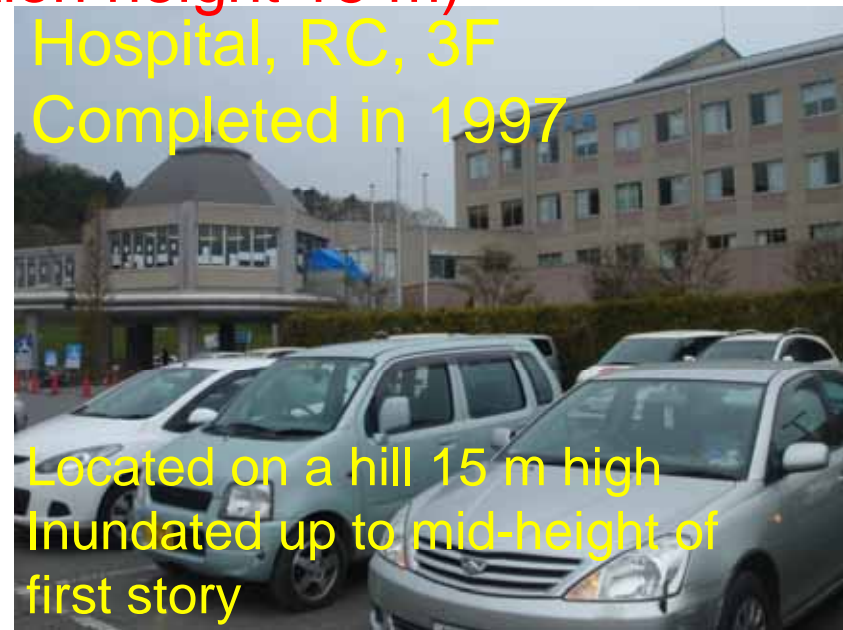
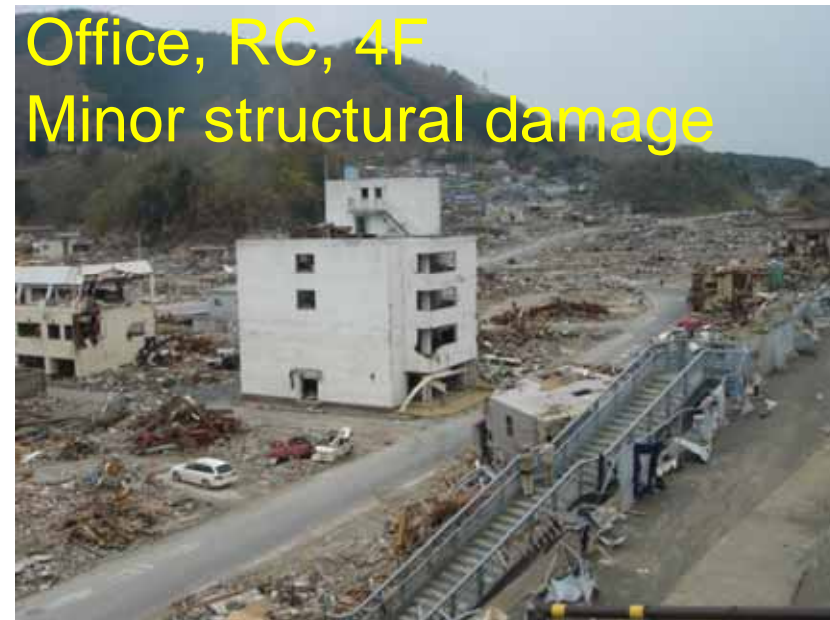
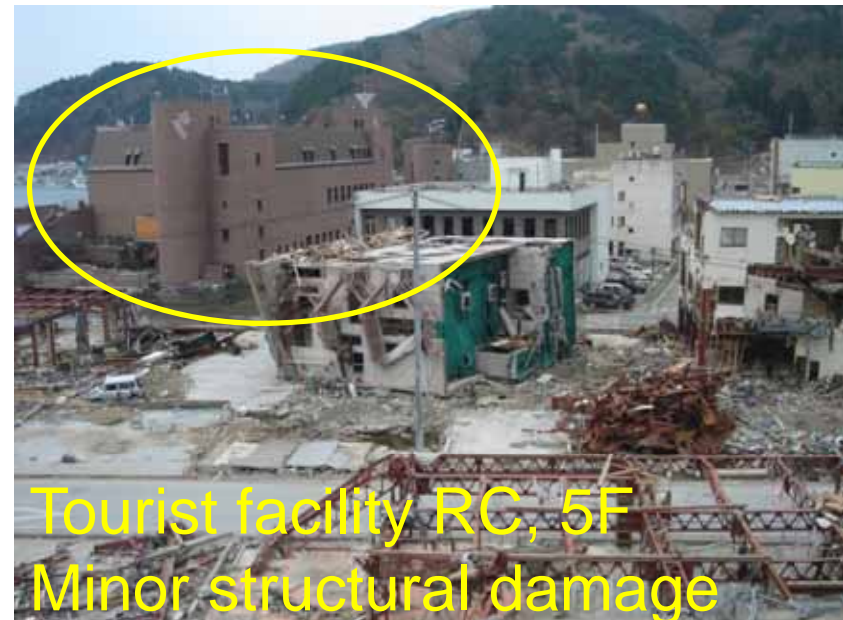
Tsunami Damage to RC Buildings 5-1

Onagawa (Inundation height 15 m)
