Seismic and Tsunami Damage on Building Structures Caused by the 2011 Tohoku Japan Earthquake

MIDORIKAWA Mitsumasa
Hokkaido Univ.

Damage to Buildings Caused by Ground Shaking and Tsunami

Summary of damage reconnaissance by the Steel Structures Committee of AIJ

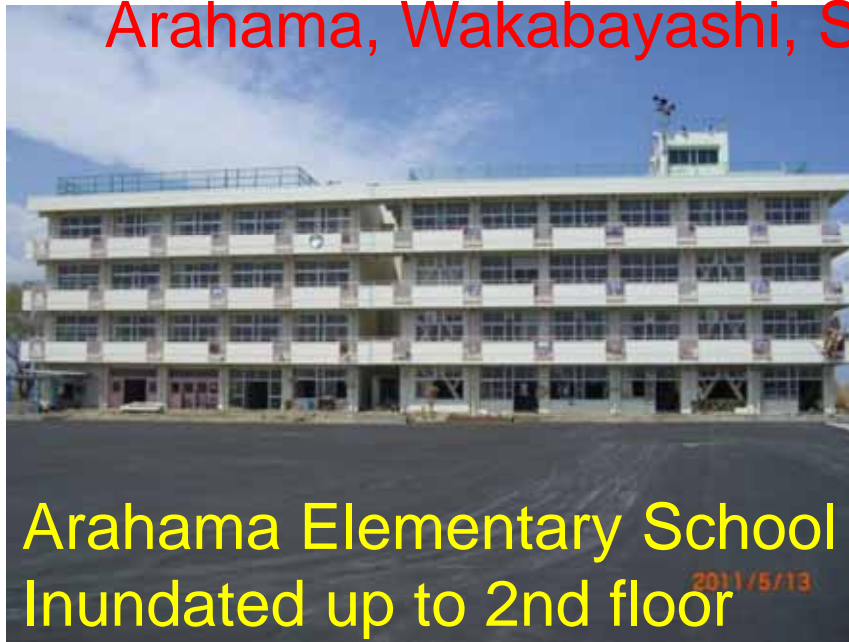
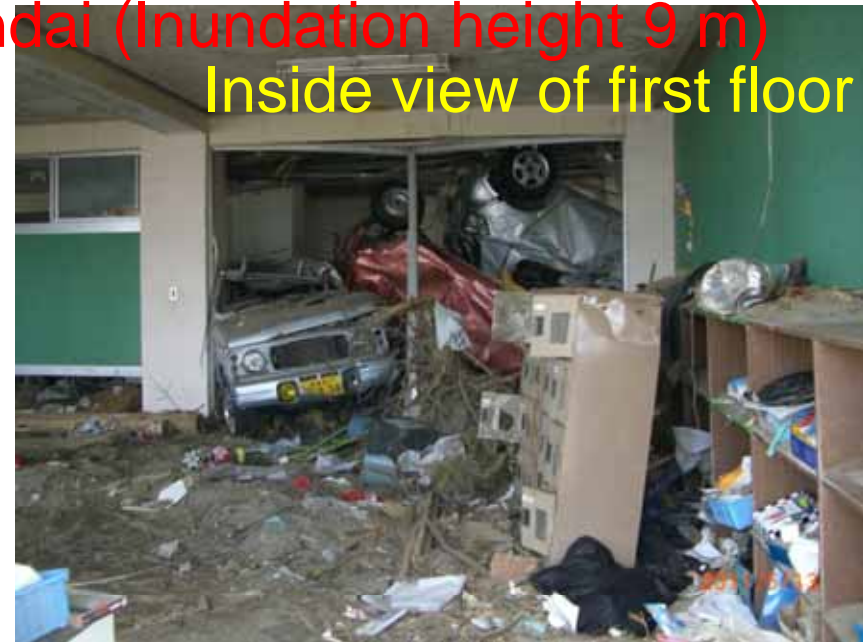
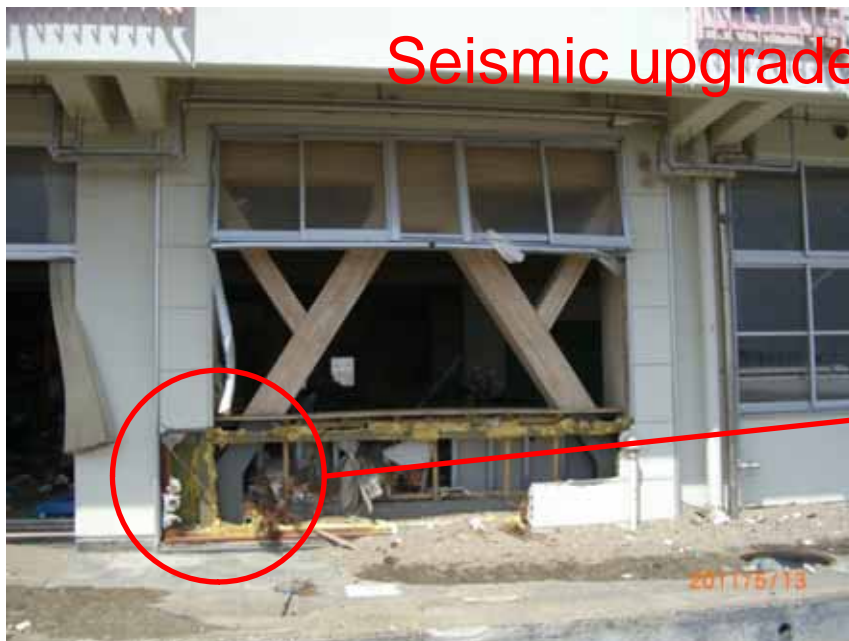
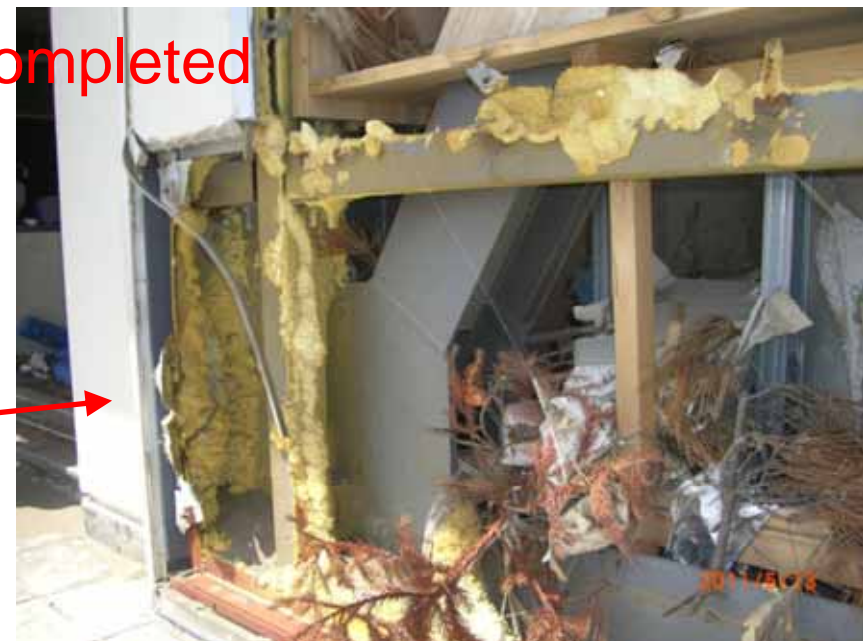
Tsunami Damage to RC Buildings 5-2

Arahama, Wakabayashi, Sendai (Inundation height 9 m)

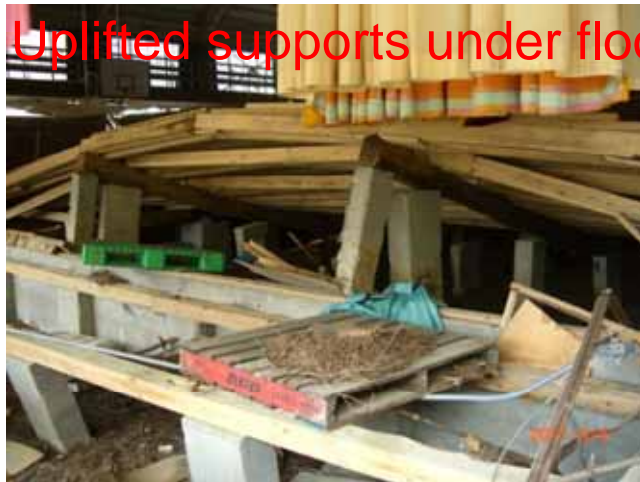
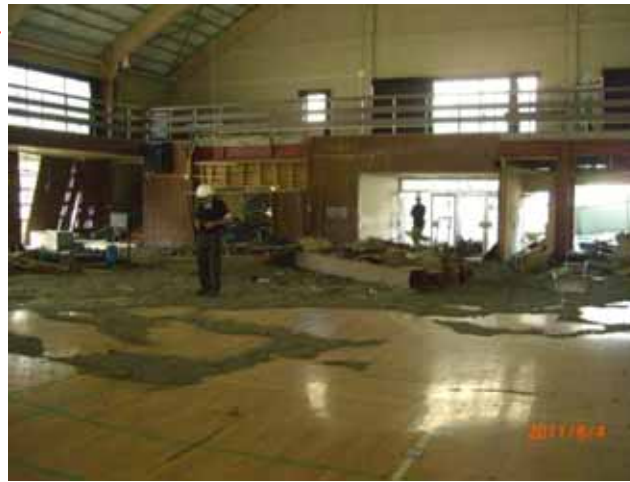
Uplifted supports under floor

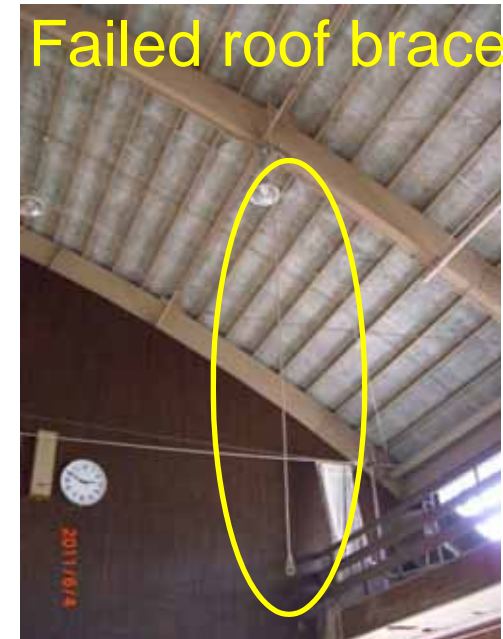
Failed roof brace

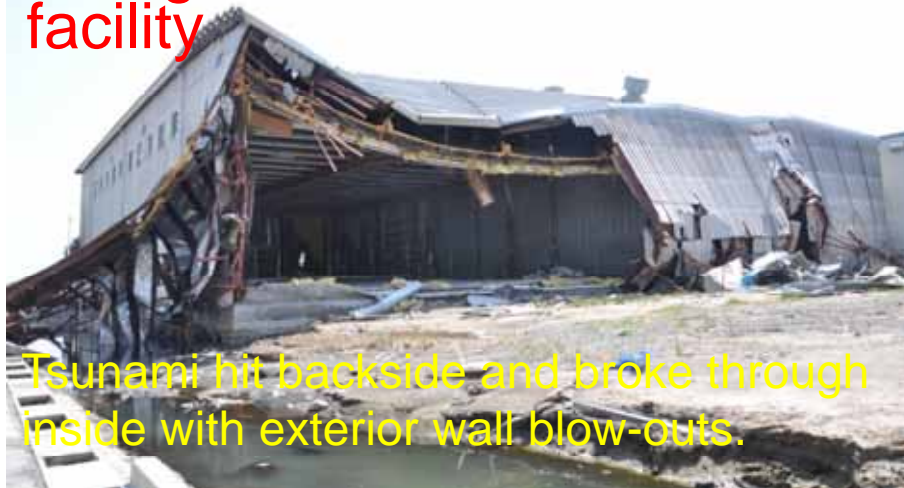
Refrigeration
facility

Tsunami hit backside and broke through
inside with exterior wall blow-outs.

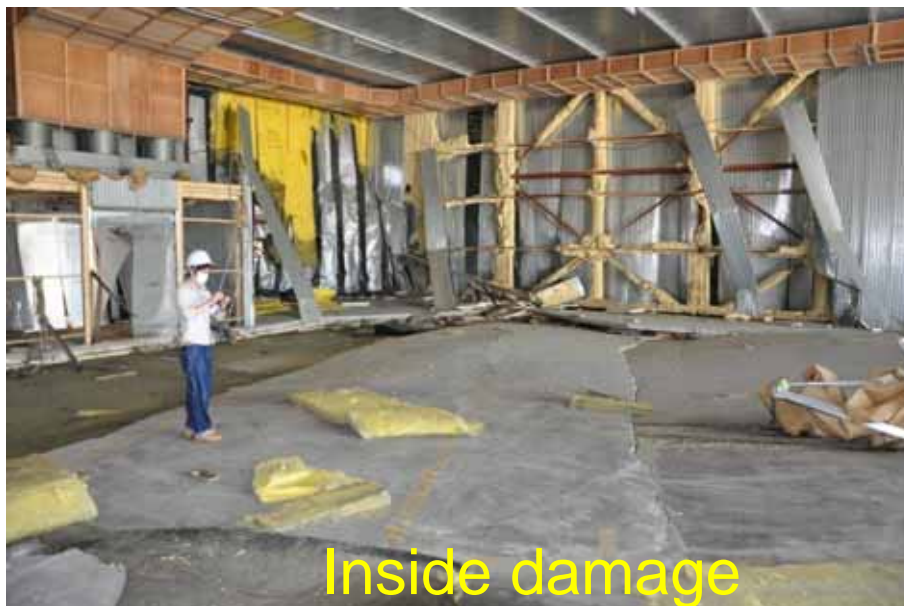
Inside damage

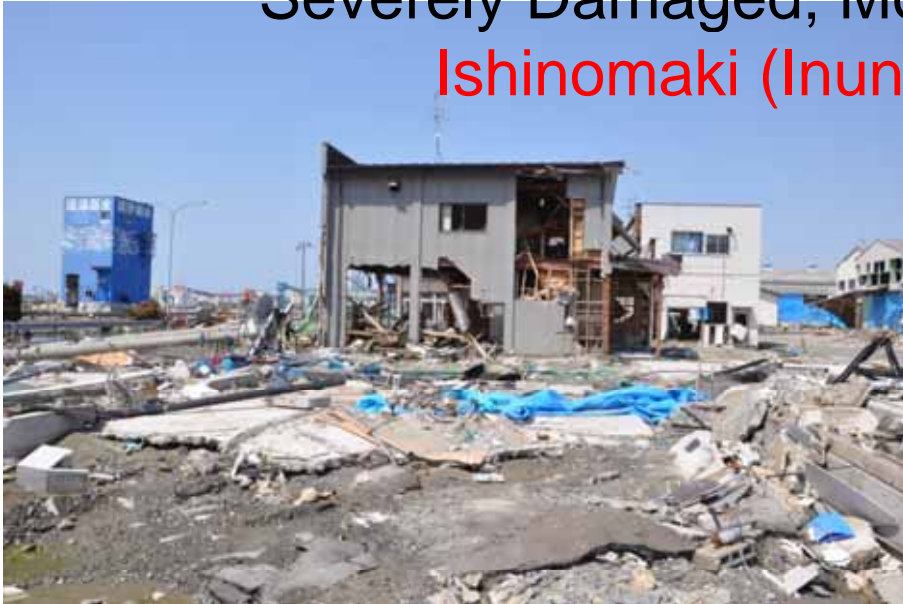
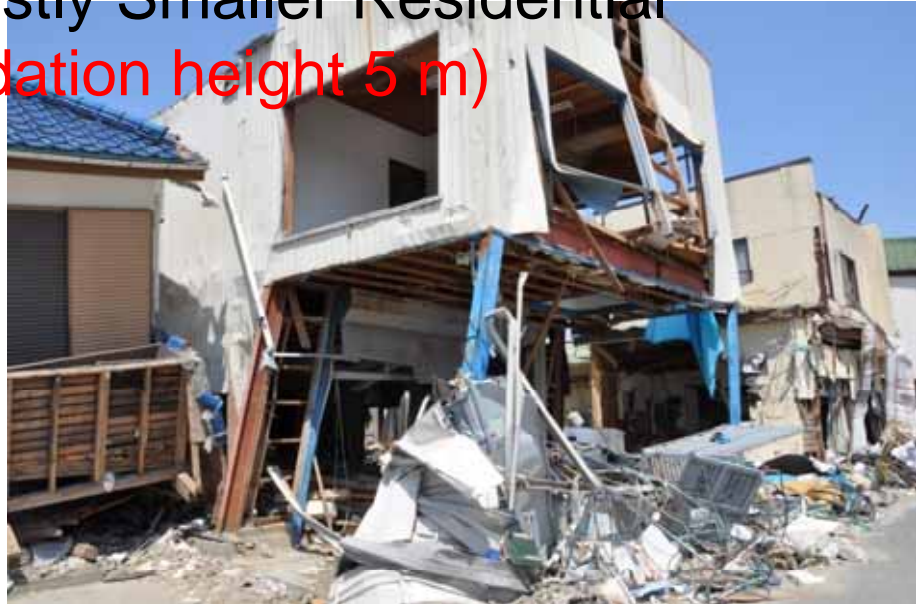
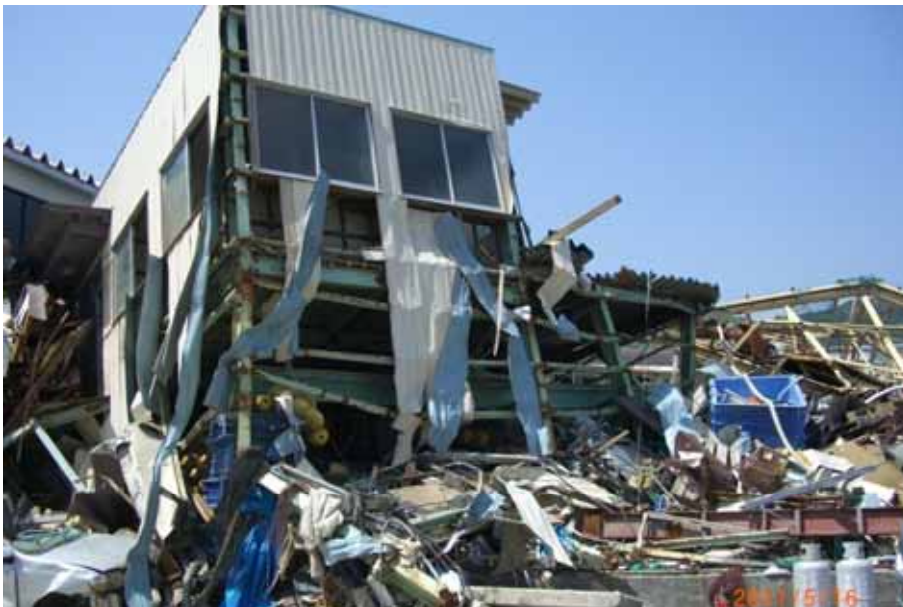
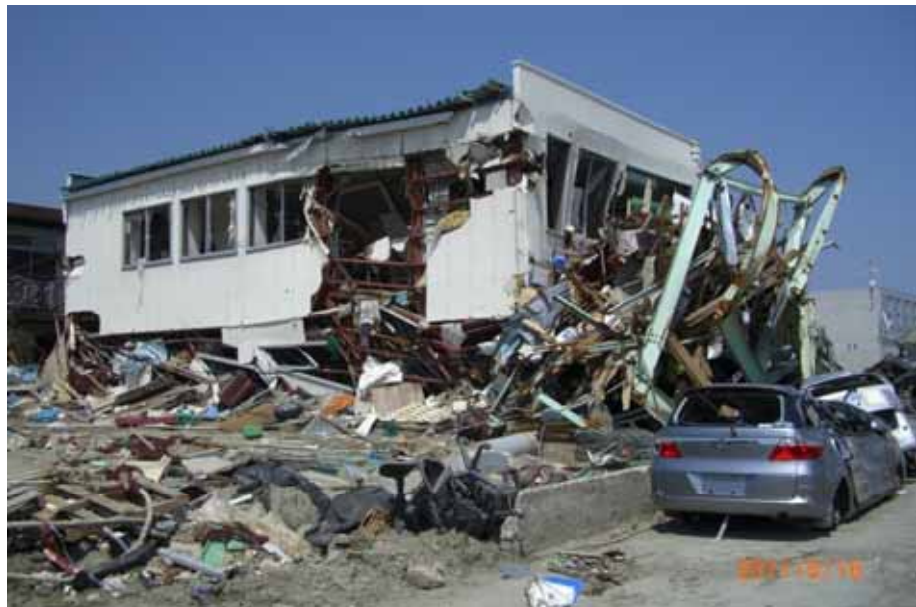
Ishinomaki (Inundation height 5 m)

Severely Damaged; Mostly Smaller Residential

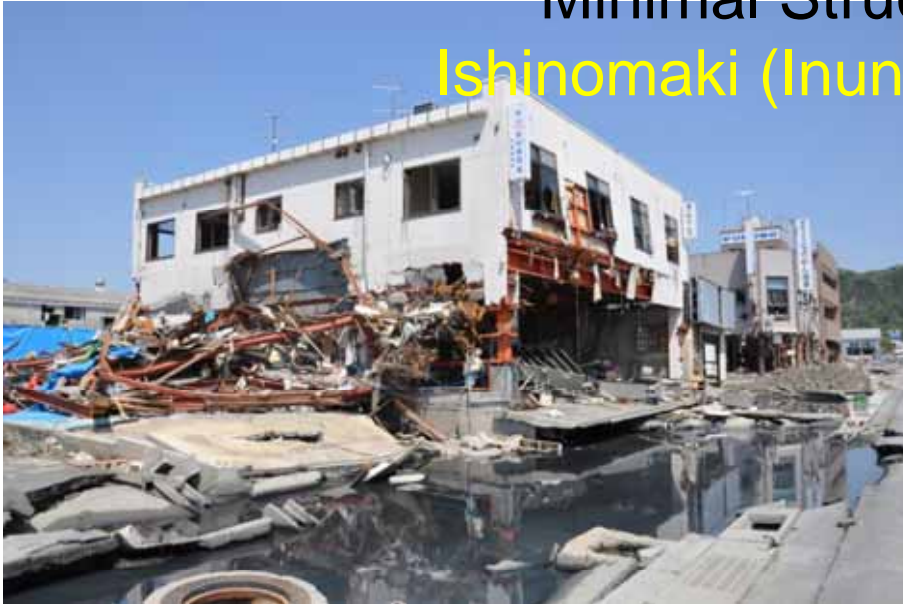
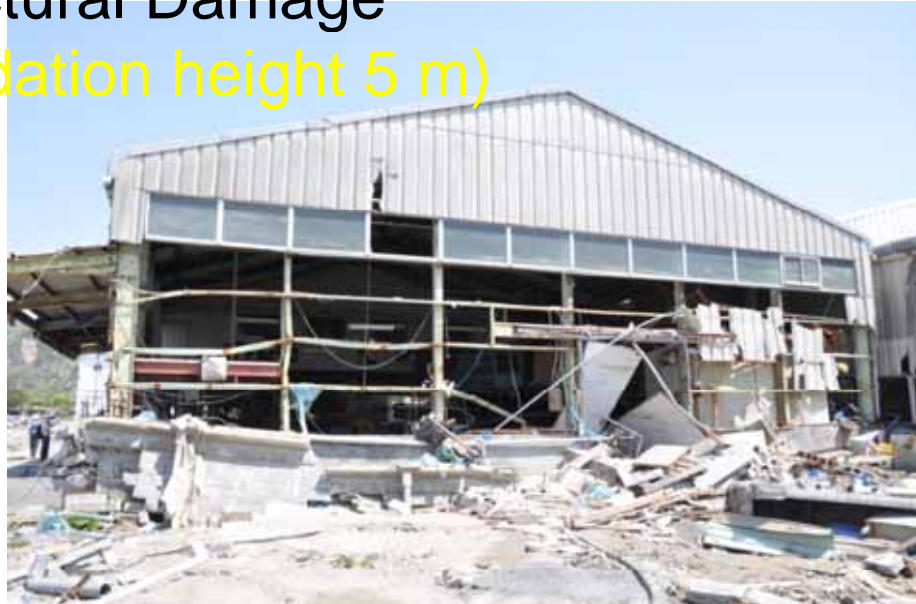
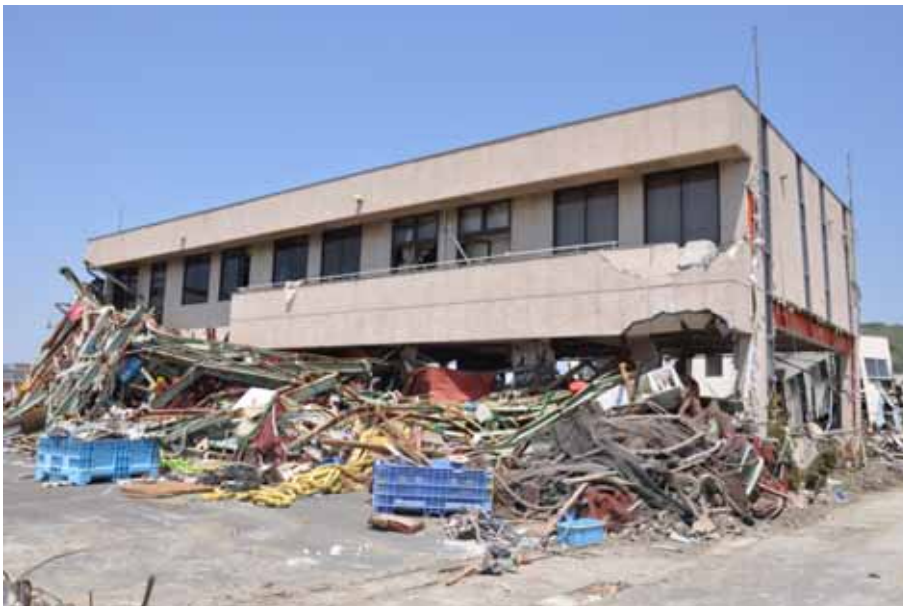
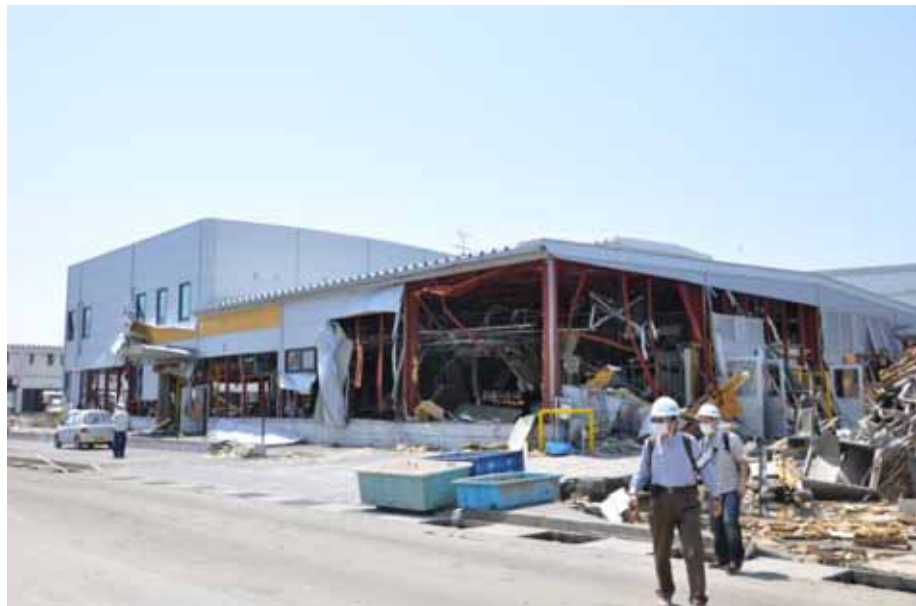
Ishinomaki (Inundation height 5 m)

Minimal Structural Damage

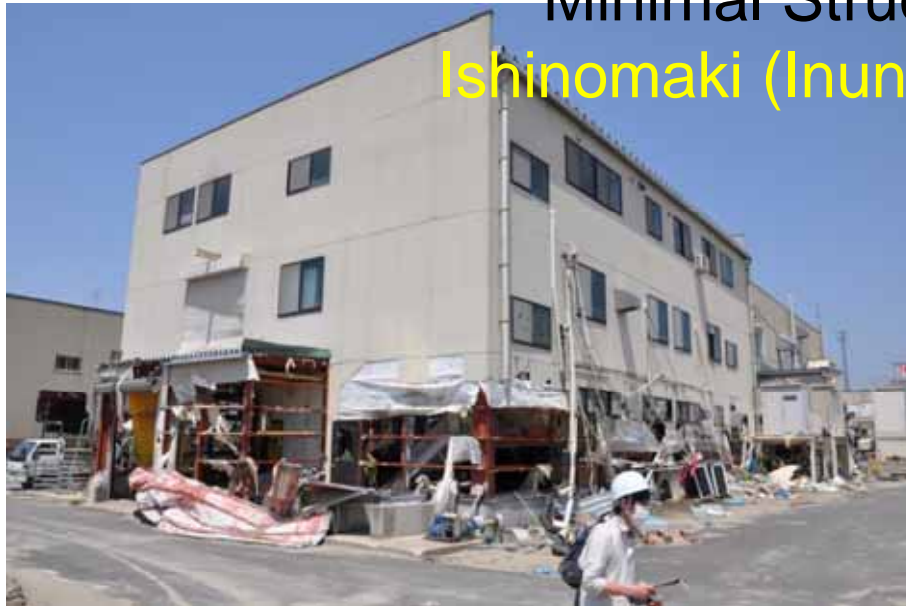
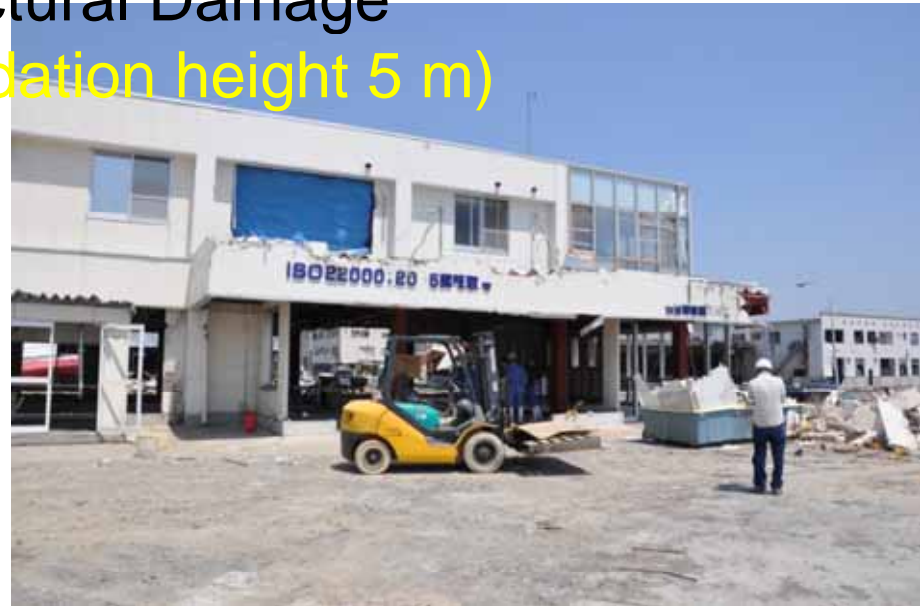
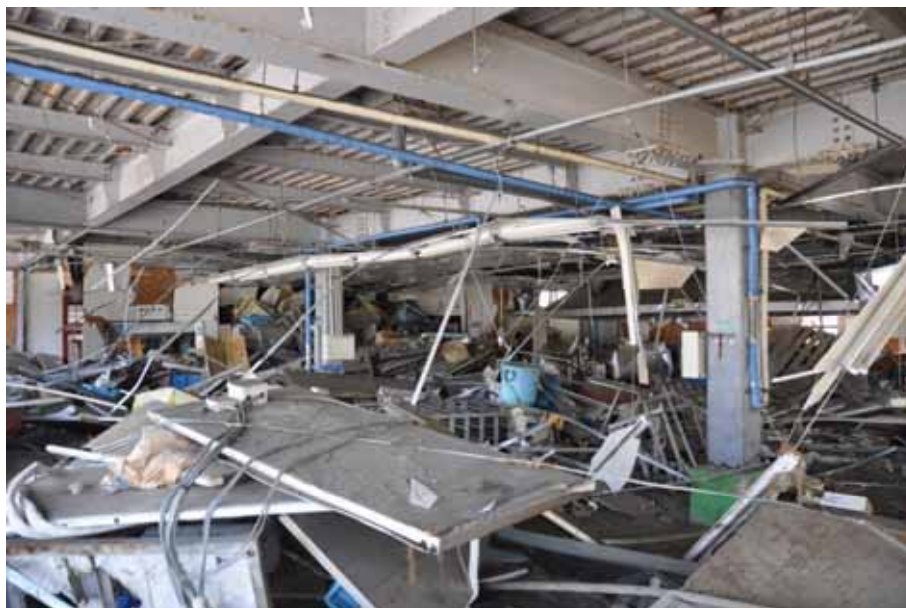
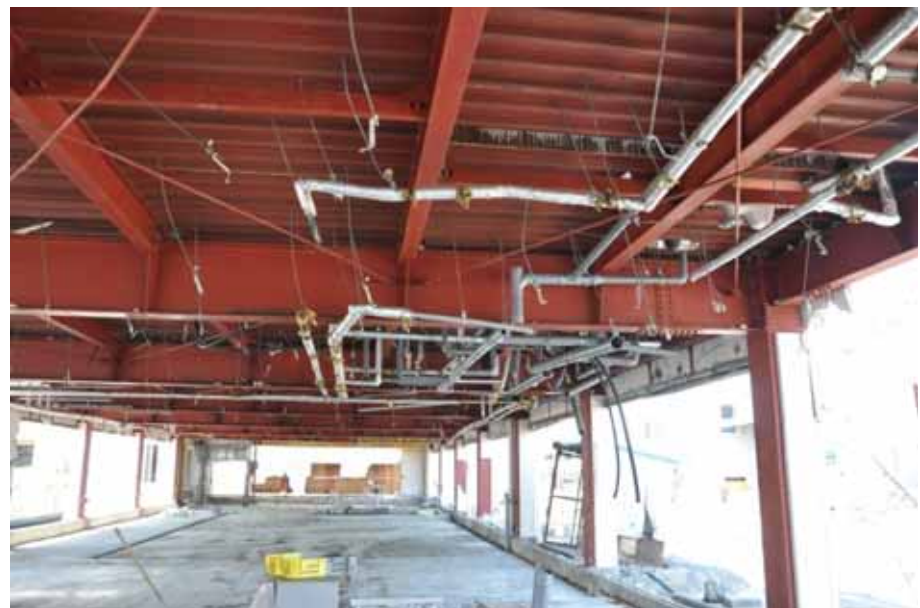
Ishinomaki (Inundation height 5 m)

Minimal Structural Damage

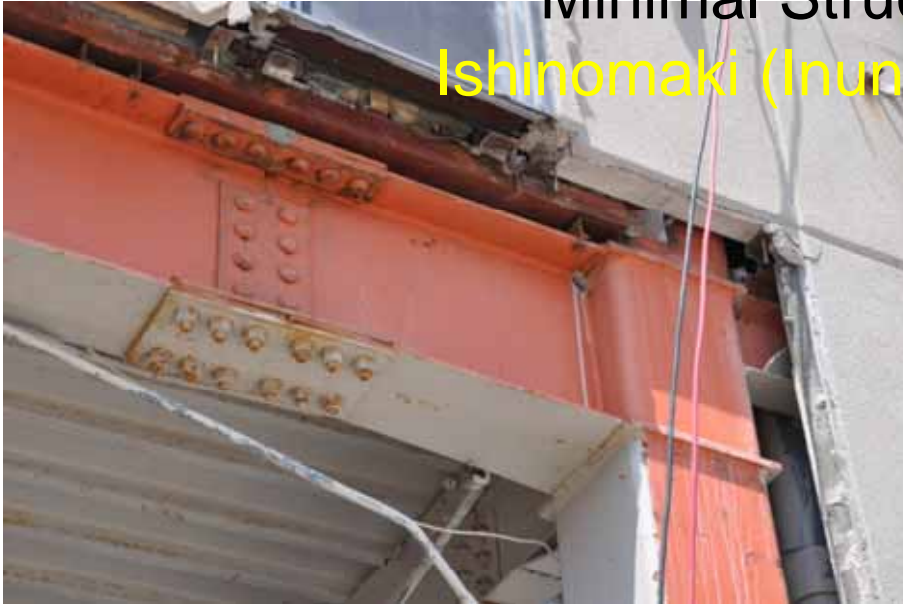
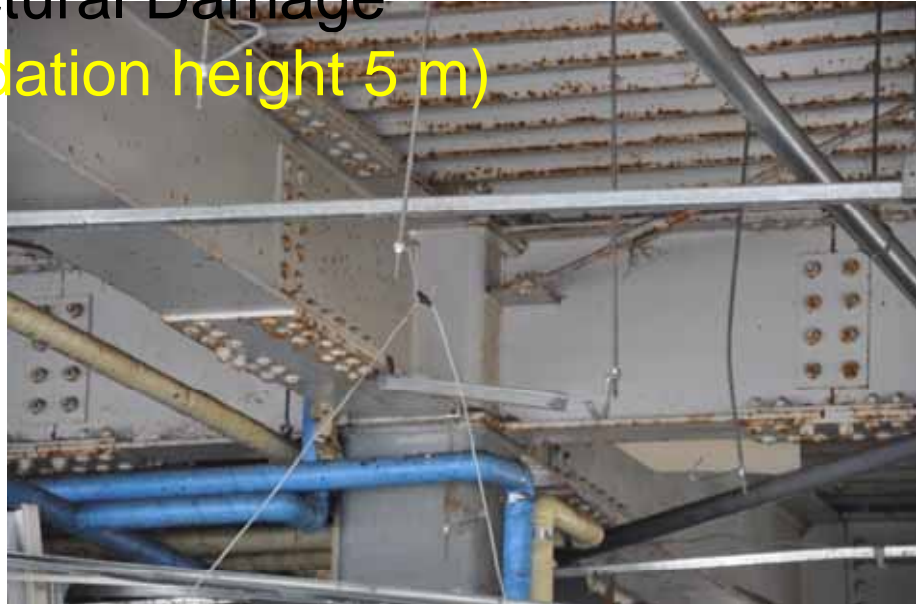
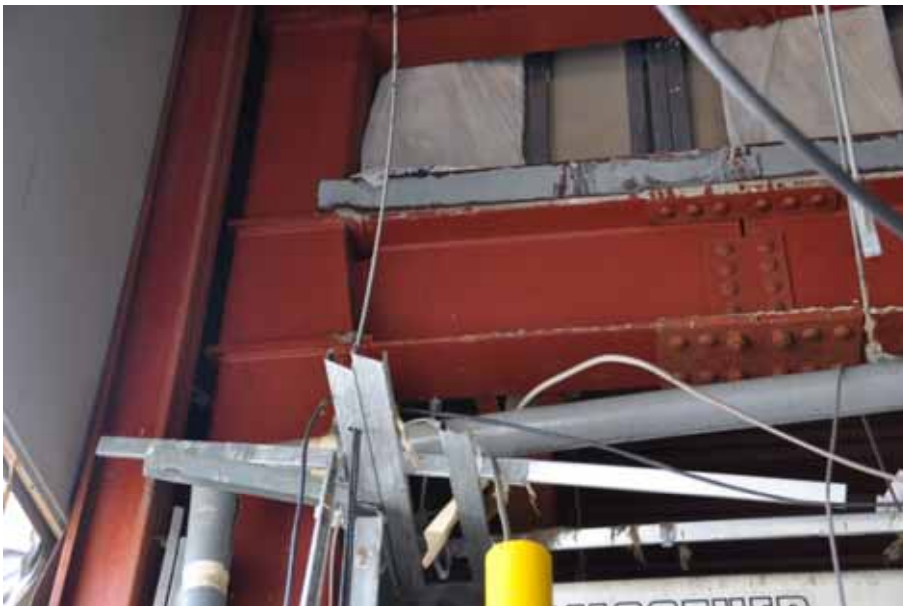
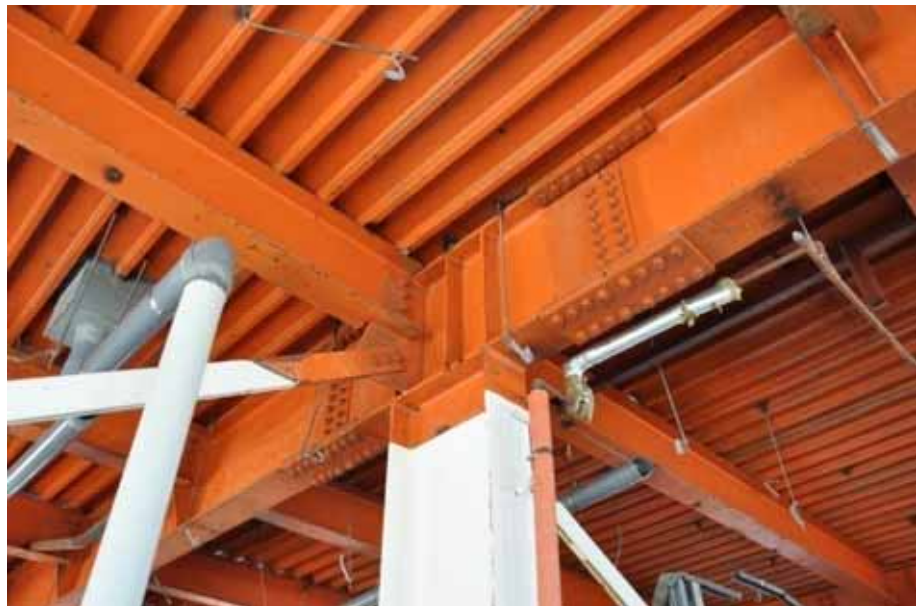
Ishinomaki (Inundation height 5 m)

Minimal Structural Damage

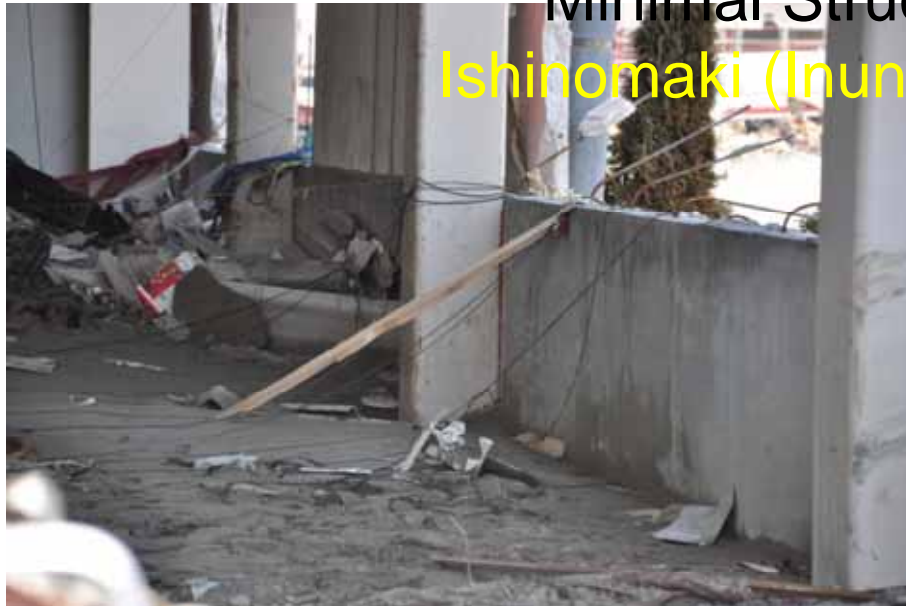
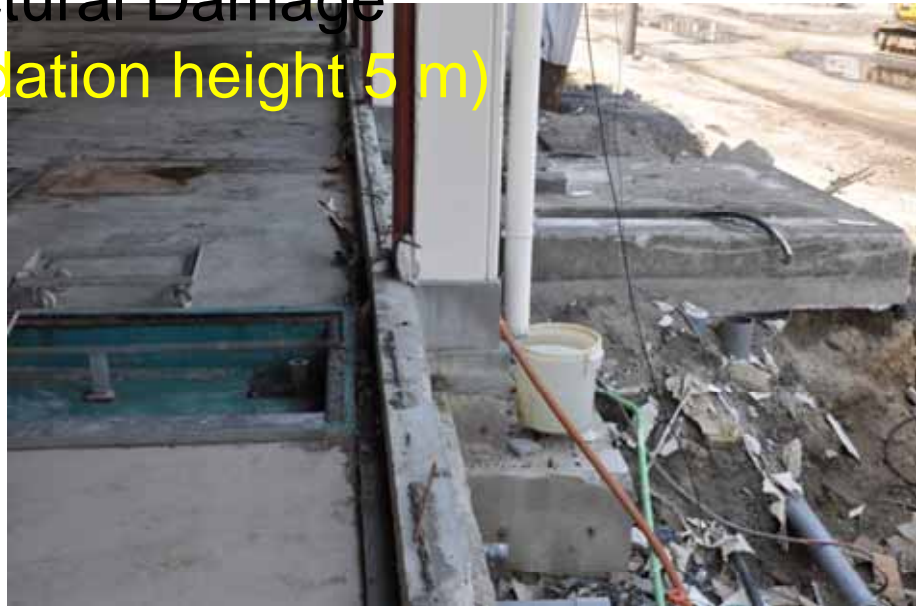
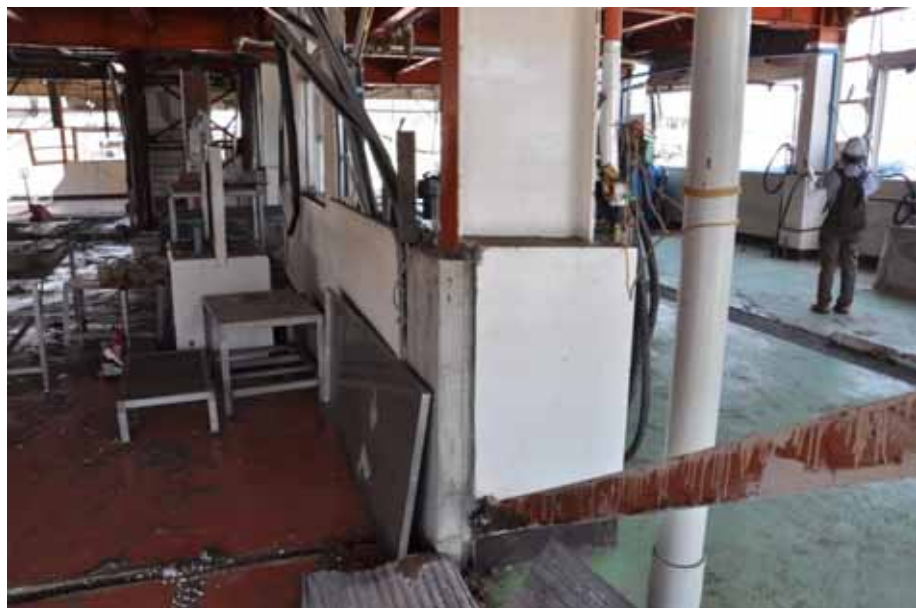
Ishinomaki (Inundation height 5 m)

Minimal Structural Damage

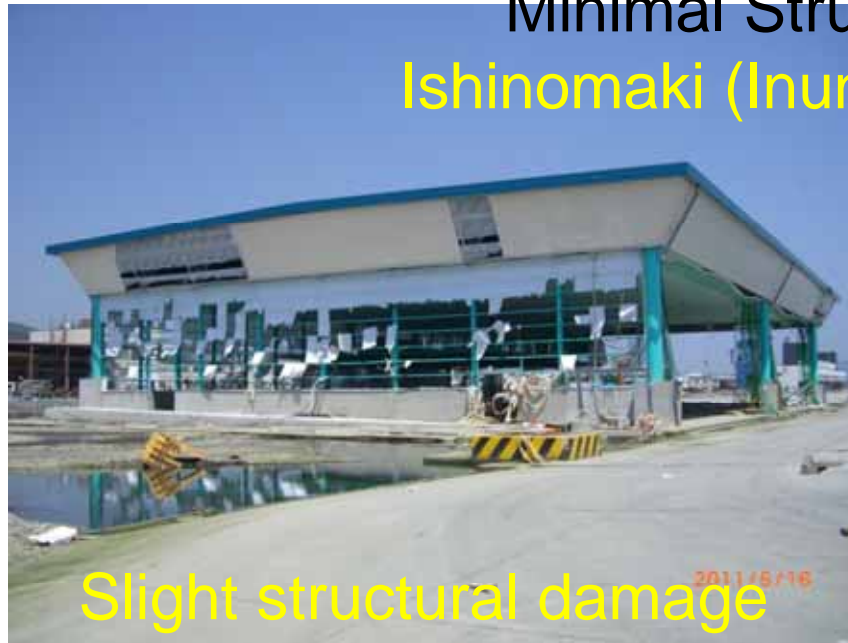
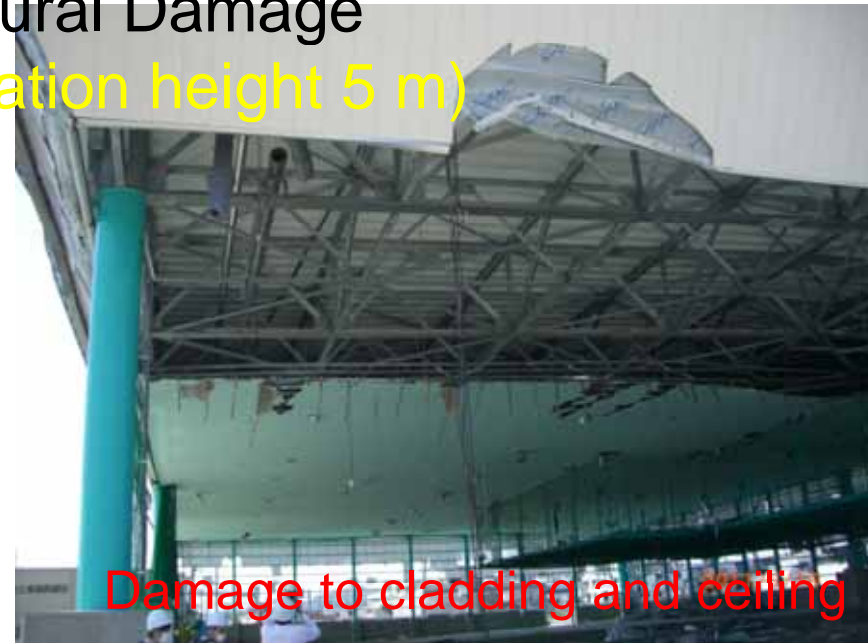
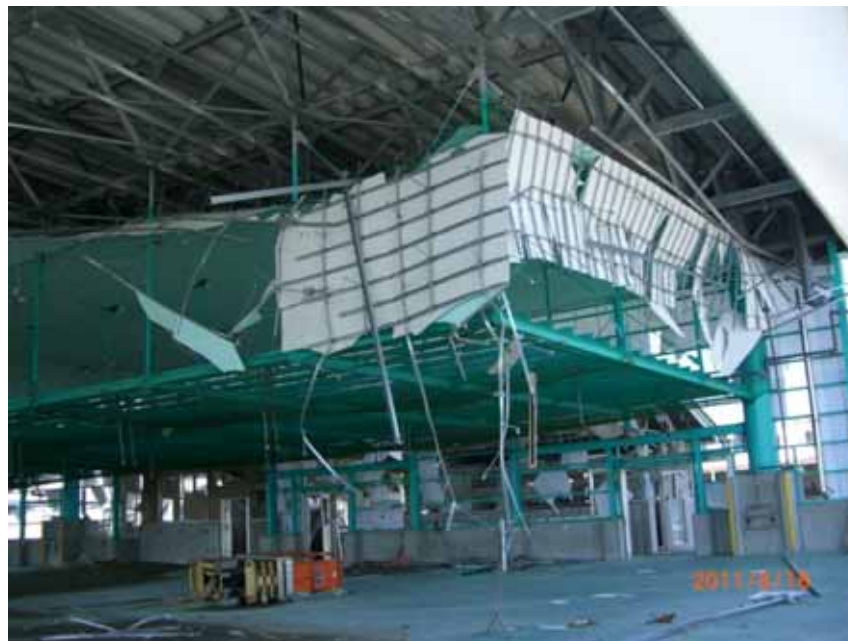
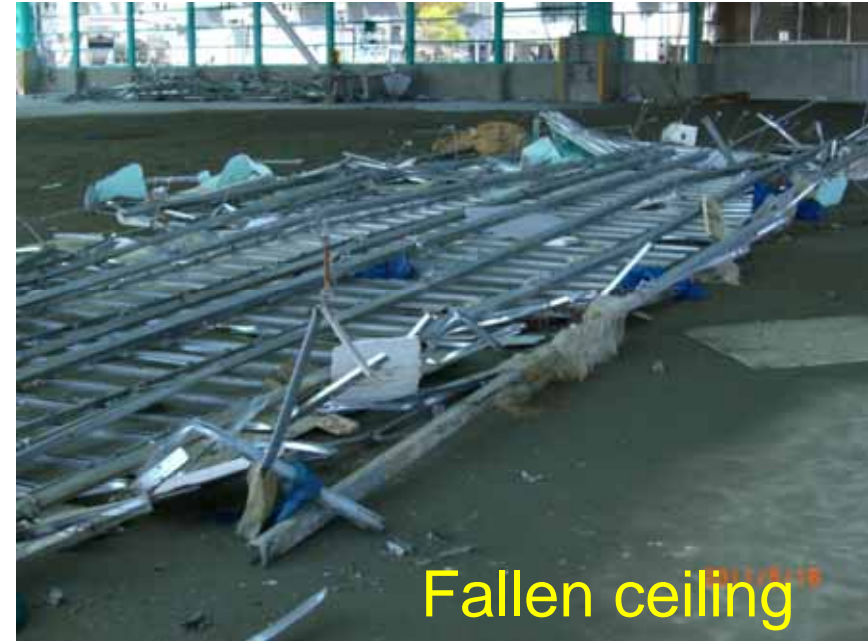
Ishinomaki (Inundation height 5 m)

Minimal Structural Damage

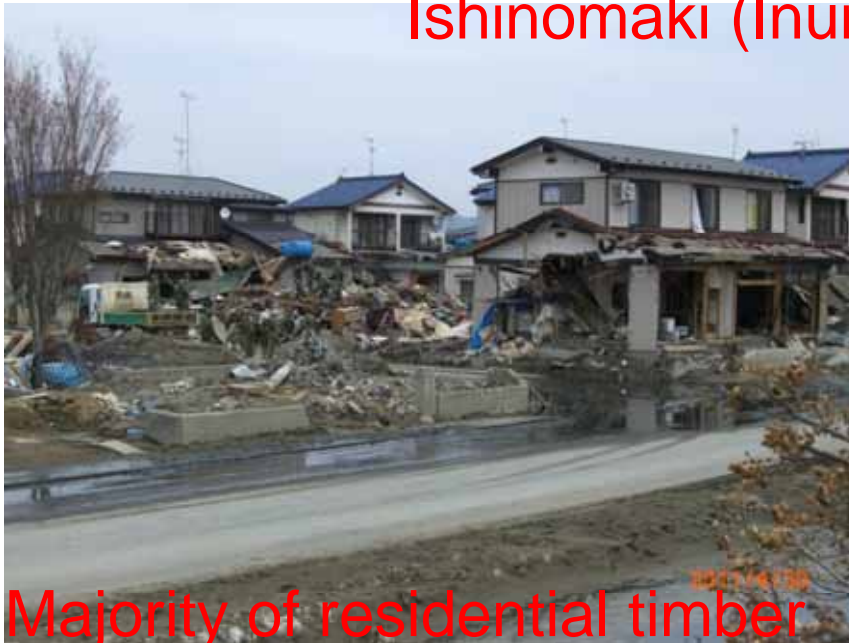
Ishinomaki (Inundation height 5 m)

Majority of residential timber buildings were washed away leaving sills and foundation.

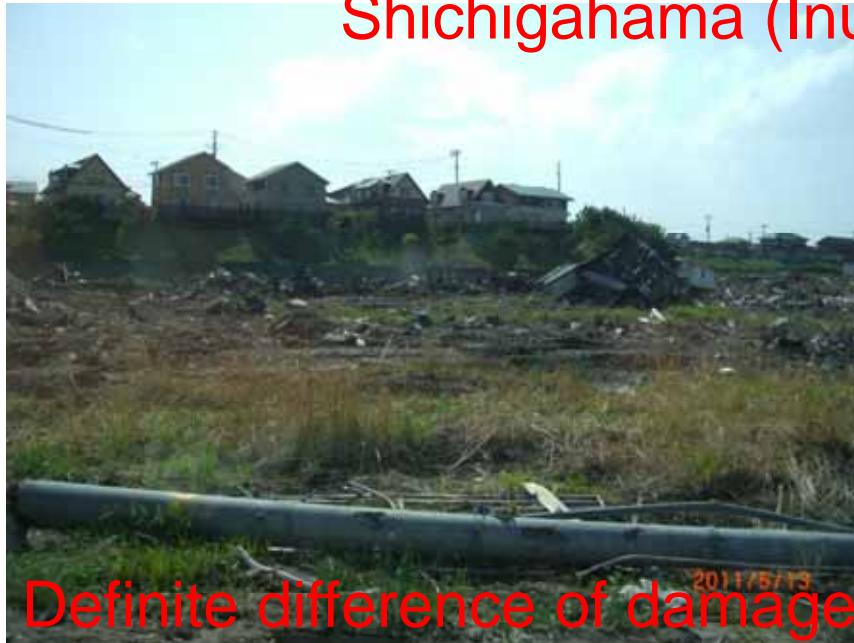
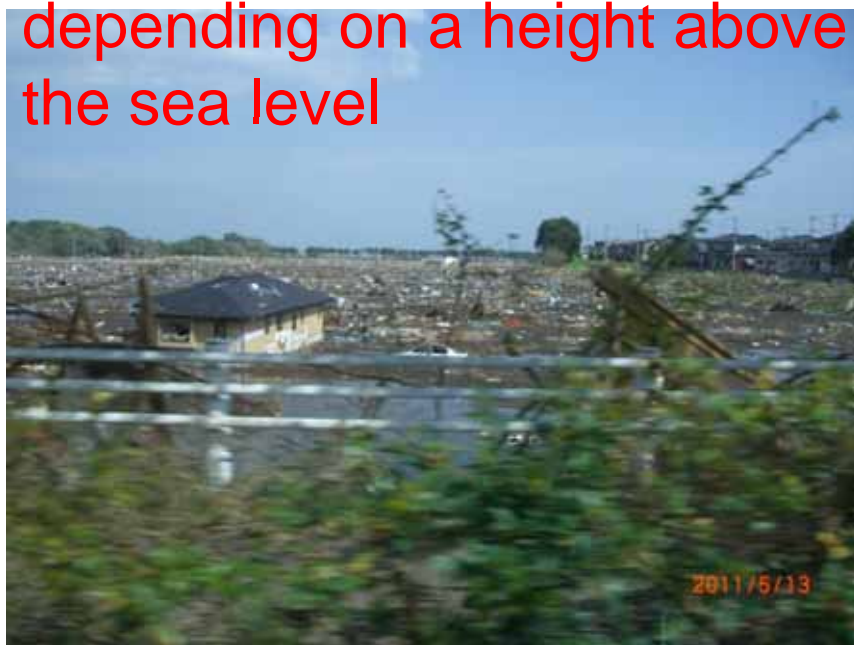
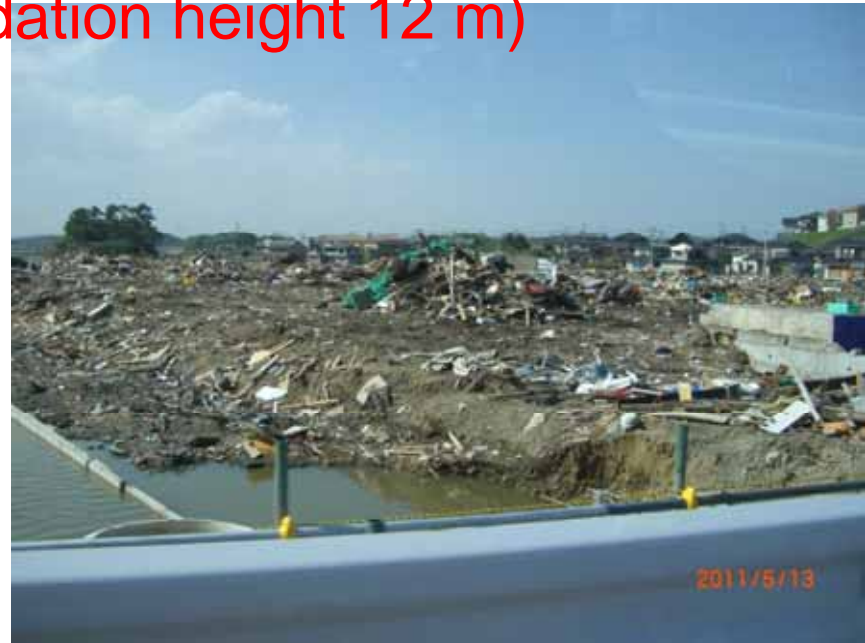
Shichigahama (Inundation height 12 m)

Definite difference of damage depending on a height above the sea level

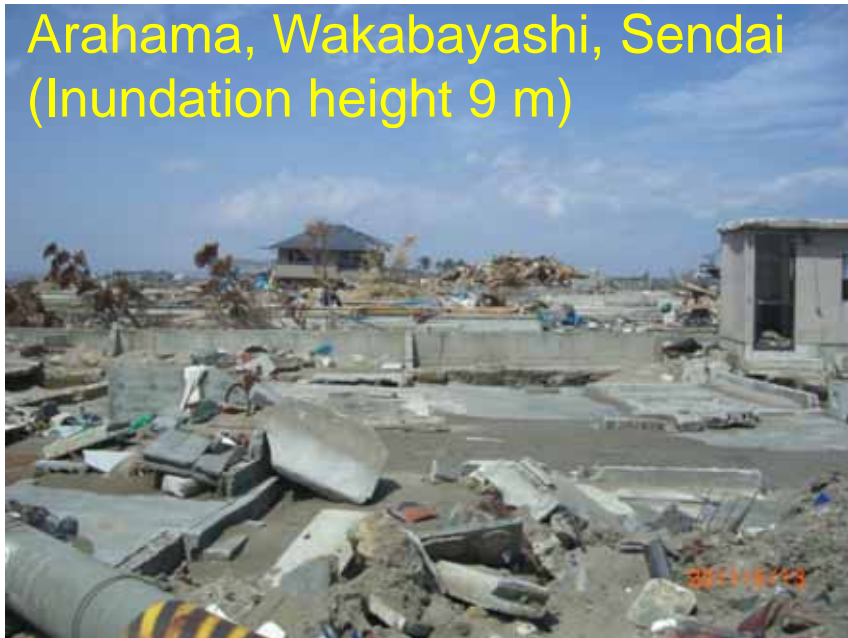
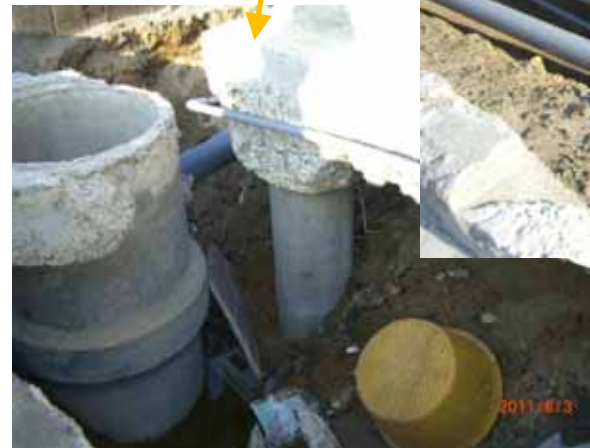
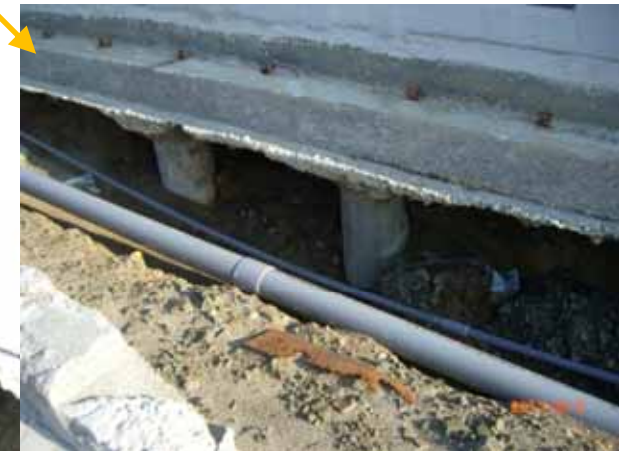
Arahama, Wakabayashi, Sendai
(Inundation height 9 m)

Foundation after
scouring

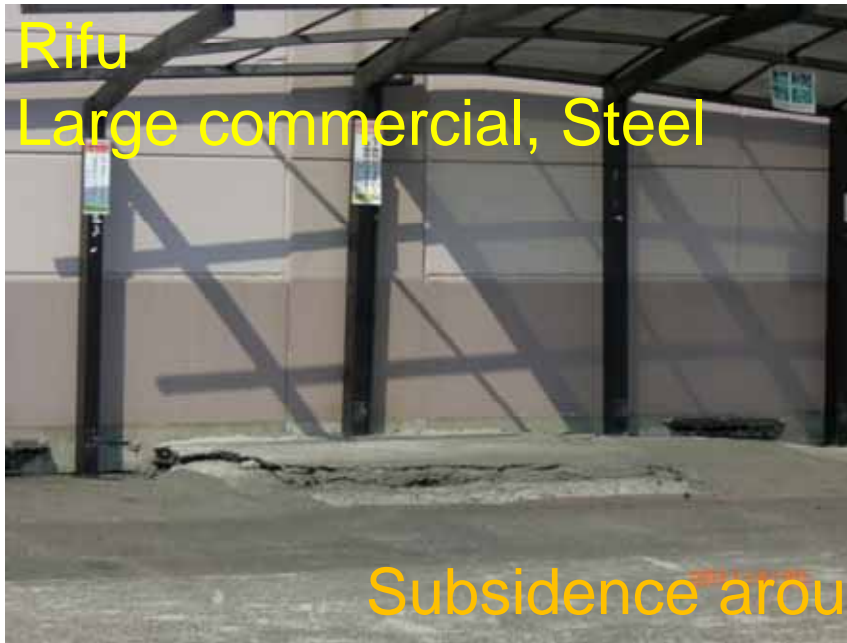
Rifu

Subsidence around footing foundation

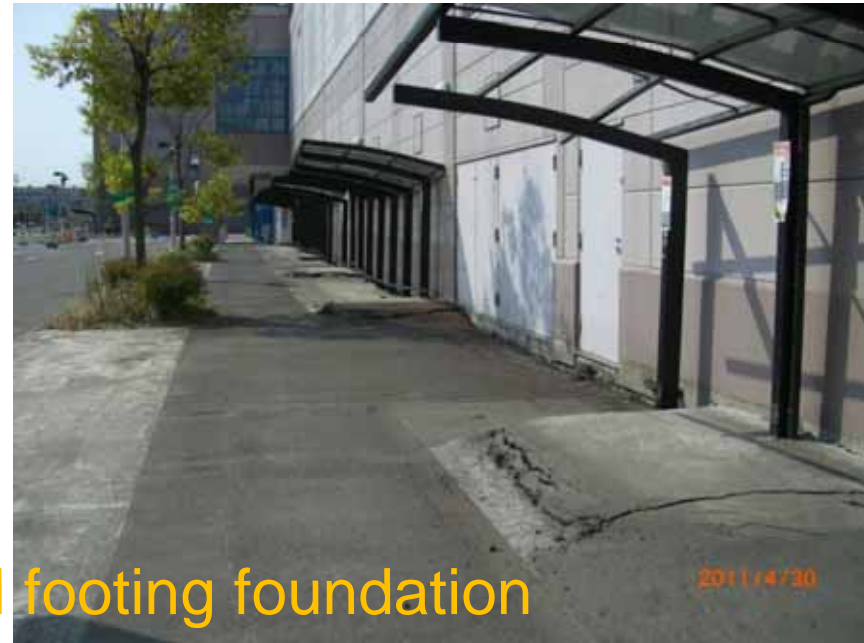
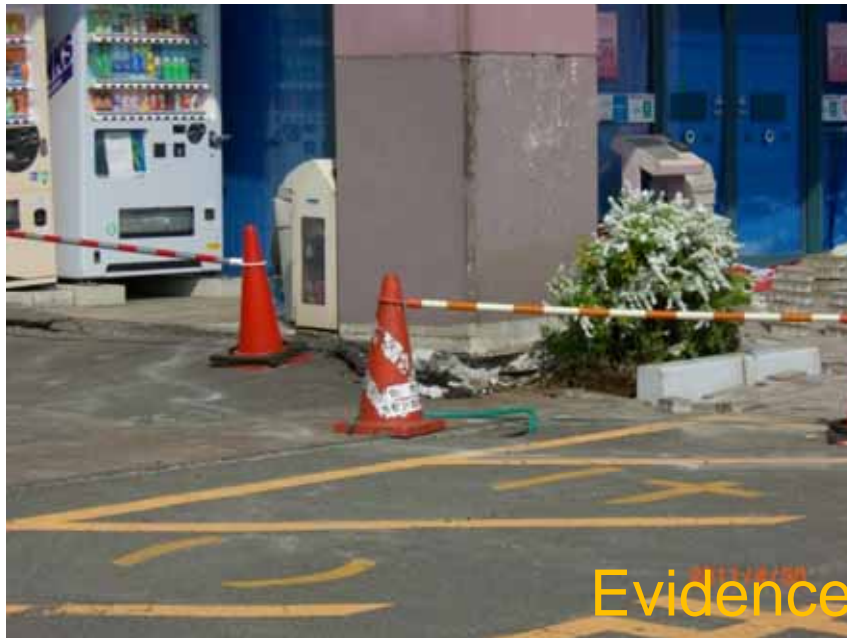
Evidence of subsidence
