Seismic and Tsunami Damage on Building Structures Caused by the 2011 Tohoku Japan Earthquake

MIDORIKAWA Mitsumasa
Hokkaido Univ.

Damage to Buildings Caused by Ground Shaking and Tsunami

Summary of damage reconnaissance by the Steel Structures Committee of AIJ

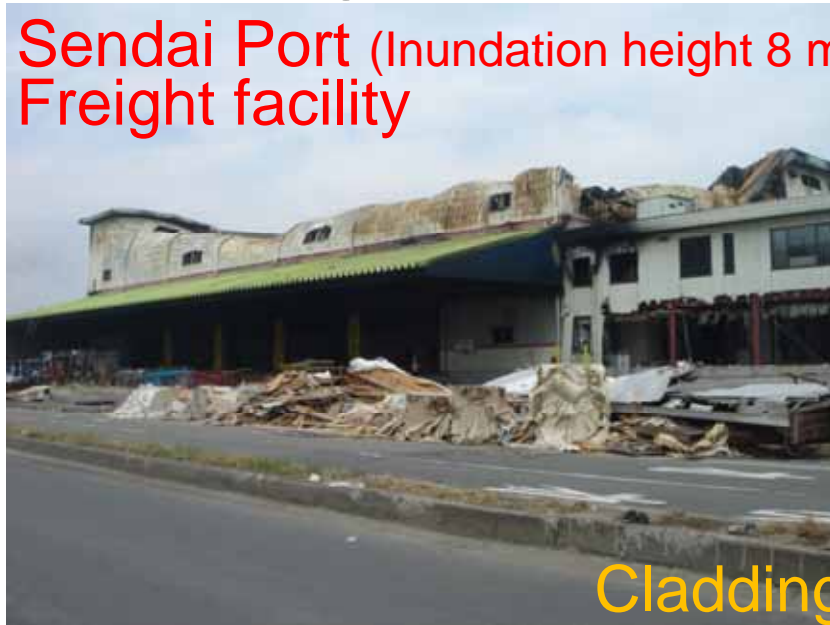
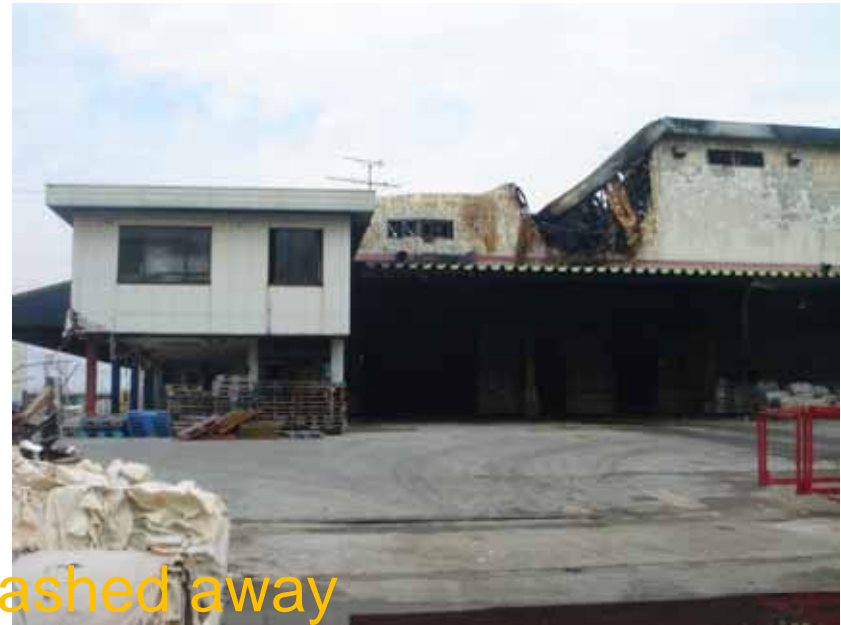
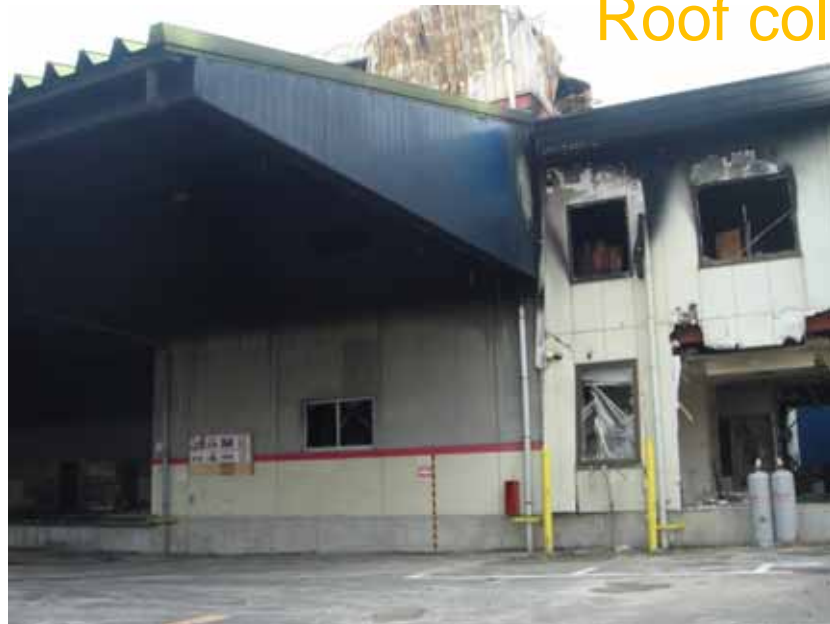
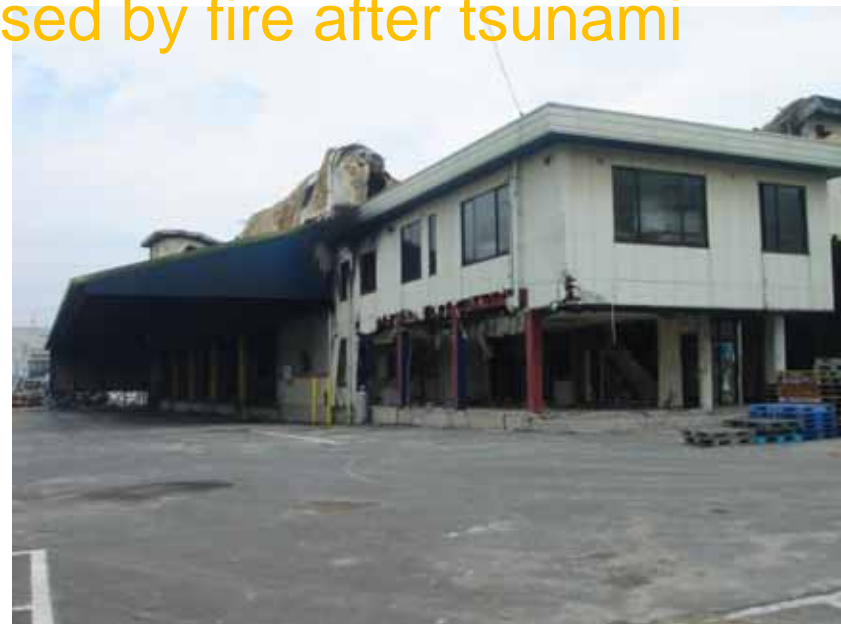
Sendai Port (Inundation height 8 m)
Freight facility

Cladding washed away
Roof collapsed by fire after tsunami
