# **Report on the Damage Investigation of the 2001 Atico Earthquake in Peru**

**Koichi KUSUNOKI**

**Senior Researcher  
Building Research Institute of Japan**

April 2002

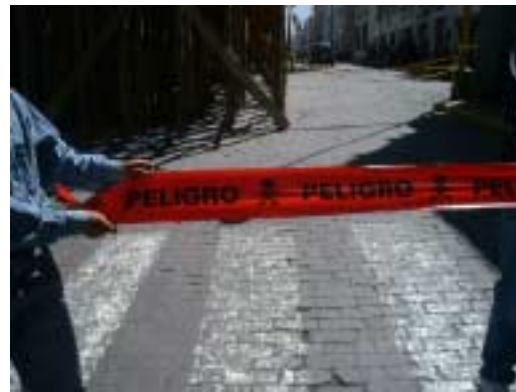
**Picture 2-1-7-5.** 'Danger' sign placed by INDECI.

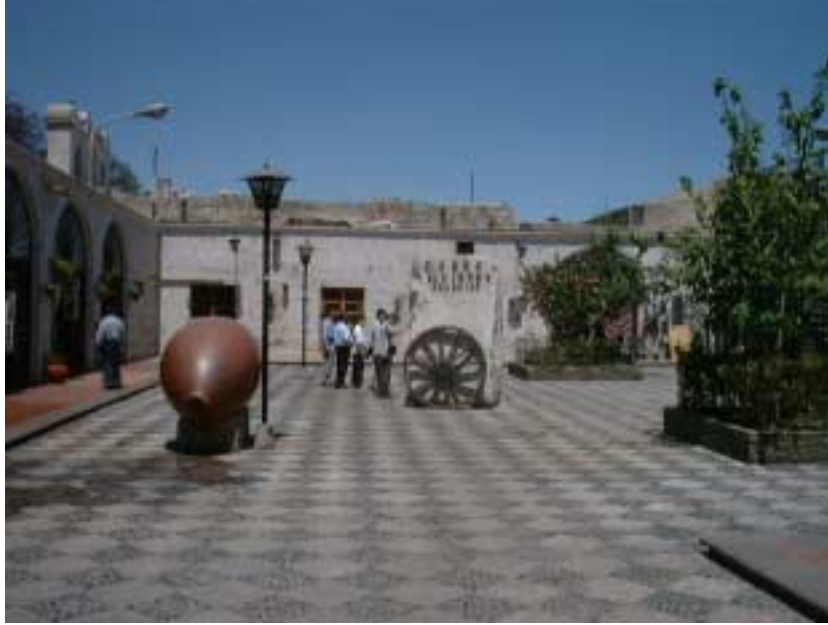
This used to be a luxurious residence, but was rebuilt as a shopping center after being damaged in the 1960 earthquake. Before reconstruction, it had two stories (basement level plus one floor). After the 1960 earthquake, the basement was filled in and the first floor rebuilt into a shopping center. Reconstruction was conducted with the technical cooperation of SENCICO (National Service for Trading to the Construction Industry). Only sillar blocks were used for reconstruction and the original structure was not changed. This building was intact after the earthquake.

**Picture 2-1-9-1.** Full view of the one-storied shopping center.

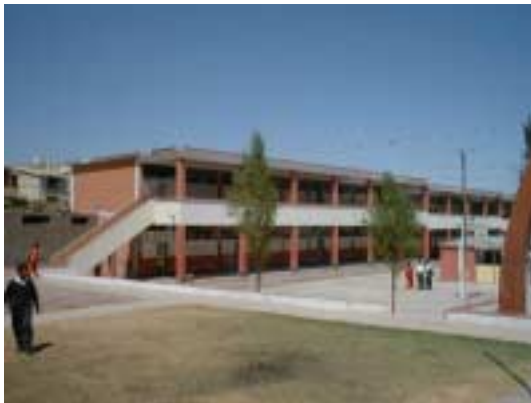
A two-storied building with a 6 x 1 span, with a structure in which brick walls are inserted into RC frames. The span in the longitudinal direction is 6 m, the span direction has a length of 3 m, and the story height is about 3.5 m. Columns on the first floor were shortened because they were limited in height by the nonstructural wall (brick; 2 m in height). Shear failure and bond splitting were observed in these short columns. The space between hoops was a very wide 25 cm.

**Picture 2-2-3-1.** Full view of the schoolhouse.

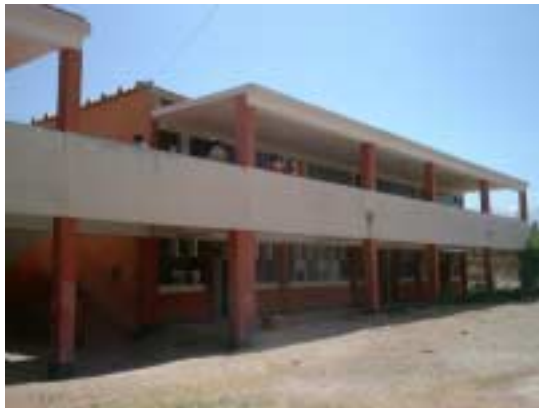
This two-storied building with 4 x 3 span has a structure of brick walls inserted into RC frames on the first floor and concrete blocks on the second floor. The story height is about 3.5 m. An engineer designed the first floor, and the second floor was homemade. Only the second floor suffered damage from the earthquake: there were shear cracks on the wall in the span direction, and the roof supports collapsed.

**Picture 2-2-3-4.** Full view of the building.

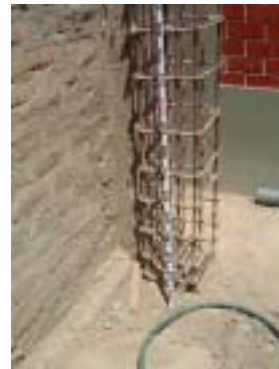
**Picture 2-2-4-7.** Bar arrangement of the extended part.

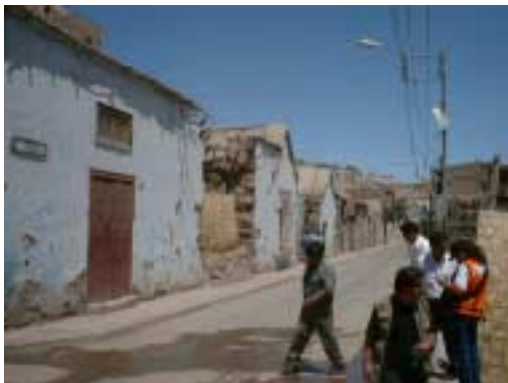
In the Centro District, the damage rate of adobe buildings was no higher than that in the San Francisco District. The damaged adobe houses were studded. There is no standard for adobe blocks; most were about 40-80 cm in size. Adobe walls are occasionally built two layers thick. INC (Peru's National Institute of Culture) has been conducting measurements of crack width in affected buildings for potential widening. The walls of affected adobe walls collapsed mostly out-of-plane. Safety measures, such as the hooping of entire buildings, are required.

**Picture 2-2-5-1.** Street scene in Centro.

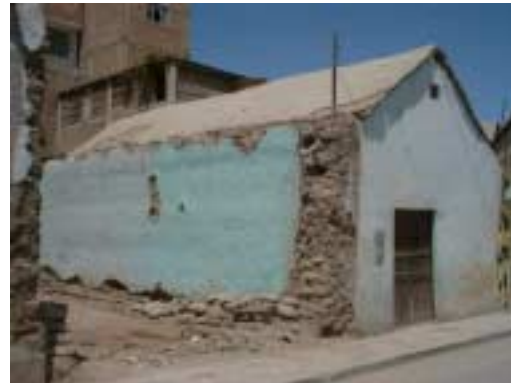
**Picture 2-2-5-2.** An adobe house saved from damage.

The collapsed house nearby was removed. The shape of the roof is called moginete-style. Bamboo-like lumber is used.

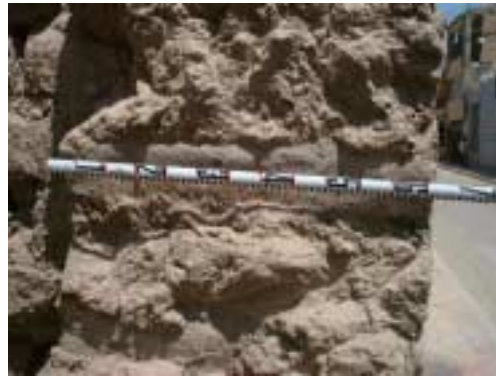
**Picture 2-2-5-4.** Unit length of an adobe block.

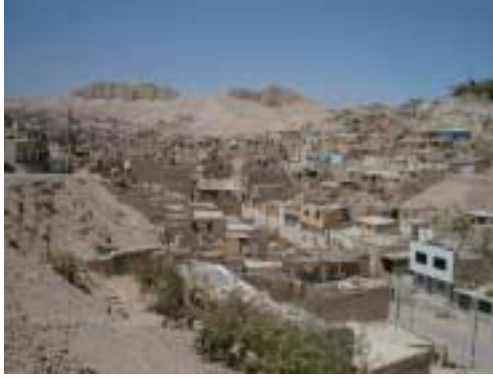
Approximately 80% of the buildings in this area are made of adobe, and most suffered some degree of damage. This district contains a ravine. Houses on the sloping areas suffered more damage than on the bottom, probably due to soil amplification. The construction of dwellings had started from the upper slopes and was extending to the bottom. No major damage was observed in non-adobe buildings. The inhabitants of buildings on this sloping area will be relocated to the Pampa de Chanchan District, which, although known to be comprised of soft bentonite, is the only available district to which people can be moved since the other potential site for relocation, the San Antonio District, is already overcrowded. The Peru-Japan Center for Seismic Research and Disaster Mitigation (CISMID) conducted a geological survey of the Pampa de Chanchan and advised that adobe buildings should be limited to one story.

**Picture 2-2-7-1.** San Francisco District. It appears to be ravine.

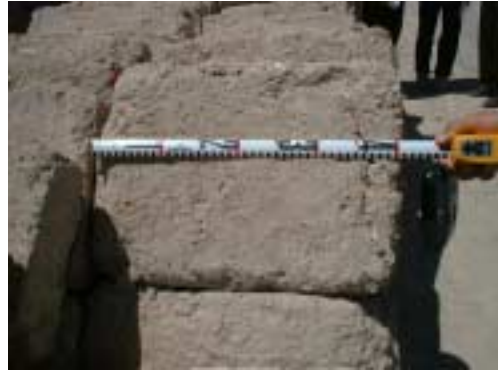
**Picture 2-2-7-2.** The size of adobe blocks used. The adobe walls are thinner than those used in the Centro District.

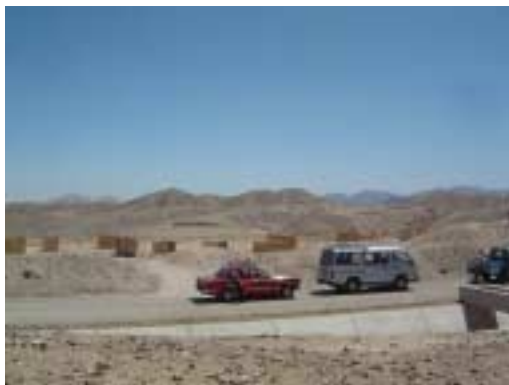
It is planned to move the population from the seriously damaged San Francisco District to the Pampa de Chanchan district. However, its expandable clay soil is now under survey and measures are being discussed. Problematic illegal occupancy has already occurred. Some people have already obtained homes in other districts and rent illegally occupied dwellings to others. Roads to the center of the city are under construction in the area.

**Picture 2-2-8-1.** Watercourse and illegal occupancy.

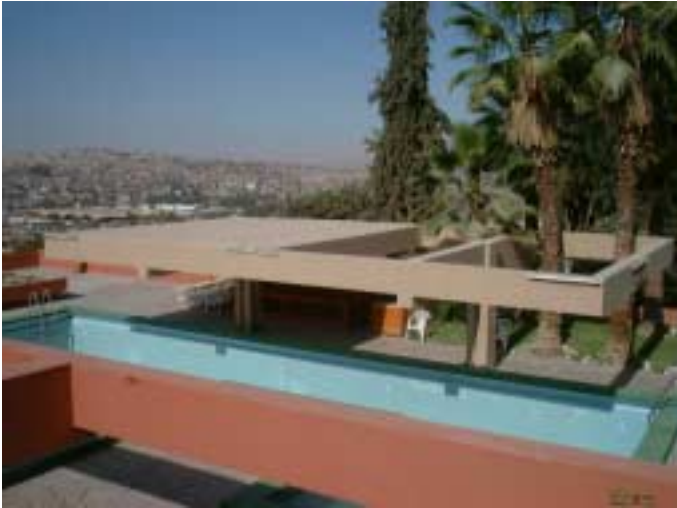
**2-2-9 A column holding a sunshade at the poolside of the El Mirador Hotel**

Flexural failure of a column holding a sunshade at the poolside of the hotel occurred at its base. Two columns had supported a roof slab. One column carried only a roof frame and the other carried a roof slab; the latter column base suffered flexural shear failure. The reinforcement bars, which were jointed at the terminal hinge region, had buckled.

**Picture 2-2-9-1.** Full view.

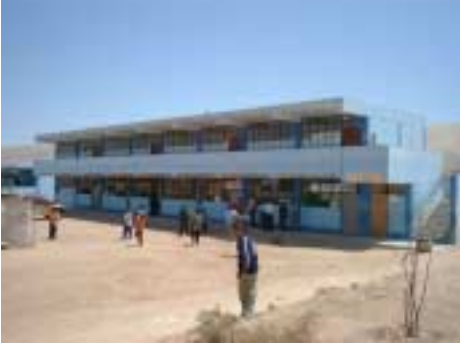
This is a two-storied schoolhouse with an 8 x 1 span, constructed in 1994. In the longitudinal direction, which extends to the northeast, it has a span of 4 m, a length of 5 m in the span direction, and a story height of about 3 m. Deformed bars were also used as lateral reinforcing bars; the size of columns was 45 cm x 36 cm, width at the core measured about 20 cm, and the thickness of covering concrete was about 7.5 cm. There is a wall in the span direction every other span. Structural calculations may have been performed for the walls; however, different diameters of reinforcement bars of columns and different types of reinforcing

**Picture 2-3-4-1.** Full view of schoolhouse.

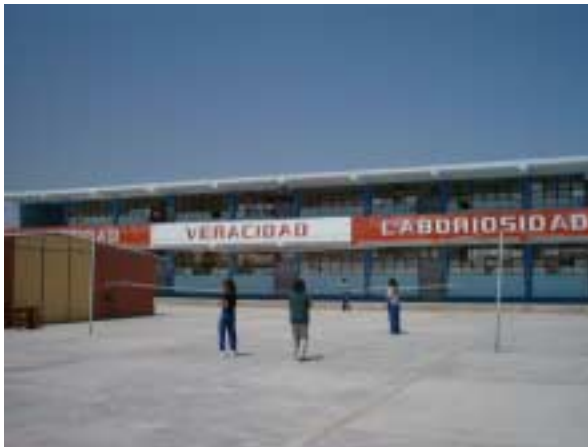
hoops were used (round steel for parts where nonstructural walls were attached, and deformed bars for parts without nonstructural walls). Concrete blocks were used for the walls. A two-storied schoolhouse at the same site and facing in the same direction, which was constructed with assistance from Japan in 1990, suffered slight damage, including a shear crack in one column.

**Picture 2-3-4-8.** A two-storied schoolhouse (1990) Constructed with assistance from Japan.

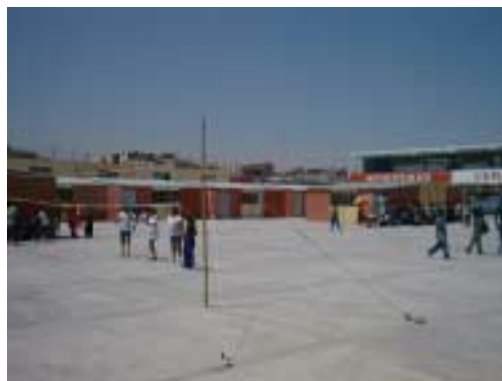
**Picture 2-3-4-10.** Classes are now being conducted in a temporary structure.

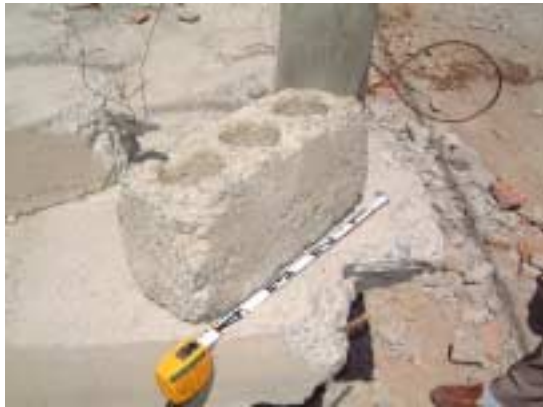
**Picture 2-3-5-3.** Concrete blocks.

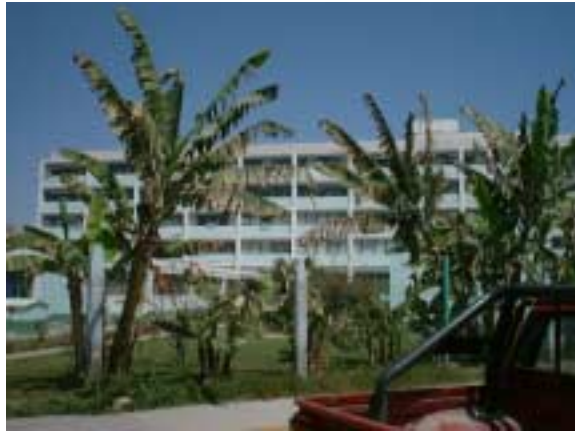
This is a national hospital with 5 floors and 1 basement level, constructed around 1950. Its structure features an R/C frame with CB wall and several brick walls. It sustained minor damage, including slight cracks in nonstructural walls. After the earthquake, both public water supply and sewerage broke down, and the gas supply facility was seriously damaged. The steam machine (used by the hospital for disinfection) was also damaged and needed to be replaced, but the entire set of equipment, including buried piping, should in fact be replaced. Normally, groundwater is pumped into an elevated water tank, but the pump did not work after the earthquake. Even now, only outpatients and emergency patients are accepted, and the number of hospital beds is very limited. The structure of the building itself is intact, but hard putty was used in the window frames, which increases the risk of shattering glass during the next earthquake.

**Picture 2-3-6-1.** Full view of the building.

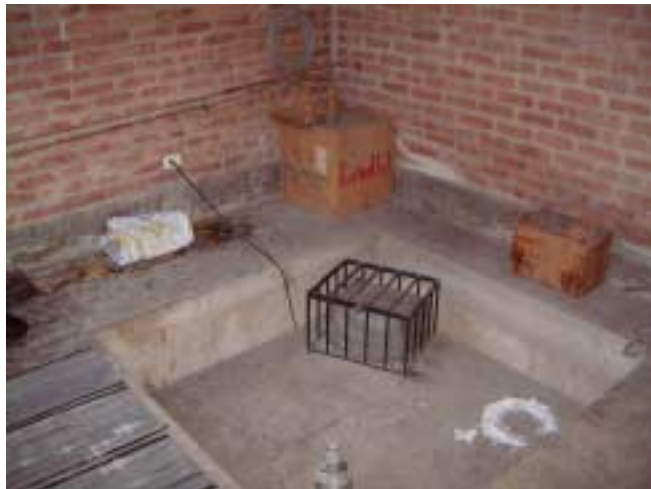
**Picture 2-3-7-4.** The seismometer.
